# **A Possible Prehistoric Boundary, Roman Field System and a Medieval Pit**

**Archaeological Watching Brief at 30 Barton Road,  
Market Bosworth, Leicestershire in 2024**

Archaeology Warwickshire  
Report No 2456  
October 2024

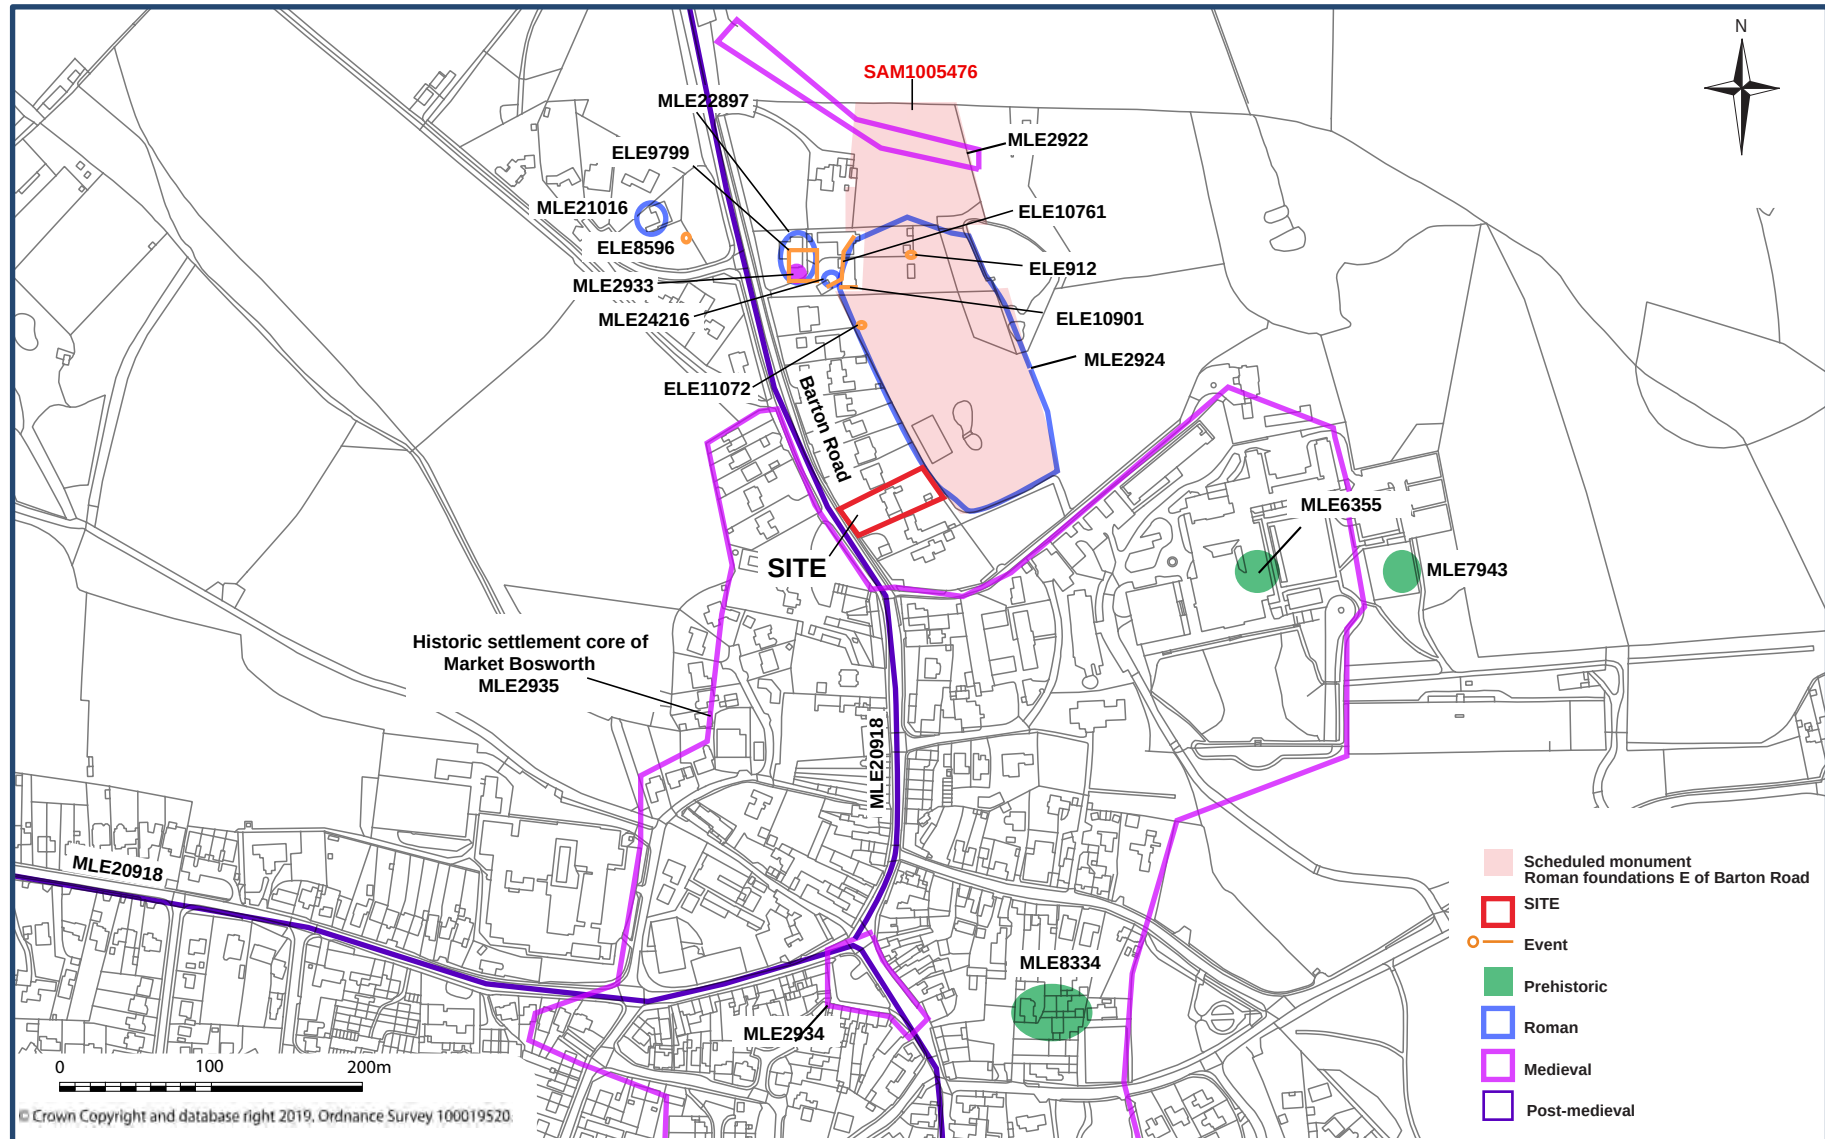
Fig 2: Selected Historic Environment Information

- 3.2 A Bronze Age palstave (Leicestershire Historic Environment Record ref. MLE 6355; Fig 2) and Iron Age spearhead (MLE 7943), recovered 200m to the east of the Site and an Iron Age settlement excavated in the centre of the modern village (MLE 8334) demonstrate that the sherds of Iron Age pottery found during the excavation of the Roman villa (NHLE 1006476), directly east of the Site derive from a wider mosaic of later prehistoric activity.

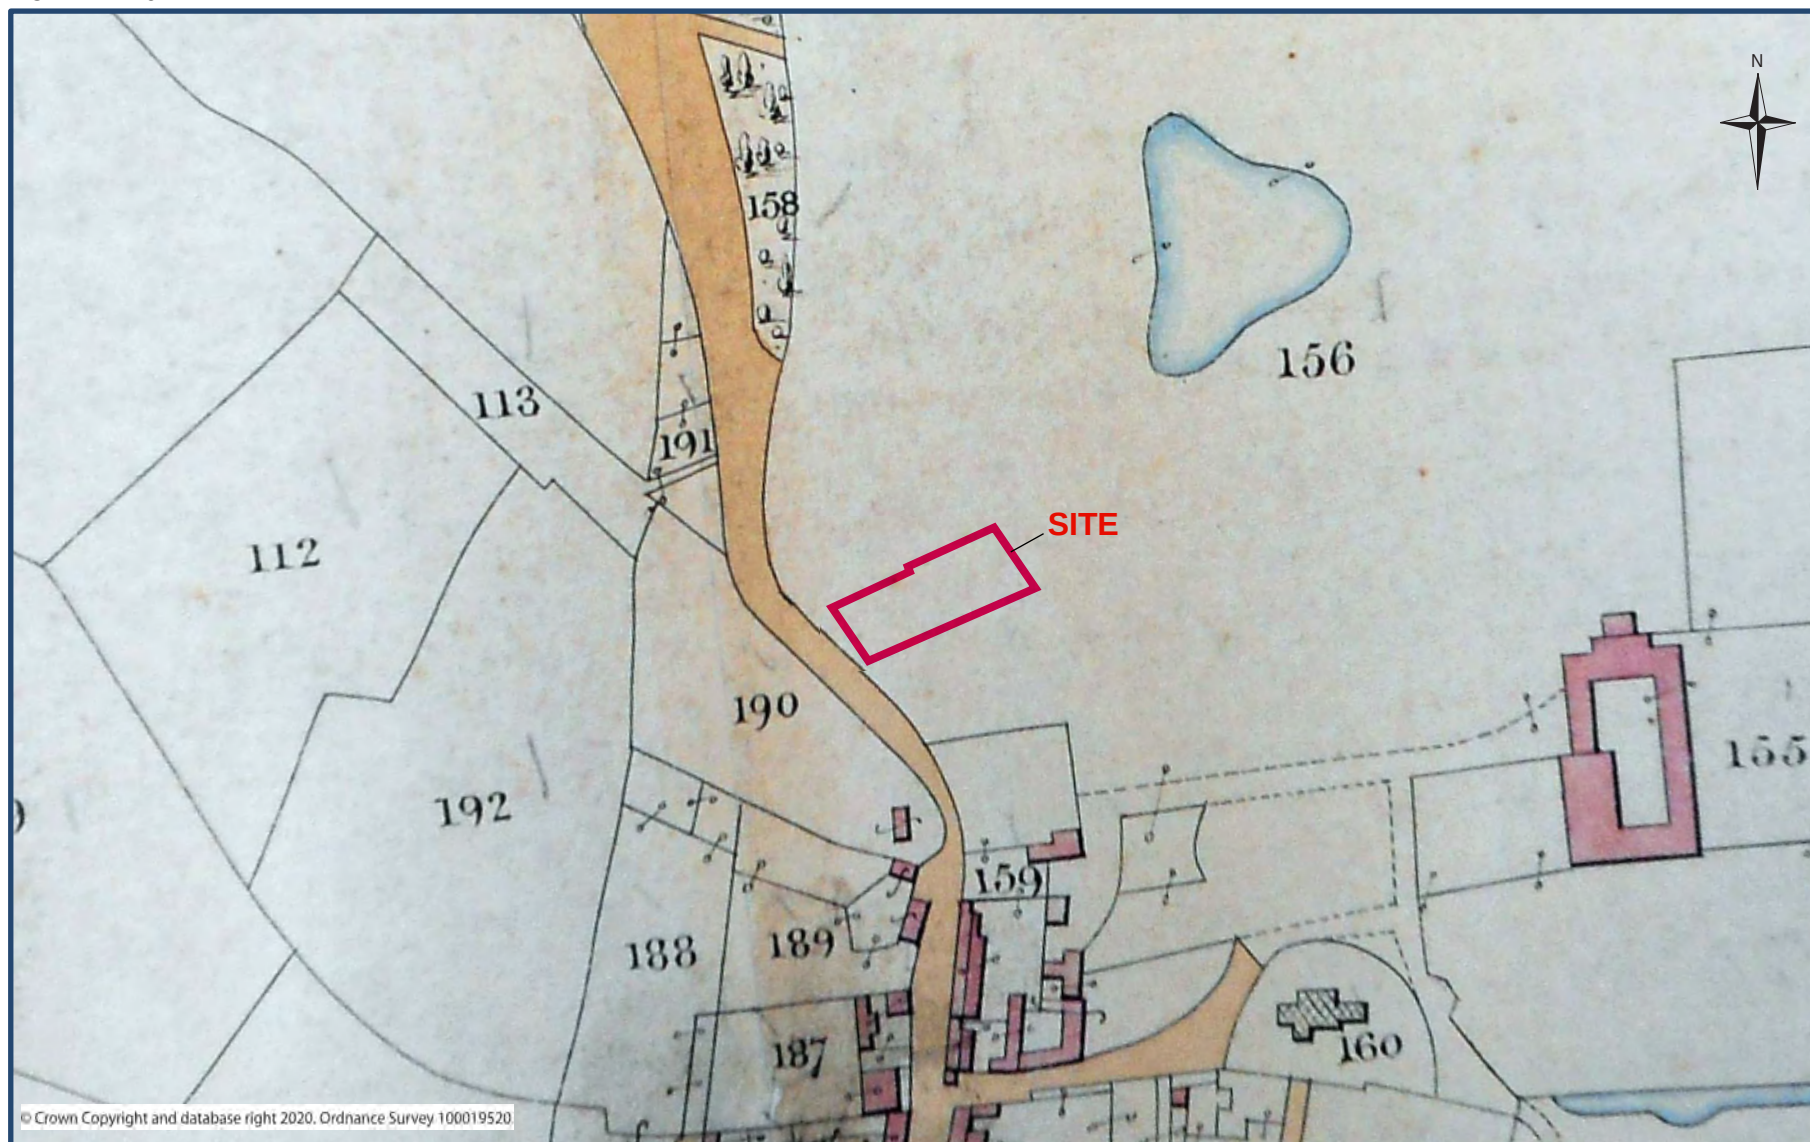
Fig 3: Detail from 1849 Tithe map of Market Bosworth (Leicestershire Record Office Ti/214/1)

- 3.7 Barton Road was a toll road between 1760 and 1872 (MLE 20918) between Market Bosworth and Measham. The Tithe map of Market Bosworth of 1849 (Leicestershire Record Office Ti/214/1; Fig 3) depicts the Site in a large field (numbered 156) which was probably associated with Bosworth Hall (MLE 12225; NHLE 1251547), 150m to the east of the Site. On this evidence it was assumed that the Site was outside the medieval village.
- 3.8 Barton Road ceased to be a toll road in 1872. The First Edition Ordnance Survey map of 1886 (Fig 4) depicts no change within the Site. This area of the road appears to have been straightened and reduced in width by this date.

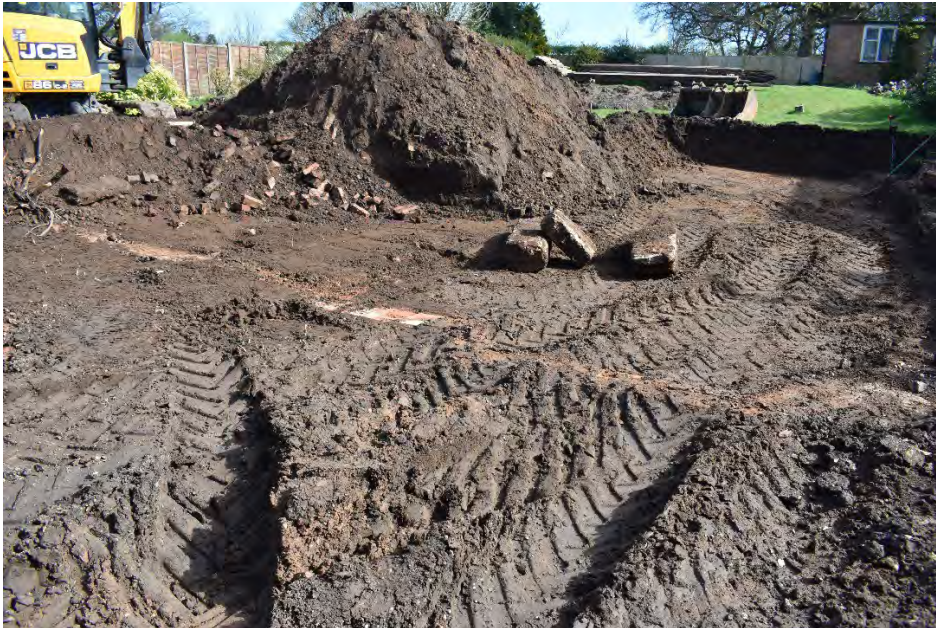
**2 Working shot of ground reduction looking north-east**

- 4.4 Upon arrival at the Site, the existing house had been demolished to slab level. The observation started whilst the ground level across the new footprint was terraced by machine using a ditching bucket to a maximum of 0.9m at the back of the Site (Photo 2). Thereafter the foundation trenches were dug up to 0.95m deep using a 0.6m wide toothless bucket (Photo 3).

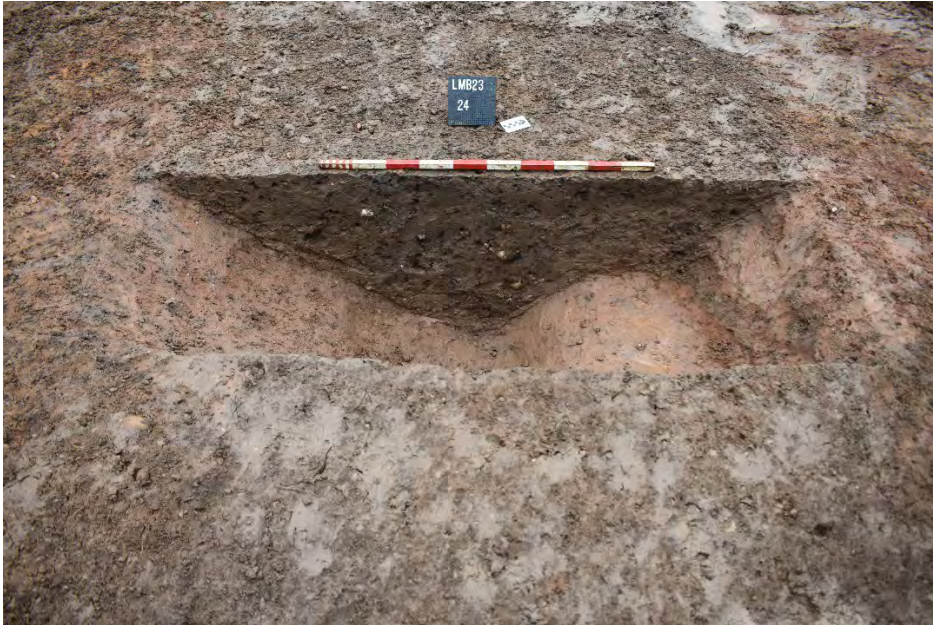
#### **4 Undated ditches 24 and 27 looking north-west**

- 5.3 Cutting the natural, NW/SE ditch 24 extended over 10m on the eastern edge of the Site (Photo 4; Fig 6). It had a broadly V-shaped profile 0.93m wide by more than 0.23m deep and was filled with light greyish-brown silty sand (25). It was recut, as ditch 27, with a wide U-shaped profile 1.96m wide and a flat base 0.39m deep which contained greyish-brown

silty sand (26) from which several fragments of a cow tooth were recovered.

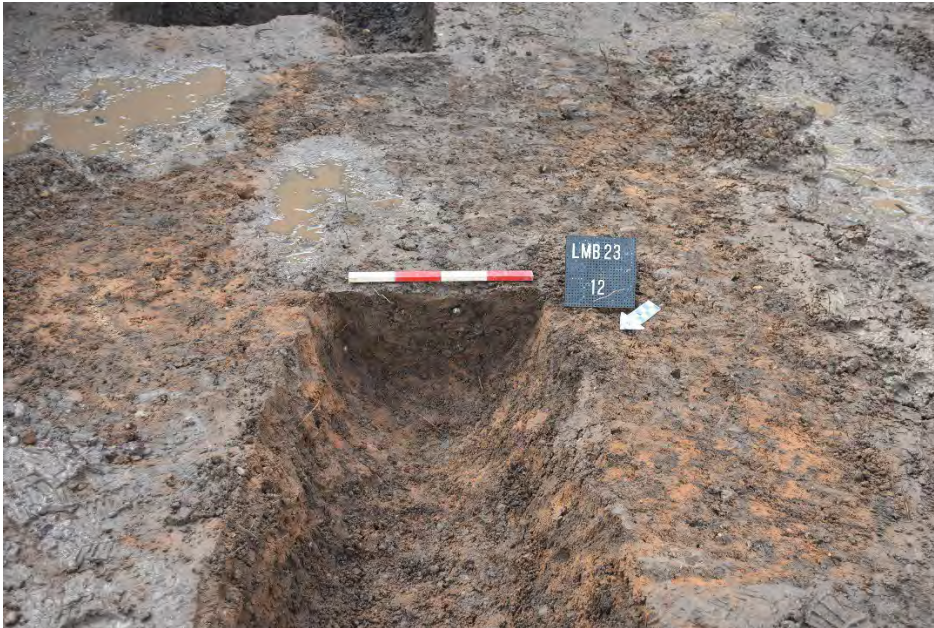
#### **5 Roman gully 12 looking south-east**

- 5.4 Gully 12 extended 8m NW from the SE corner of the reduced area (Photo 5). It was 0.51m wide and 0.22m deep, filled with light brownish-grey sand (13) containing one small fragment of Roman period roof tile (tegula). A very small sherd of 13<sup>th</sup>-15<sup>th</sup> century Chilvers Cotton Ware pottery probably derives from adjacent pit 10.

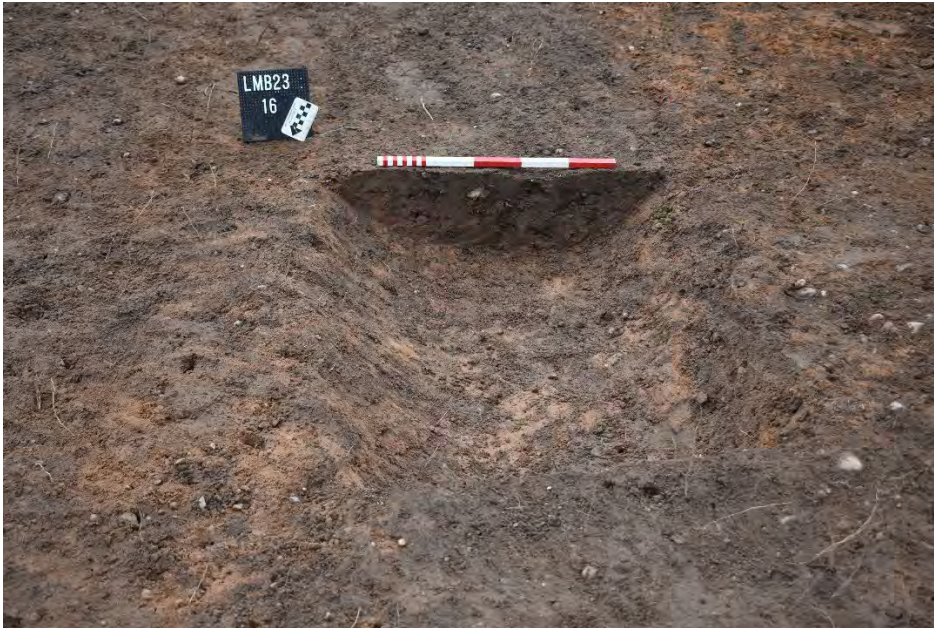
## **6 Roman gully 16 looking south-east**

- 5.5 Parallel to gully 12, gully 16 was visible for 10m between areas of later disturbance (Photo 6). It was 0.75m wide and 0.18m deep and filled with greyish-brown silty sand (17). It contained a sherd of mortaria and a sherd of coarse reduced ware pottery, a fragment of tegula and three fragments of possible roof slate.
- 5.6 These parallel gullies must interact with the undated ditches 24 and 27 to the north of the recorded sections. However, the disturbance from the remains of the previous dwelling had removed all trace of the gullies further to the north due to their shallow depth.

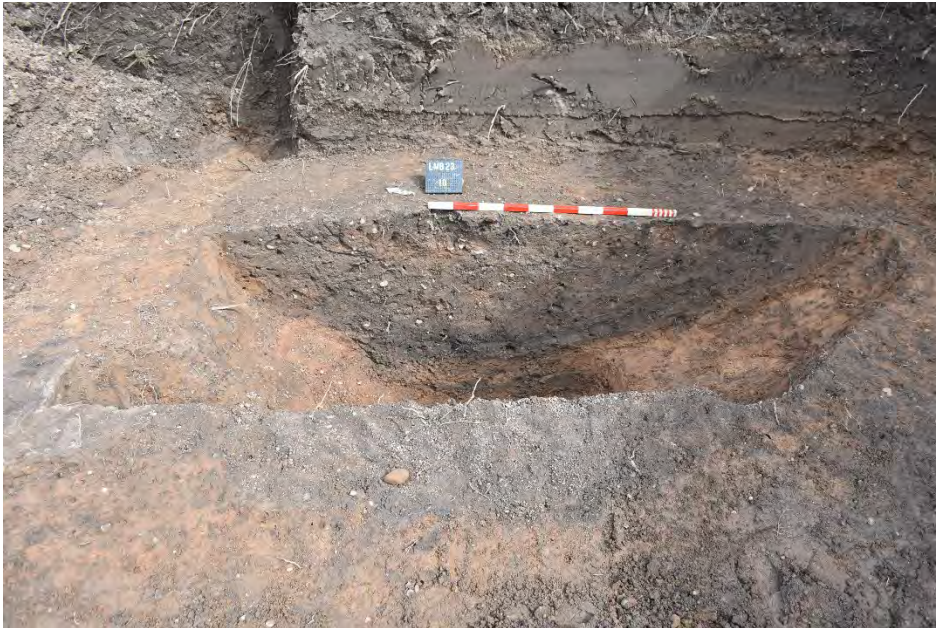
#### **7 Medieval pit 10 looking north-east**

- 5.7 Sub-circular pit 10, in the south-east corner of the reduced area was 5.05m long by 2.76m wide by 0.92m deep with moderate to steep irregular sides and a rounded base (Photo 7). A primary fill of reddish-brown silty sand (21), 0.24m thick, yielded seven sherds of 12<sup>th</sup>-14<sup>th</sup> century Potters Marston pottery. A secondary fill of dark greyish-brown sandy silt loam (22) contained ten sherds of mostly cross-fitting 12<sup>th</sup>-14<sup>th</sup> century pottery and two sherds of 13<sup>th</sup> to 15<sup>th</sup> century Chilvers Cotton Ware. Overlying greyish-brown silty sand (23), contained twelve sherds of medieval pottery. Twelve of these sherds were of 12<sup>th</sup>-14<sup>th</sup> century pottery that included two jar rim sherds of the same jar as in fill (22) with a combed wavy line decoration on the rim-top and shoulder. The uppermost fill of the pit was dark reddish-brown silty sand (11), 0.24m thick, yielding 14 sherds of 12<sup>th</sup>-15<sup>th</sup> century pottery. The full extent of the feature extended beyond the limits of the ground reduction

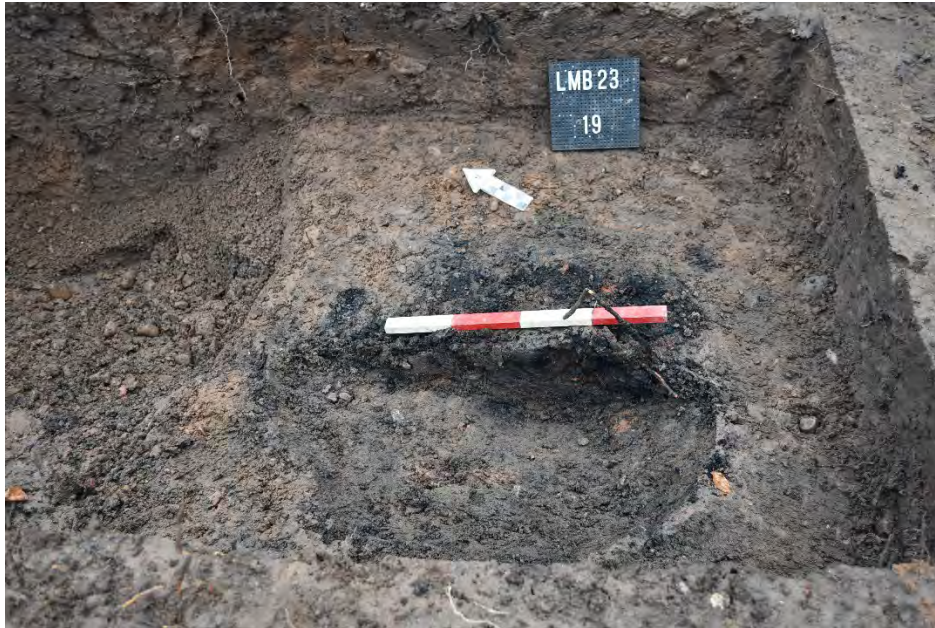
**8 Pit 19 looking north-east**

- 5.8 Pit 19 was cut into the top of pit 10 (Photo 8). This pit had irregular, sloping sides and a rounded base 0.70m in diameter and more than 0.15m deep. It was filled with dark greyish-brown sandy silt with frequent fragments of coal (20) and two sherds of medieval pottery of similar types to those found in the earlier pit and eight fragments of, possibly structural, burnt daub.
