## **Heritage Impact statement**

25nr proposed apartments at  
127 Upper Bond St. Hinckley LE10 1RT  
for  
Fortress Eight Limited

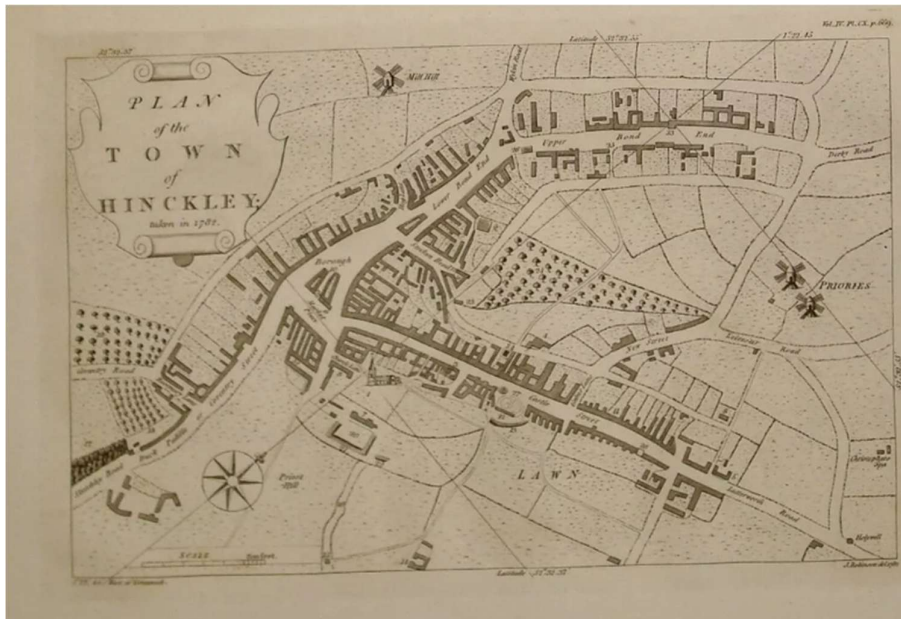
1782 map of Hinckley, with the assessment area problematic to locate along Upper Bond Street.

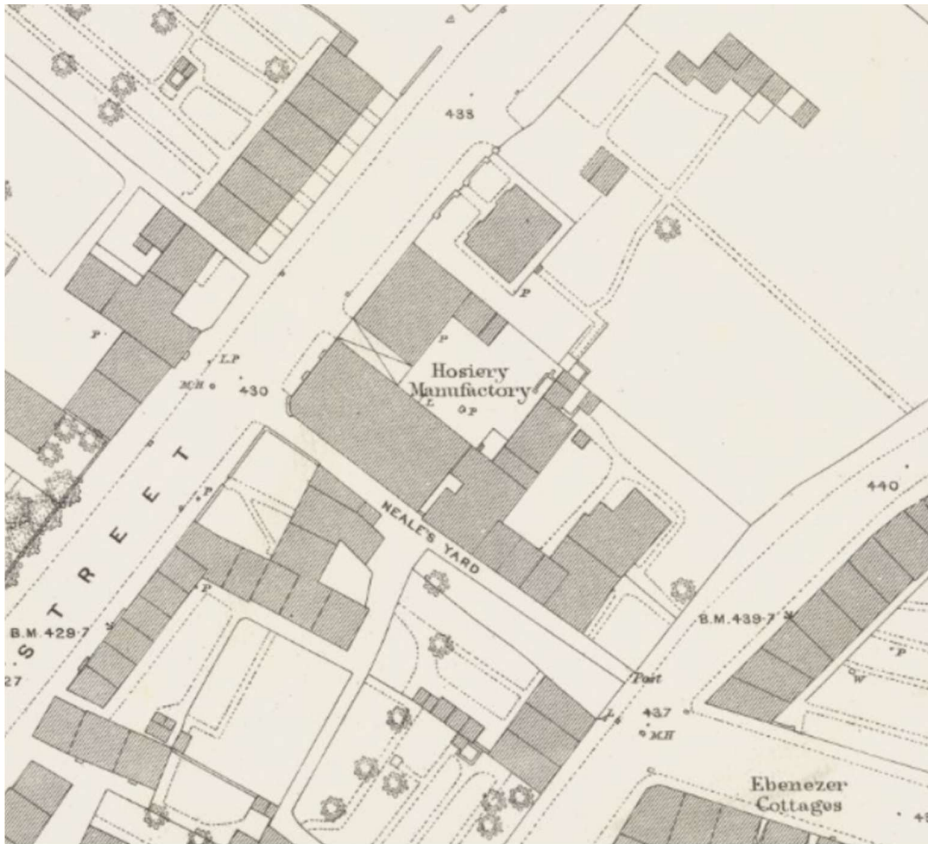
Detail of Hinckley - Leicestershire XLII.4.21 Surveyed: 1887 shows the existing building along Upper Street but also some earlier buildings at the corner of Neals yard and Druid Street.

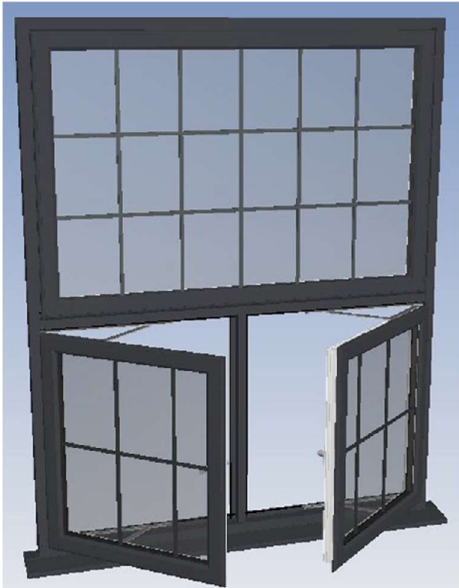
Proposed Windows

- The replacement option would allow additional advantages. Opening lights could be incorporated at a more convenient height and in compliance with existing Building Regulations. Windows could also incorporate double glazing which would improve thermal and acoustic performance and offer greater convenience and thermal resilience to residents over secondary glazed units.

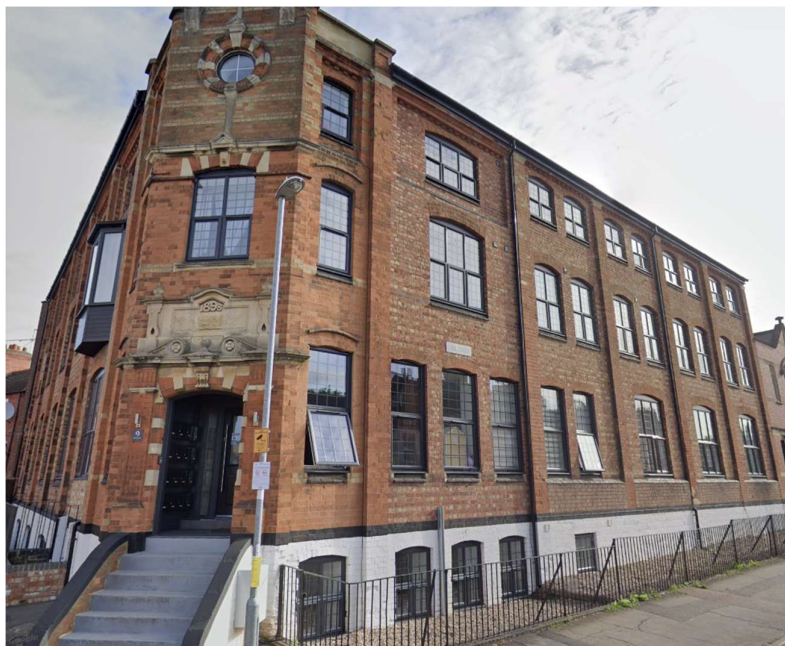
Completed Development

9 Mill Road, Wellingborough, Northamptonshire NN8 1PF. A Non-designated Heritage Asset. This was a Conversion of a former Shoe Factory built at the end of the 19<sup>th</sup> Century into 22 apartments in 2022. This is comparable architecture, comparable windows and shows what we would hope to achieve in Hinckley.
