# **Bat Emergence Survey Report**

**174 Newbold Road, Nuneaton**

**Survey Date: June 2026**

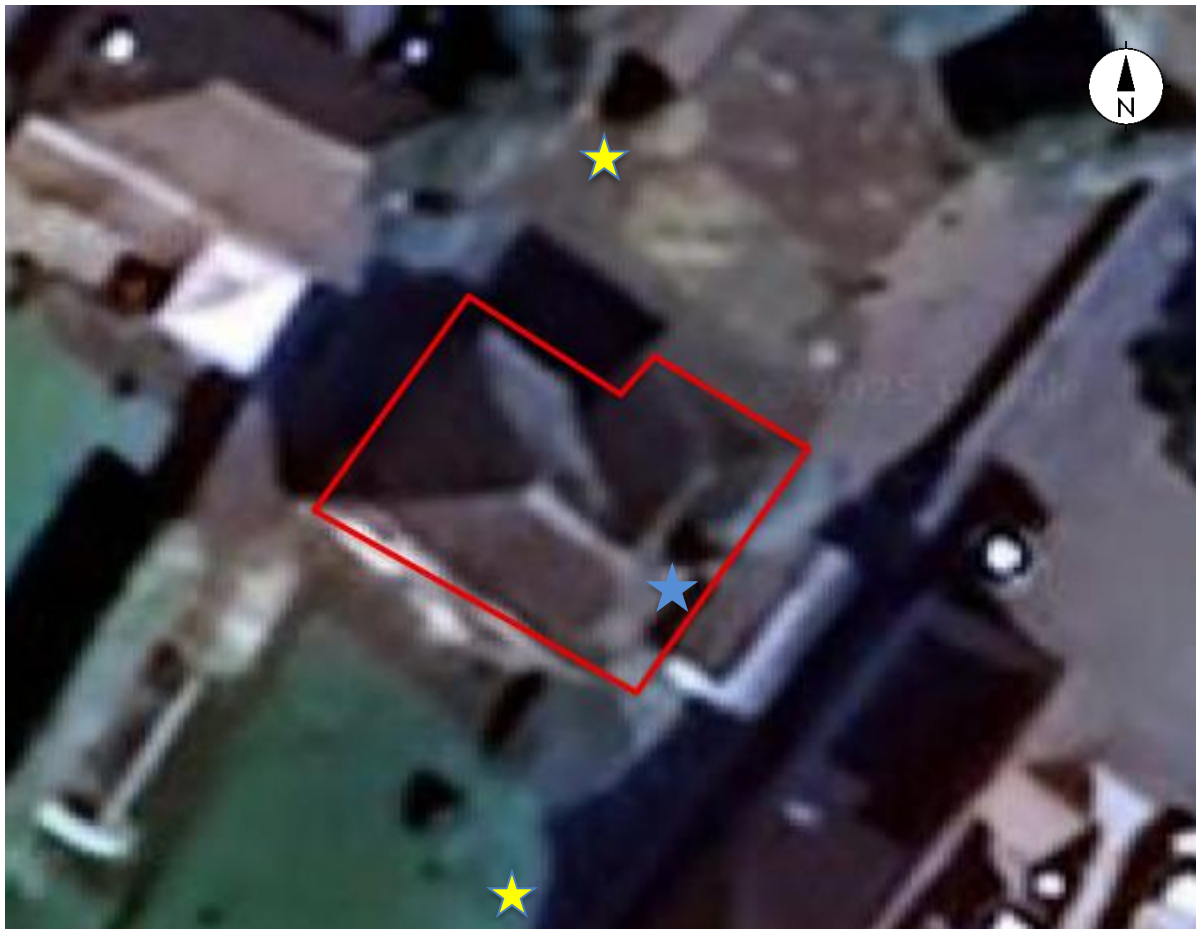
Several Common Pipistrelle bats were recorded commuting through the surrounding landscape. One Common Pipistrelle was observed emerging from beneath the roof tiles adjacent to the chimney on the eastern elevation of the building. Additional passing activity was recorded throughout the survey. No further emergence or re-entry behaviour was observed.

**Figure 3:** An aerial photograph of the surveyed buildings (red outline), the surveyor/infrared camera locations (yellow stars). The blue stars illustrate the ingress/egress points in use by the bats using the building.

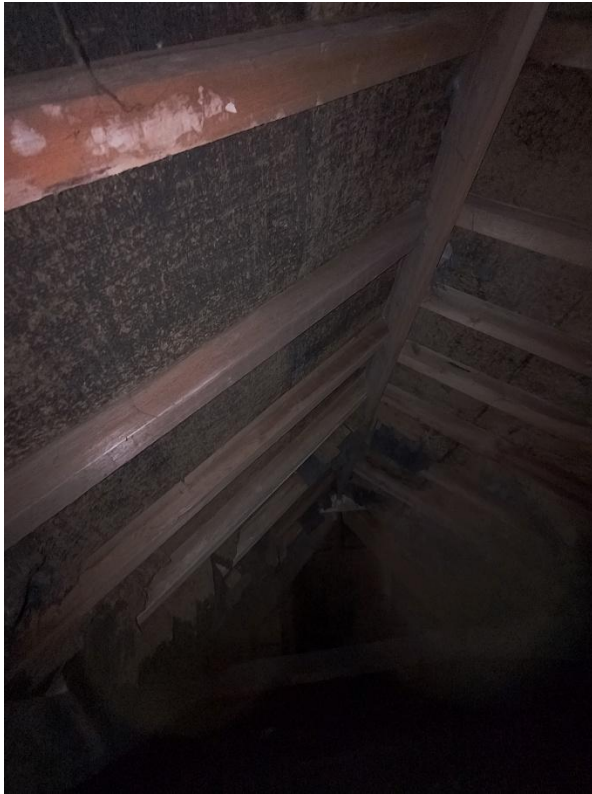
The interior of the loft space was accessed during the survey. The roof lacked an intact bitumen or breathable membrane, which was observed to be severely degraded throughout, revealing occasional narrow spaces between the roof tiles and the deteriorated underlay. These voids may provide access for bats into the roof void, although the degraded state of the underlay likely reduces the number of usable crevices.

**Photo 1: View of loft space.**

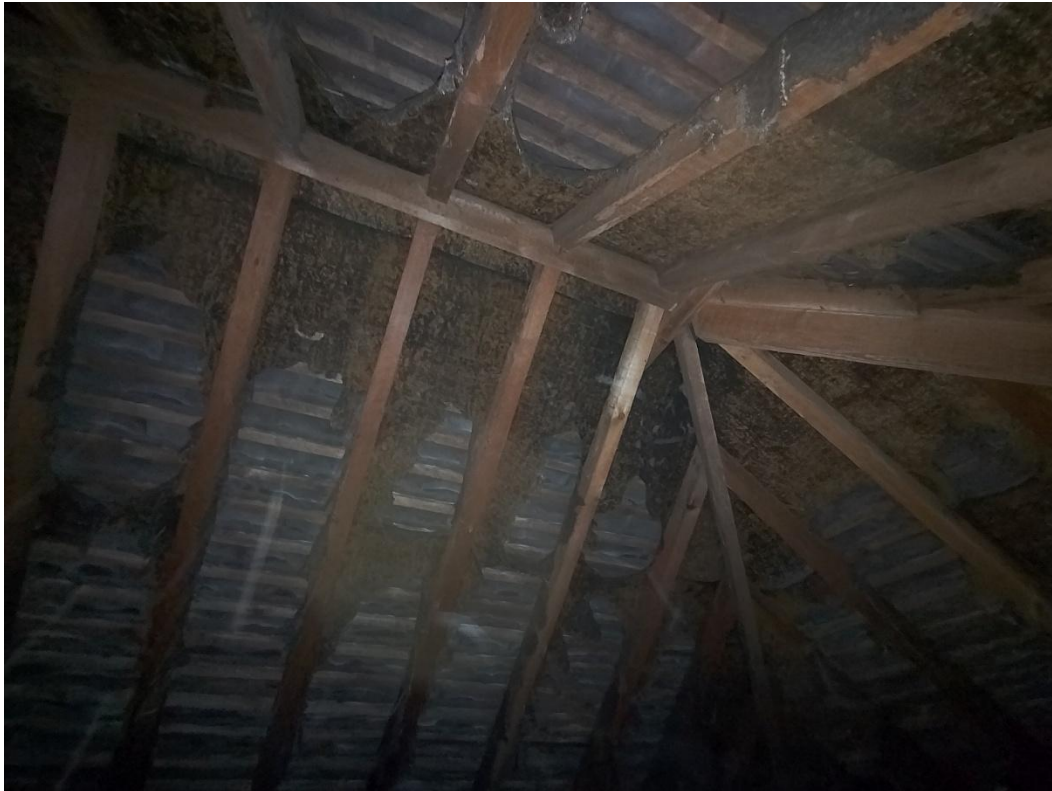
The loft structure comprised traditional timber beams and rafters, all of which appeared dry and undisturbed. No evidence of bats (e.g. droppings, staining, scratch marks, feeding remains) was recorded during the inspection. However, insect remains were identified. No bird nests were found within the loft void.

**Photo 2: View of internal roof structure.**

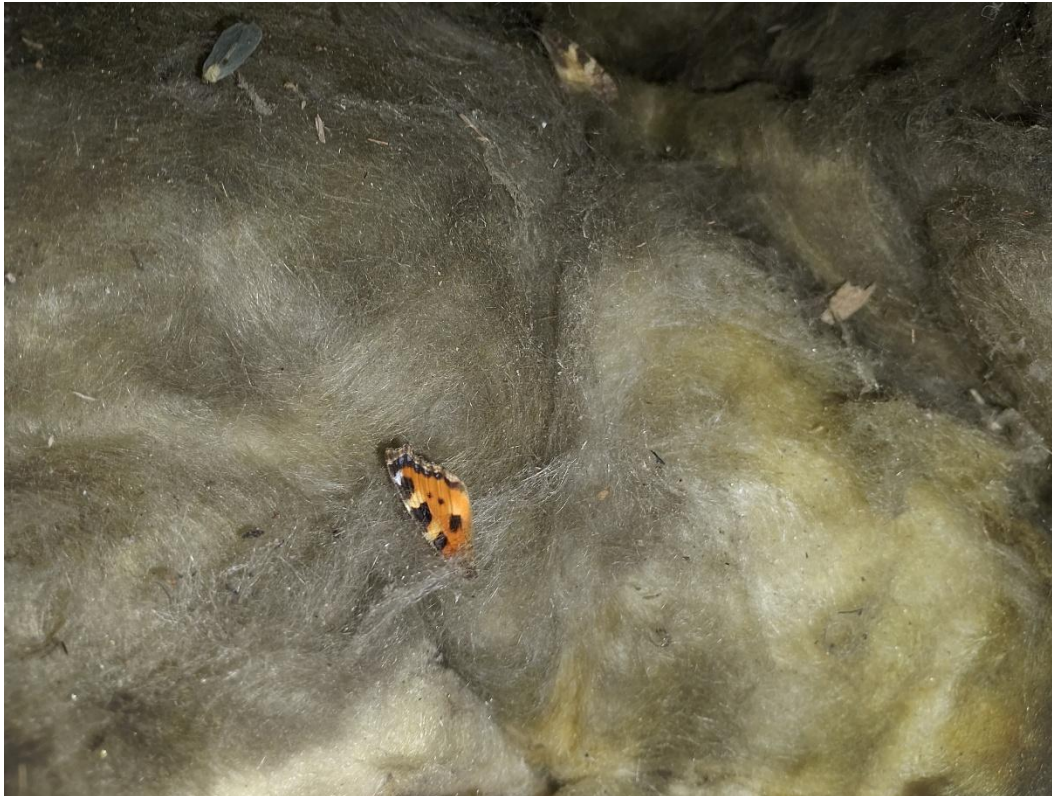
**Photo 3: Insect remains found within the loft space.**

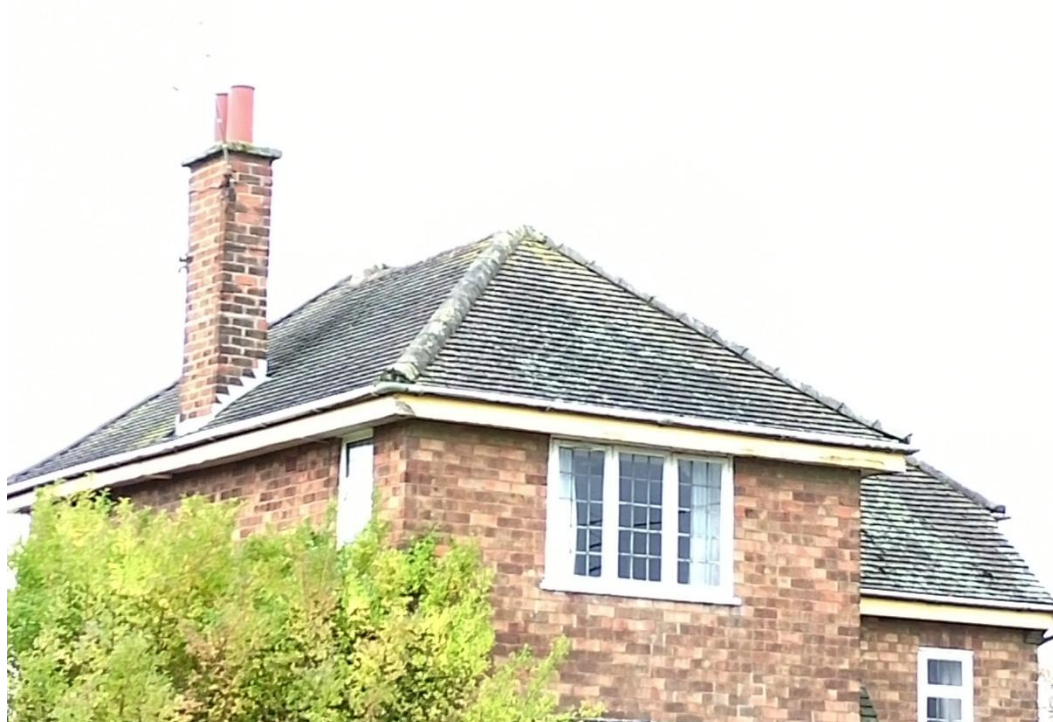
Gaps were observed beneath ridge tiles along the northwest and south apex of the building where mortar had degraded or fallen out. A significant gap was noted under the ridge tile on the southern apex where the cement had completely failed.

Photo 5: Overview of external roof.

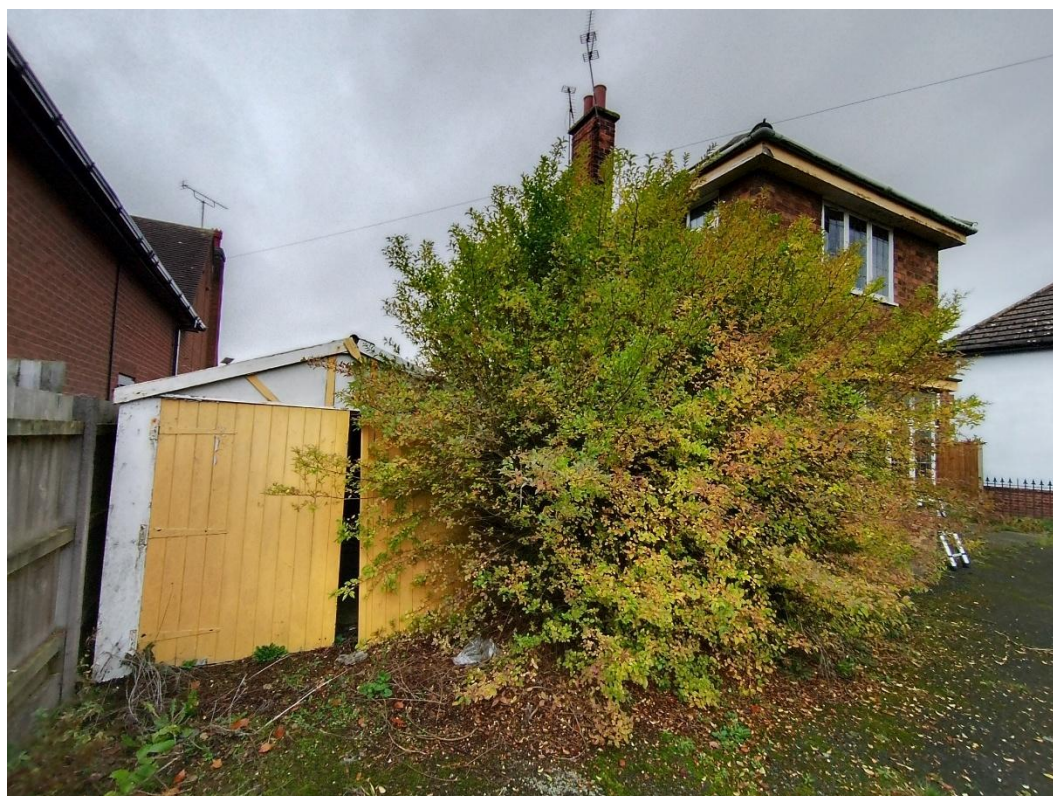
Two detached outbuildings/garages are located to the rear of the property. Both structures are of a prefabricated concrete-panel construction with corrugated sheet roofing and wooden support beams. The buildings are in a poor state of repair. Due to exposure to weather and light, these buildings offer negligible suitability for roosting bats.

Photo 6: View of garage to the side of the main dwelling.

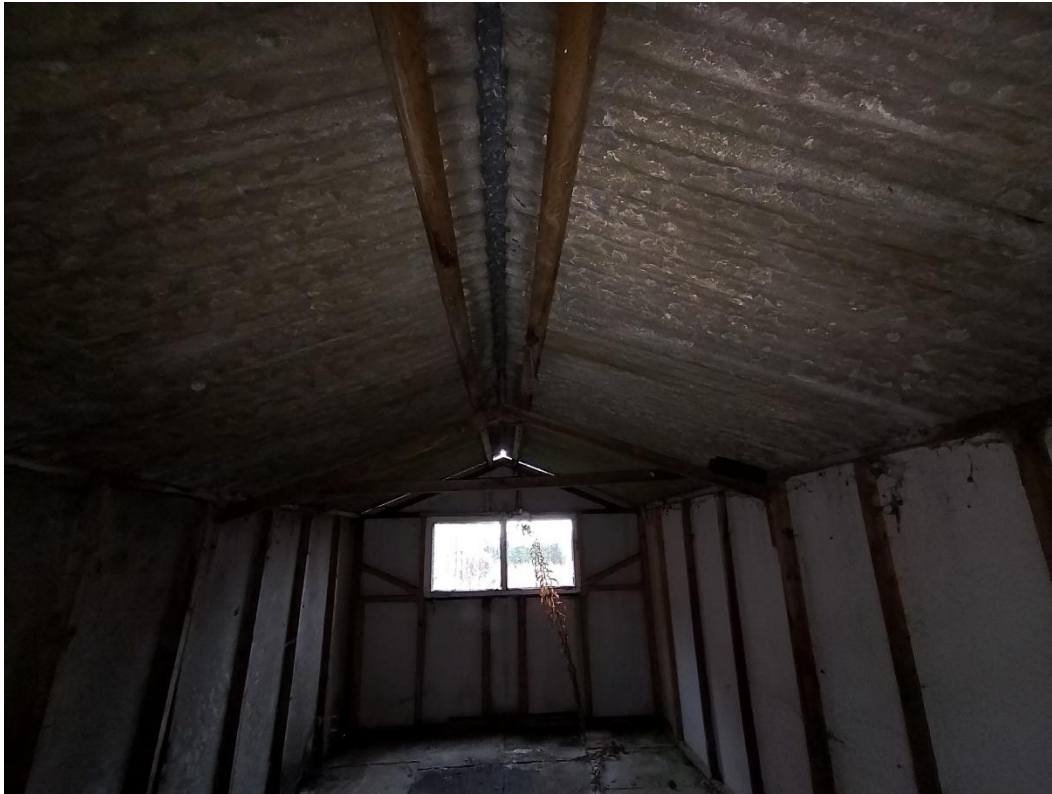
Photo 7: Interior of garage at the side of the main dwelling.

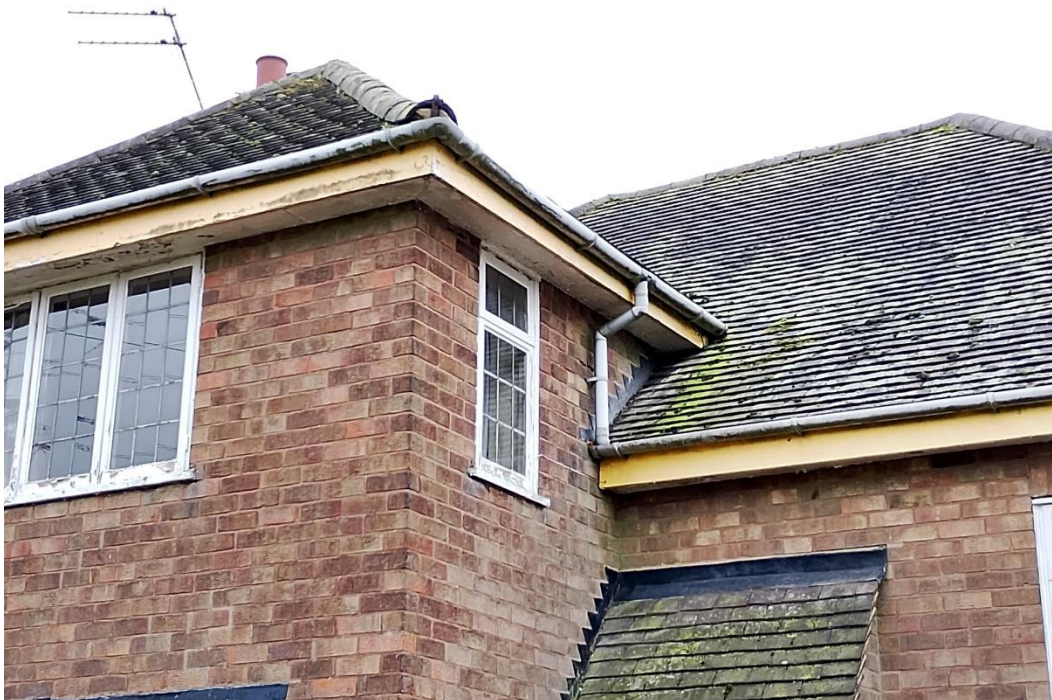
The windows are modern uPVC framed units in fair condition; however, the condition of the soffits and roofline junctions presented several potential roosting features (PRFs). No bird nests were observed during the external inspection, and there was no visible evidence of bat droppings beneath the PRFs, although these areas had been swept and were relatively clean.

Photo 8: View of soffits, windows and roof tiles at the front of the property.

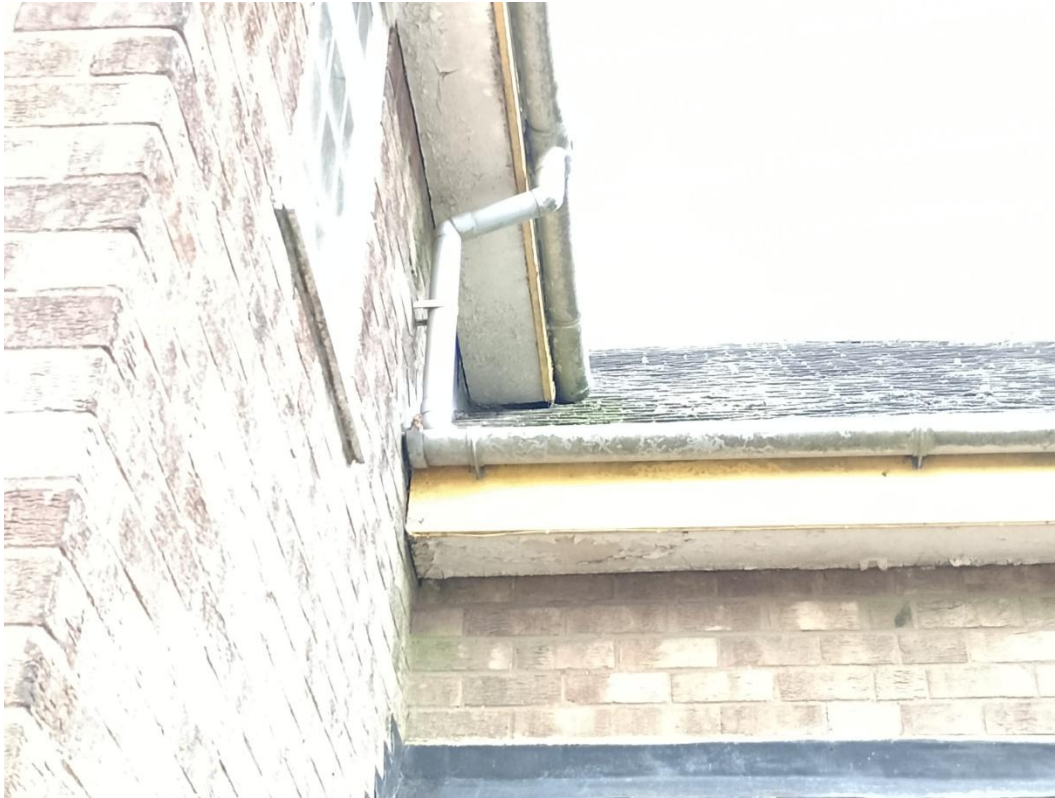
Additional crevice features were observed under the soffits, particularly along the northwest, west, and south elevations, where gaps were present between the wall top and soffit boards. Along the southeast ridge, mortar had deteriorated significantly, resulting in gaps running along the ridge line. A further gap was identified beneath the main tiling along the southwest roof slope, in proximity to the ridge tile.

**Photo 9: View of gaps at the soffit.**

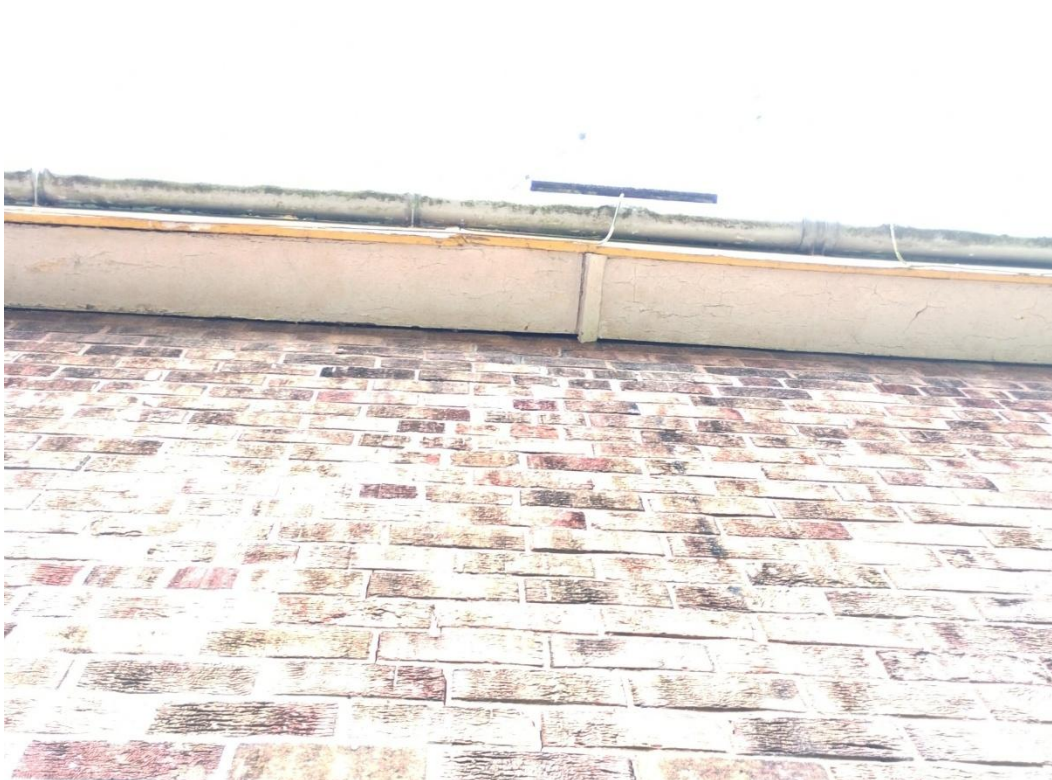
**Photo 12: View of gaps between soffits and brick walls.**

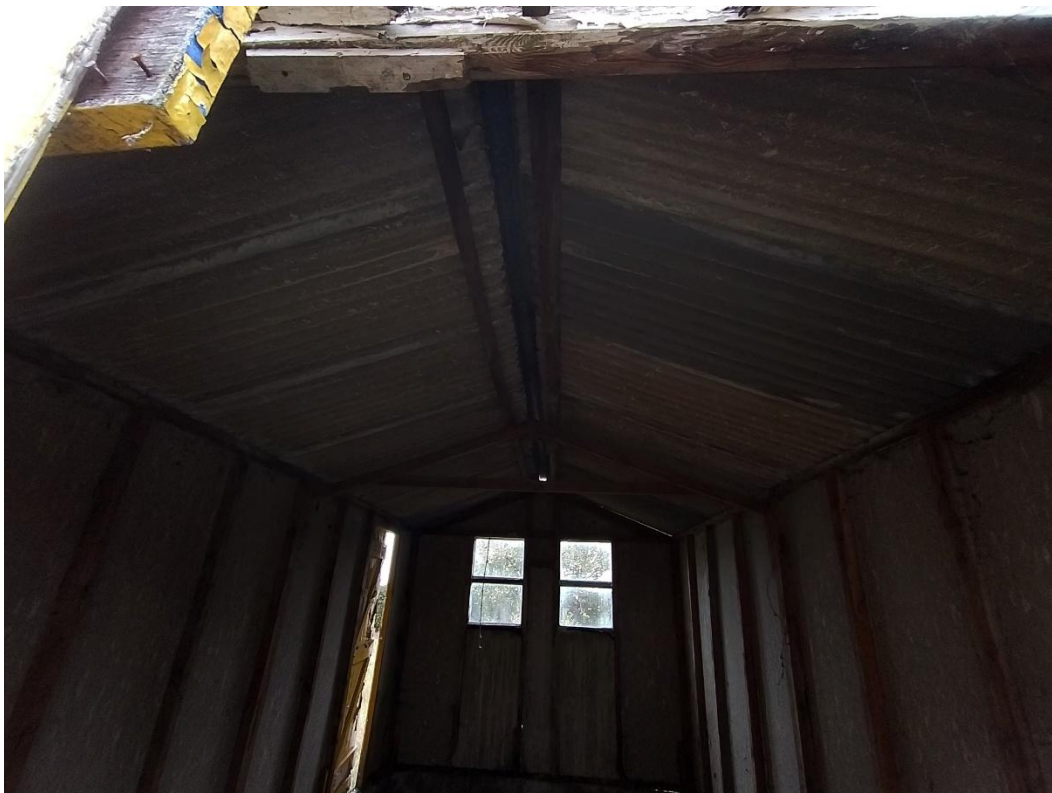
Photo 14: Interior of garage.

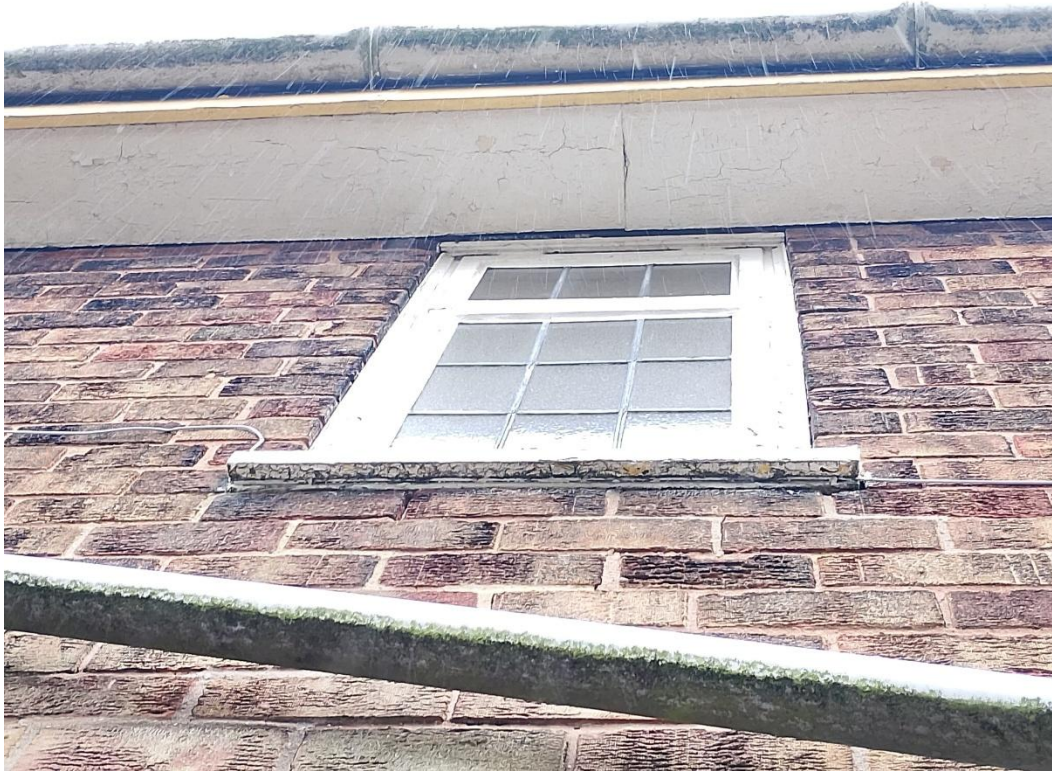
Photo 15: View of the soffits.

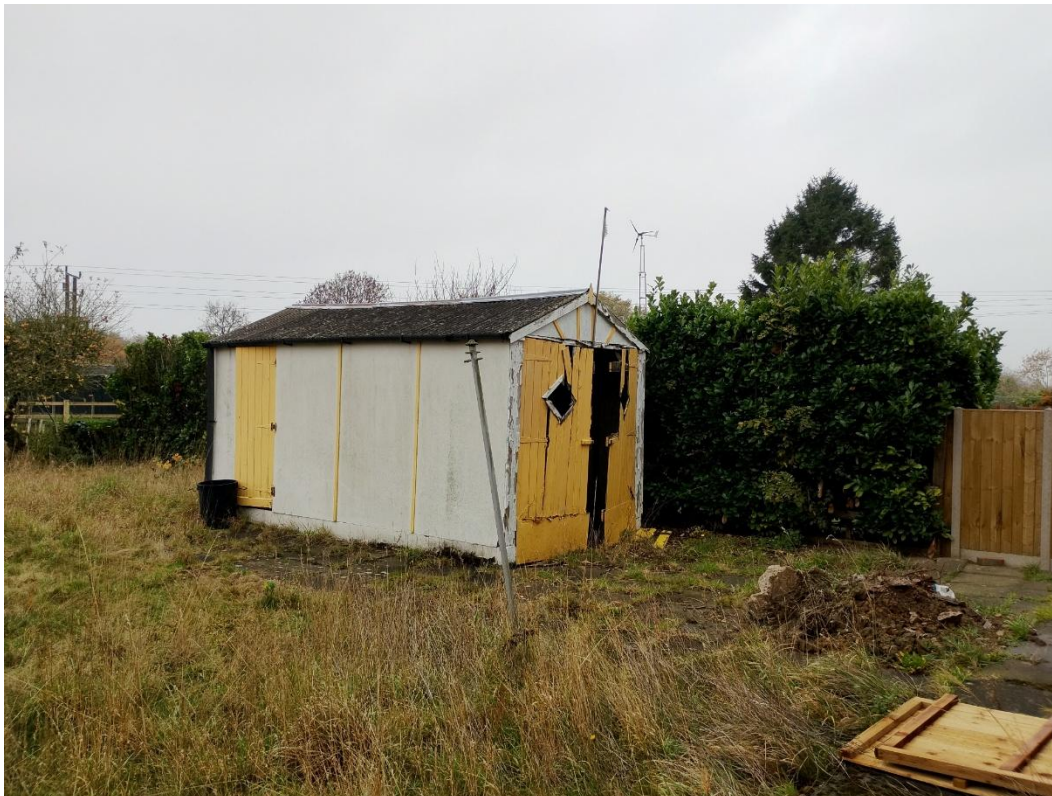
Photo 16: View of garage to the rear of the property.
