# NOCTURNAL BAT SURVEY REPORT

The Old Rectory,  
Rectory Lane,  
Nuneaton,  
CV13 0LS

1512-NBR-V1-A

Witherslack Group

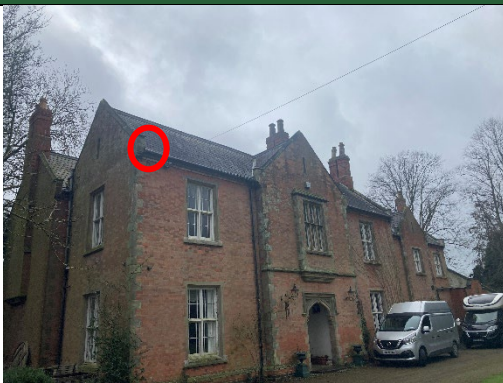
| Reference | Location |
|---|---|
| E1 | |

- VP3 recorded one brown long-eared bat emerging from the roofing tiles/guttering at 22:55 (E1).
  - VP4 recorded two common pipistrelles emerging from the open vent on the eastern aspect at 21:44 and 21:45 (E2).

- **Roost 1** – located emerging from the roofing tiles/guttering. A count of 1 brown long-eared bat (E1) recorded on 1<sup>st</sup> survey only - **Assessed as a transitional, non-breeding roost.**

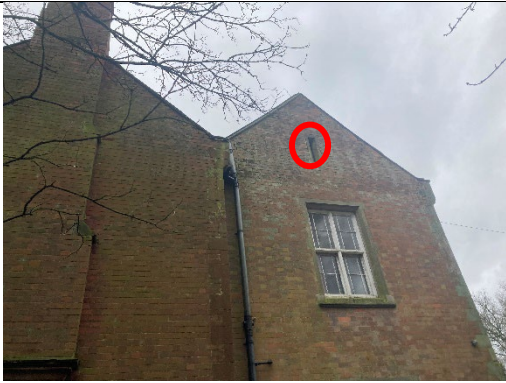
| E2 | |

- **Roost 2** – emerged from open vent on eastern aspect which will lead to loft void, with a peak count of 8 common pipistrelle (E2), recorded on 1<sup>st</sup> and 2<sup>nd</sup> survey – **Assessed as a day, non-breeding roost.**

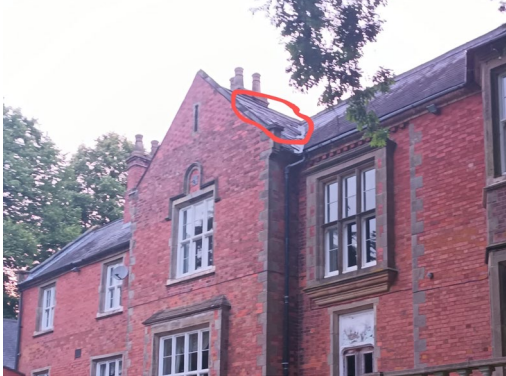
| E3 | |

- VP5 recorded one common pipistrelle emerging from the roofing tiles on the southern aspect of the site at 21:45 (E3).
  - VP6 recorded two common pipistrelles emerging from (1 count per emergence point); base of middle chimney, from lead flashing (E4) at 21:44 and from ridge tile at 22:06 (E5).

- **Roost 3** – emerged from slipped tiles, with a peak count of 2 common pipistrelle (E3), recorded on all surveys– **Assessed as a day, non-breeding roost.**

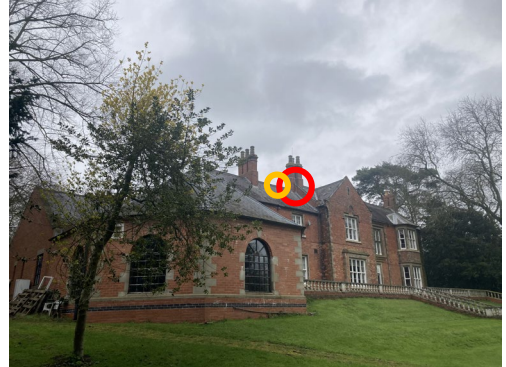
| E4 in red<br>E5 in orange | |

- **Roost 4** – emerged from lifted lead flashing at base of middle chimney, with a peak count of 1 common pipistrelle (E4), recorded on 1<sup>st</sup> survey only - **Assessed as a transitional, non-breeding roost.**

- **Roost 5** – emerged from ridge tile, with a peak count of 1 common pipistrelle (E5), recorded on 1<sup>st</sup> survey only - **Assessed as a transitional, non-breeding roost.**

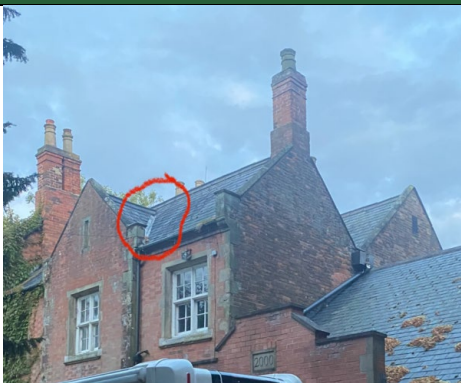
| Reference | Location |
|---|---|
| E6 | |

- **Roost 6** - emerged from slipped tiles and ridge tiles, with a count of 6 common pipistrelle (E6), recorded on 2<sup>nd</sup> survey only - **Assessed as a transitional, non-breeding roost.**

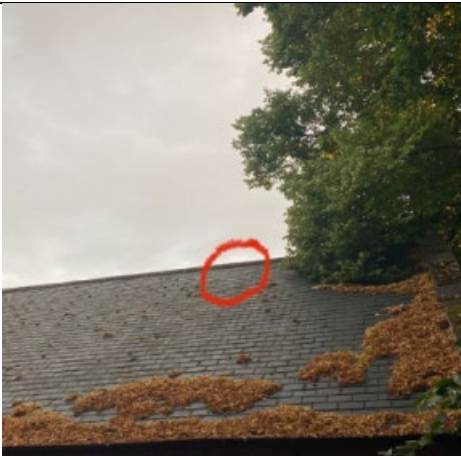
| Reference | Location |
|---|---|
| E7 | |

- **Roost 7** – emerged from under the ridge tile on the western aspect of the single storey extension built in 2000. A count of 1 common pipistrelle (E7) recorded on 2<sup>nd</sup> survey only - **Assessed as a transitional, non-breeding roost.**

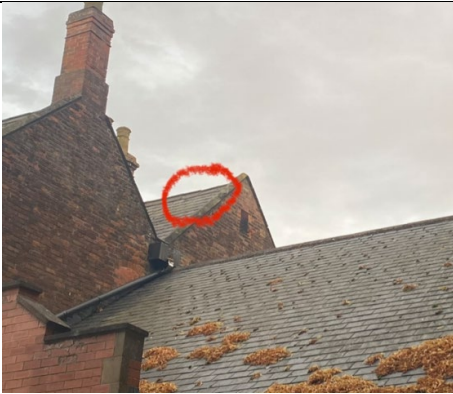
| E8 | | | |

- VP3 recorded five common pipistrelles emerging at ridge tiles at 21:25, 21:29 and 21:31 on the northern aspect (E10).
- VP4 recorded eight common pipistrelles emerging from the open vent on the eastern aspect at 21:15, 21:25, 21:27, 21:32 and 21:42 (E2).
- VP5 recorded one common pipistrelle bat emerging from the roofing tiles on the southern aspect of the site at 21:30 (E3).
- VP6 recorded two common pipistrelles emerged from a vent on the southern aspect of the site at 21:40 (E11).
- VP7 recorded one common pipistrelle bat emerging from under ridge tiles at 20:59 (E8).

- **Roost 8** - emerged from under the ridge tile. A count of 3 common pipistrelle (E8) recorded on 2<sup>nd</sup> survey only - **Assessed as a transitional, non-breeding roost.**

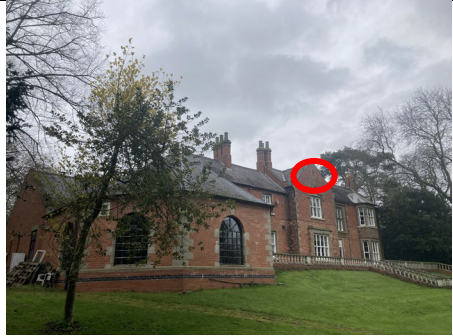
| E11 | | | |

- **Roost 11** - emerged from vent on southern aspect which connects to the loft void on the southern aspect. A count of 2 common pipistrelles (E11) recorded on 2<sup>nd</sup> survey only - **Assessed as a transitional, non-breeding roost.**

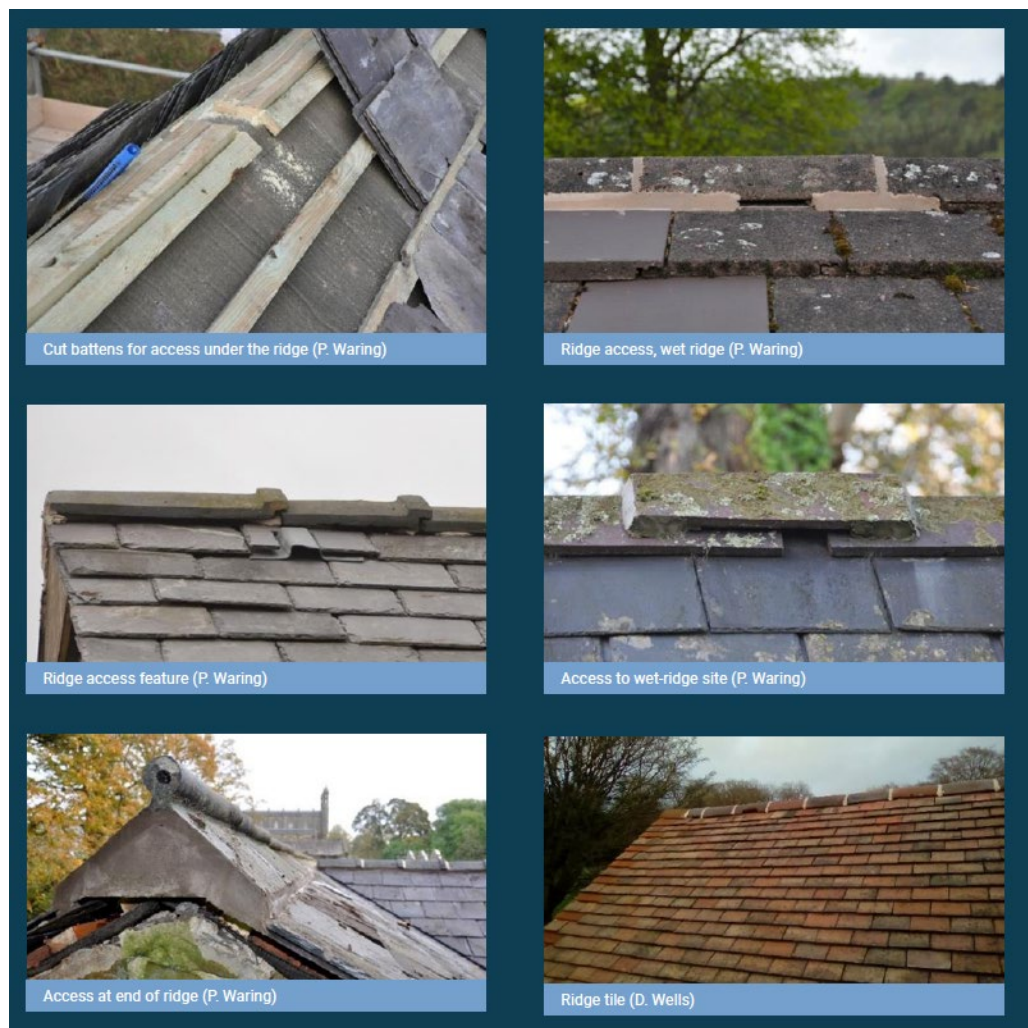
**Figure 3** – Imagery of example ridge access points (Reason, P.F. and Wray, S., 2023)

- 4.1.13. **Access Tiles:** If the ridge tiles which have been identified as supporting bat roosts require repair works, consideration of the installation of new tiles to provide a bat access gap should be included. As stated within the UK Bat Mitigation Guidelines (Reason, P.F. and Wray, S., 2023), access gaps can be created under ridge tiles by leaving out mortar (particularly at the end of the ridge) and removing ventilation structures within them or using specific bat access tiles. The roofing felt can be cut to allow access into the roof void at these points also. See Figure 3 for example imagery extracted from the guidelines (2023).
