## APPENDIX D – PHASE 1 GEO-ENVIRONMENTAL DESK STUDY

**Burbage Fields,  
Burbage**

**Geo-environmental  
Desk Study**

REDROW HOMES LTD.

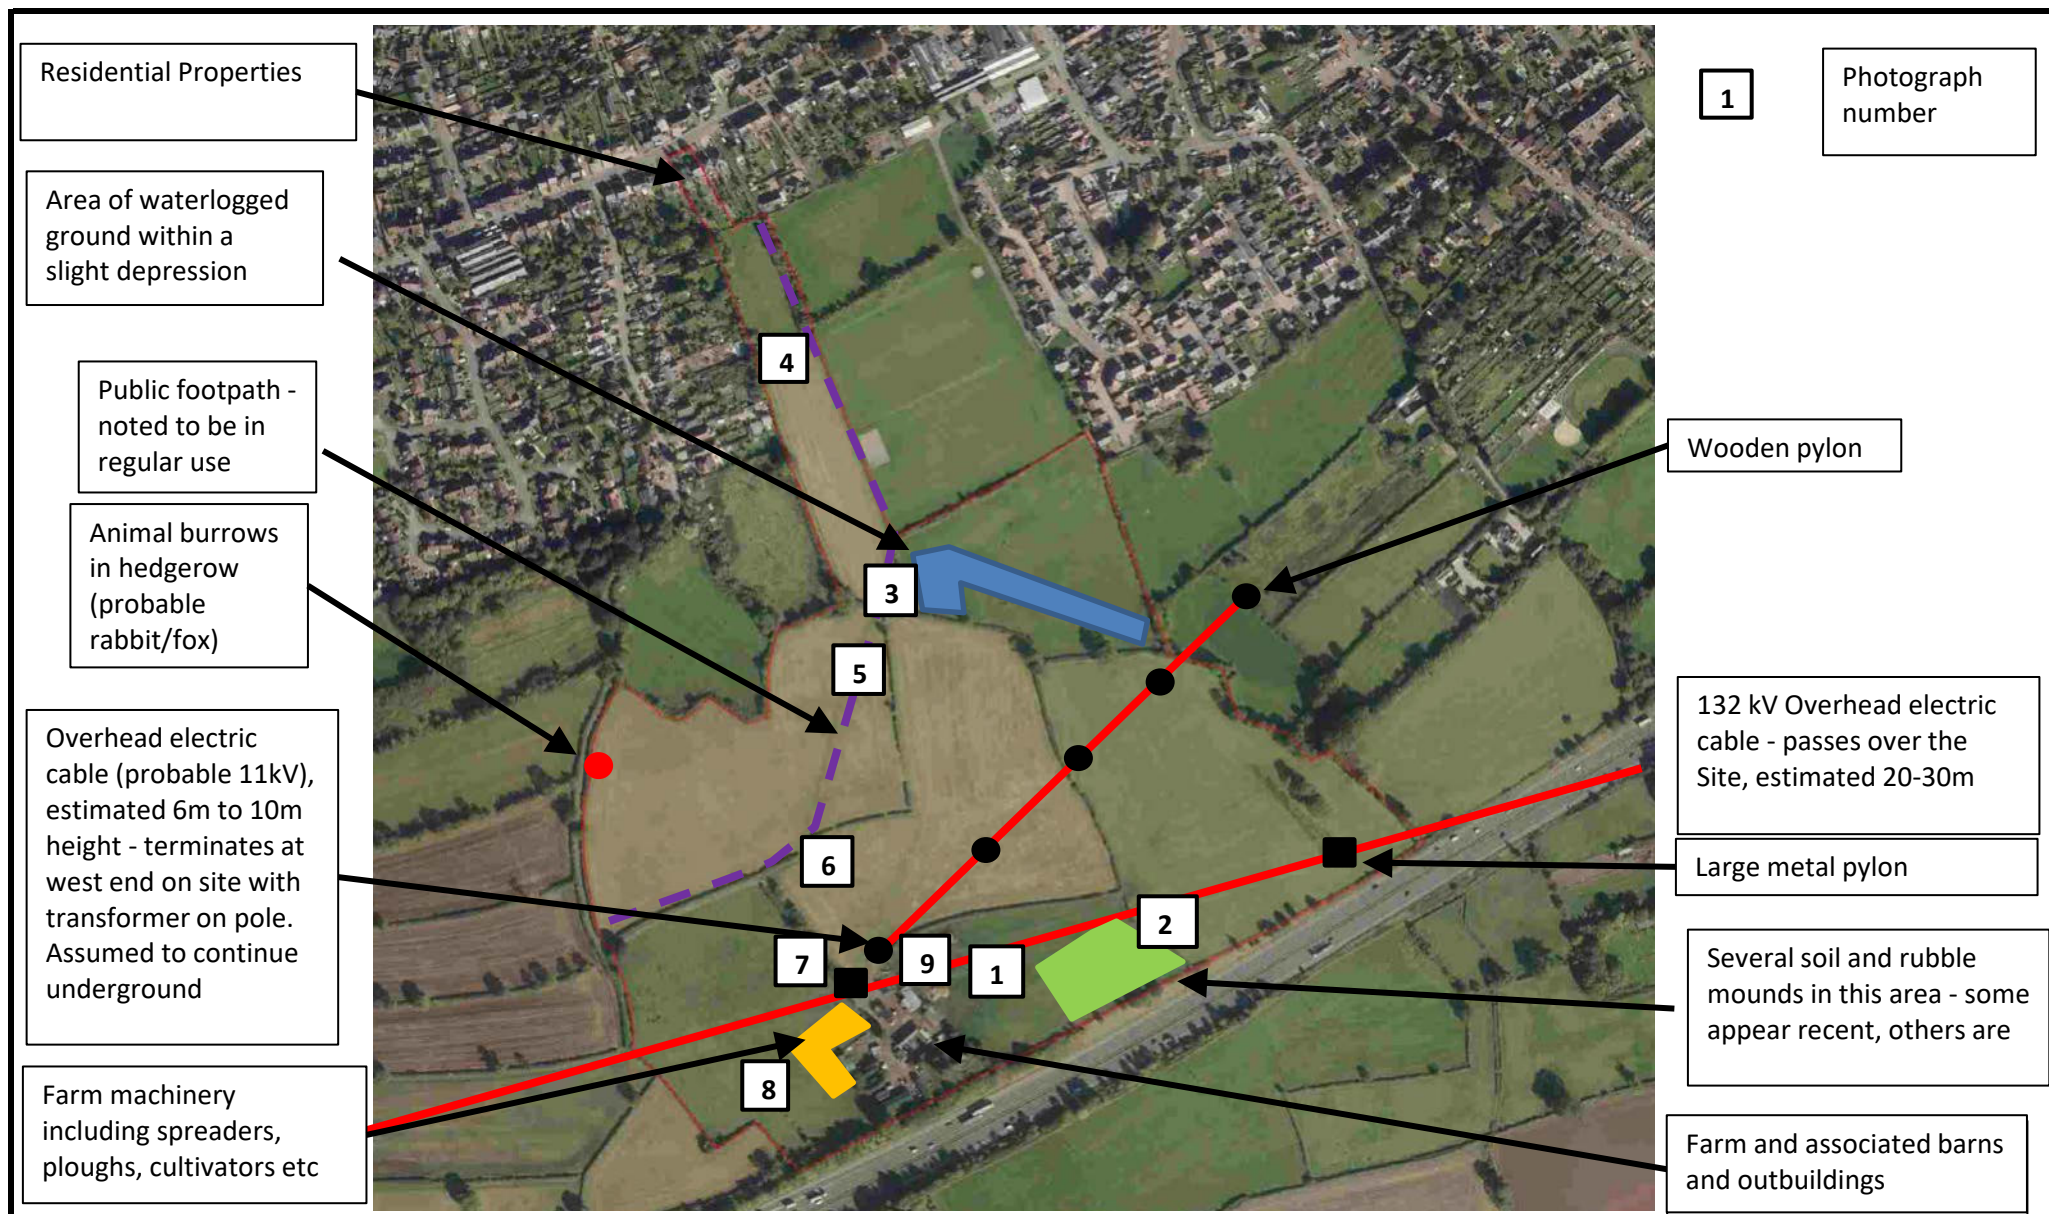
| Project No. | P20-291 | Title | Site Features Plan | Drawn | AT |

- Overhead electric power cables (assumed 132kV) pass over the site at approximately 20-30m height, trending east to west through the southern site extents.
- Overhead electric power cables (assumed 11kV) pass over the site at approximately 6-10m height, trending east to west through the centre of the site. This cable terminates with a transformer at a wooden pole close to the farm in the south-centre of the site and is assumed to continue underground.
- Several soil and rubble mounds are present in the south of the site, to the east of the farm. Several stockpiles appear recent whilst others are grassed over.

- Farm machinery including trailers, spreaders and cultivators was noted in the southwest of the site adjacent to the farm.
- A public footpath crosses the west of the site from north to south, from Bullfurlong Lane (near to the farm) towards Burbage in the north. Several users of this right of way were noted during the walkover.
- A ditch with a small stream runs from northwest to southeast through the centre of the site. An area of waterlogged ground with reeds was noted in the north of the site close to this stream, possibly indicating a spring.
- A possible animal burrow (likely fox or rabbit) was noted in a hedgerow along the western boundary with Bullfurlong Lane.

Photographs and a site features plan are located in Appendix B.
