# Geo-environmental Assessment

Richborough Estates

Brascote Lane, Newbold Verdon.

Ref: PJSG21-47-RT-02

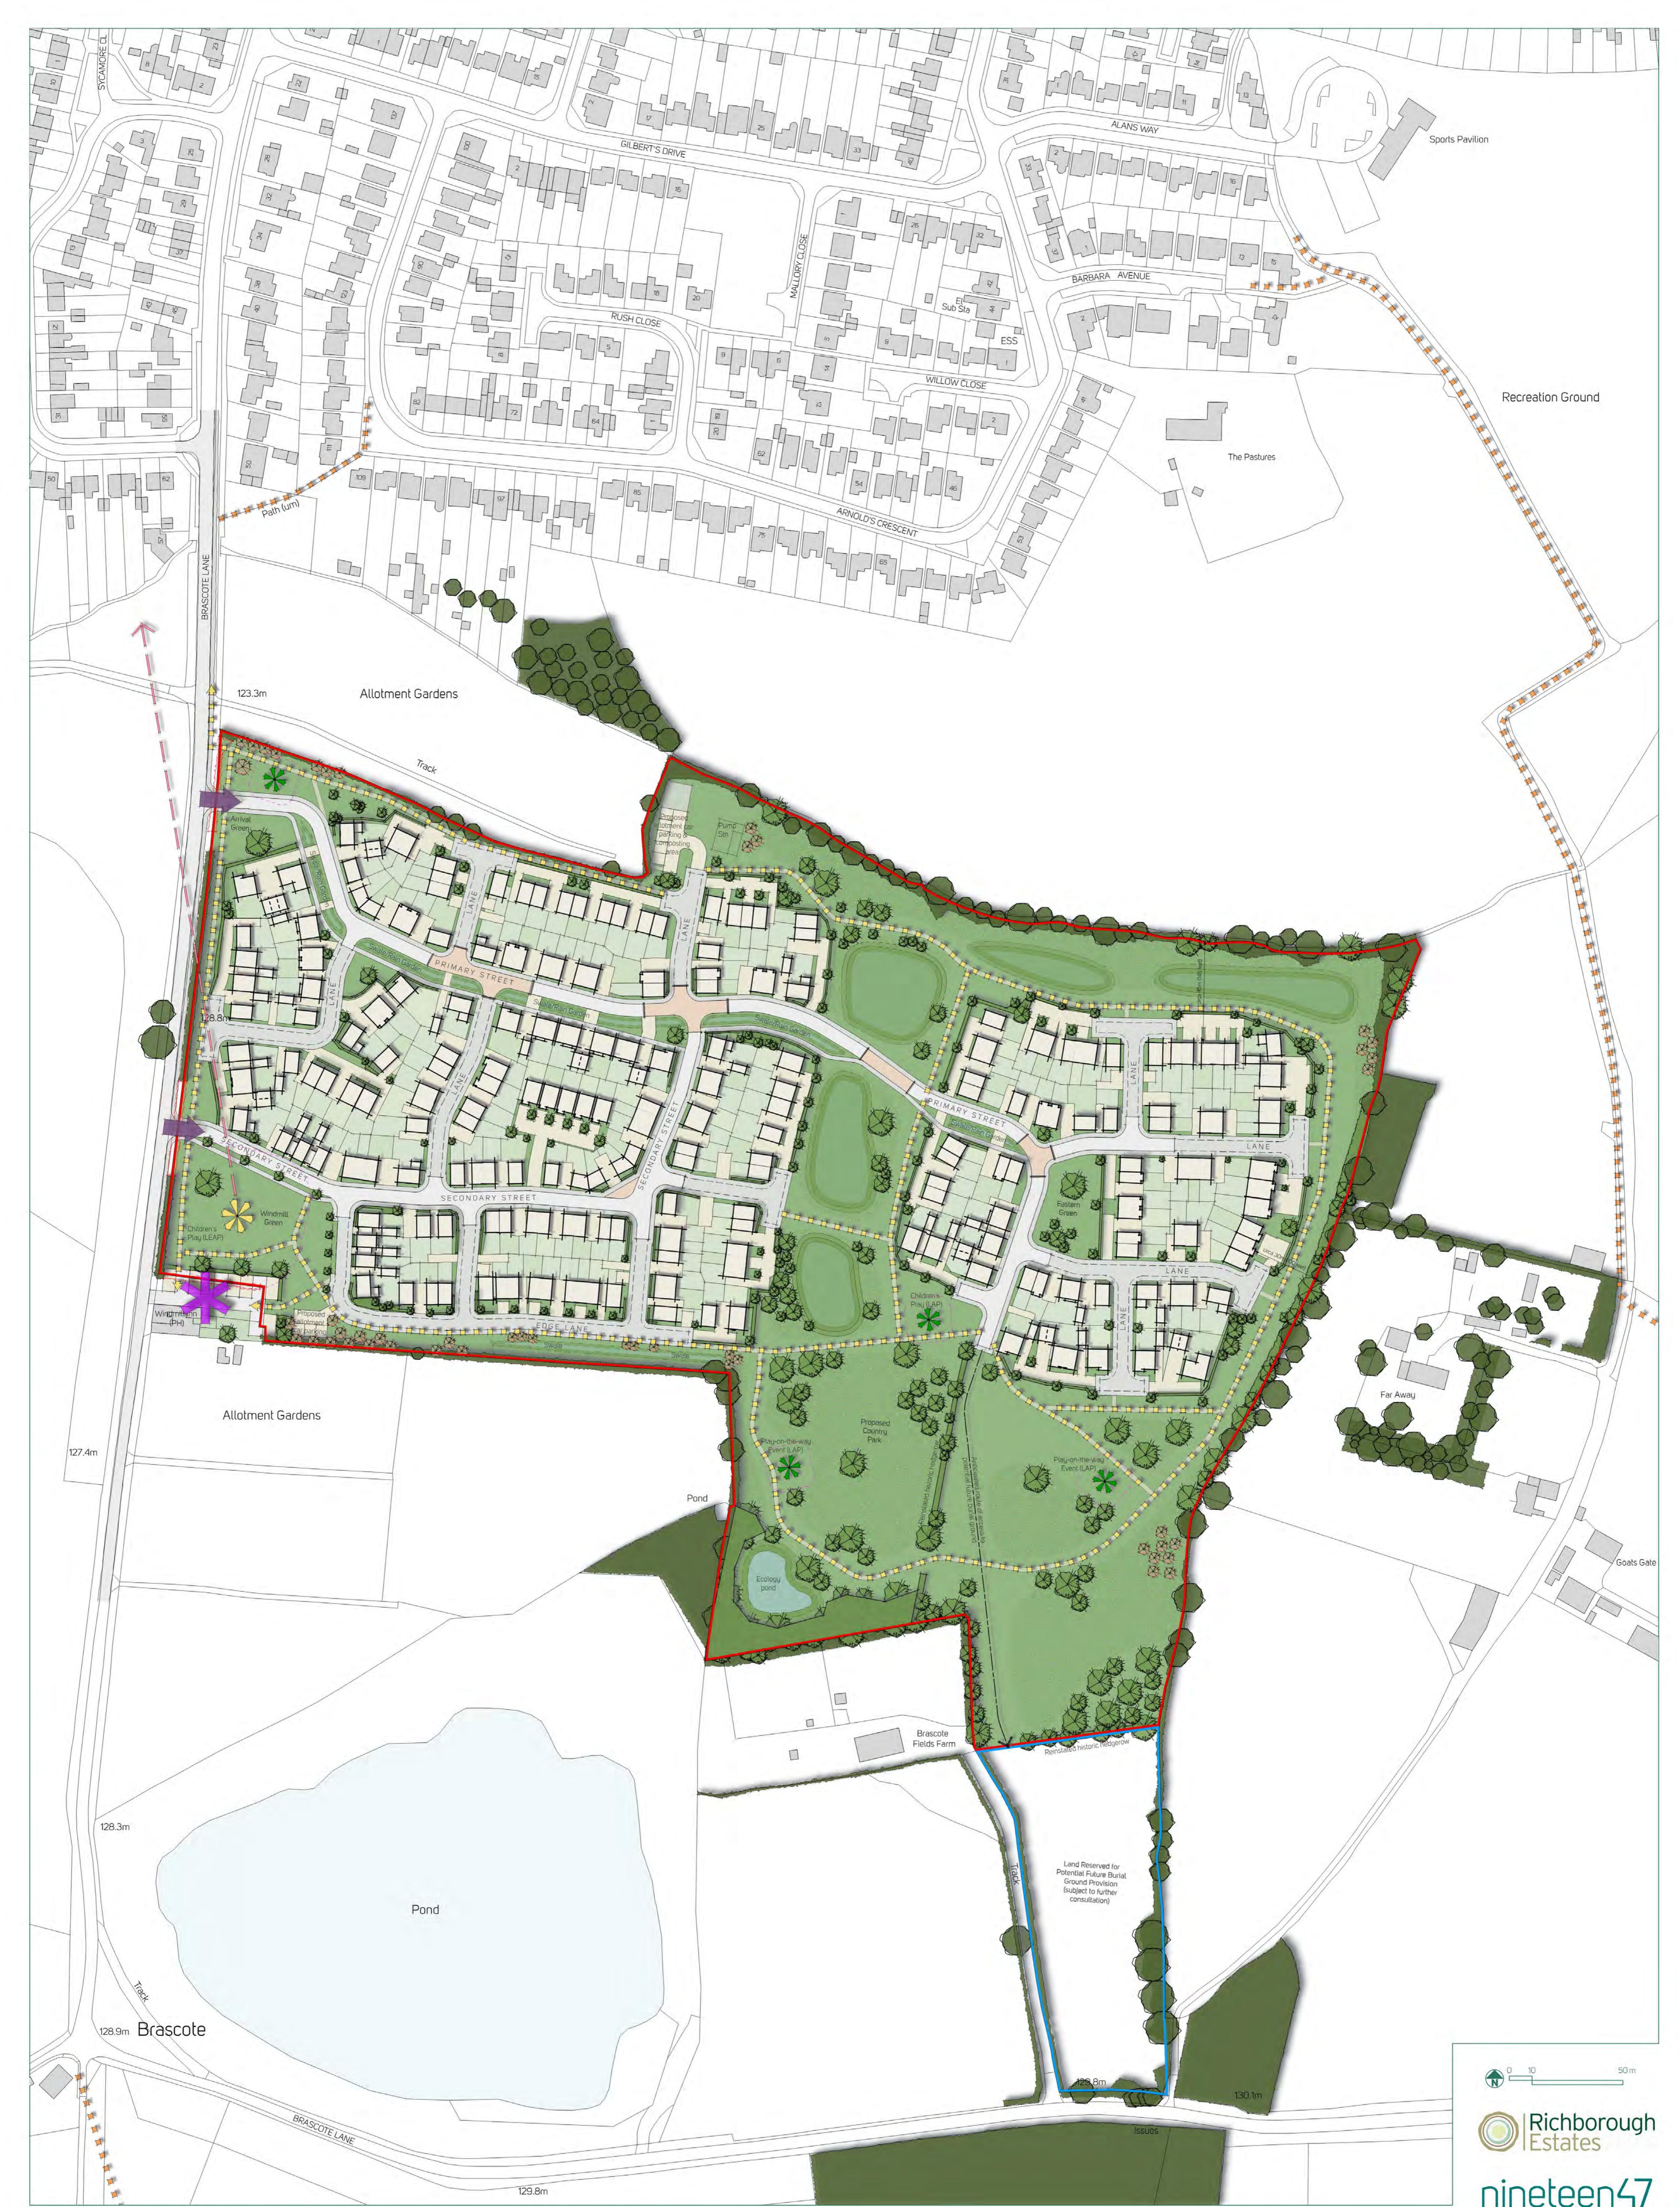
Project Code: n1741 Drawing No: 006 Rev: A

Key		Illustrative Layout									
	Application site boundary		Indicative proposed planting		Potential for children's play ar and/or event along a trim-trail (with min 5m development offset shown)		Existing Public Right of Way		Visual link with the spire of The Church of St. James		Potential for improvements at Windmill pub
	Other land under control of applicant		Potential for fruit-tree planting		Indicative marginal wildflower and grassland planting		Proposed pedestrian/cycle routes		Proposed vehicular access from Brascole Lane		Indicative dwellings (and associated garages)
	Existing (retained) trees & hedgerow		Areas of new publicly-accessible open space		Indicative surface water attenuation basin						
	Proposed tree/hedge removal		Potential for equipped area of children's play (with min 20m development offset shown)
