**An Archaeological Standing Building Survey  
Moore's Arms  
Orton Lane  
Norton Juxta Twycross  
Leicestershire**

**ABRS Project No 2022-MANL**

**Planning Permission 21/01146/FUL**

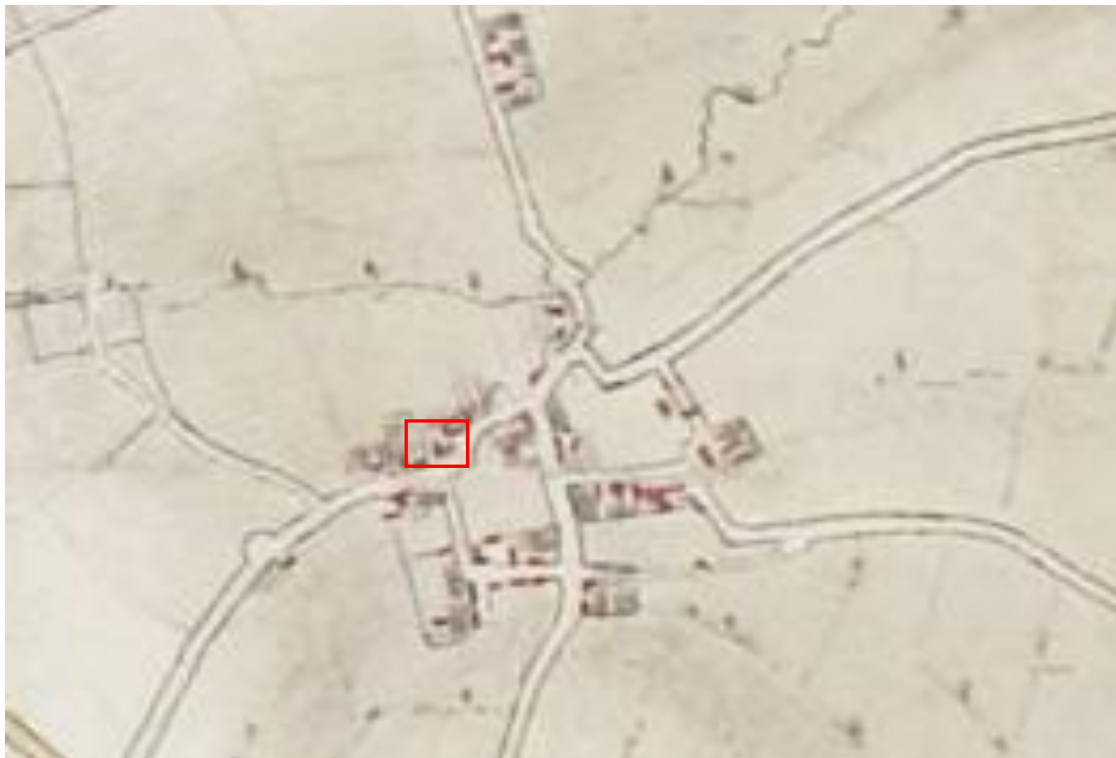
**Figure 2**  
Ordnance Survey Drawings: Lichfield, Staffordshire (1815).  
(OSD 258)

The earliest, currently available map of the proposed development area is the Ordnance Survey Drawing Lichfield, Staffordshire (*Figure 2*) drawn in 1815. The map was published at a small scale, 2 inches to the mile, the equivalent of 1:31,680; nevertheless it is possible to accurately locate the proposed development area and identify an "L" shaped building fronting the highway which could potentially be identified as the Moore's Arms.

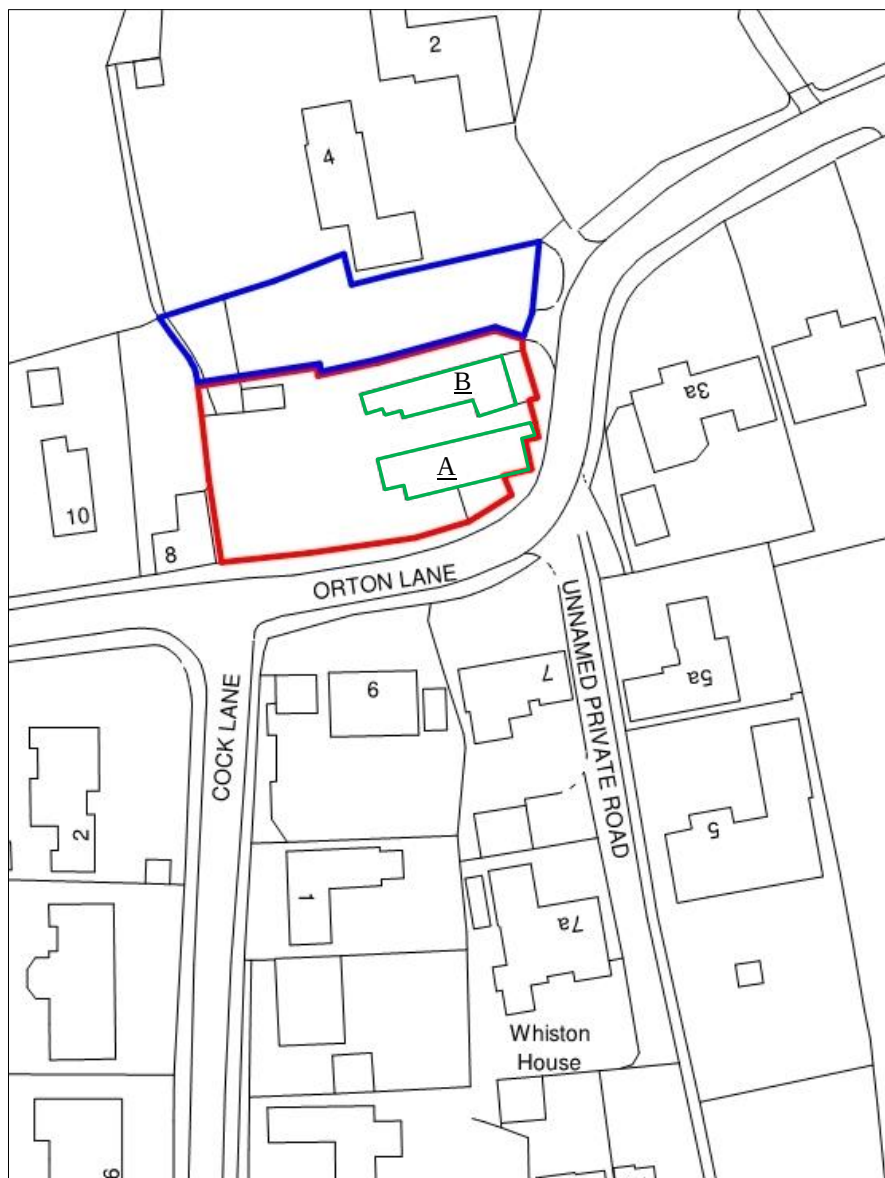
**Figure 5**  
Plan of the Proposed Development Area (in Red), Recorded Buildings in Green.  
(1:1250 (Provided by client))

*Orientation:* The buildings subject to this historic building recording are linear in plan, the long axis is aligned east-north east – west-south west (*Figure 5*); for ease of description this is taken hereafter to be east – west; the principal elevation being that facing south (Moore's Arms) and east (outbuilding). Where the terms 'left', 'right', 'front' and 'back' etc are used in the report, this is in relation to the principal elevations as viewed from Orton Lane. For the purposes of this historic building recording a letter identification has been added to the buildings and number suffix have been added for significant partitions where required.

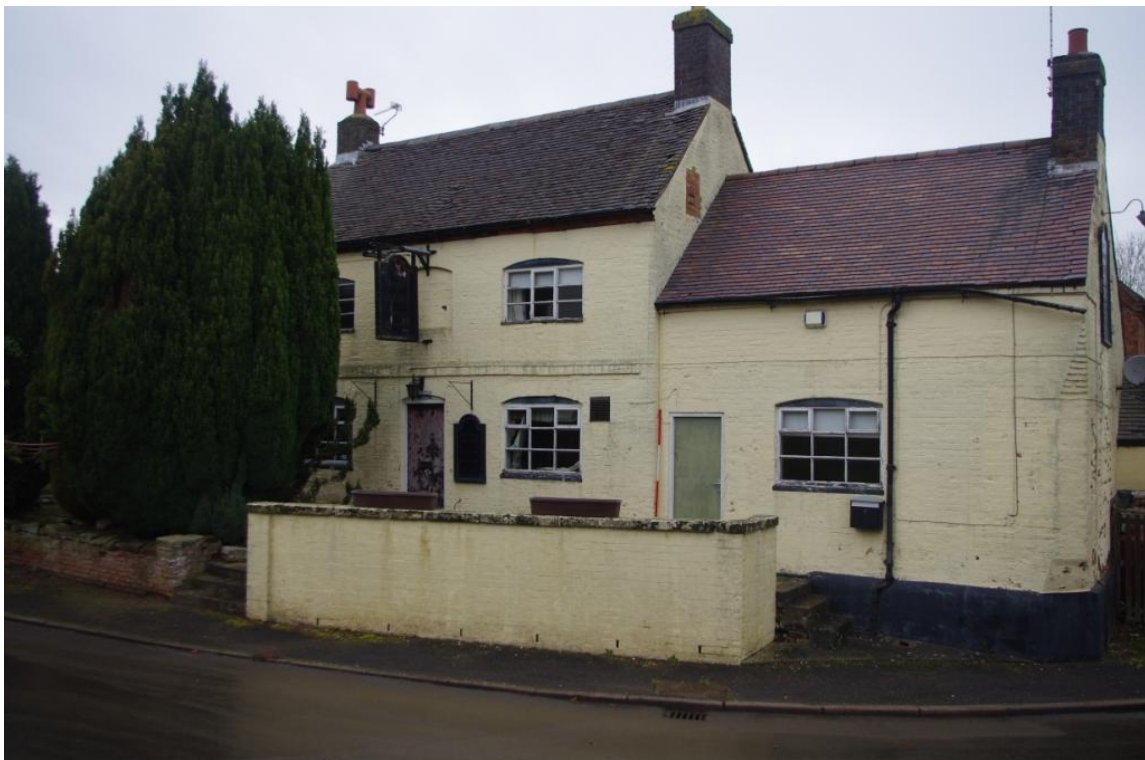
**Figure 6**  
Building A, Principal Elevation (Looking North West).

The building is linear in plan, fronting Orton Lane; the two storey painted brick building is under a pitched plain tile roof with brick end stacks. Although difficult to measure accurately with the paint layers, the bricks are smaller than the standard 3inch bricks so are likely to be pre 19th century handmade bricks. There were brick kilns located north west of Appleby Magna during the 19th century. There are single storey bays to the east and west, straight joints indicate both are later extensions, each of these single storey extensions have later extensions in modern brick, the easternmost under a pitched roof, the west being under a flat roof. The straight joint visible at ground level may suggest that the western extension is an earlier element rebuilt and enlarged. The principal elevation (*Figure 6*) has a central plain door under a segmental headed opening with flanking with identical openings and a central blind window at first floor level, along with a brick band, and a 20th century pub sign. The windows are three light glazing bar timber casements, probably mid 20th century in date. The window on the easternmost extension is the same, and also has a plain door to the left; the westernmost extension has a later bay window.

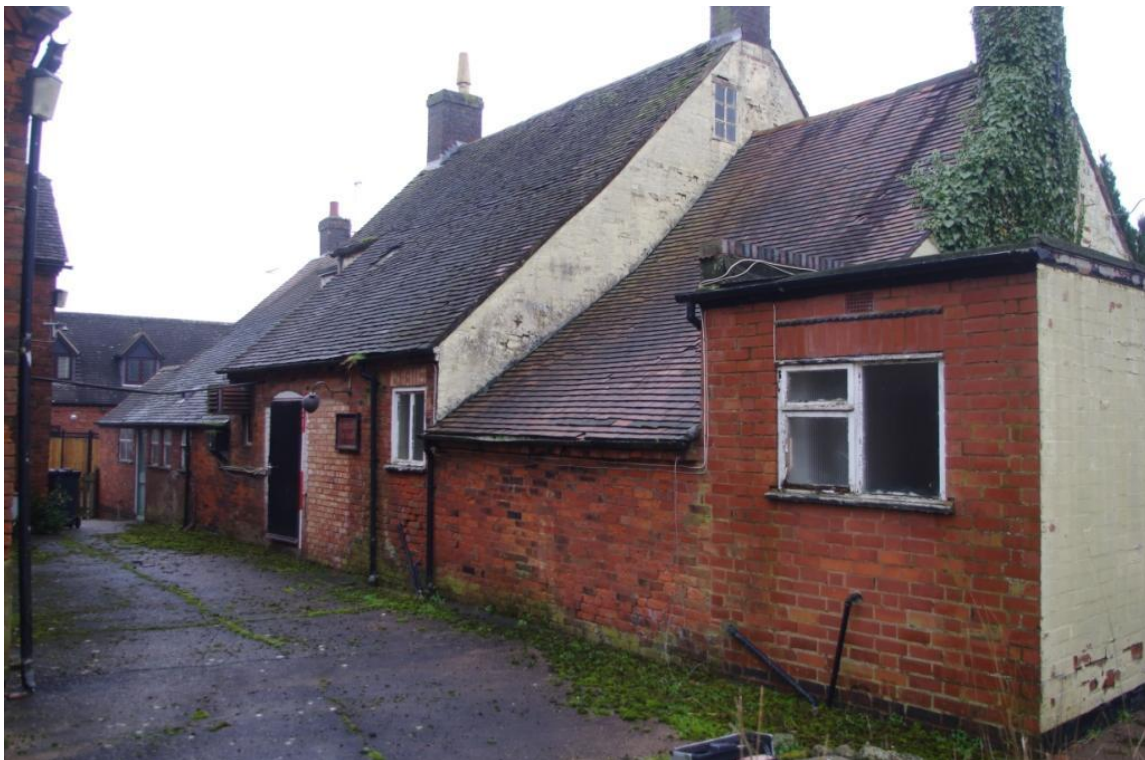
**Figure 7**  
Building A, North – North West Facing Elevation (Looking East – South East).

The rear elevation is exposed brick with the multiple phases clearly visible as is the expansive catslide roof (*Figures 7 & 32*). The openings appear to be limited to the later extensions, although there is a central opening under a segmental head, immediately to the west is a second, identical doorway blocked with 20th century Fletton bricks. This arrangement may suggest the historic central bay may have originated as two single unit cottages.

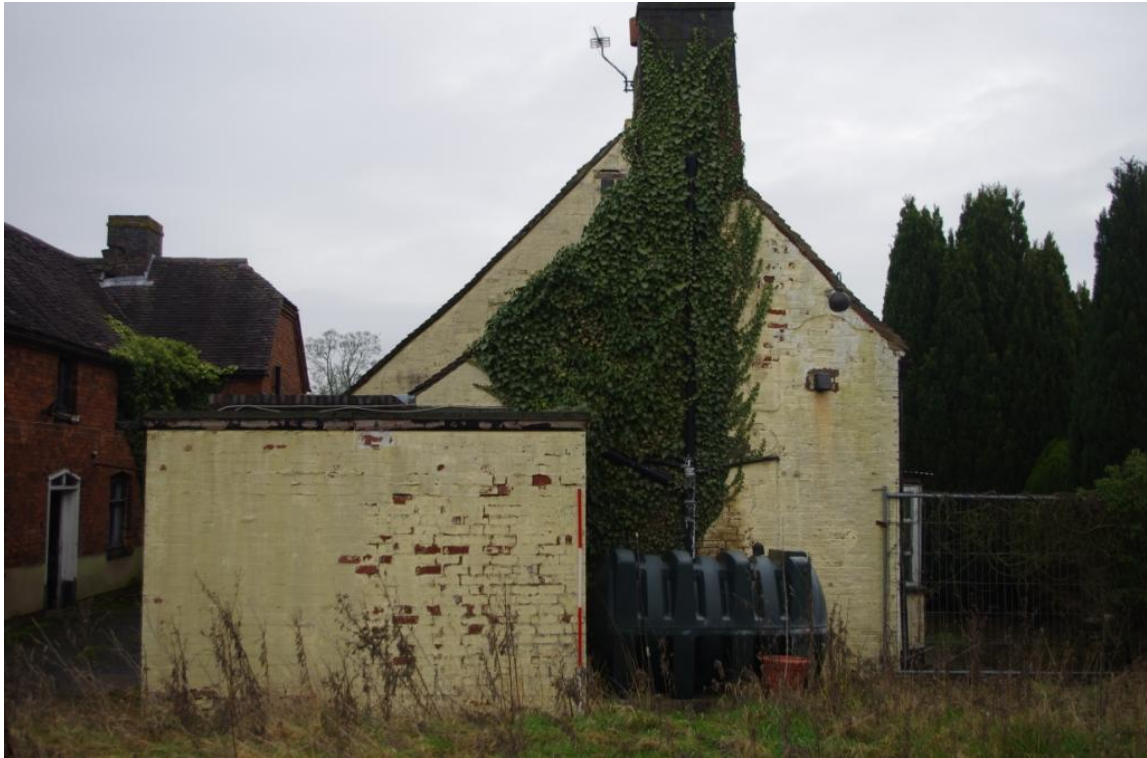
**Figure 8**  
Building A, West – South West Facing Gable (Looking East – North East).

Both gables are largely concealed by the later extensions, although the visible bricks of the westernmost extension are of similar dimensions to those on the principal elevation suggesting this may also be pre, or early 19th century in date (*Figure 8*). There is however a straight joint visible at eaves level to the north indicating that the central bay has been extended to the north. The east facing gable (*Figure 9*) is more interesting as it retains an unusual arrangement of blocked openings and apparently an off centre pitching door. The exact origin of the blocked openings is unclear, the two southernmost openings are under decorative segmental arches (*Figure 10*), so are likely to have originally been external windows, however the central opening is in line with the chimney so would have prevented a fireplace from being here which suggests the chimney is later. There is no evidence of a head to the northernmost, which is also partially concealed by a later extension.

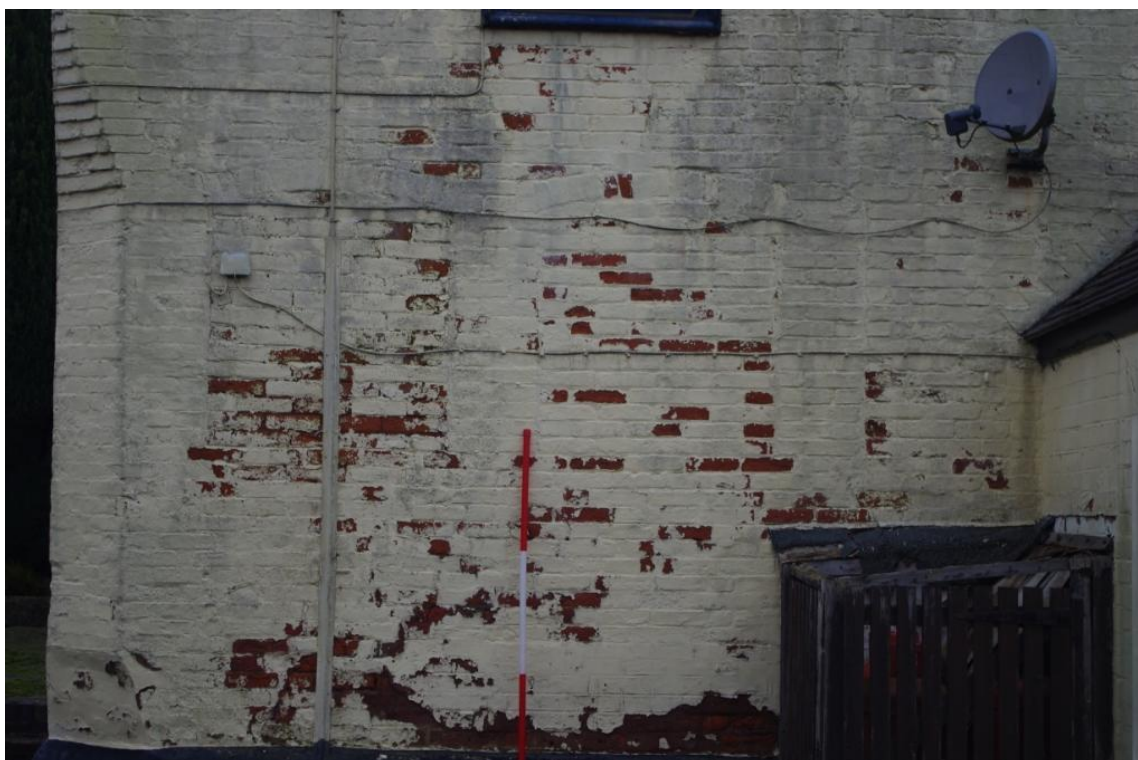
Building A, East – North East Facing Gable, Showing Blocked Openings (Looking West – South West).

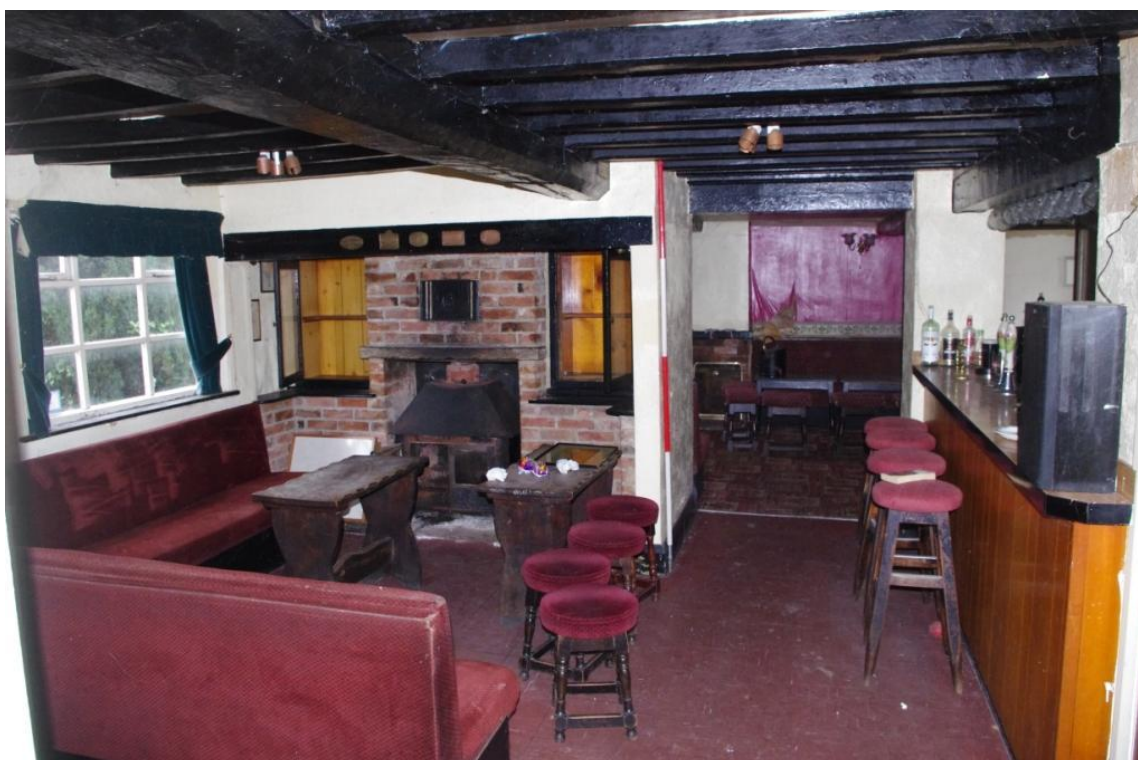
The central bay, (3) houses the servery against the rear wall, which is largely modern and relatively small in size and retains a number of features of historic and architectural significance. On the cross wall between (2) and (3) is a large inglenook-type fireplace (*Figure 11*) which indicates the original gable wall prior to the construction of (2), the fireplace contains two glazed cupboards (*Figure 12*), which although clad in modern deal are likely to have been originally spice or salt cupboards, which were normally located near the fire to prevent the contents from getting damp. Probate inventories suggest that by the late 17th century salt boxes were separate, moveable items. There is, potentially a chamfered timber overmantle, although it is largely concealed by later timber cladding.

A(3), Fireplace (Looking West – South West).

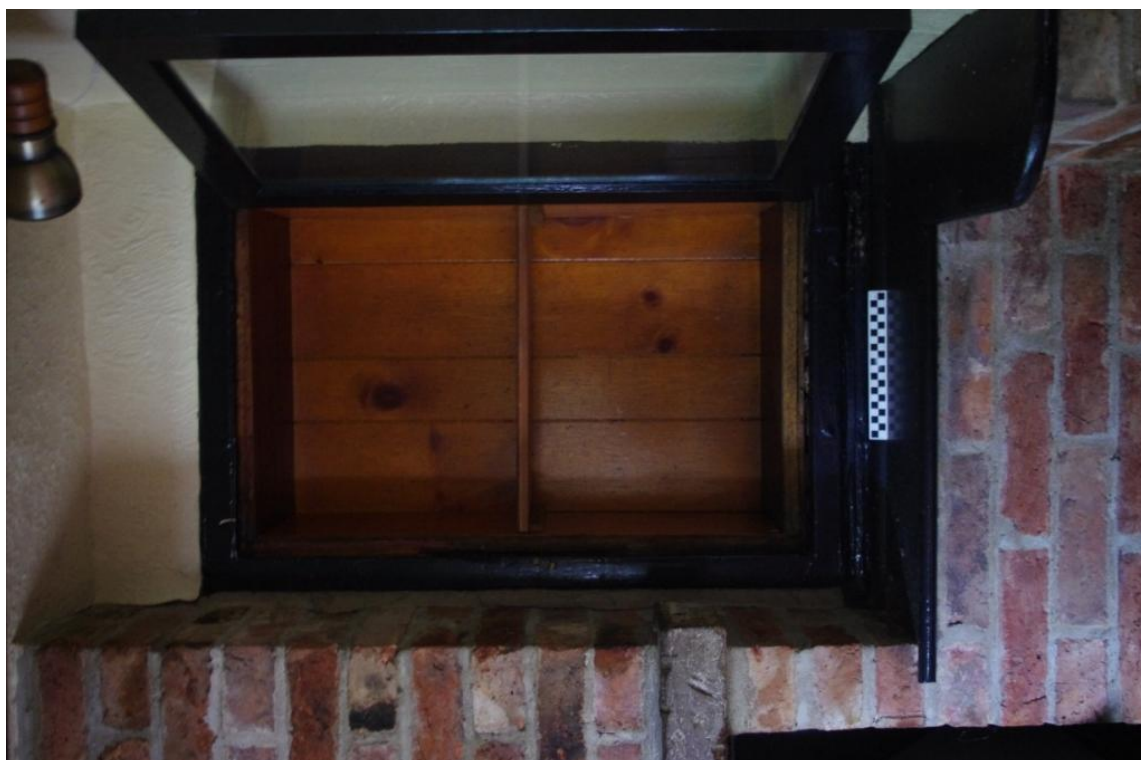
**Figure 12**  
A(3), Spice Cupboard to North of  
Fireplace (Looking West – South  
West).

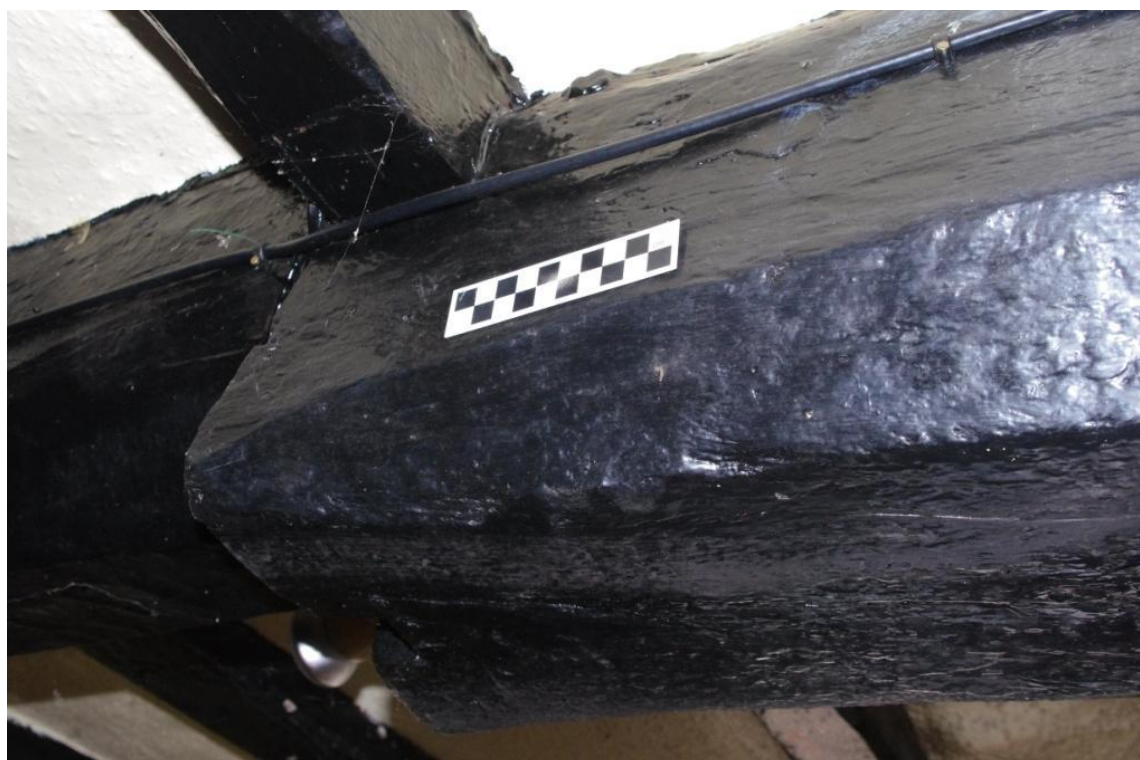
The ceiling is carried on a heavy chamfered bridging beam, the beam is stopped at its eastern end with a simple runout stop which could potentially be early 18th century in date (*Figure 13*). The location of the stop would indicate the original wall line, this has clearly been altered with a short length of smaller bridging beam now extending to the east. The joists are of varying scotling and potentially original. The fireplace in the eastern wall of (3) is much smaller and almost certainly late 19th century in date with a 20th century tiled, or inscribed cement insert.

**Figure 13**  
A(3), Chamfered & Stopped Bridging Beam (Looking South East).

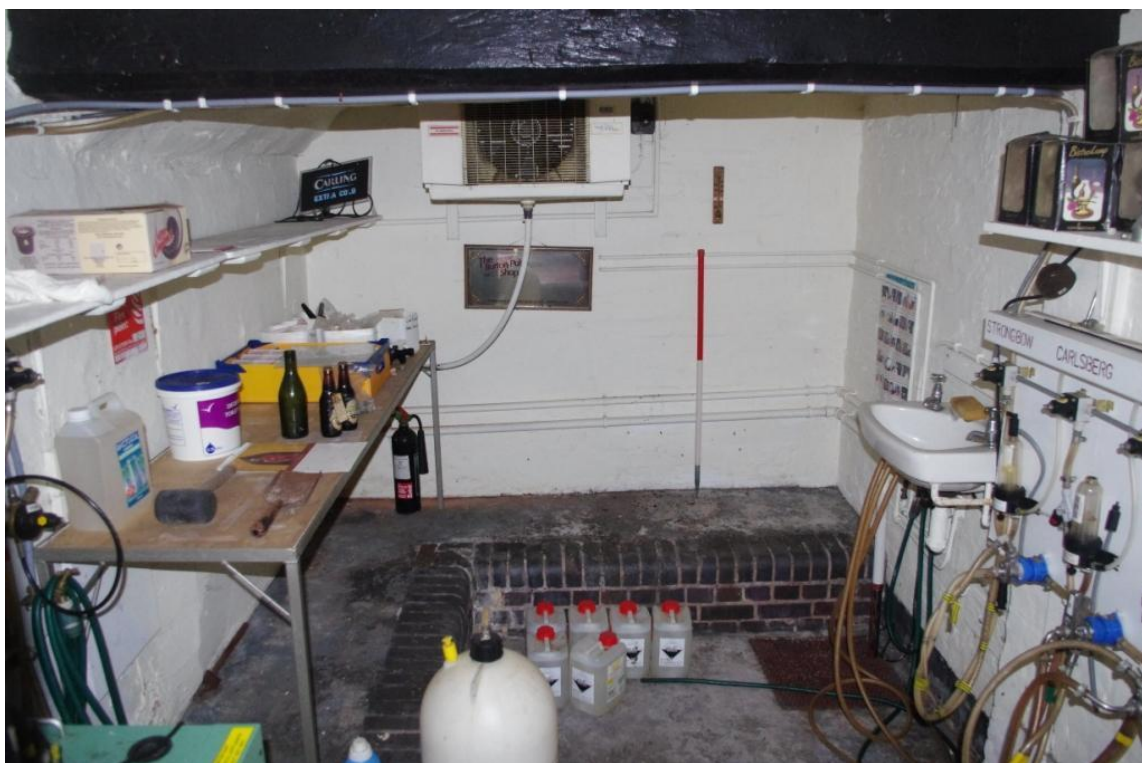
To the north of (3) is a small sunken barrel store with brick thralls on the north and east walls (*Figure 14*). The ceiling is carried on a clearly reused chamfered bridging beam.

**Figure 14**  
A(4), Barrel Store (Looking East – North East).

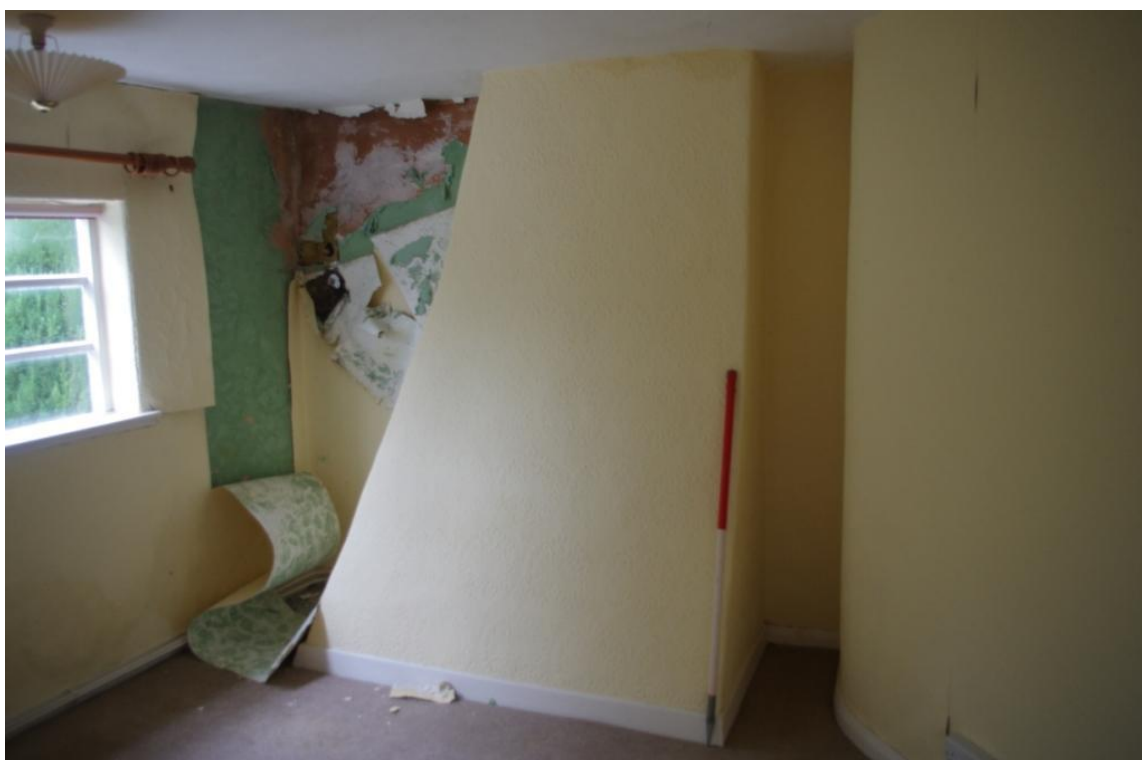
Access to the first floor is via a straight flight stair between (3) and (5). The first floor consists of the two principal bays (*Figure 27*). There is clearly a third bay to the east which is inaccessible. The first floor retains very little of historic or architectural significance. There is a large chimney breast within (9) which indicates the original gable wall (*Figure 15*) and exposed, partly chamfered purlins in (8).

**Figure 15**  
A(9), Chimney Breast (Looking West – South West).

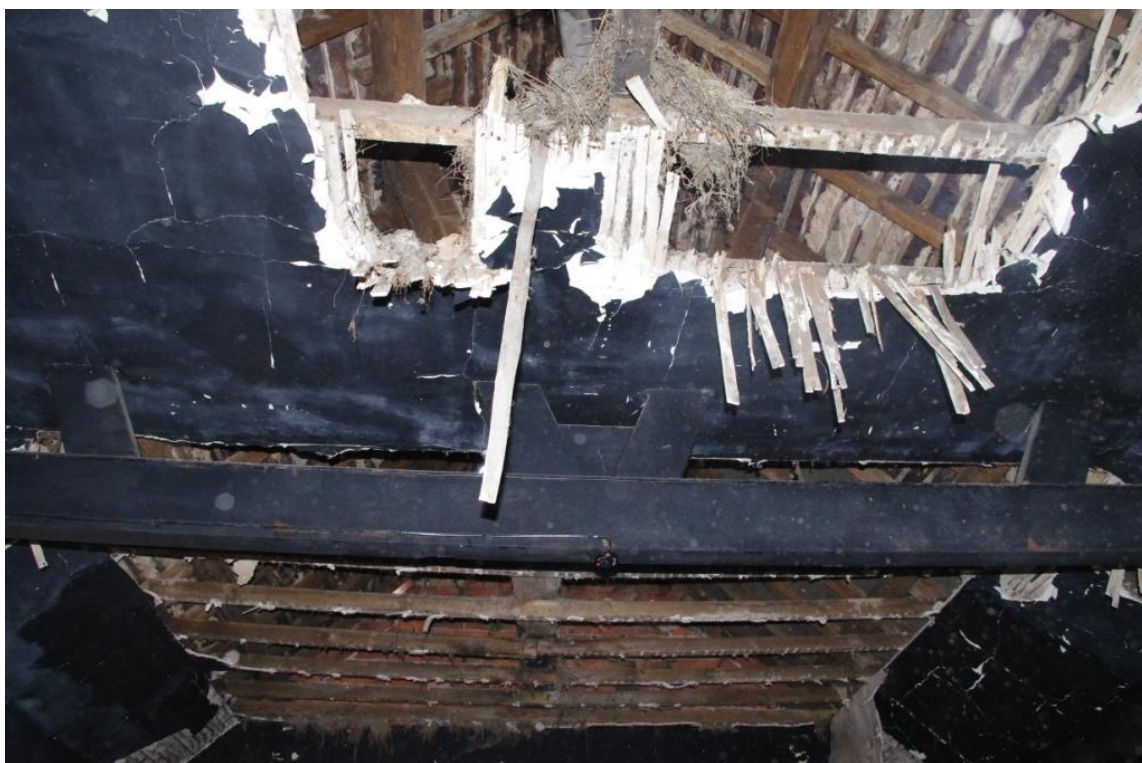
**Figure 20**  
B(2), Roof Truss (Looking West – South West).

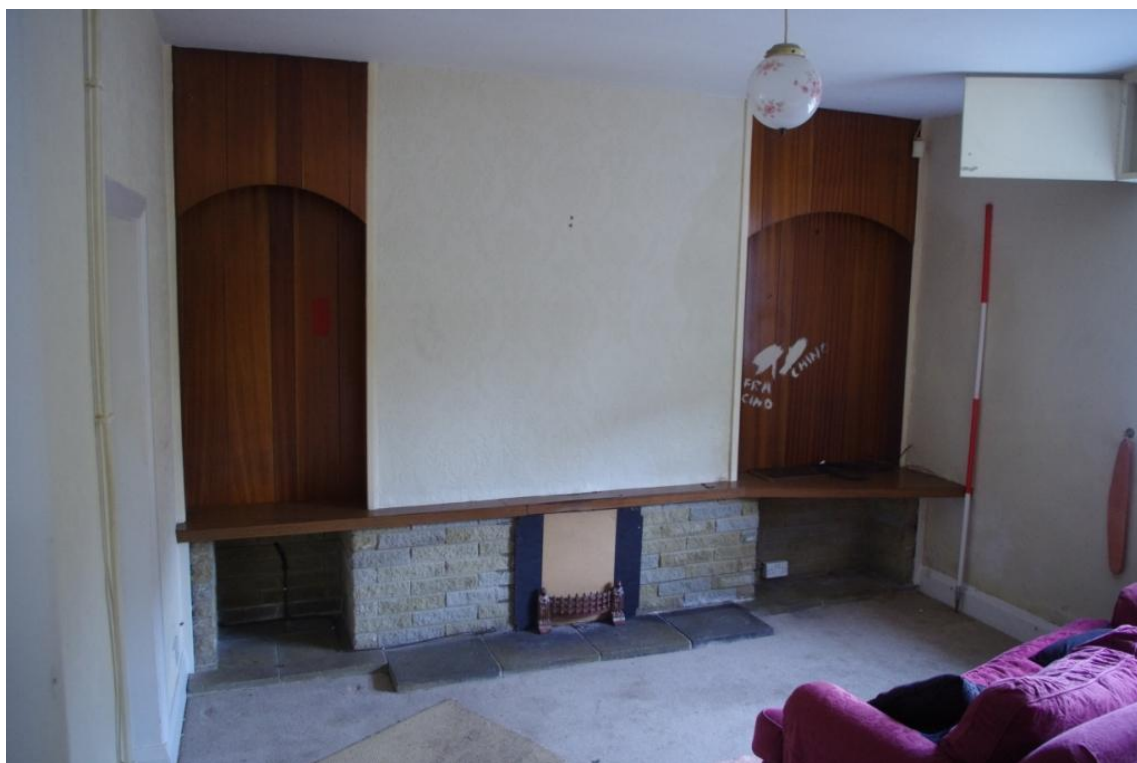
The easternmost bays, (5) and (7) are clearly domestic. There is evidence of a fireplace on the east wall of (5) with alcoves to the north and south (*Figure 22*). There is no evidence of the blocked openings observed externally visible on this wall, although the extensive modern cladding and décor is likely to conceal it.

**Figure 22**  
A(5), General View (Looking East).

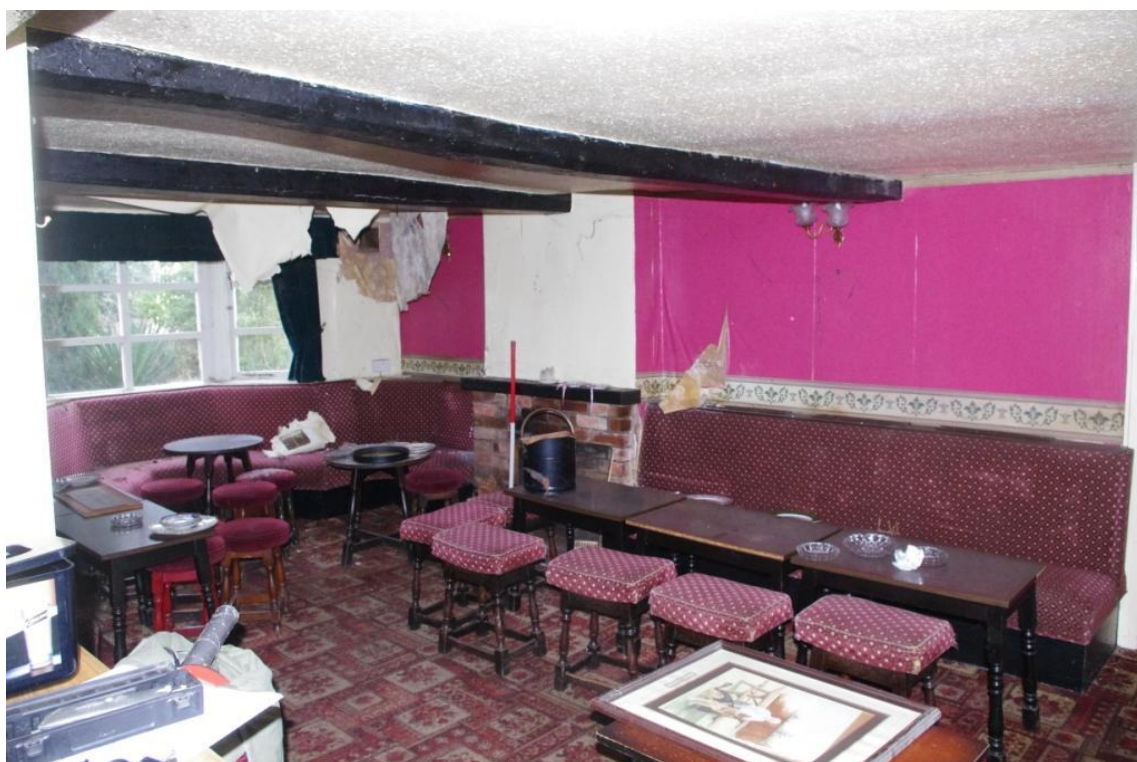
The westernmost bay, (2) retains little of historic or architectural significance and may have originally been the lounge – a better quality pub room (*Figure 23*). There are two bridging beams, the southernmost (central) is underdrawn, and the northernmost is chamfered with a possible runout stop at its western end.

**Figure 23**  
A(2), General View (Looking South West).

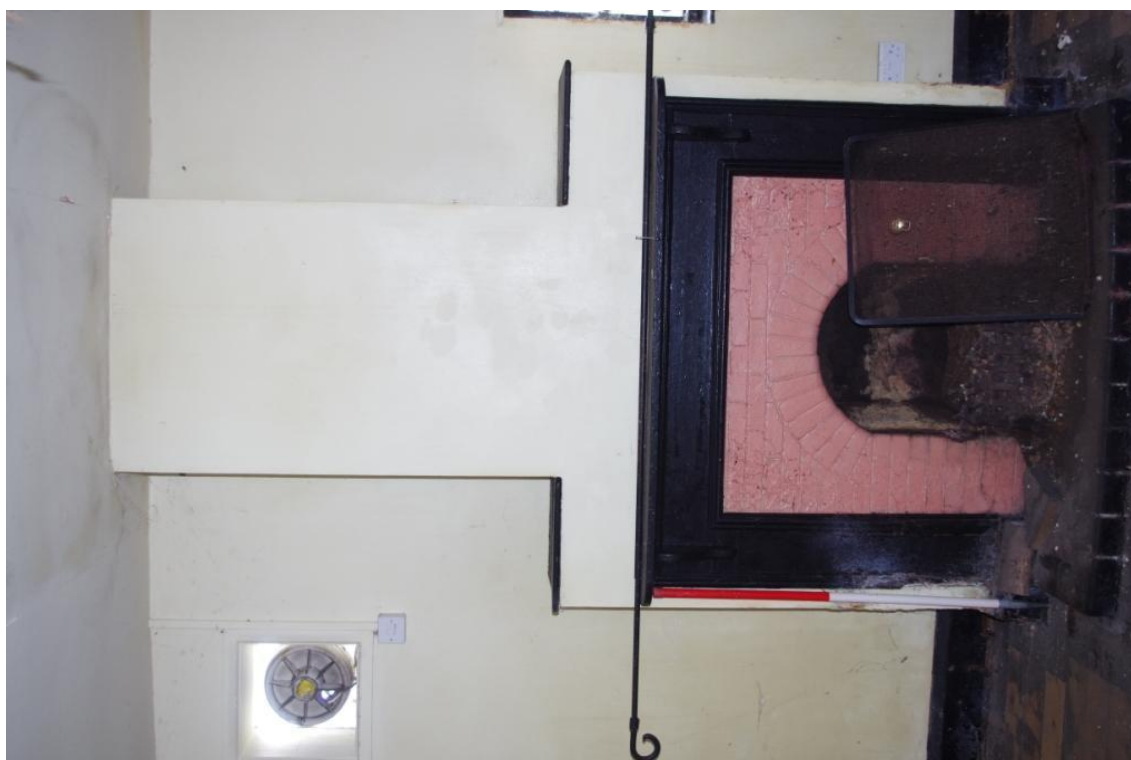
Internally, the building consists of three principal bays (*Figure 28*). Due to structural instability, the easternmost bay was inaccessible (the architect supplied drawing is reproduced in Fig. 28 but not verified for accuracy). The principal bay, B(2) consists of single room with a central fireplace against the rear (north) wall (*Figure 21*), there is a 20th century suspended ceiling concealing two late 19th or early 20th century trusses in deal (*Figure 20*). It is clear that the room was originally open to the roof, which is confusing given the first floor windows on the south facing elevation, which may suggest a more complex history, this is supported by the chimney which blocks one of the ground floor windows, suggesting the two are not contemporary, the fireplace itself is too small for the room (*Figure 25*).

**Figure 25**  
**B(2), Fireplace (Looking North – North West).**
