Hillmoren Limited,  
32 Shaw Lane,  
Markfield,  
LE67 9PU

## **Ground Investigation at Hall Farm, Markfield**

Erda Associates Ltd were instructed by Hillmoren Limited to assist with a Ground Investigation at the site known as Hall Farm, Markfield.

The ground investigation is to assist with the proposed redevelopment of the site through the demolition of the existing buildings and the construction of two new commercial units with car parking

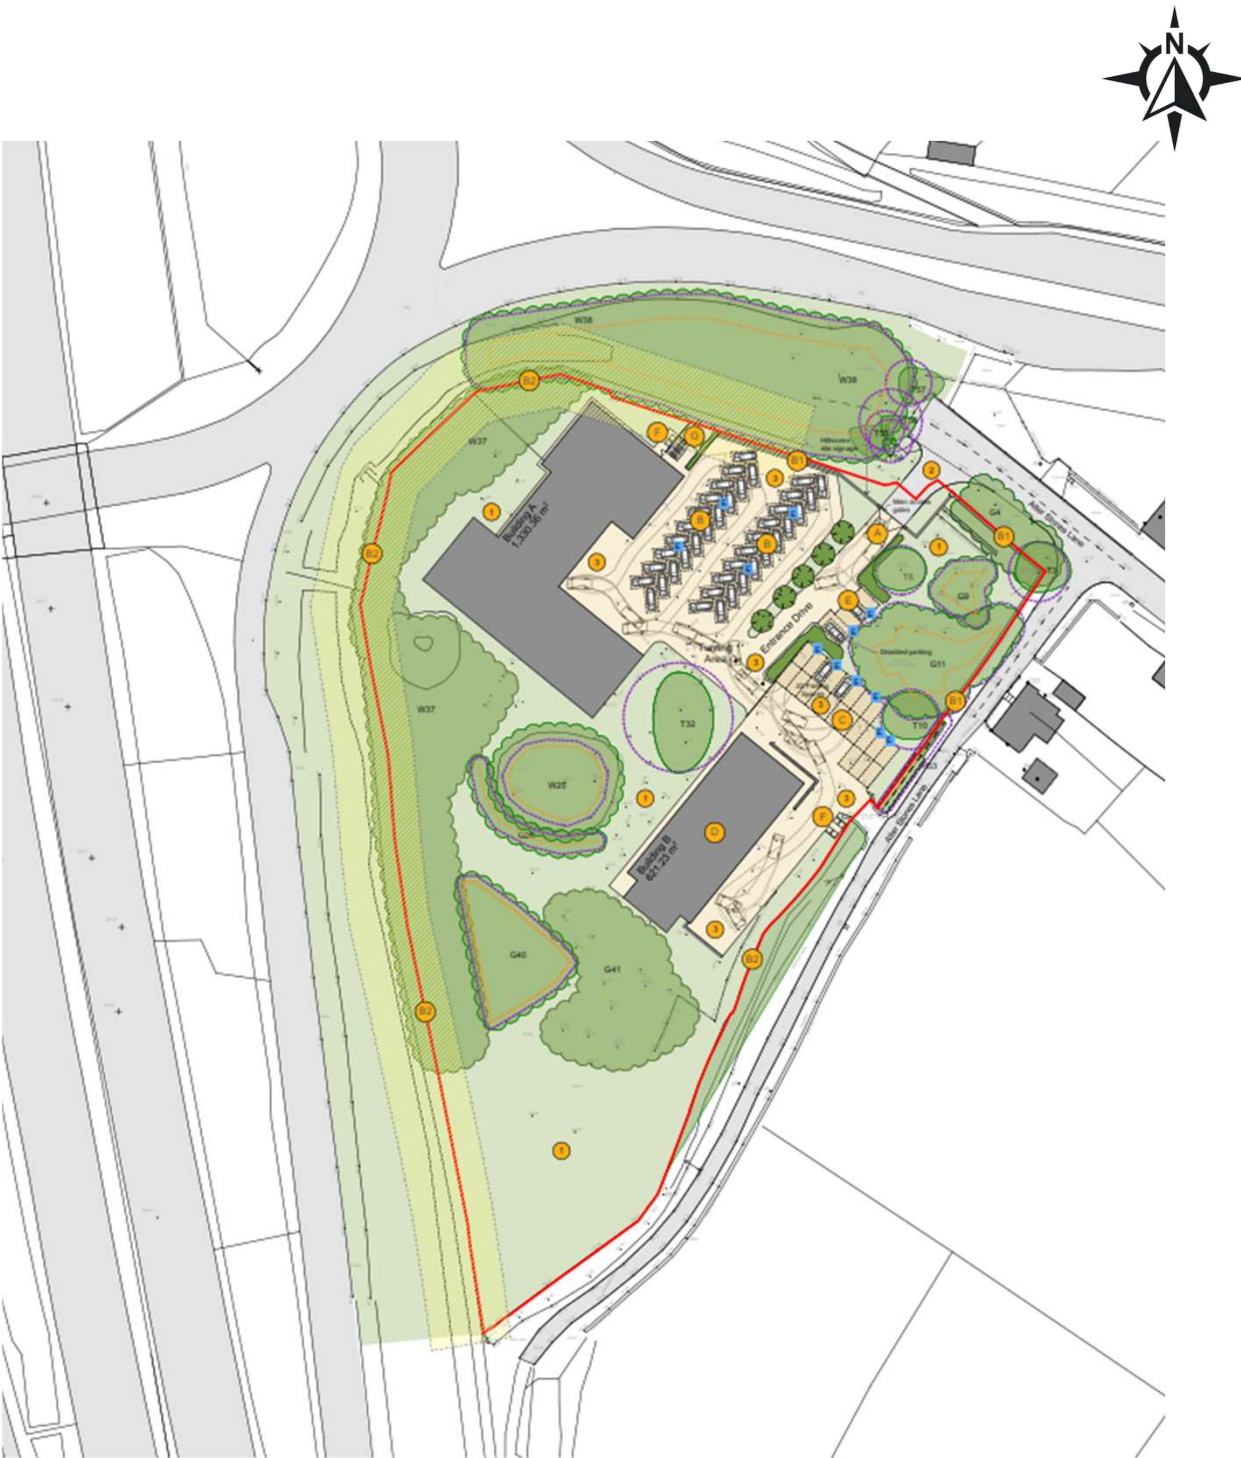
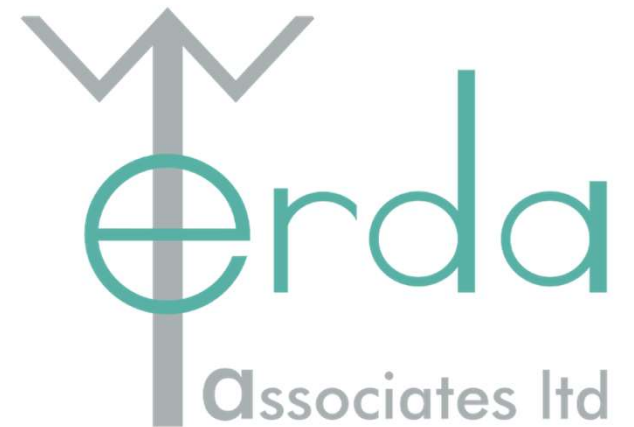
Figure 3

Development Proposal

However, the development proposal incorporates a permanent cap over much of the site, including at the location of TP02. This is considered sufficient to break the source-pathway-receptor linkage and no further remedial measures will be required.

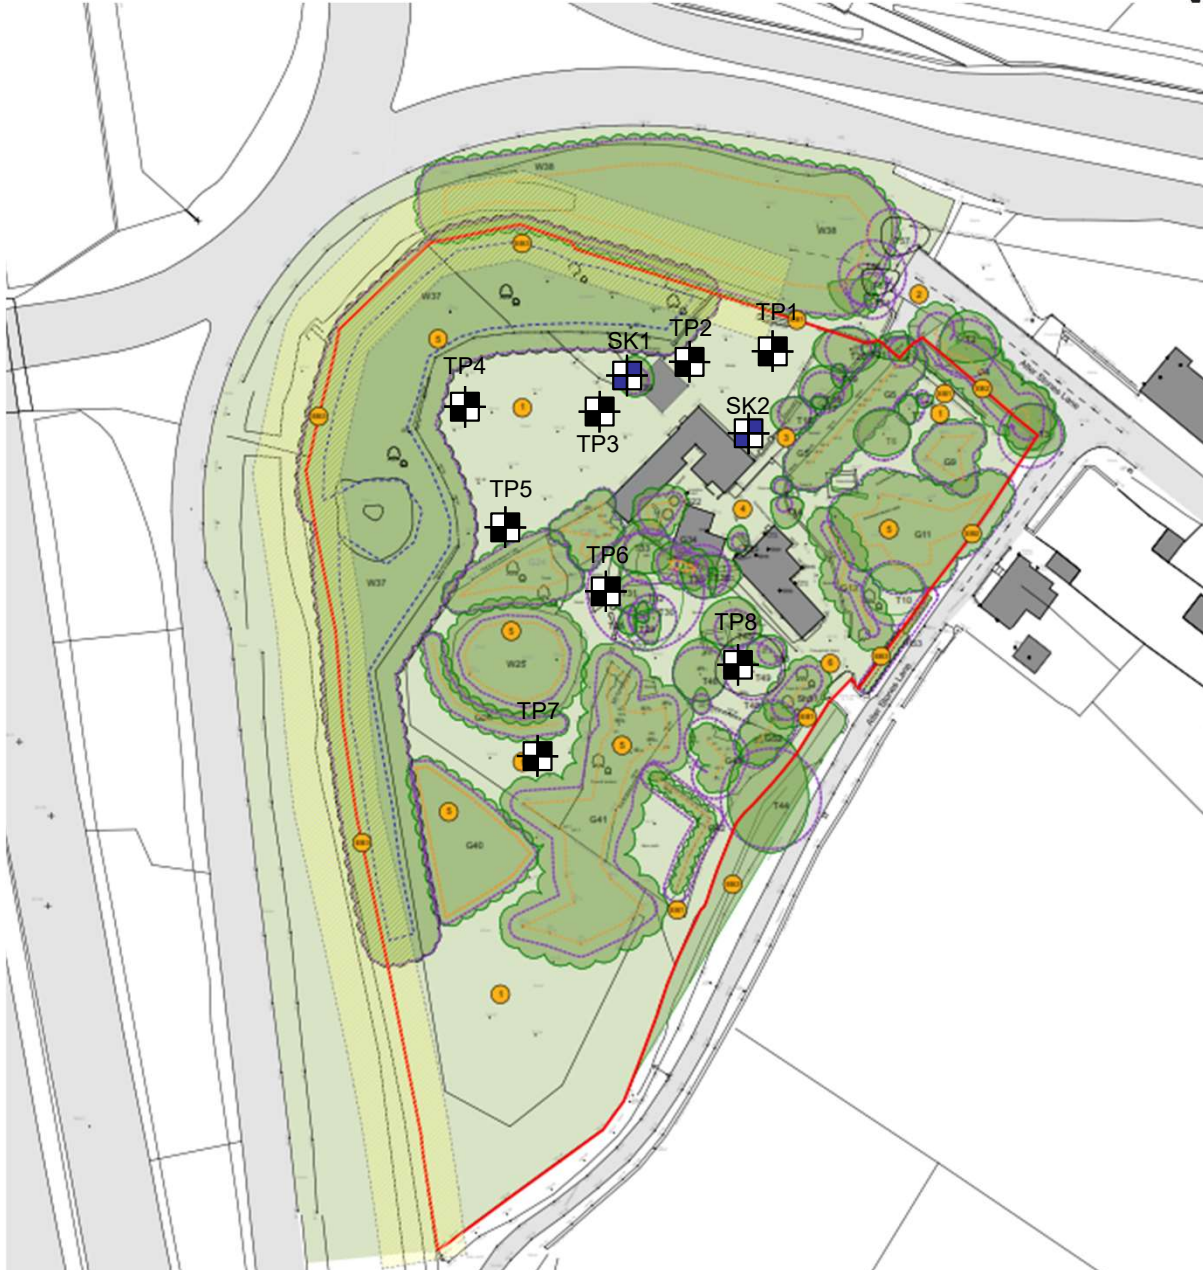
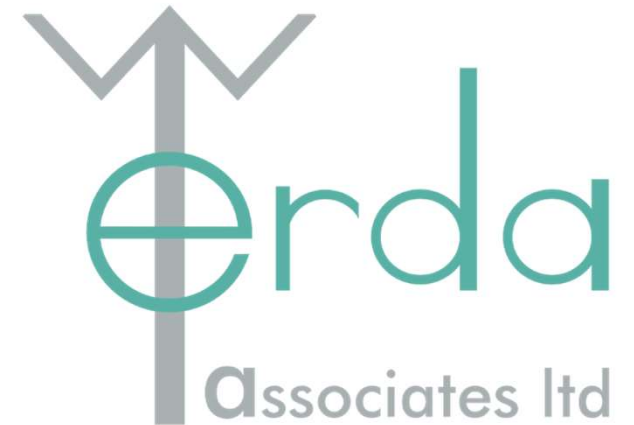
Figure 4

A total of eight machine excavated trial pits (TP01-TP08) were advanced to depths up to 2.7m. A further two trial pits were excavated to 1.5m (SK01 & SK02) which soakaway tests were undertaken.

Exploratory Hole Location Plan

Refer to **Appendix A** for exploratory hole locations.
