# Cadeby Hall, Cadeby

## Non-Licensed Method Statement for Bats

Report No. 260710.2.NLMS.v1.0

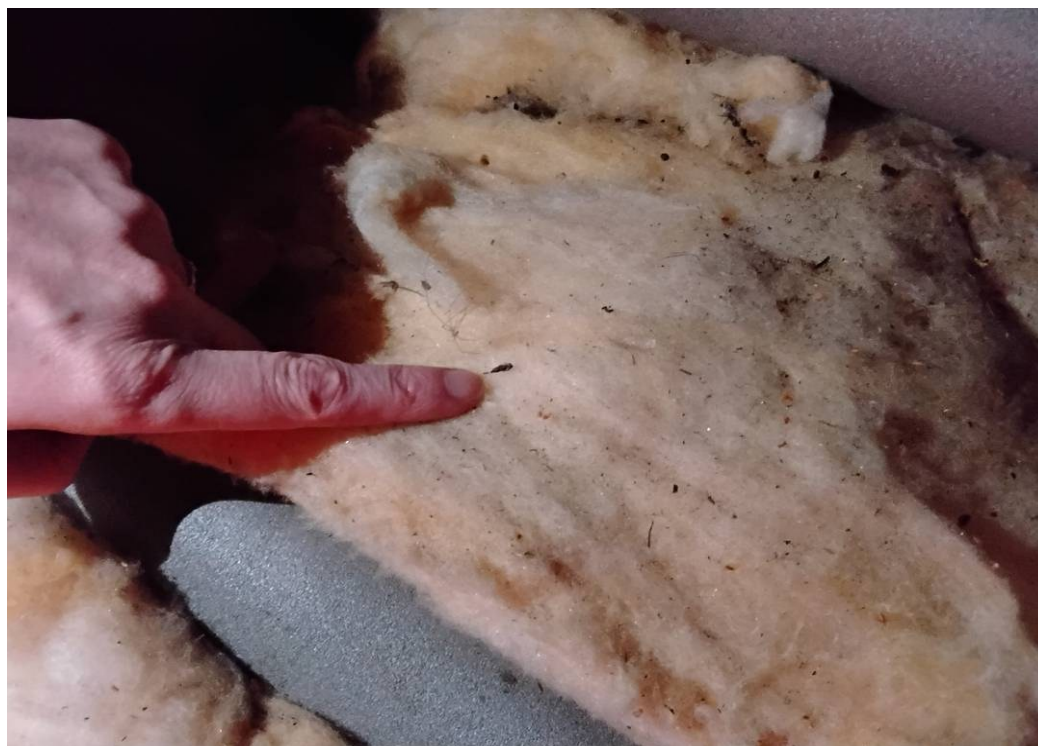
*Figure 3 Bat dropping located within the void of B1*

A Preliminary Roost Assessment undertaken by Croft Ecology on 03 March 2026 identified Building B1 as having moderate potential for roosting bats due to several potential access points around the ridge tiles, roof tiles and lead flashing. A small number of pipistrelle-type droppings were also recorded within the roof void. These indicated that bats may occasionally

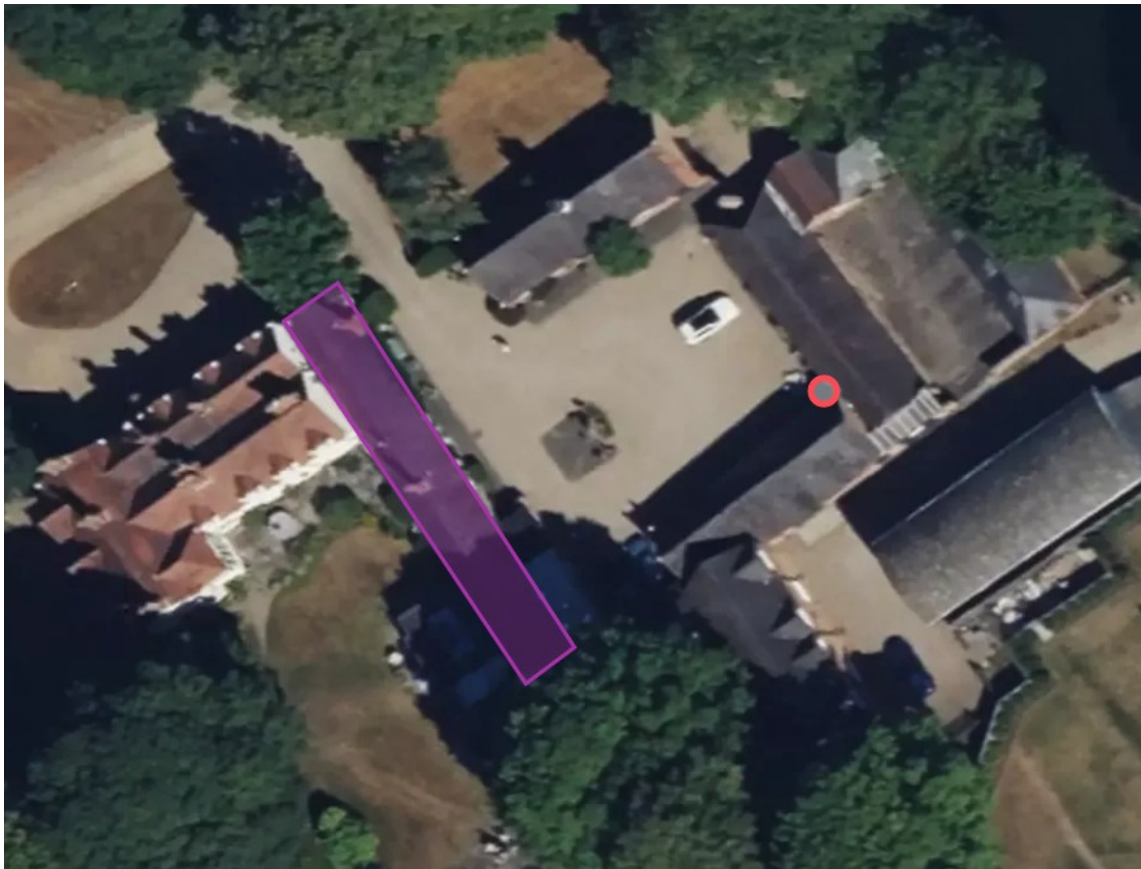
*Figure 4, Red dot showing the emergence location of the Myotis bat, adjacent to the Site*

External lighting associated with the development will be designed and positioned to avoid unnecessary illumination of retained trees, garden habitats and surrounding buildings, including the nearby courtyard building from which a *Myotis* sp. bat was recorded emerging during the bat surveys. Figure 4 below shows the building in which the bat was seen emerging from.
