## Bat Emergence and Re-Entry Surveys (BERS)

6 Chapel Street, Stapleton, Leicester, Leicestershire, LE9 8JH

This report is prepared to inform a planning application with Hinkley and Bosworth Borough Council. The proposal is described as: Single storey side and rear extension with new front porch.

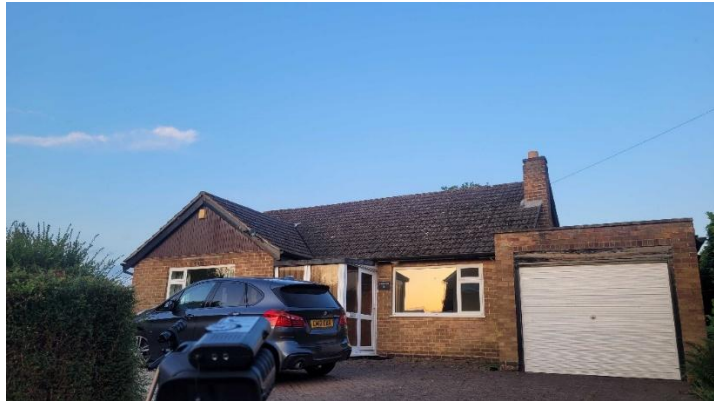
| <b>Surveyor 1</b> | <b>No emergencies observed.</b><br><br>Bat species observed: noctule and common pipistrelle<br>Key foraging areas: northwest to southeast along the road, and over the front garden<br>Key flight paths: east over the garage towards the back garden<br><br>Summary of general activity:<br>The first bat observed was a common pipistrelle at 22:01, the bat was passing from the west, heading east over the building towards the back garden. At 22:05 a noctule was observed passing behind the surveyor, travelling from the south to the | | | <b>Full elevation photo showing surveyor's view.</b><br> | | | |

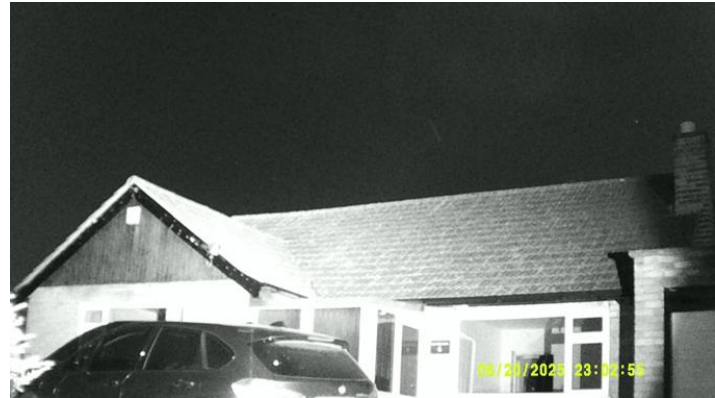
| <p><i>IR position 1</i><br/> <i>Nightfox Whisker IR</i><br/> <i>Camera &amp; Nightfox IR</i><br/> <i>Torch</i></p> | <p>Camera position: observing west elevation of building.</p> <p><b>No emergencies observed.</b></p> <p>At 22:19, the common pipistrelle that was detected by the surveyor can be seen passing over the building towards the back garden, travelling from the west.</p> | <p><b>Darkest point full elevation photo showing surveyor's view.</b></p> |

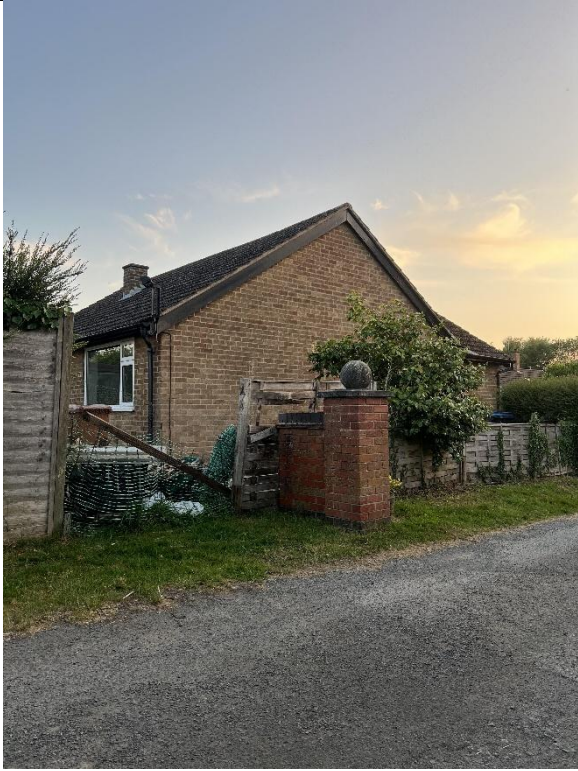
| <p><i>Surveyor 2</i></p> | <p><b>No emergencies observed.</b></p> <p>Bat species observed: noctule and common pipistrelle<br/> Key foraging areas: over the back garden</p> | <p><b>Full elevation photo showing surveyor's view.</b></p> |

| | <p>Key flight paths: following the road and hedgerows north of the building</p> <p>Summary of general activity:<br/>The first bat activity was at 22:04, a common pipistrelle was detected audibly but not visually confirmed. At 22:05, a noctule was detected audibly but not visually confirmed. Between 22:09 and 22:11, 4 common pipistrelle passes were observed in front of the northern elevation following the road. At 22:22 three common pipistrelles were observed foraging around the northern elevation, travelling to the back garden and following the hedgerow around the building. Between 22:24 and 22:40 there was frequent foraging activity and passes from at least two common pipistrelles around the elevation and in the back garden, following the road and hedgerows in both directions. Throughout the survey there were several occasions of common pipistrelle calls detected audibly but not visually confirmed, the last of which was at 22:59 and was the final bat activity.</p> | |

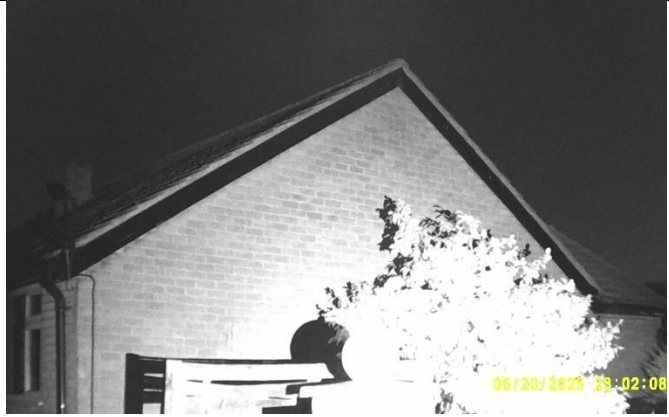
| <i>IR position 2</i><br><i>Nightfox Whisker IR</i><br><i>Camera &amp; Nightfox IR</i><br><i>Torch</i> | <p>Camera position: observing north elevation of building.</p> <p>No emergencies were seen. No additional observations or bat activity observed upon review.</p> | <p><b>Darkest point full elevation photo showing surveyor's view.</b></p> |

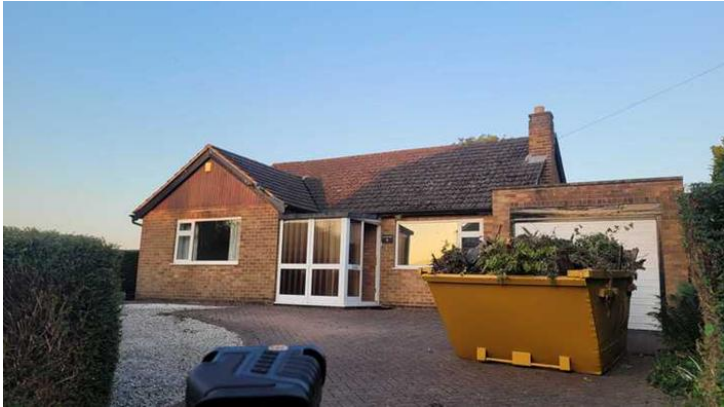
| <p><i>Surveyor 1</i></p> | <p><b>No emergencies observed.</b></p> <p>Bat species observed: soprano pipistrelle and common pipistrelle</p> <p>Key foraging areas: northwest to southeast along the road, neighbouring gardens west of the site</p> <p>Key flight paths: east over the garage towards the back garden</p> <p>Summary of general activity:</p> <p>The first bat observed was a soprano pipistrelle at 21:58, the bat was passing from the north, heading east over the building towards the back garden. At 22:00, a common pipistrelle was observed commuting and foraging, travelling from the church to the north of the site, following the road over the surveyor before returning back towards the church. At 22:03, an unidentified bat was seen over the front garden, it appeared to be foraging but it was not echolocating. A common pipistrelle was detected audibly at 22:05 but not visually confirmed; there were frequent calls detected throughout the survey. At 22:10 a soprano pipistrelle was detected audibly but not visually confirmed. At 22:10, a common pipistrelle was observed foraging over the road until 22:13. At 22:20, a common pipistrelle was observed foraging and commuting, travelling from north to east over the building towards the back garden. Common pipistrelles were also observed foraging over the neighbouring gardens to the west of the site frequently between 22:21 and 22:50. At 22:23, a common pipistrelle was observed passing from the north, heading east over the building towards the back garden. At 22:25, two common</p> <p><b>Full elevation photo showing surveyor's view.</b></p> |

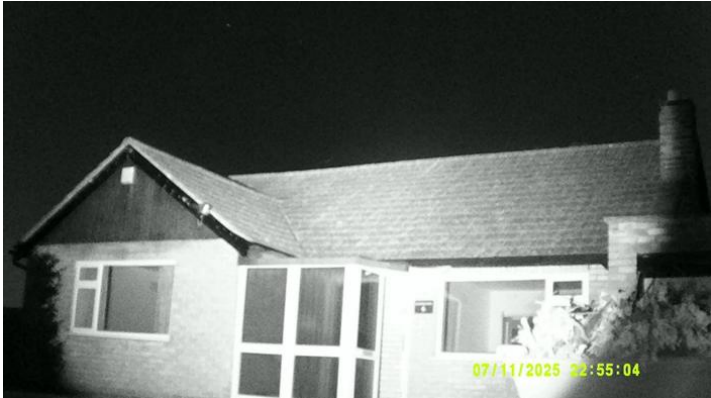
| <p><i>IR position 1</i><br/> <i>Nightfox Whisker IR</i><br/> <i>Camera &amp; Nightfox IR</i><br/> <i>Torch</i></p> | <p>Camera position: observing west elevation of building.</p> <p>No emergences were seen. No additional observations or bat activity observed upon review.</p> | <p><b>Darkest point full elevation photo showing surveyor's view.</b></p> |

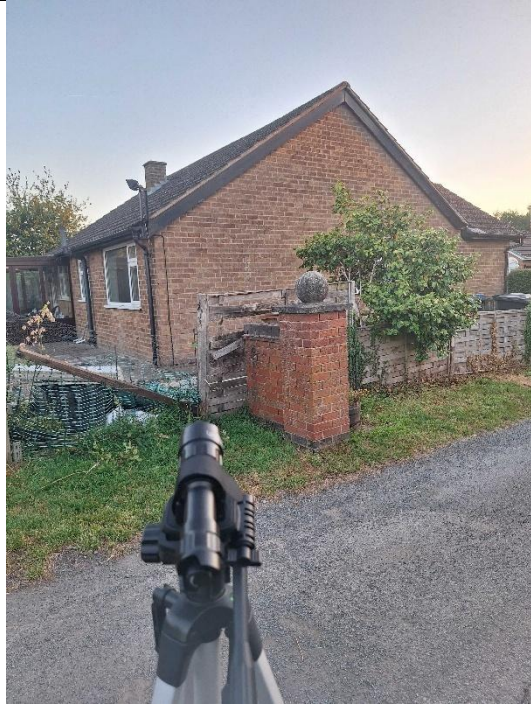
| <p><i>Surveyor 2</i></p> | <p><b>No emergences observed.</b></p> <p>Bat species observed: noctule and common pipistrelle</p> <p>Key foraging areas: northwest to southeast along the road, trees west of the site</p> <p>Key flight paths: following the hedgerow and road around the building and into the rear garden</p> <p>Summary of general activity:</p> <p>The first bat activity was at 22:06, an unidentified bat was observed commuting from the church north of the site, travelling south towards the building before returning north.</p> | <p><b>Full elevation photo showing surveyor's view.</b></p> |

| | <p>From 22:13 to 22:40 there was frequent common pipistrelle foraging activity observed, around the trees west of the site, following the hedgerow and road around the building and into the rear garden, travelling in all directions. The final bat activity was a noctule at 22:40, which was observed passing from north to south.</p> | |

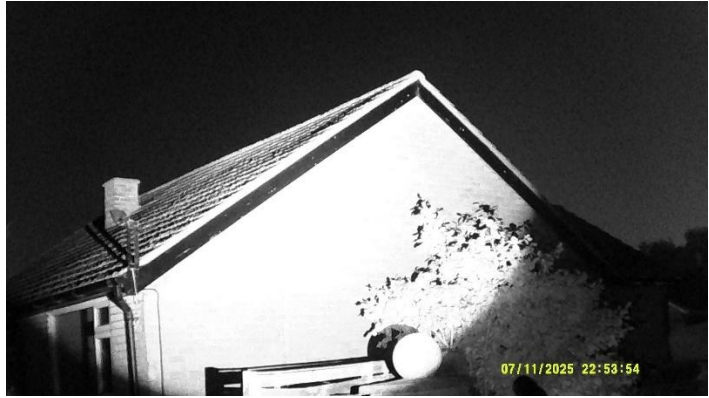
| <p><i>IR position 2</i><br/> <i>Nightfox Whisker IR</i><br/> <i>Camera &amp; Nightfox IR</i><br/> <i>Torch</i></p> | <p>Camera position: observing north elevation of building.</p> <p>No emergences were seen. No additional observations or bat activity observed upon review.</p> | <p><b>Darkest point full elevation photo showing surveyor's view.</b></p> |

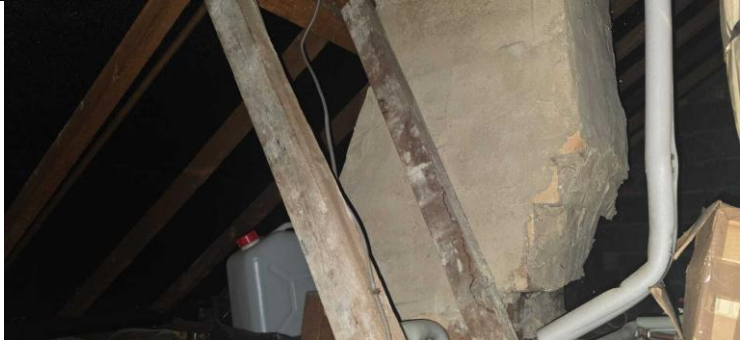
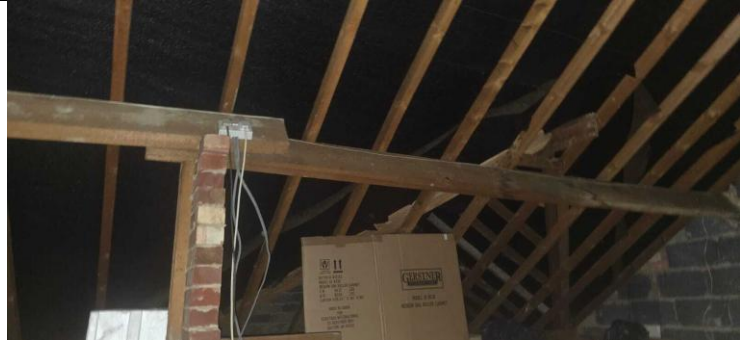
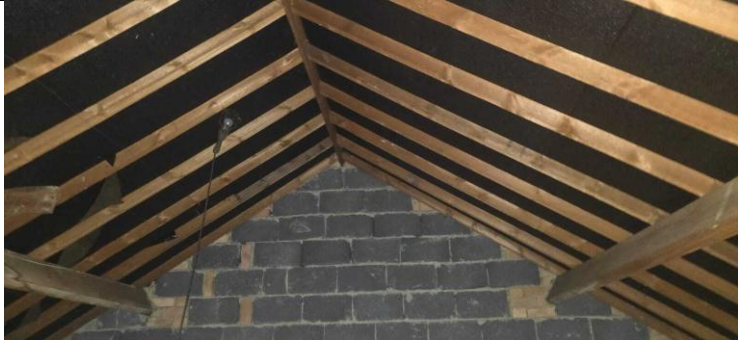
| Building B1 | |
|---|---|
| Building inspection prior to survey | <p>Carried out by: Millie Holland BSc (Hons) MSc, Consultant Ecologist (Accredited Agent on Natural England Bat Licence Number: 2018-33540-CLS-CLS)</p> <p>Structures inspected: B1 loft void</p> <p>Bat evidence found: No evidence found.</p> <p>The internal condition of the building was found to be good at the time of the survey, with no notable changes observed since the Preliminary Roost Assessment (PRA). The layout and structural features remained consistent with those previously recorded, and there were no signs of recent disturbance or deterioration that would affect its suitability for bats.</p> <p>During the internal inspection, the surveyor did not identify any additional bat droppings or other evidence indicative of bat activity, such as staining, feeding remains, or scratch marks. The absence of new signs suggests there has been no recent use of the internal space by bats.</p> <p>Environmental conditions recorded during the survey showed an internal temperature of 21.8°C and a relative humidity of 66.1%. These stable conditions are within the tolerable range for many bat species but do not alone indicate the presence or absence of roosting activity.</p> |
| | <div> <p>B1 loft void: exposed timber beams and bitumen felt in good condition</p> </div> <div> <p>B1 loft void: exposed timber beams and bitumen felt in good condition</p> </div> |

| | B1 loft void: exposed timber beams and bitumen felt in good condition | | | | |

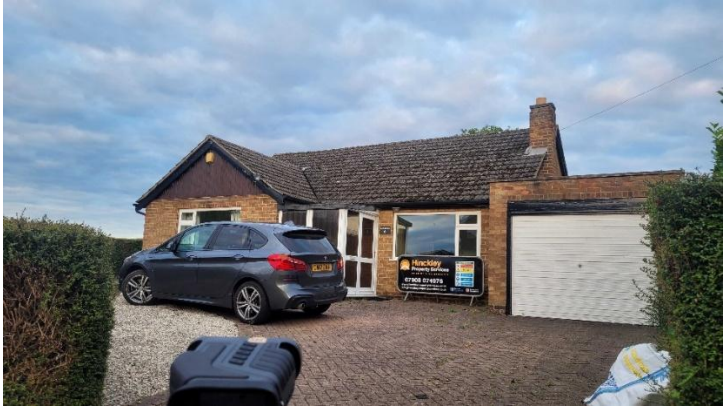
| <p><i>Surveyor 1</i></p> | <p><b>No emergencies observed</b></p> <p>Bat species observed: noctule, soprano pipistrelle and common pipistrelle</p> <p>Key foraging areas: north to south along the road and following hedgerows, neighbouring gardens west of the site</p> <p>Key flight paths: north to southeast following the hedge line</p> <p>Summary of general activity:</p> <p>The first bat activity was a common pipistrelle at 21:25, which was detected audibly but not visually confirmed. At 21:27, a common pipistrelle was observed foraging over the front garden, travelling from the northwest heading southeast before returning back northwest. At 21:34 a common pipistrelle was observed passing over the building from the east and heading north. Straight after this, two common pipistrelles were observed commuting from the north travelling southeast following the hedge line. At 21:43, a common pipistrelle was observed foraging over the neighbouring gardens to the west of the site. From 21:41 to 22:09, there were 4 occasions of common pipistrelle detected audibly but not visually confirmed. At 21:44, a noctule was observed passing over the building, travelling from north to south. At 21:48, a soprano pipistrelle was detected audibly but not visually confirmed. At 22:10, a common pipistrelle was observed commuting from north to south following the hedge line. The final bat was a common pipistrelle at 22:18 which was detected audibly but not visually confirmed.</p> | <p><b>Full elevation photo showing surveyor's view.</b></p> |

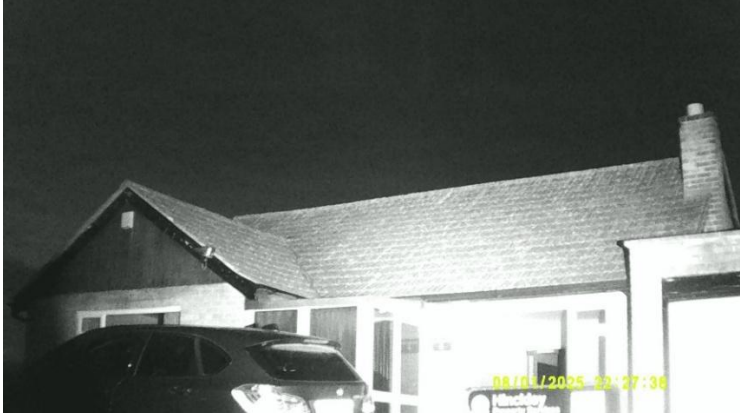
| <p><i>IR position 1</i></p> | <p>Camera position: observing west elevation of building.</p> | <p><b>Darkest point full elevation photo showing surveyor's view.</b></p> |

| <p><i>Nightfox Whisker IR<br/>Camera &amp; Nightfox IR<br/>Torch</i></p> | <p>No emergencies were seen. No additional observations or bat activity observed upon review.</p> | |

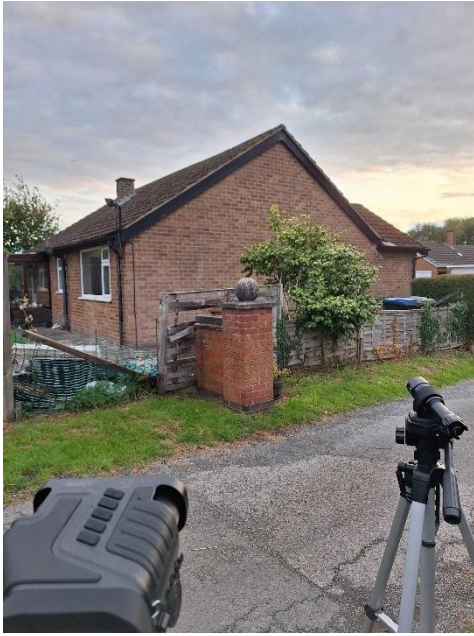
| <p><i>Surveyor 2</i></p> | <p><b>No emergencies observed.</b></p> <p>Bat species observed: noctule and common pipistrelle</p> <p>Key foraging areas: in the back garden of the property and around the church northwest of the site</p> <p>Key flight paths: east to west along the road and following hedgerows</p> <p>Summary of general activity:</p> <p>The first bat activity was at 21:25, a common pipistrelle was observed passing from east to west along the road before returning east. Between 21:28 and 21:43 there were occasional common pipistrelle passes observed, following the hedgerow and road in front of the elevation, travelling both east to west and west to east. There was also common pipistrelle foraging activity observed during this time near the church to the northwest of the site, and in the rear garden of B1. There were two occasions of noctule calls being detected audibly but not visually confirmed at 21:44 and 21:51. From 21:54, there were seven occasions of common pipistrelle calls being detected</p> | <p><b>Full elevation photo showing surveyor's view.</b></p> |

| | audibly but not visually confirmed, the last of which was at 22:26 which was the final bat activity. | |

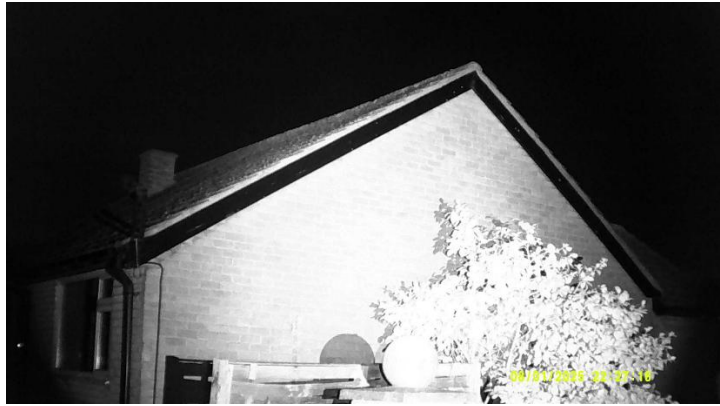
| <i>IR position 2</i><br><i>Nightfox Whisker IR</i><br><i>Camera &amp; Nightfox IR</i><br><i>Torch</i> | <p>Camera position: observing north elevation of building.</p> <p>No emergences were seen. No additional observations or bat activity observed upon review.</p> | <p><b>Darkest point full elevation photo showing surveyor's view.</b></p> |
