## Preliminary Roost Assessment

64 Priesthills Road, Hinckley, Hinckley and Bosworth, Leicestershire, LE10 1AH

This report is prepared to inform a planning application with Leicester County Council. The proposal is described as: Two storey front and side with single storey rear and side extensions with internal alterations and raised ridge loft conversion.

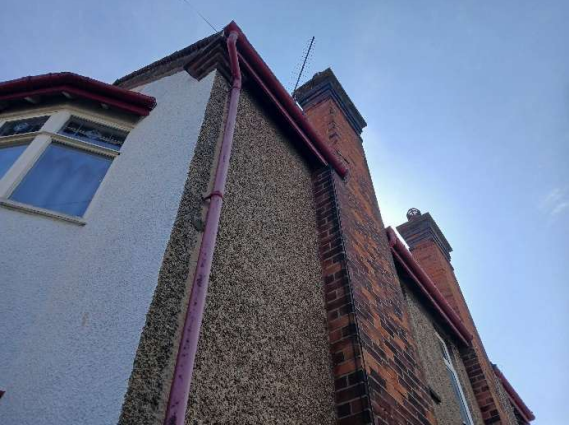
Feature	Materials	Condition/description/suitability	Photograph(s)
Walls	Brick and mortar, render	<p><b>Condition/description</b>                      Render and brick and mortar are in good condition, with no gaps or damage present.</p> <p><b>Suitability/access/evidence of bats</b>                      No suitable habitat for roosting bats. No evidence found.</p>

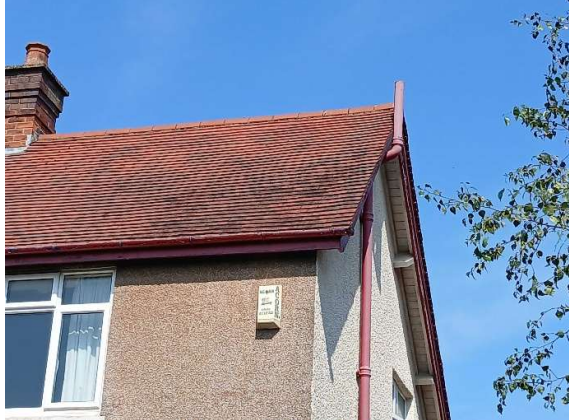
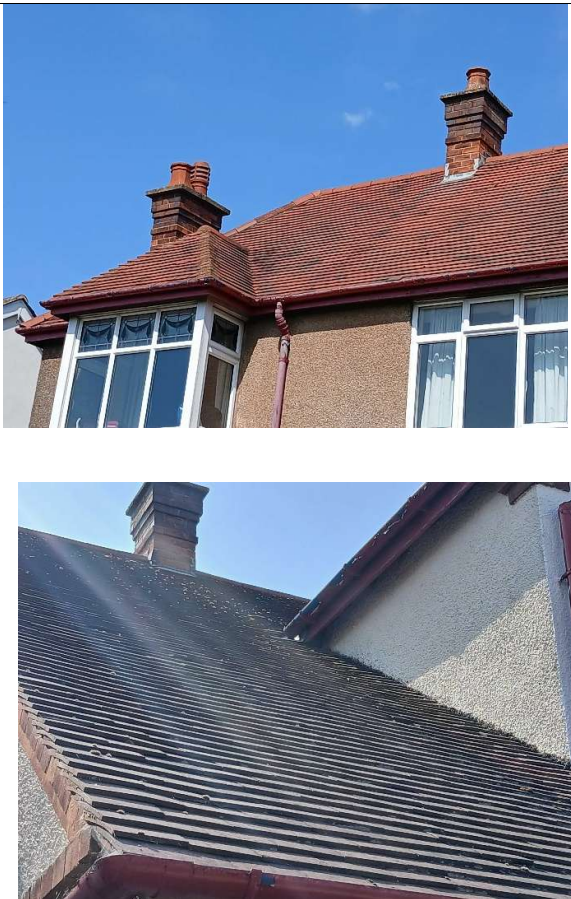
Roof	Clay	<p><b>Condition/description</b>                      Gabled roof, cat slide to the north elevation. Slightly raised tiles present throughout cat slide roof. Tiles appear to be in good condition and flush with each other on the main roof. Small gaps are present occasionally between tiles.</p> <p><b>Suitability/access/evidence of bats</b>                      Space under tiles could accommodate crevice dwelling bats. No evidence found but recent and current rain would wash this away externally</p>

<p><i>Recommendations</i></p>	<p><b>Roosting habitat [Buildings]</b>                  One bat emergence/re-entry survey is required on B1 during the active bat season (May – September) to confirm presence/likely-absence of bats roosting in or on the building.</p>

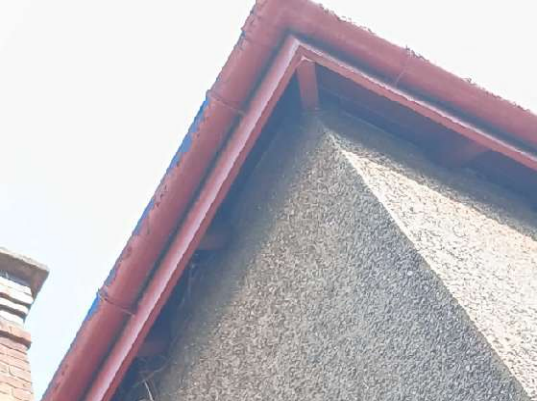
<p>Eaves</p>	<p>Overhanging</p>	<p><b>Condition/description</b> Gaps/crevices on wall tops. <b>Suitability/access/evidence of bats</b> Provides possible bat access into internal void and crevices on wall tops. No evidence found but recent and current rain would wash this away externally. Could support maternity roosts of crevice dwelling bats.</p>

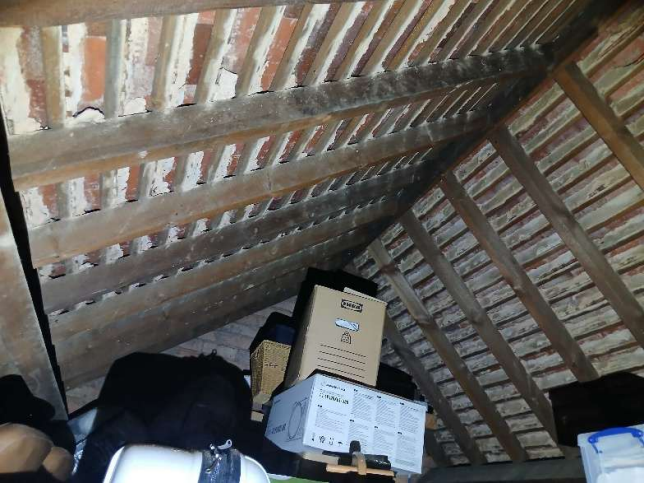
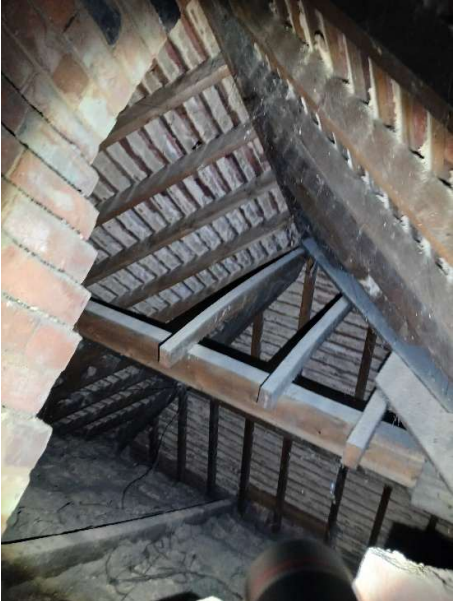
<p>Barge boards/fascia boards</p>	<p>N/A</p>	<p>N/A</p>	<p>N/A</p>
<p>Window/doors frames and lintels</p>	<p>Timber</p>	<p>Tight fitting</p>	<p>N/A</p>
<p>Internal voids</p>	<p>Timber rafters and ridge beam.</p>	<p><b>Condition/description</b> Internal space measures approx. 7m long, 7m wide, floor to ridge height approx. 2m. The internal timbers appear to be original but are in good condition with no gaps or crevices present. There is no lining under the tiles present. Internal temperature: 23°C Humidity: 75%</p> <p><b>Suitability/access/evidence of bats</b> No droppings or evidence of bats were identified. The void has suitable habitat for void dwelling bats but has limited suitability for crevice dwelling bats.</p>
