**Land at Lindridge Lane,
Desford**

**Ecological Appraisal
and
Biodiversity Net Gain Statement**

January 2026

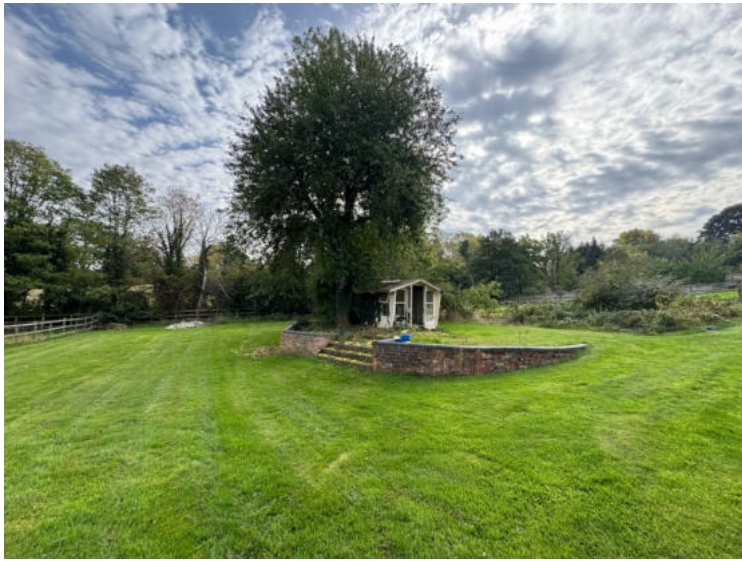
Photo 1: Modified grassland, building B2, individual trees T1 and T2

- 4.9 This area failed Criteria A of the condition assessment and was therefore considered to be in poor condition.

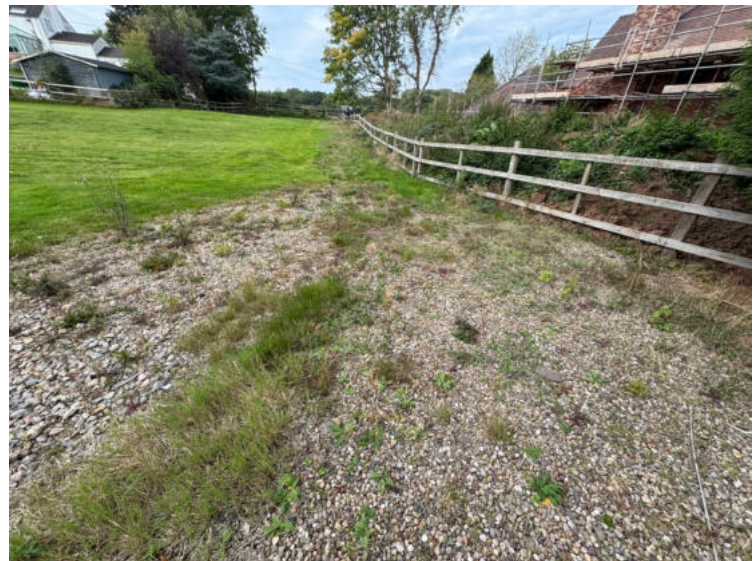
Photo 4: Ruderal / ephemeral habitats and tall forbs

- 4.10 One driveway leads from the adjacent road, to one of the existing buildings. This was formed of aggregate / stone waste, with grass and forbs growing through it. Species present here include great willowherb *Epilobium hirsutum*, creeping bent, dock, common fleabane *Pulicaria dysenterica*, greater plantain, red fescue *Festuca rubra*, red campion *Silene dioica*, wood avens *Geum urbanum*, spear thistle, dandelion and white clover.
- 4.11 Some rubbish / rubble piles were present in this area.
- 4.12 The area of ruderal / ephemeral habitat was assessed as being in poor condition.

- 4.13 A soil bund runs along the northern boundary of the site which had tall forb vegetation growing there, including mostly fat hen *Chenopodium album*, common nettle *Urtica dioica* and dock.
- 4.14 The area of tall forbs was assessed as being in moderate condition.

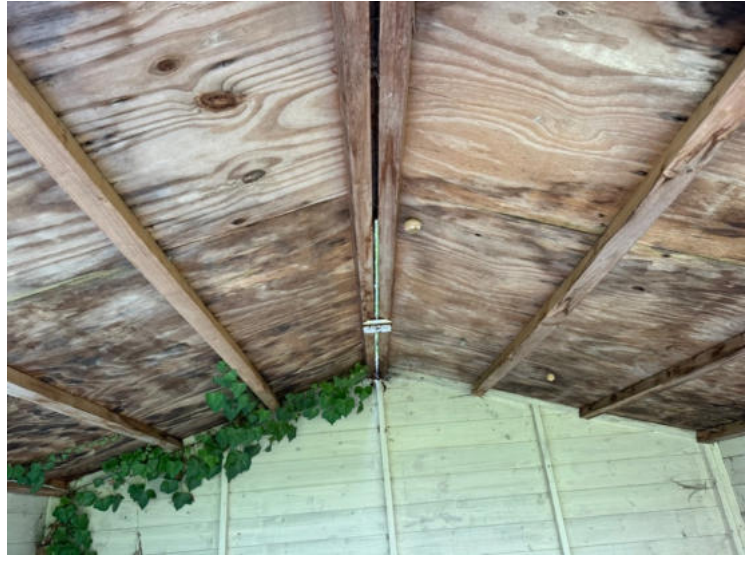
Photo 6: Building B2 interior

- 4.28 No soffits or barge boards are present. The building is very light inside due to the windows. No evidence of bats was recorded inside the building.
- 4.29 Building B2 was considered to be of negligible potential to support roosting bats.
- 4.30 During the nocturnal emergence survey of building B1, no evidence of bat roosts were recorded, and relatively little bat activity was noted, with sporadic foraging activity throughout the survey. The first contact was at 20:40 of a common pipistrelle *Pipistrellus pipistrellus*. Soprano pipistrelle *Pipistrellus pygmaeus* were also recorded.

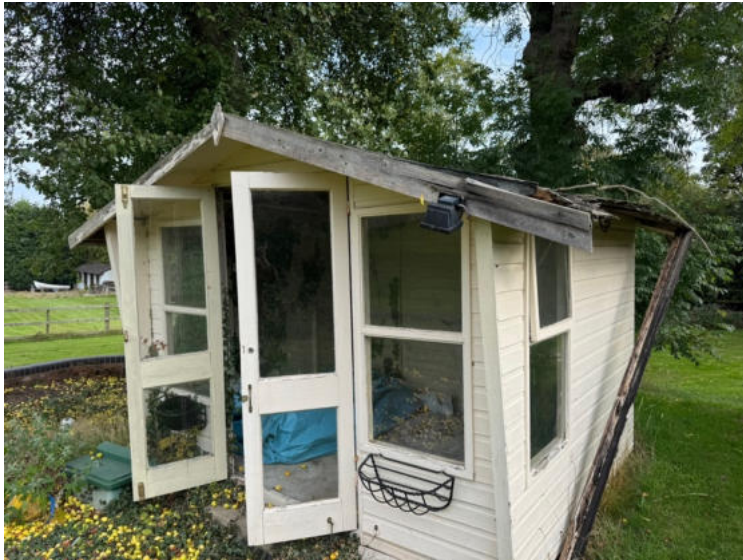
Photo 7: Building B2 exterior

- 4.27 Building B2 was a small, single-storey wooden summerhouse with windows in three of the walls. The single skin roof is formed of plywood which has deteriorated causing several gaps, including one along the ridge. No roof void is present.

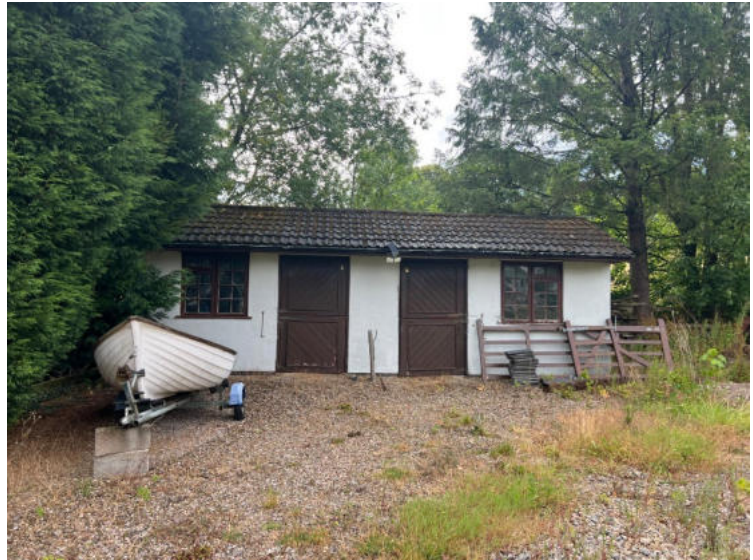
Photo 8: Building B1 exterior

- 4.24 Potential bat access points comprised gaps in the soffits between the wall and the soffit boxes, in particular above the windows on the western aspect but also on the edges near the gutter. Gaps around the doors were also potential access points on this aspect. Further access points were noted underneath the southern and northern barge boards, although trees cluttered the access to the northern aspect of the structure. Access points were also noted underneath the tiles on the eaves on the western aspect. Missing mortar on the western side of a couple of the central ridge tiles was missing provided a further potential access point.

- 4.26 Potential roost features for bats comprised the soffit boxes on the western aspect, underneath the barge boards on the southern aspect, underneath the tiles (with access noted on the western aspect) and underneath the ridge tiles in the centre. Gaps were also present around the door frames inside the building offering roost potential.

- 6.10 No further bat surveys are recommended, and bats are not considered to pose a constraint to development.

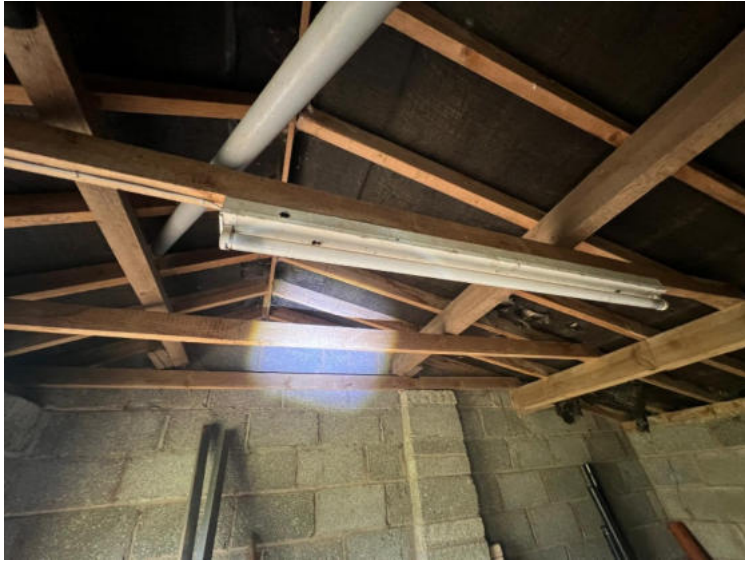
Photo 9: Building B1 interior

- 4.25 Internally the building was divided into two equal sized rooms, each with a window and a door. The tiles were backed with felt which was damaged in some places and there were no voids. It was relatively light inside.

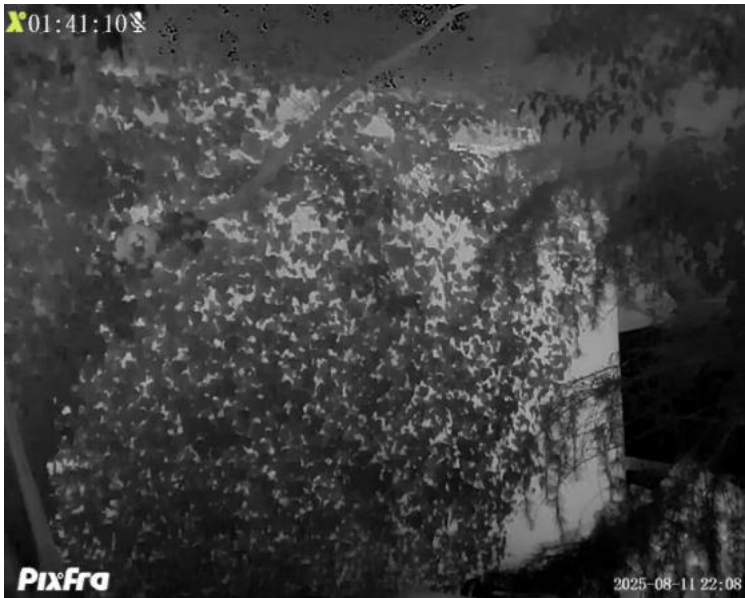
Photo 15: Nocturnal emergence survey darkest point – northern surveyor location

undertaken in appropriate conditions, i.e., ambient temperatures above 10°C and with little wind and no rain. Survey dates and conditions are provided below in Table 2. Photos of the darkest point of the survey are shown in Appendix 1 and Figure 7 shows the surveyor locations.
