**2 Peckleton Road, Kirkby Mallory, Leicester, LE9 7QH**

**Bat& Bird Survey - Preliminary Roost Assessment**

15<sup>th</sup> June 2023

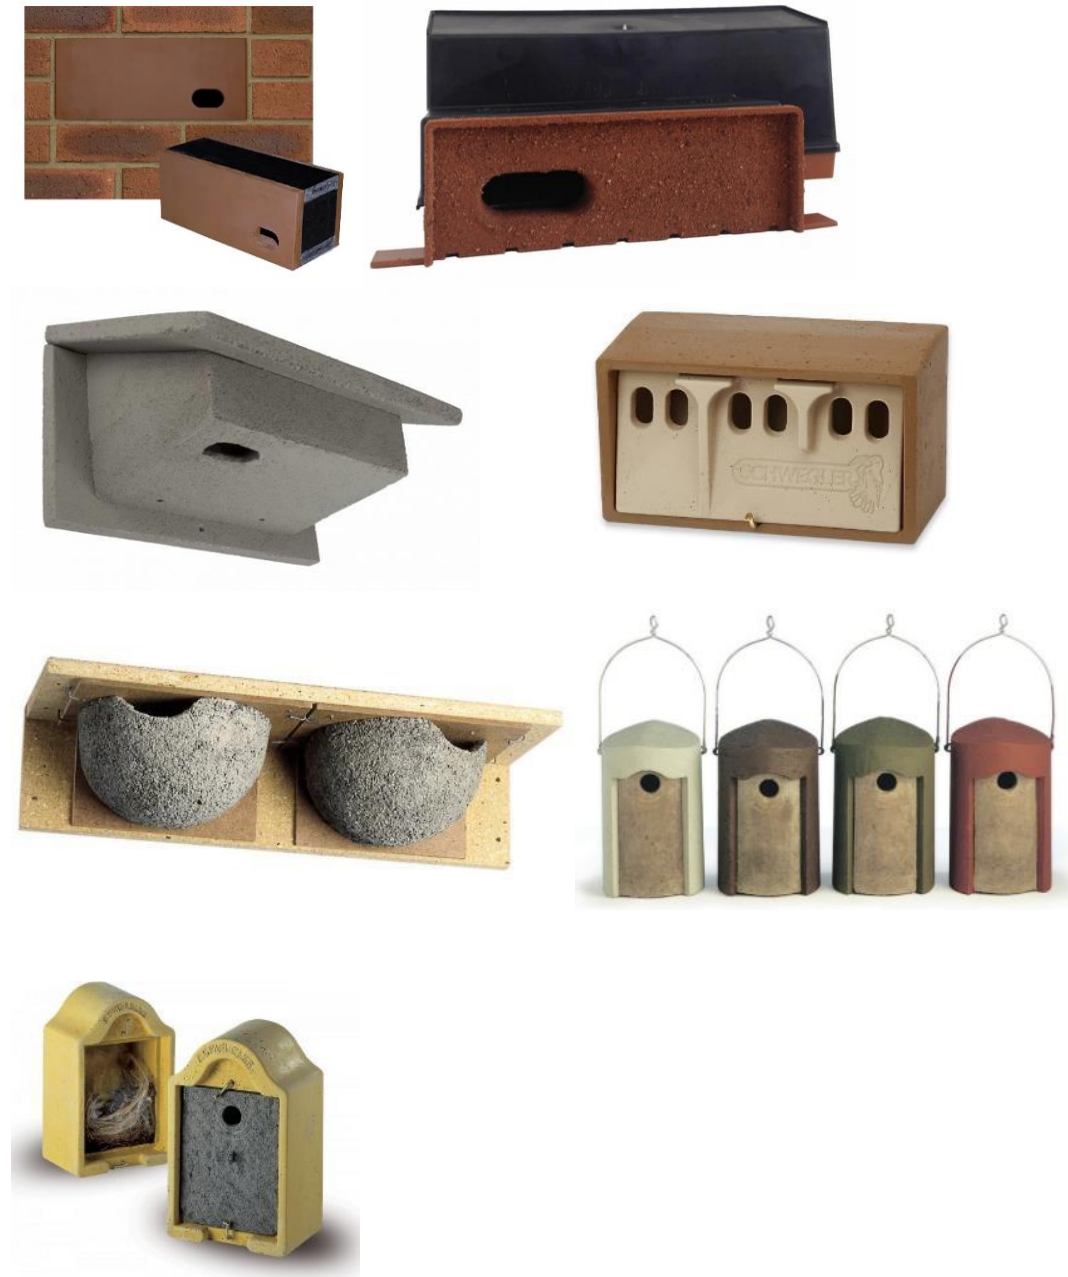
Figure 2: Examples of Schwegler swift brick (top left), Manthorpe swift brick (top right). WoodStone swift box (middle left) Schwegler 1SP Sparrow Terrace nesting box (middle right); Schwegler Double House Martin Nests (middle left); Schwegler Woodcrete 1B nest boxes (middle right); and a Schwegler Bird House boxes (bottom).

The provision of bird nesting boxes is recommended as an enhancement for biodiversity on the site. Ideally these should be either swift boxes, house martin nests or sparrow terrace nest boxes but other nest boxes discussed below. These should be installed in sheltered locations (such as under the eaves of a suitable building), installed at a minimum height of 2m and orientated in southerly/ westerly direction. All bird boxes must be retained in perpetuity and their exact location/ specification may be discussed with a suitably-qualified ecologist, and alternative options can be considered. A selection of reliable options is detailed below, although suitable equivalents are acceptable (Figure 2):

- Schwegler and Manthorpe Swift bricks (this would be the preferred option).
- WoodStone Swift nest boxes.
- Schwegler Single & Double House Martin Nests.
- Schwegler 1SP Sparrow Terrace nest boxes.
- Schwegler Woodcrete 1B nest boxes (for trees) and/ or Schwegler Bird House nest boxes (for buildings).

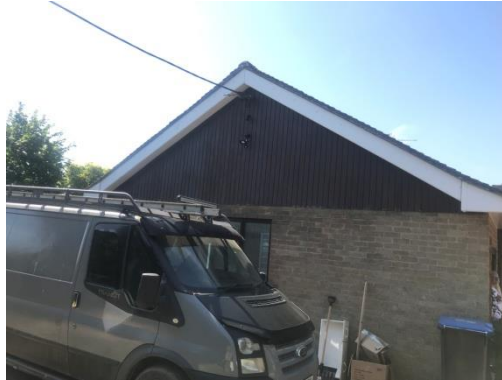
Image 1: B1 viewed from north side

- Approx. 20m x 5m
- Walls of brick. The walls were in good condition, with no visible cracks or crevices of a suitable size to accommodate bats.
- The roof was clad in tiles with felt liner and no insulation present underneath.
- There were some gaps under the tiles. The ranged in size, but several were large enough to allow access by bats (>5mm).
- The lead flashing around the chimneys was tightly sealed.
- The soffits were tightly sealed.
- There was a standard sized roof void, with timber support beams and a bitumen felt liner. The roof lining was largely intact, although some areas of damage were observed.

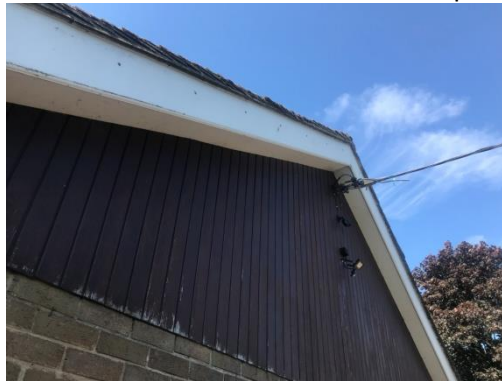
Image 2: B1 viewed from north side. Close up on soffits

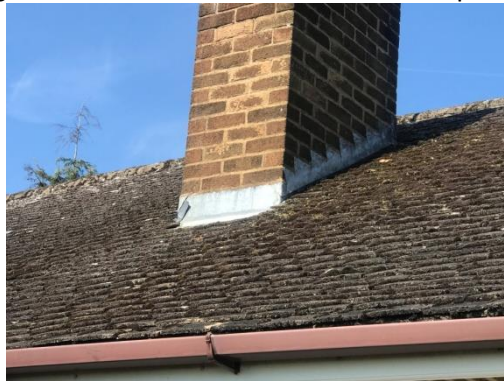
Image 6: B1 viewed from east side. Close up on roof

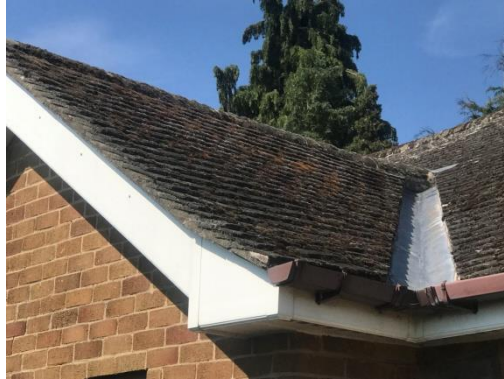
Image 7: B1 viewed from east side. Close up on roof

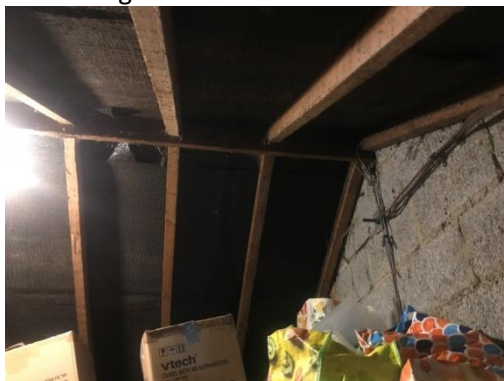
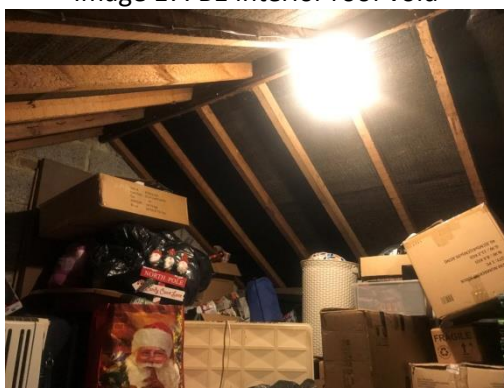
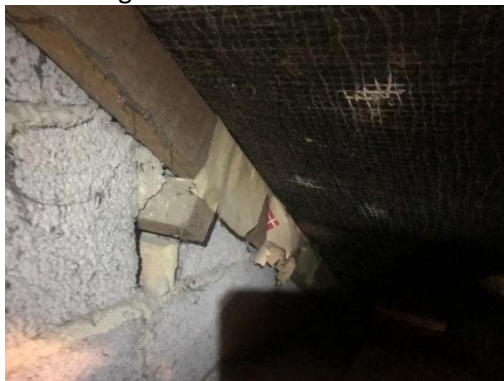
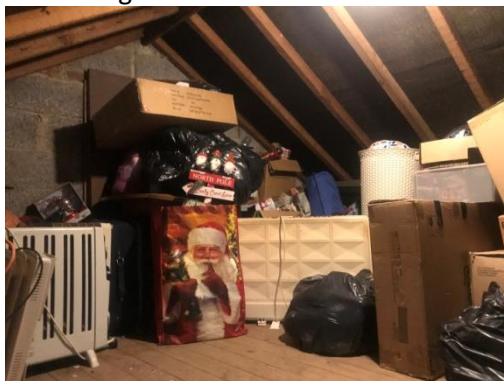
| Reference | Likelihood of bats using the building for roosting | Brief summary of justification |
|---|---|---|
| B1 (main house) | Low | <p>Several gaps of suitable size for bats were identified during the external inspection. Some of these were not accessible during the internal inspection, due to the presence of a (largely) intact roof lining.</p> <p>The surrounding area has good foraging habitat and commuting routes.</p> <p>The bat trigger index returned a score of 0.59 (low potential).</p> |

Image 16: B1 interior roof void

Image 17: B1 interior roof void

Image 18: B1 interior roof void

Image 19: B1 interior roof void

| Building Ref | Value for / Likelihood of supporting roosting bats | Recommendations |
|---|---|---|
| B1 (main house) | Low | A minimum of one nocturnal survey carried out between May-August in order to establish presence or absence of bats. |
