Phase 2: Site Investigation

Former Leisure Centre, Hinckley

PHASE 2 SITE INVESTIGATION REPORT

FORMER LEISURE CENTRE, HINCKLEY

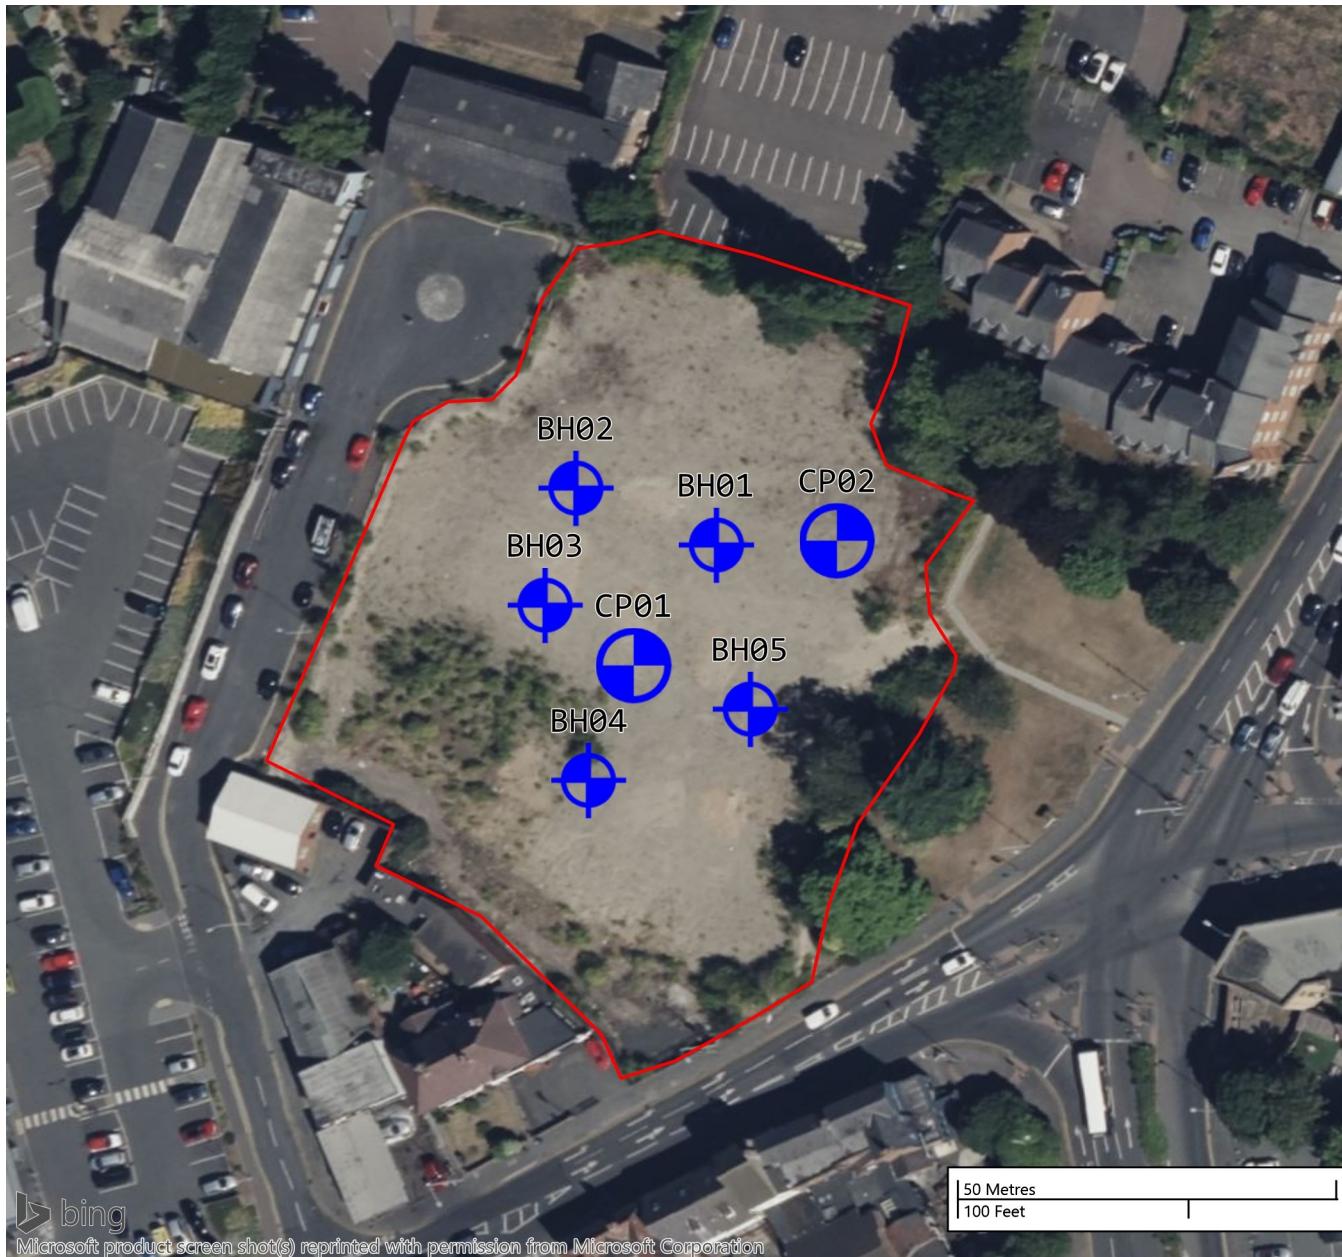
A plan showing the location of the boreholes and trial pits can be found in Appendix A (Figure 2).

- Locations By Type - Empty
- ◆ Locations By Type - BH
- ◆ Locations By Type - CP
- Project Bounds - Project Bounds
