Willowbank Road,  
Hinckley

Interpretative Desk Study &  
Exploratory Investigation

May 2025

**Report Reference:** GJ352-01-R001-DS-V1

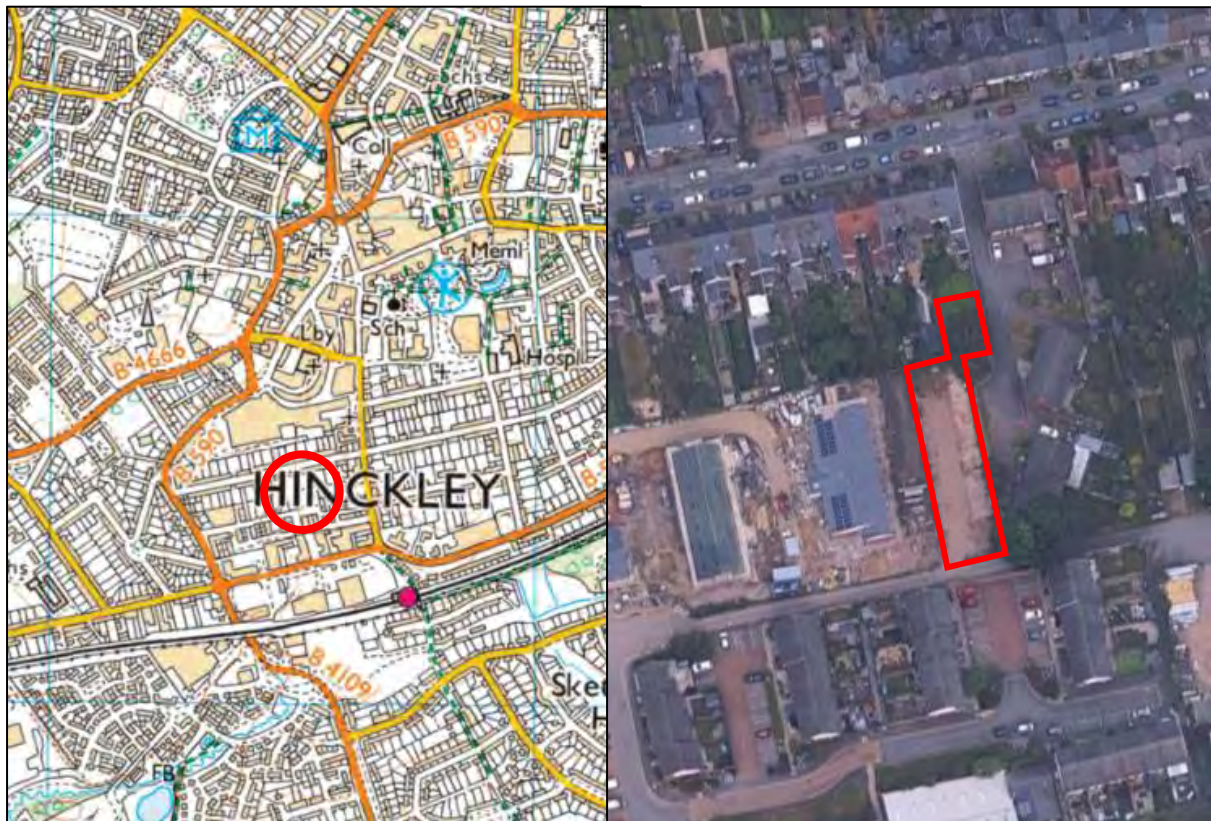
Figure 2.1 Site Location and Layout

The site is located between 47-53 Clarendon Road to the north and Willowbank Road to the south, approximately 500m south of Hinckley town centre. The site is approximately centred on National Grid Reference 442460, 293400. The site location and layout are shown in Figure 2.1.

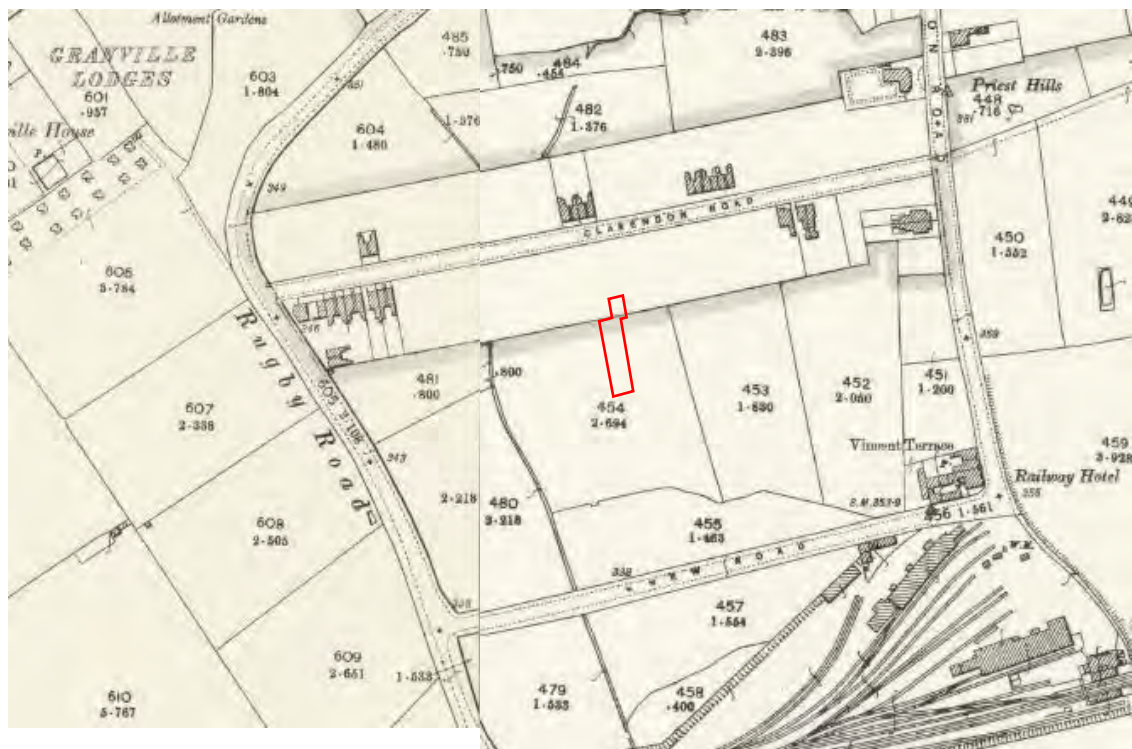
1901

The earliest mapping shows the site was part of undeveloped fields around the start of the 20<sup>th</sup> century. Railway sidings / sheds are shown to the south-east at this time. By the 1930s, houses had been developed along Clarendon Road, with gardens extending into the northern part of the site. The majority of the site to the south, however, is shown as part of allotment gardens. Some industrial development is shown around the same time, with the 'Benco' works shown to the north of Clarendon Road and a hosiery works shown to the south-east.

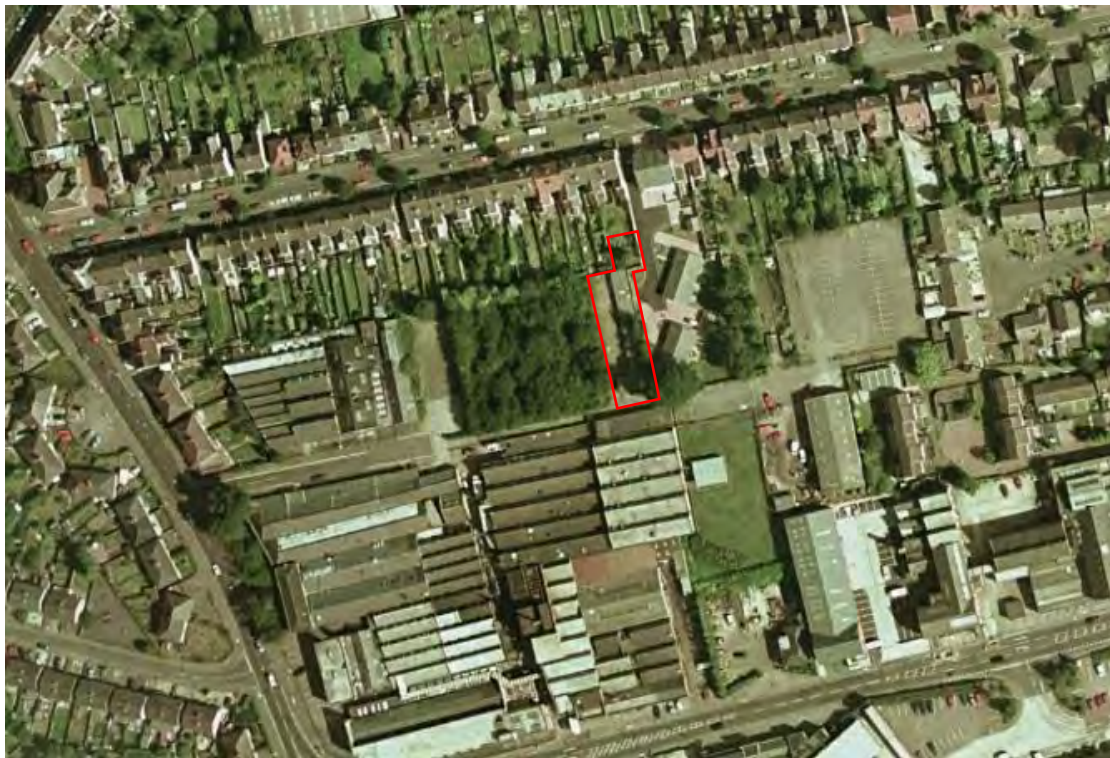
1999 (Google Earth)

Google Earth aerial imagery shows garages occupying the eastern side of the site by 1999. The factories are still shown to be present, while the land immediately to the west is shown to be occupied by trees. Residential properties are now shown to the west of the site where the depot was formerly located.

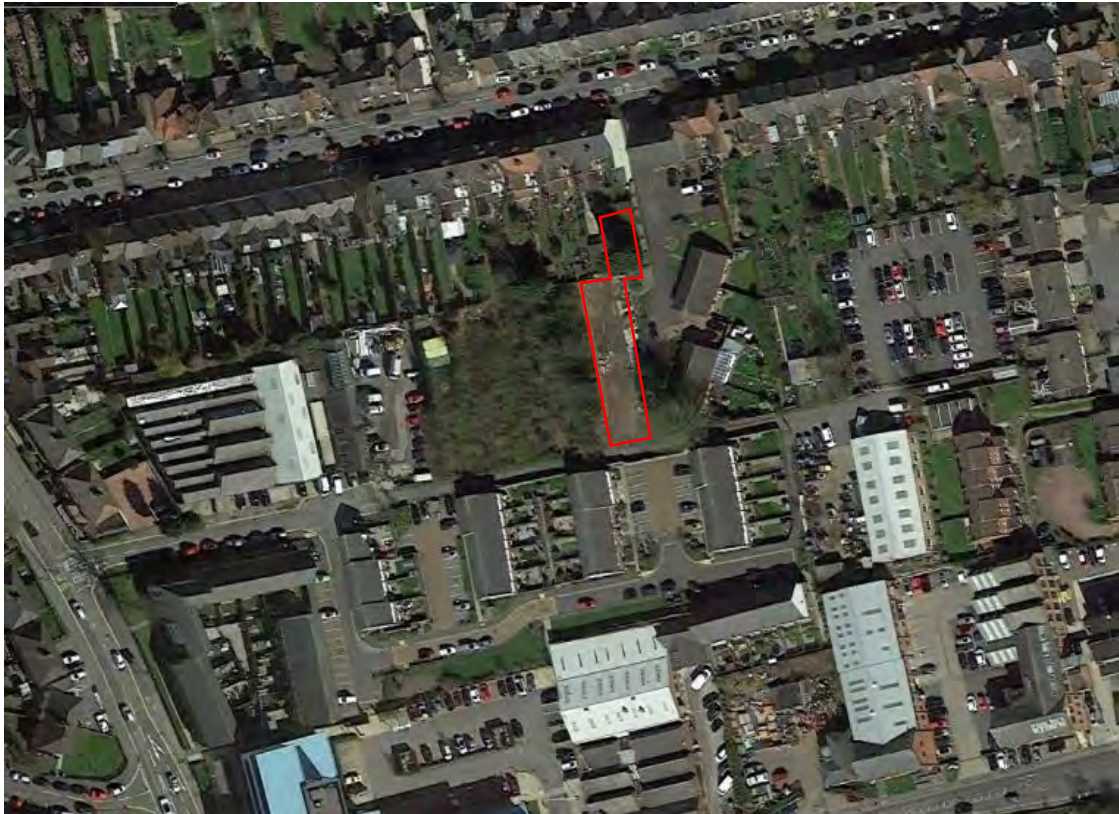
2018 (Google Earth)

Imagery from 2018 shows only partial remains of the garages (slab and some remnant walls), while the factories to the south have been replaced by residential developments. By 2023, the part of the site that extends onto the former gardens of 47 & 49 Clarendon Road is shown to have been cleared and joined to the rest of the site. Residential apartments have been constructed on the land immediately west of the site.

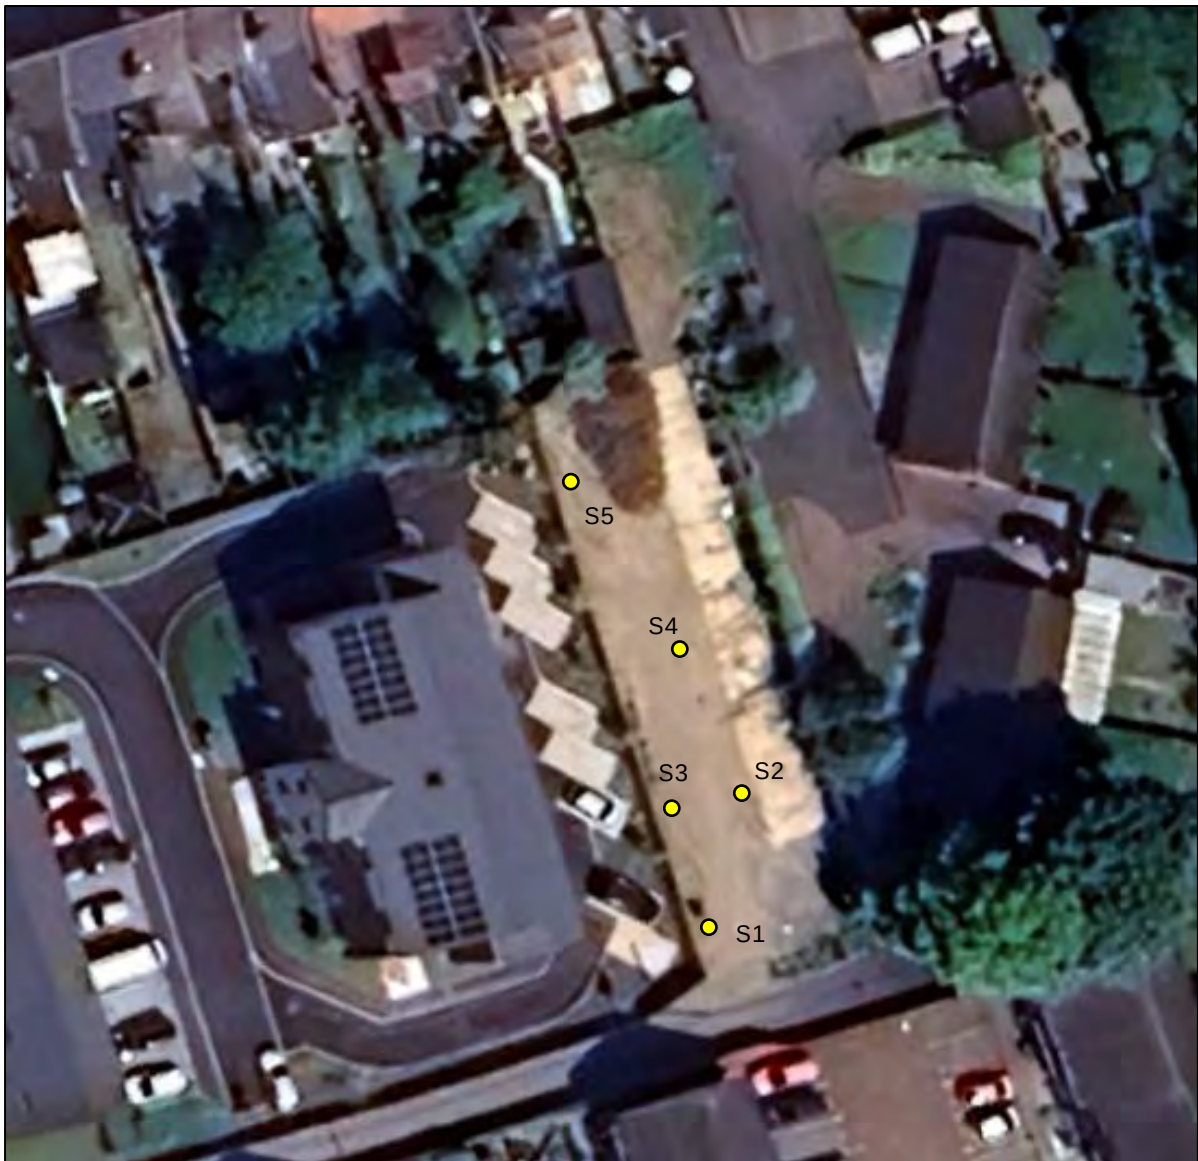
Figure 6.1 Sample Locations

During the walkover survey, undertaken on 24<sup>th</sup> April 2025, five soil samples were taken from shallow (0.1-0.2m) hand dug pits in accessible areas and sent for chemical analysis in order to provide additional information with respect to near surface Made Ground. The sample locations are shown in Figure 6.1 below, while photographs of the sample locations are included in Appendix A.

The samples were taken from hand dug pits at approximately 0.1m in areas of accessible soft ground. Samples S1 to S3 were taken from rough ground within the footprints of the proposed garden areas, while S4 and S5 were taken from within the proposed building footprints. No samples were taken from the location of the garages as these were under construction at the time of the site visit.

- S1 – Dark brown, sandy, silty, clayey soil with fragments of brick, concrete and glass
- S2 – Sand and gravel aggregate including stone and brick
- S3 – Red-brown, sandy gravel of stone to 5cm depth, over dark brown, silty loam soil
- S4 – Red-brown, sandy gravel of angular stone
- S5 – Sandy, gravelly clay including brick and glass fragments

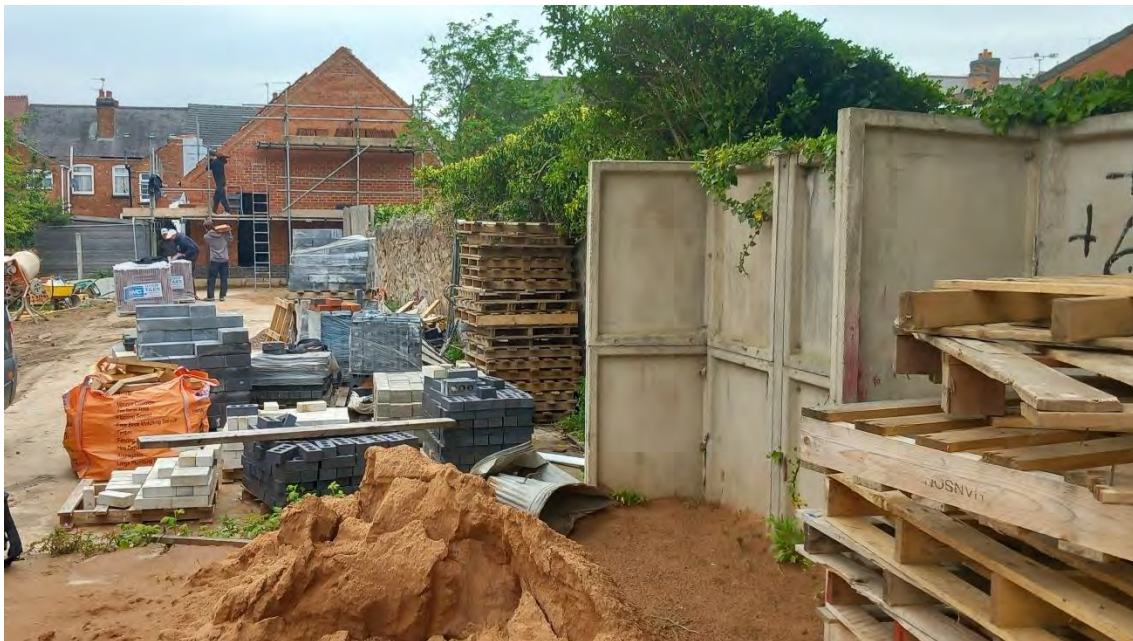
Looking north along the eastern boundary, with remaining garage walls on the right

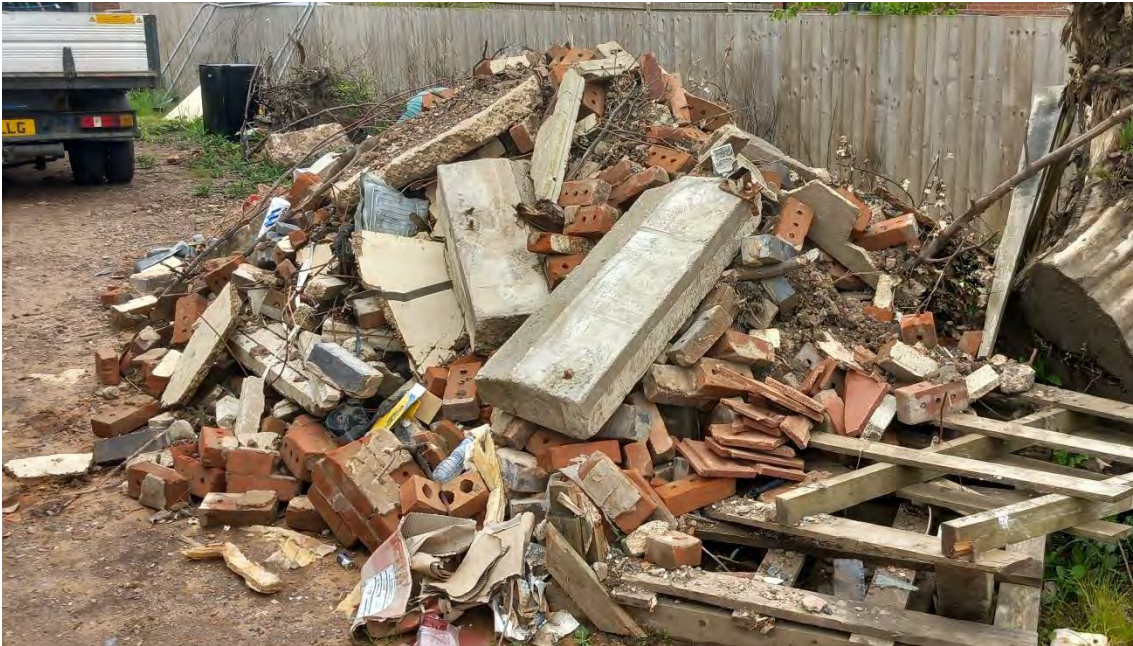
Rubble pile on western site boundary

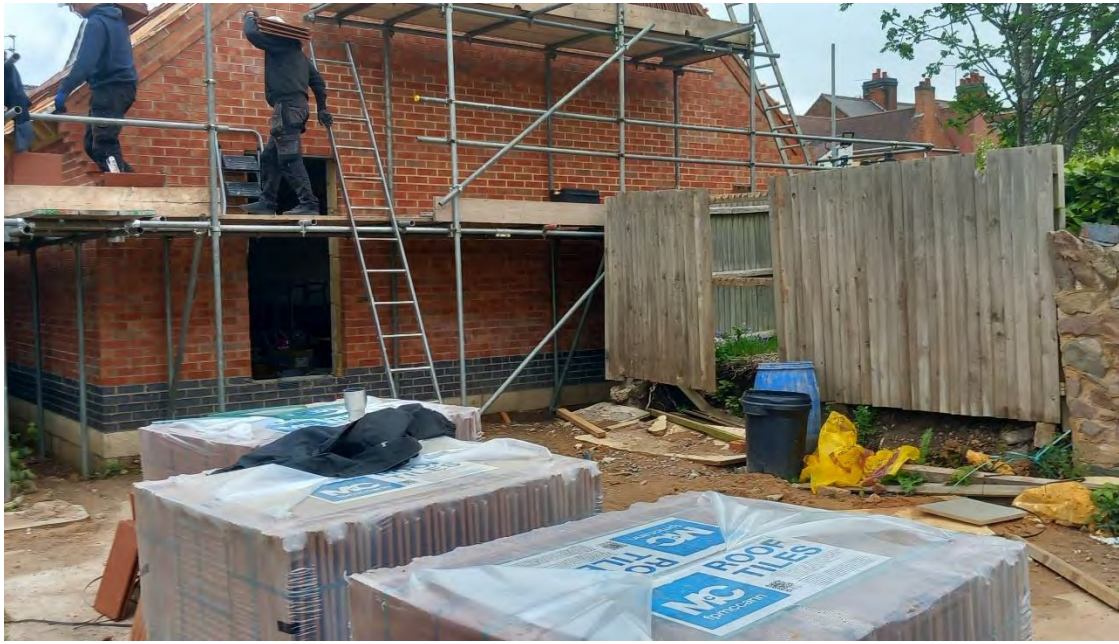
Garages under construction in the north of the site
