# Holywell Farm, Ratby

## PRELIMINARY ROOST ASSESSMENT & BAT EMERGENCE SURVEY REPORT

Report No. 250227.PRA.BES.V1

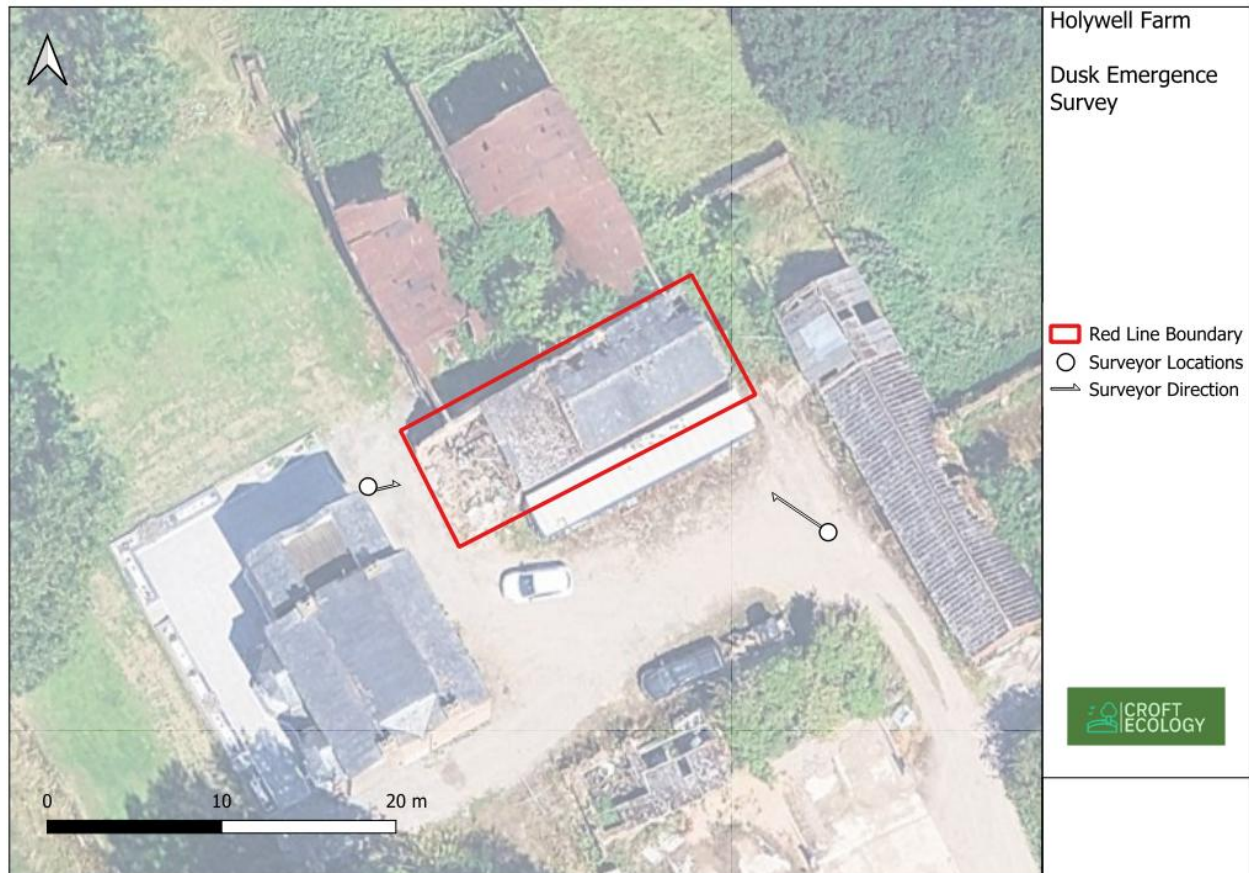
Two surveyors, equipped with EMT2 Pro bat detectors and Nightfox Whisker infrared cameras and additional infrared floodlights made observations of any bat activity or bat emergence both from and around the existing building, focusing on areas with potential roosting features. Echolocation calls were analysed with Kaleidoscope when required. An additional camera was positioned inside the eastern doorway of the upper floor to capture any bat activity within the upper floor of the building.

*Figure 2. Surveyor and NVA positions during the bat emergence surveys*

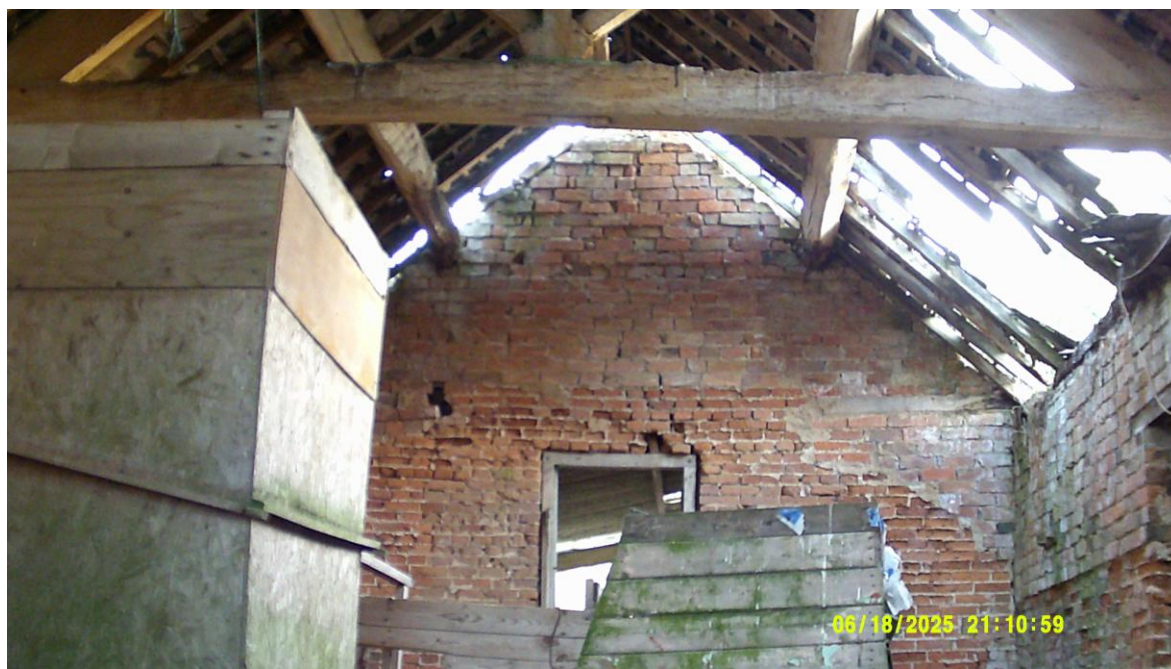
Internally the upper floor was vaulted (Photo 3), with the unlined roof slates supported by a wooden ridgeboard, battens, rafters, purlins and a king post truss. The large gaps in the roof and doorways at both gables created a light and draughty room. Two ground floor rooms were present. The eastern of these was inaccessible, while the western comprised a former stable with whitewashed brickwork and thick timbers forming the ceiling joists. Gaps were noted in the brickwork of the walls and where the joists met the brickwork, though these were largely heavily cobwebbed. A window in the northern wall allowed flighted access to the roof along with the open doorway on the southern elevation.

*Photo 3: Internal view of the upper floor*

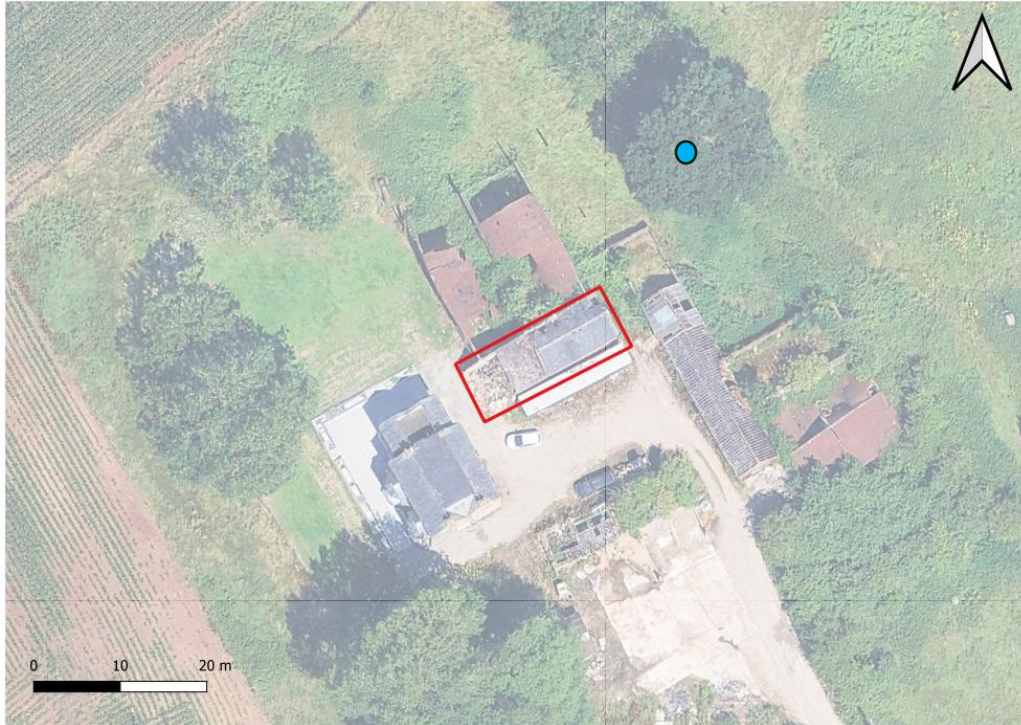
*Figure 3: Proposed location of bat box shown by blue dot (not to scale).*

- One bat box, suitable for pipistrelle bats, such as the 2F Schwegler bat box (or similar approved) will provide temporary compensation and post-development enhancement during and after the construction works. This will be sited on a suitably mature tree (such as the mature oak tree to the northeast of the building).

This box will be installed in advance of works, facing between southwest and southeast and located over 3m above the ground. Once building works are complete, a bat box will be installed on the southern elevation of the building to replicate the lost day roosts of common pipistrelle. If possible, an integrated bat box should be used, such as the habibat bat box (Figure 4) which comes in styles to match the brickwork of the building. These boxes will be retained through their lifespan.
