**BAT SURVEYS 2022**

**39 MAIN STREET  
CARLTON  
MARKET BOSWORTH  
LEICESTERSHIRE**

**October 2022**

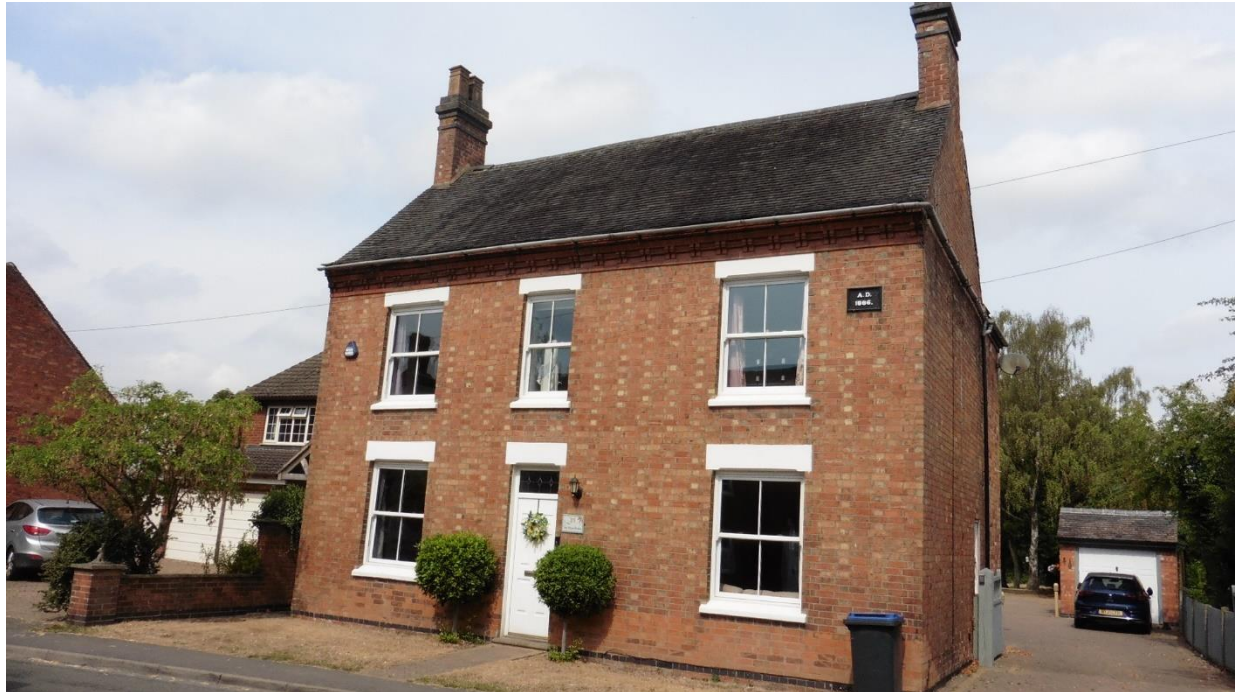
**Photograph 1: the frontage to 39 Main Street, Carlton. This shows the two-storey traditional dwelling section being retained as part of the development.**

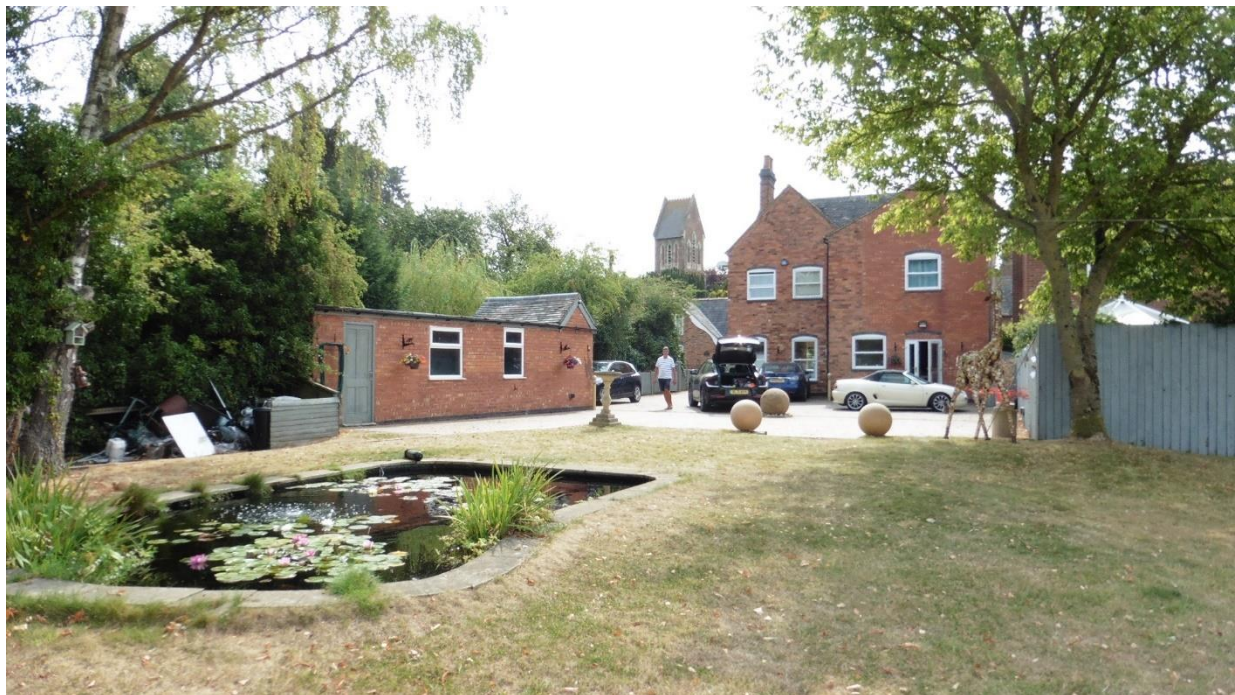
**Photograph 2: view looking south from the northern garden area showing habitat connectivity to the dwelling and adjacent churchyard to the left (east) of the property and the garage block and house extensions proposed for demolition and redevelopment.**

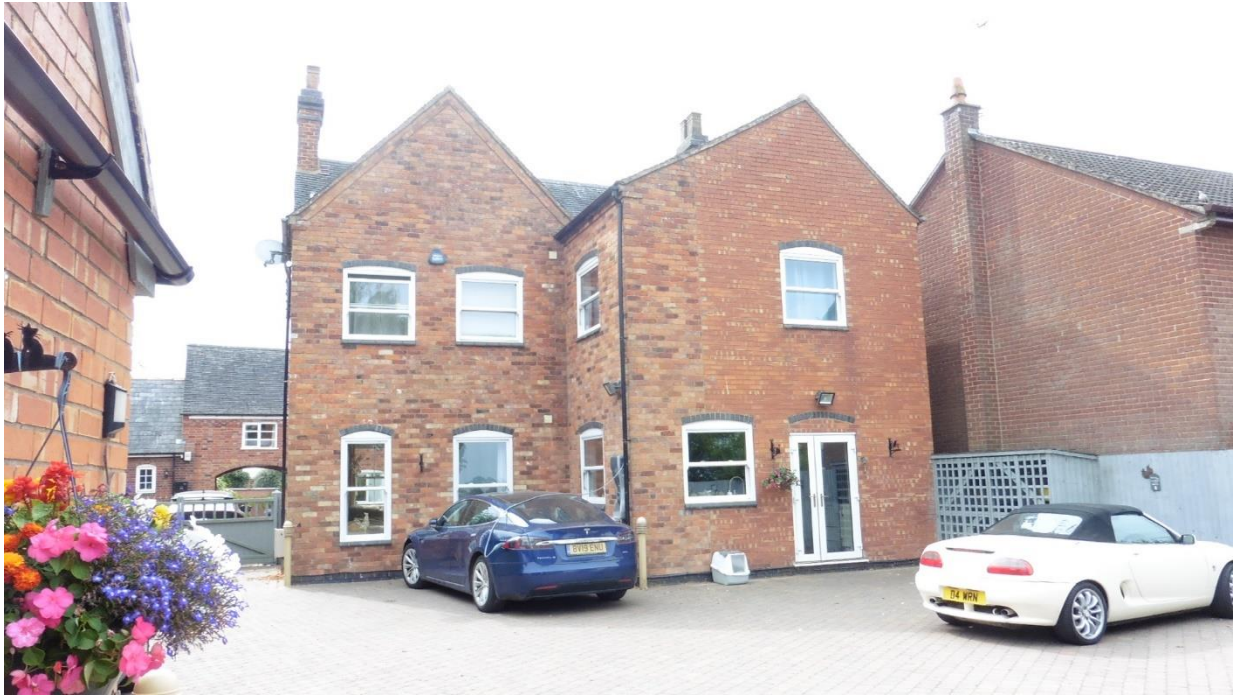
**Photograph 3: showing the two house extensions proposed for removal to make way for the redevelopment.**

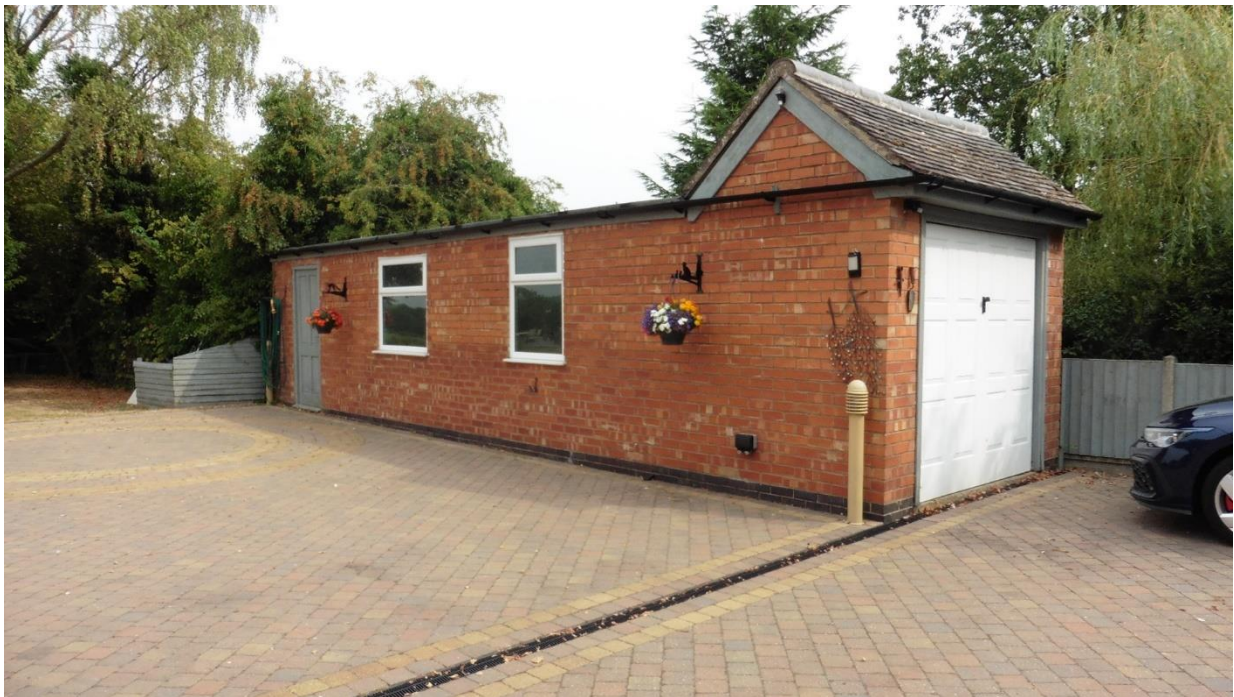
**Photograph 4: showing the garage proposed for removal as part of the development proposal.**

The internal and external search of the garage block north-east of the dwelling found no evidence of bat roosting and no features with significant bat roost potential. No further emergence and activity surveys were recommended.

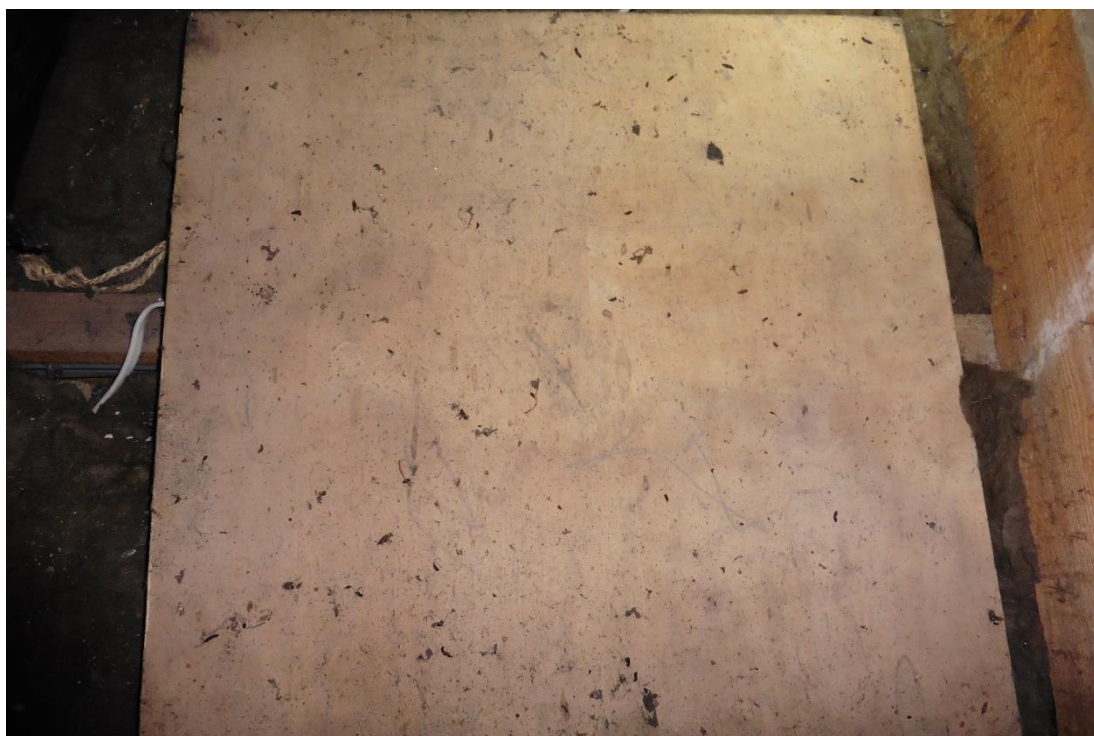
The search of the attic spaces found an aggregation of droppings at the apex of the north-western extension. This amounted to approximately 50 droppings typical of those voided by the Pipistrelle (*Pipistrellus* sp.) bat species.

Photograph 5 - Pipistrelle droppings below the ridgeboard in the north-east extension

Like-for-like habitat for the pipistrelle bats is required due to evidence that suggests previous use by this species by dropping evidence. Whilst this bat species was not present during the August 2022 survey, sufficient activity was present around the building to suggest usage in the future.

The mitigation design is to install an enclosed bat tube into the eastern gable of the traditional dwelling, to be converted to an annex, and rendered over or faced with the same brick as the existing gable, resulting in a limited aesthetic impact. Different makes and finishes are available from building suppliers and two examples are provided below.

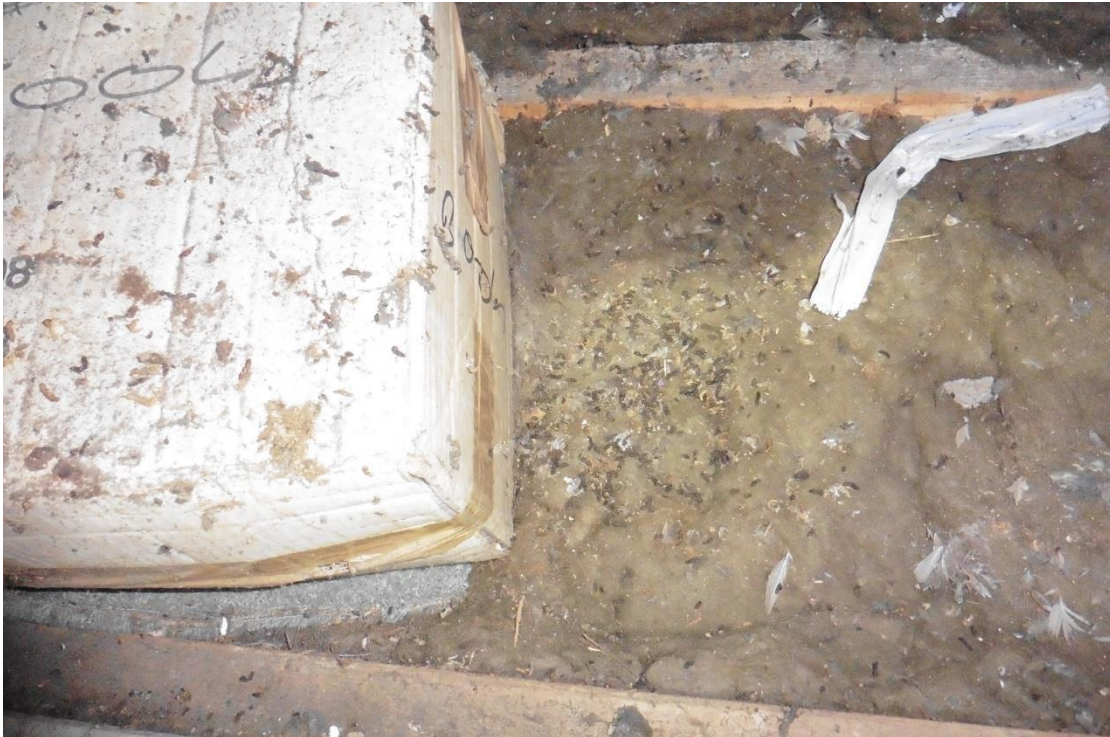
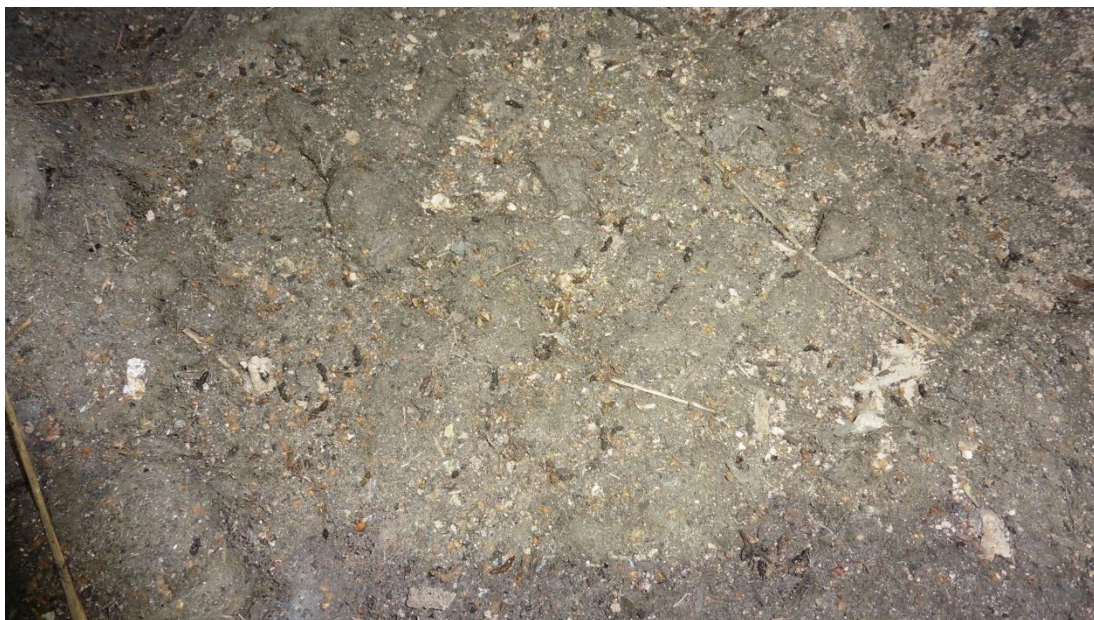
The search of the main attic space found one aggregation of old droppings typical of those voided by the Brown long eared bat (*Plecotus auritus*) in one isolated location. This amounted to approximately

100 old droppings, all grey and desiccating. There was a similar but lighter aggregation at the western end of the roofline below a large gap in a ridge tile in this area suggesting a potential bat roost access.

There was then a smaller number of more recent droppings scattered throughout the attic, with no aggregation sufficient to suggest a number of bats or an established bat roost such as a maternity colony.

**Photograph 6 and 7 - aggregations of droppings found within the traditional attic space area**

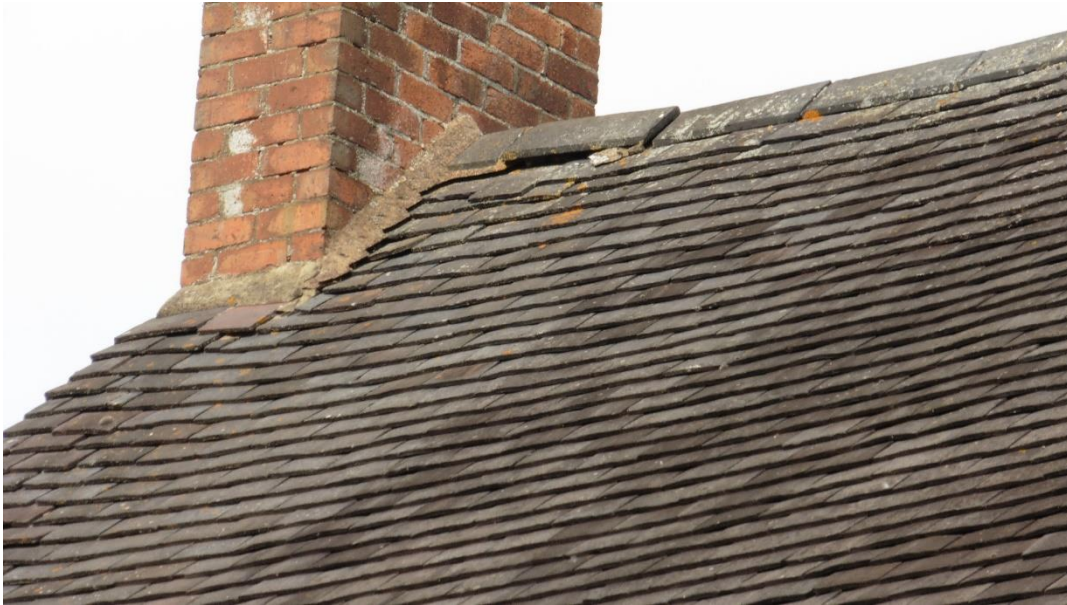
Externally, there was a potential roost access point in the north-western extension by a gaps underneath tiles in this location. There was then potential access into the attic over the traditional house section via multiple gaps under tiles and ridge tiles.

Photograph 8: example of potential bat roosting feature under ridge tiles on the main traditional house.

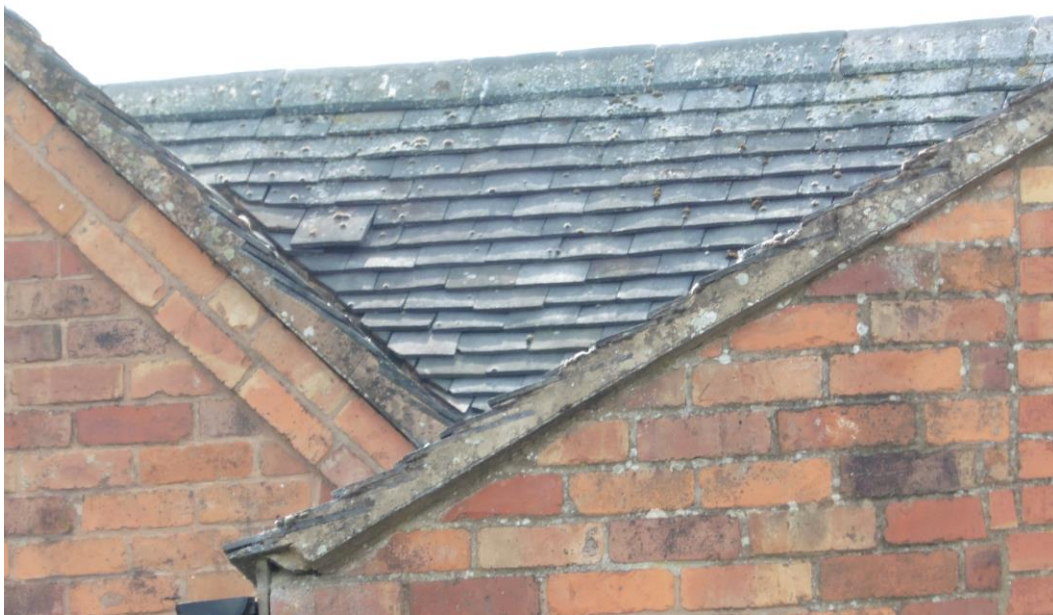
Photograph 9: example of the multiple gaps present under the existing rosemary tiles on the traditional house section.

There was no evidence of nesting birds at the time of the preliminary bat roost assessment. The roof over the traditional building contains defects which offer opportunities for building associated birds to nest.

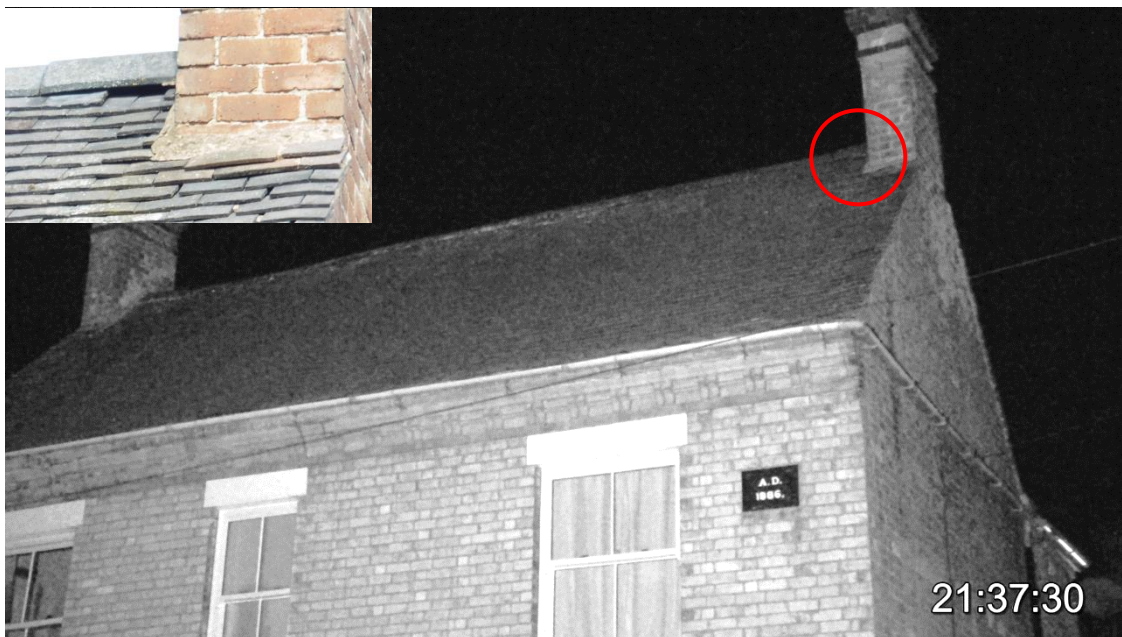
**The surveyor on the south-east of the building recorded a single bat, considered to be Brown long eared bat, emerging from the ridge by the eastern chimney at 20:42 hours.**

Figure 2 - Field of view from Camera F at end of survey 21:37:30. The bat emerged from the area encircled in red.

The results of the follow-up survey recorded a single bat emerging from the eastern ridge line adjacent to the chimney. The lack of echolocation and the general behaviour of the animal suggests this was a Brown long-eared bat. There were no bats observed emerging from the location where evidence of the Pipistrelle bats had been found. The survey was carried out at the end of the peak survey season, August 2022, and was therefore supported by a single emergence and activity survey.

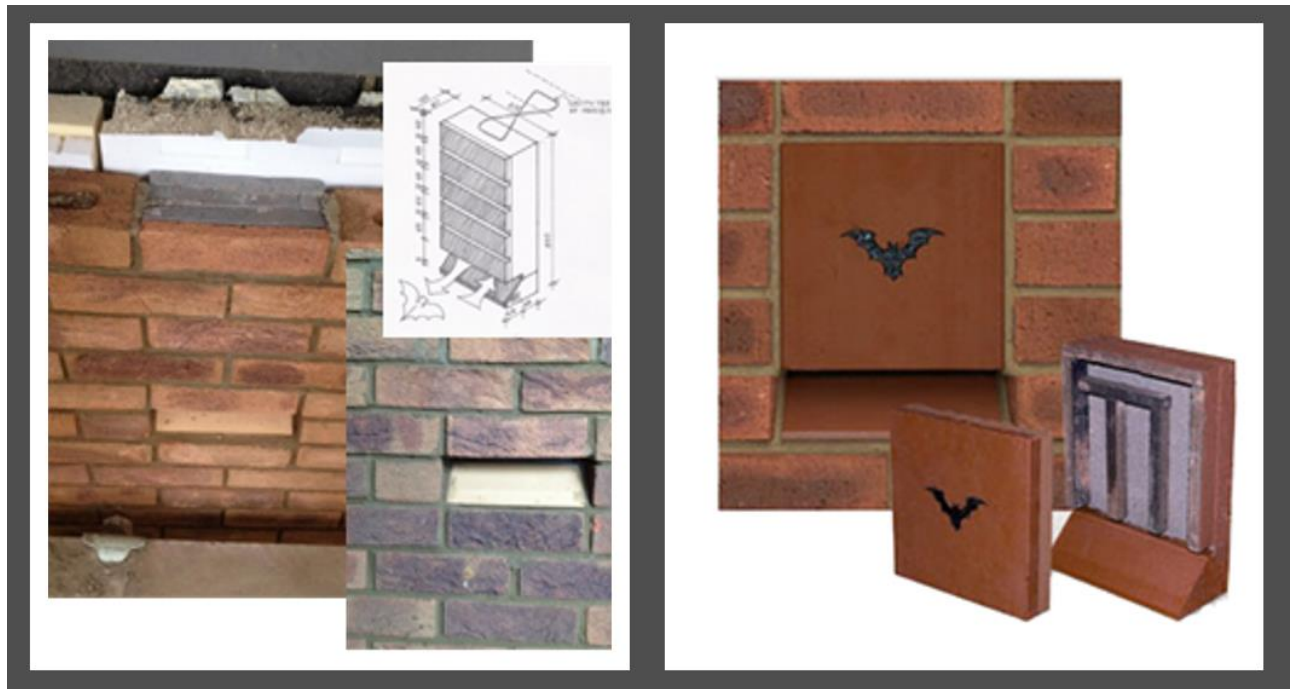
Figure 5: Examples of integrated bat tubes.

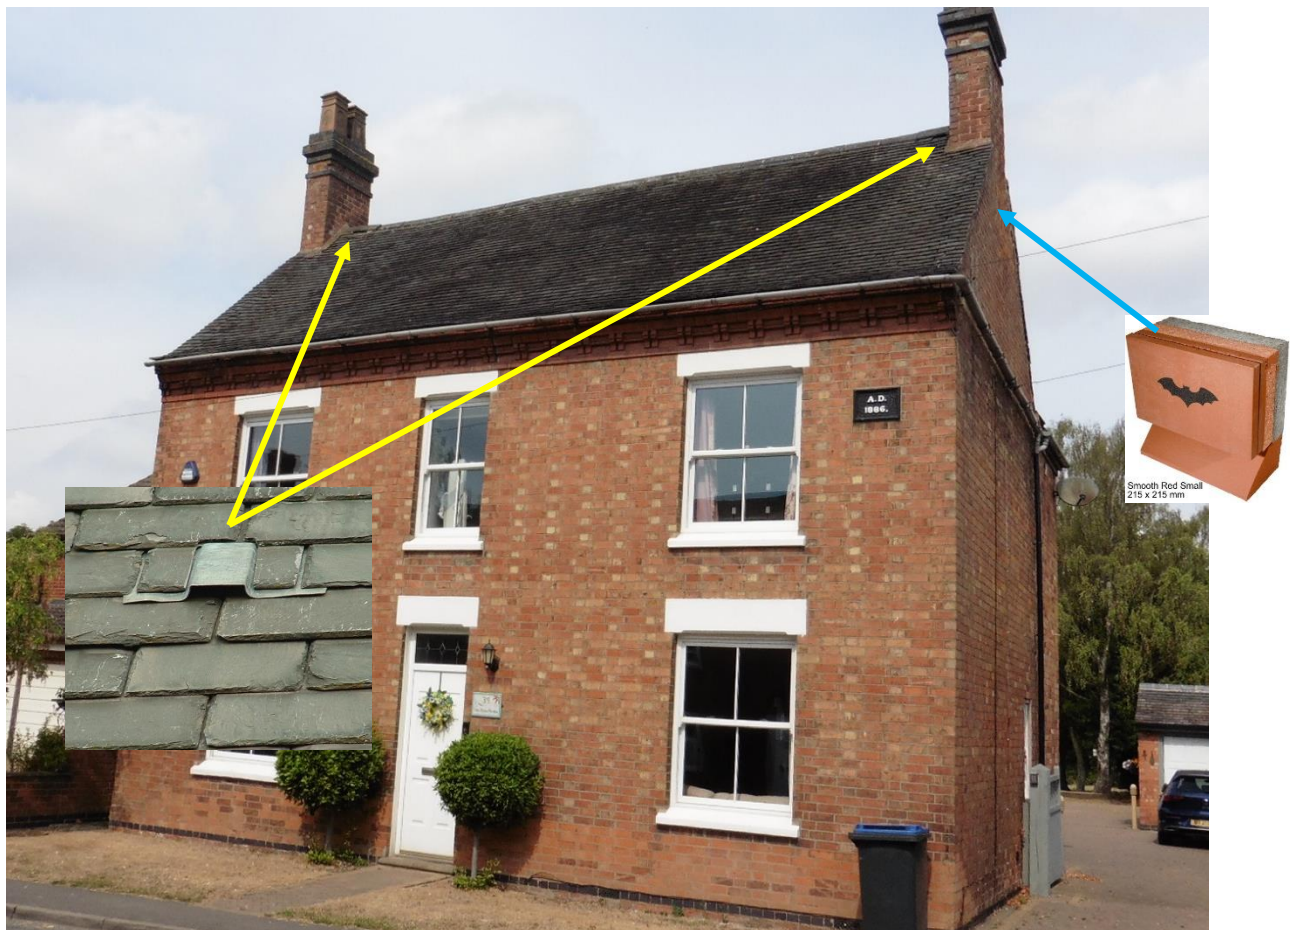
Figure 6 - proposed locations for the bat accesses into the traditional dwelling section (annex). Inset an example of the bat access tile to go alongside the chimney breasts. The blue arrow shows the proposed location for the bat tube to provide for day roosting common pipistrelle, see section 6.4.1.

The attic space will be retained using the same dimensions as existing within the traditional section of house, but with the removal of the extensions to the north.

The replacement roof will be underlined with a traditional Bitumen type 1F felt with a hessian matrix.

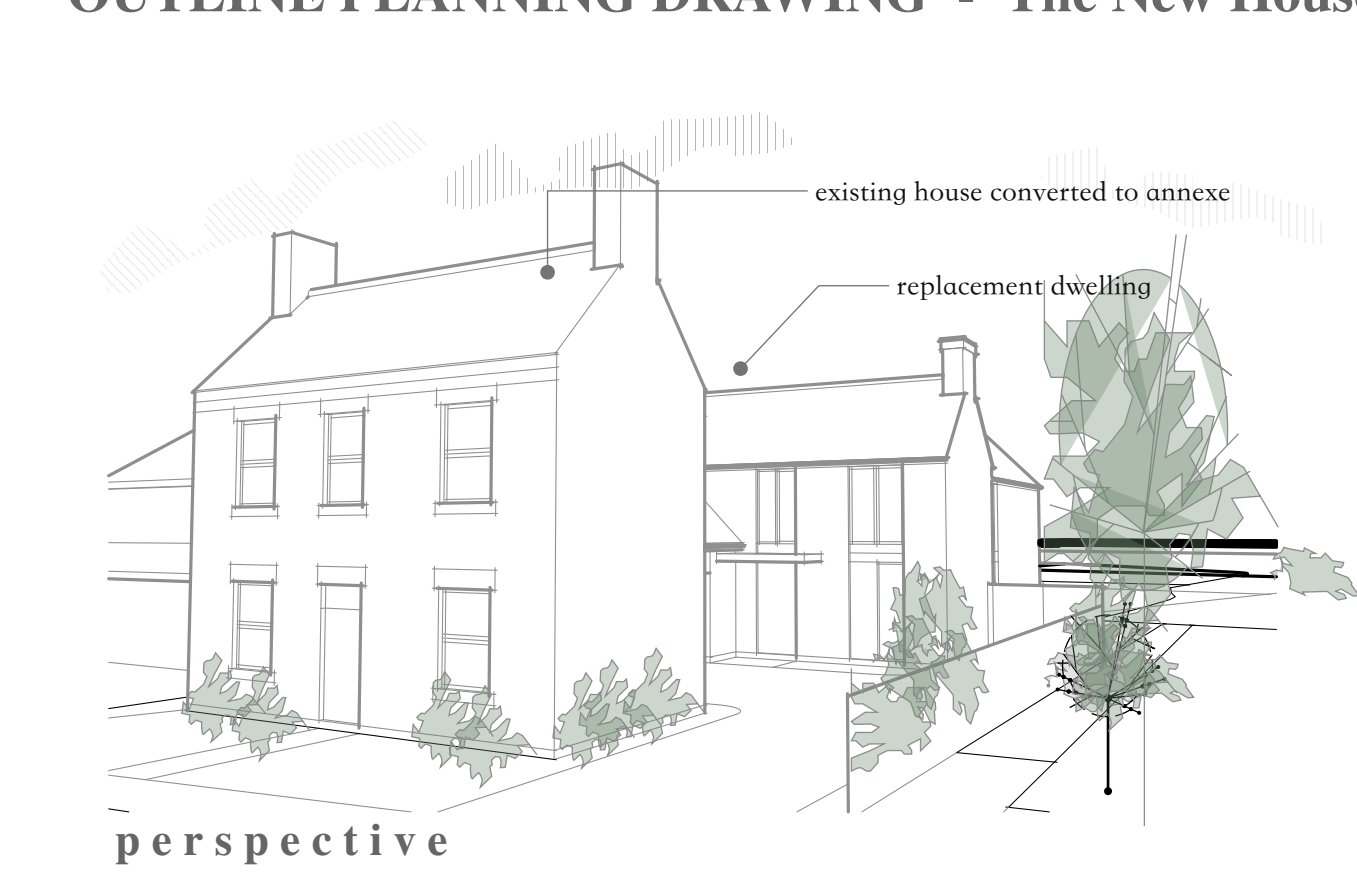
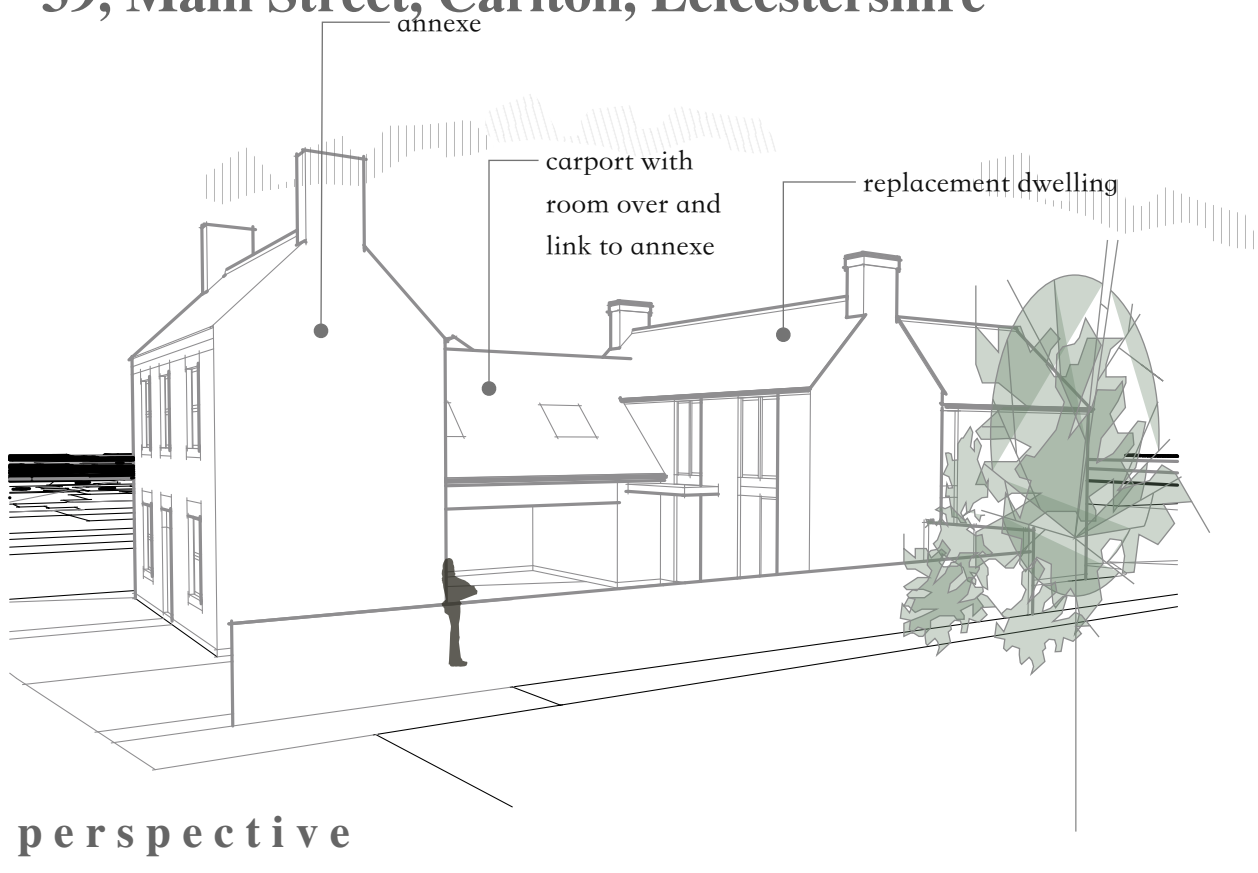
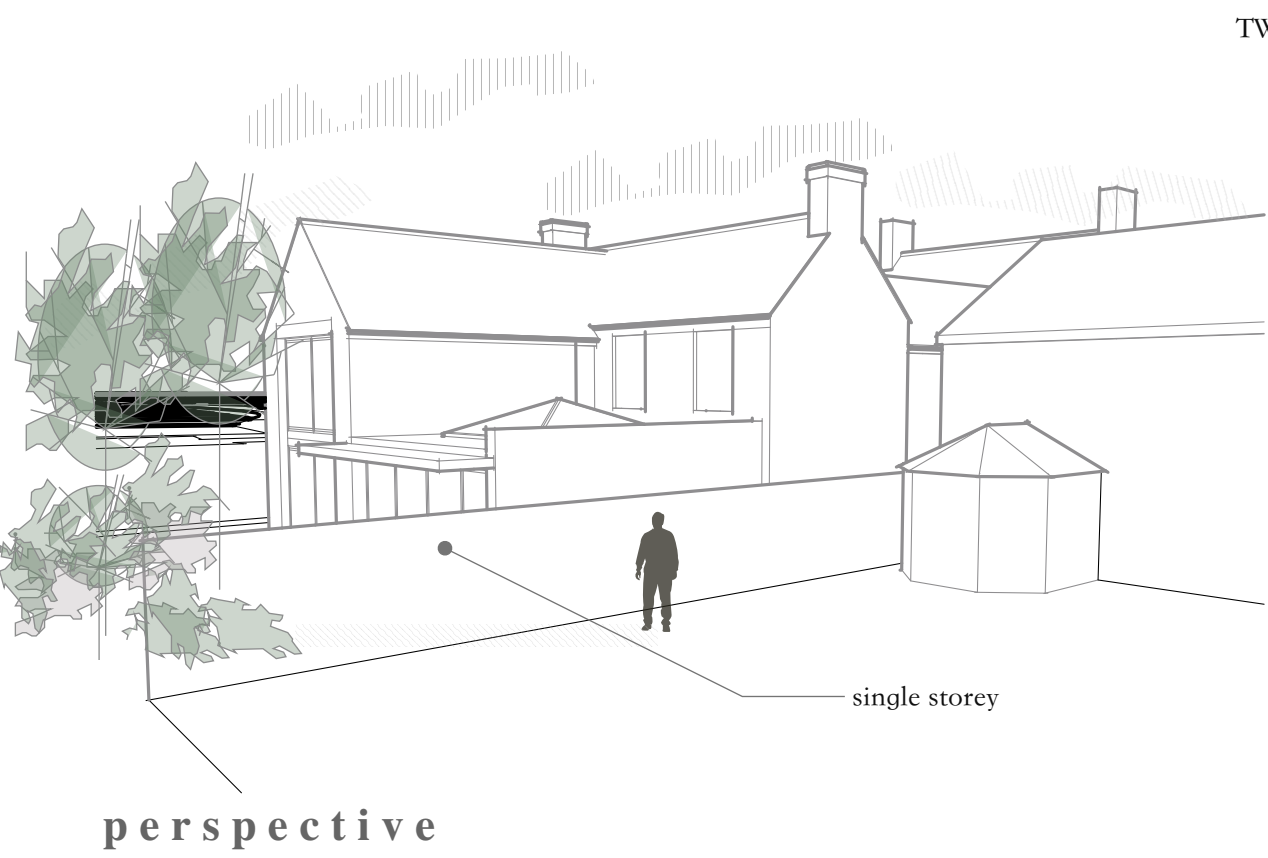
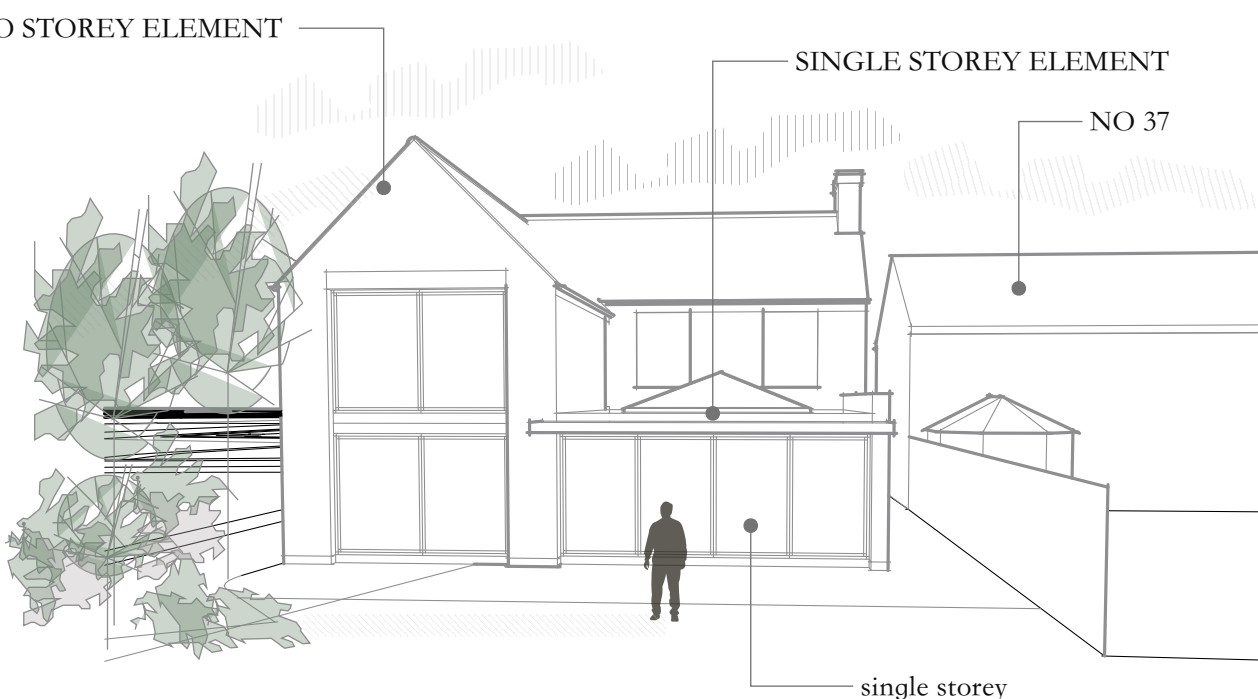
OUTLINE PLANNING DRAWING -“The New House” 39, Main Street, Carlton, Leicestershire

The outline planning drawing is provided overleaf:
