## Preliminary Roost Assessment

White Rose Barn, Lount Road, Osbaston, Nuneaton, Hinckley And Bosworth, Leicestershire, CV13 0HR

This report is prepared to inform a planning application with the Hinckley and Bosworth Borough Council. The proposal is described as:  
Two storey front extension, reconfigured entrance, installation of solar panels and erection of detached timber carport.

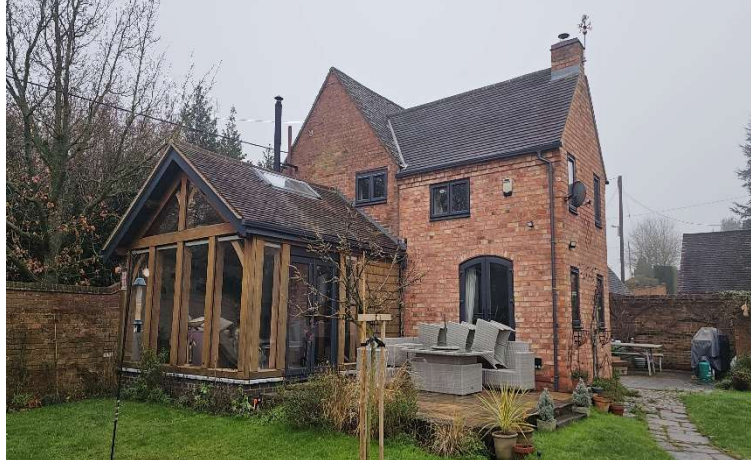
<i>Building B1</i>	<i>Photographs</i>
<p><b>Summary</b></p> <p>B1 consists of a two-storey residential dwelling. The building comprised brick walls with a pitched roof of clay tiles. A conservatory was present on the west of the building with a pitched roof of clay tiles.</p> <p>The building B1 was assessed to provide <b>moderate roosting habitat</b> to bats.</p>

A photograph of a two-story brick house with a conservatory and a garden. The house is made of red brick and has a pitched roof of dark grey tiles. A conservatory with a wooden frame and glass panels is attached to the west side of the house. The garden is green and has a paved path leading to the house. There is a stone patio area with outdoor furniture in the foreground.

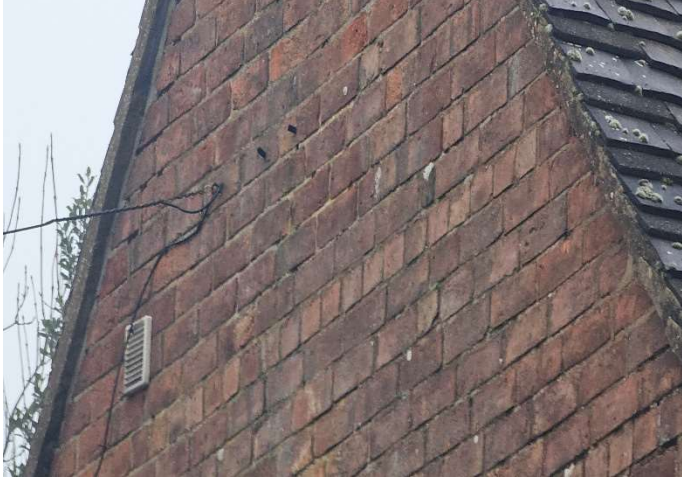
Feature	Materials	Condition/description/suitability	Photograph(s)
Walls	Brick	<p><b>Condition/description</b> Areas of missing mortar between the brickwork was observed on the western gable.</p> <p><b>Suitability/access/evidence of bats</b> The gaps from missing mortar offered suitable roosting habitat to crevice dwelling bats.</p>

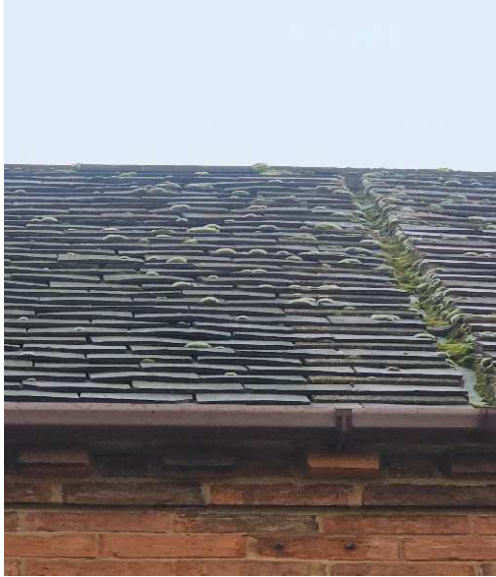
Roof	Clay tiles	<p><b>Condition/description</b> Lifted tiles were observed throughout the roof.</p> <p><b>Suitability/access/evidence of bats</b> The lifted tiles offered suitable roosting habitat to crevice dwelling bats.</p>

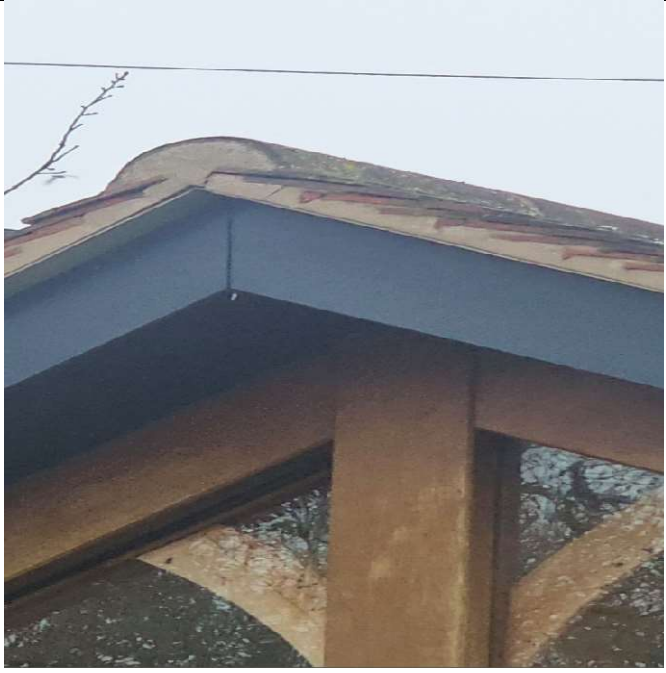
<p>Barge boards</p>	<p>Plastic</p>	<p><b>Condition/description</b>                  Plastic barge boards were present on the conservatory. The barge boards appeared to be well-sealed.</p> <p><b>Suitability/access/evidence of bats</b>                  No suitable bat access points or roosting locations observed.</p>

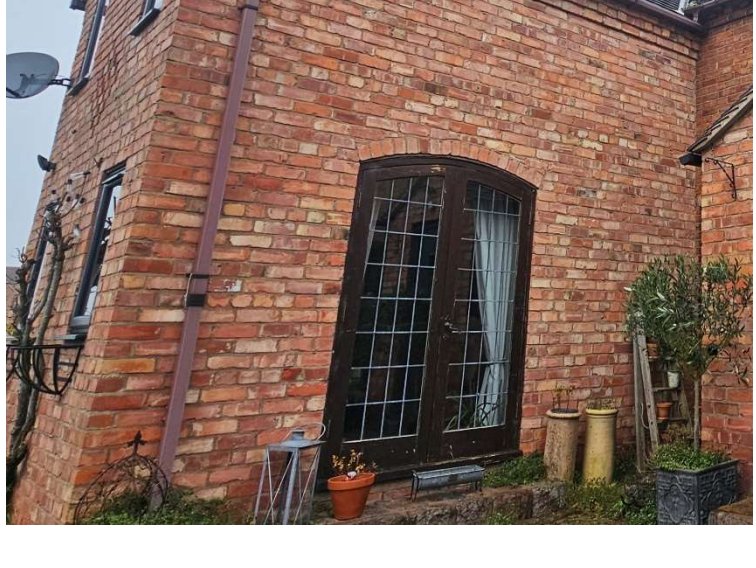
<p>Window/door frames and lintels</p>	<p>Timber</p>	<p><b>Condition/description</b>                  The windows and doors appeared to be well-sealed.</p> <p><b>Suitability/access/evidence of bats</b>                  No suitable bat access points or roosting locations observed.</p>

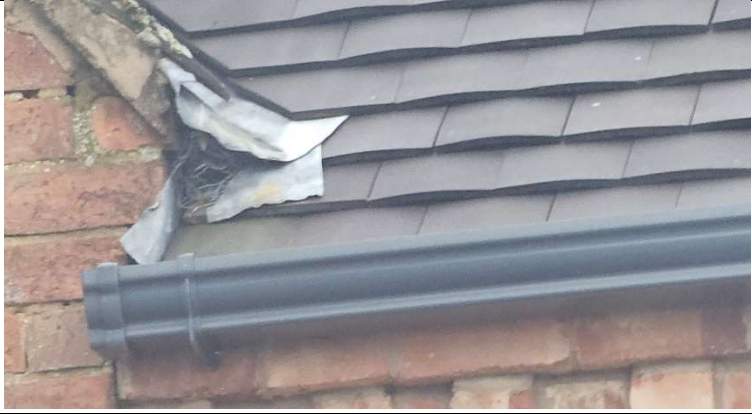
<p>Lead flashing</p>	<p>N/A</p>	<p><b>Condition/description</b>                  An area of lifted lead flashing was present on the southwest elevation.</p> <p><b>Suitability/access/evidence of bats</b>                  The lifted lead flashing offered suitable roosting habitat to crevice dwelling bats.</p>

<i>Suggested enhancements</i>	Enhancements are dependent on the outcome of further surveys.
<b>Nesting birds</b>	
<i>Summary of Survey Findings</i>	A bird's nest was present under the area of lifted lead flashing on the southwest elevation of the building B1. The building was assessed to provide suitable habitat to nesting birds.
<i>Foreseen Impacts</i>	The proposed development could result in the destruction or the disturbance and subsequent abandonment of active bird nests.

<i>Recommendations</i>	<p>Any building works should be undertaken outside the period 1st March to 31st August. If this timeframe cannot be avoided, a close inspection of the vegetation should be undertaken immediately, by a qualified ecologist, prior to the commencement of work. All active nests will need to be retained until the young have fledged.</p> <p>Precautions should be taken with machinery and noise levels when working close to any retained nests so as not to disturb any nearby nesting birds during construction works. At least a 3-5m buffer should be created between any machinery and active nests until the young have fledged.</p>
<i>Suggested enhancements</i>	<p>It is recommended that new bird boxes* are installed on the retained building to provide nesting opportunities within the site post-development.</p> <p>*Suggestions for bird boxes:  Schwegler No 17 Swift Nest Box (buildings)  Schwegler 1SP Sparrow Terrace (buildings)  Woodstone Nest Box (buildings or trees)  Or a similar alternative brand.</p>

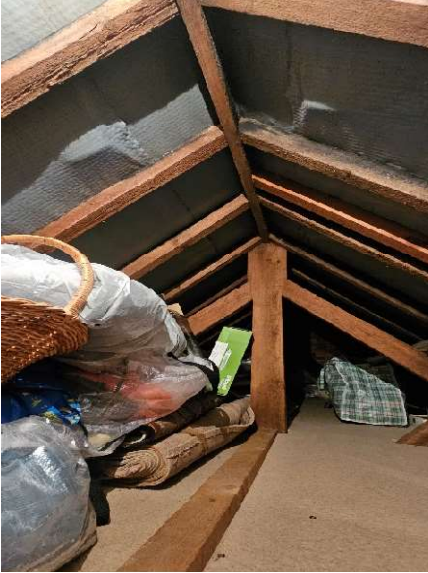
<p>Internal voids</p>	<p>Timber ridge beams, timber rafters, timber trusses, plastic lining</p>	<p><b>Condition/description</b>                  The loft had been partially converted, leaving a small loft space, approximately 1m in height, 9m in length and 6m in width. The roof structure comprised a timber ridge beam, timber rafters and timber trusses lined with plastic sheeting.</p> <p><b>Suitability/access/evidence of bats</b>                  No evidence of bats was found during the survey.</p> <p>Suitable roosting locations included at the ridge beam convergence points.</p>
