## STANTON LANE, STANTON UNDER BARDON

### PHASE II SITE APPRAISAL FOR SUTTON LAND DEVELOPMENT LTD.

**Project Ref:**  
P8079

**Date:**  
September 2017

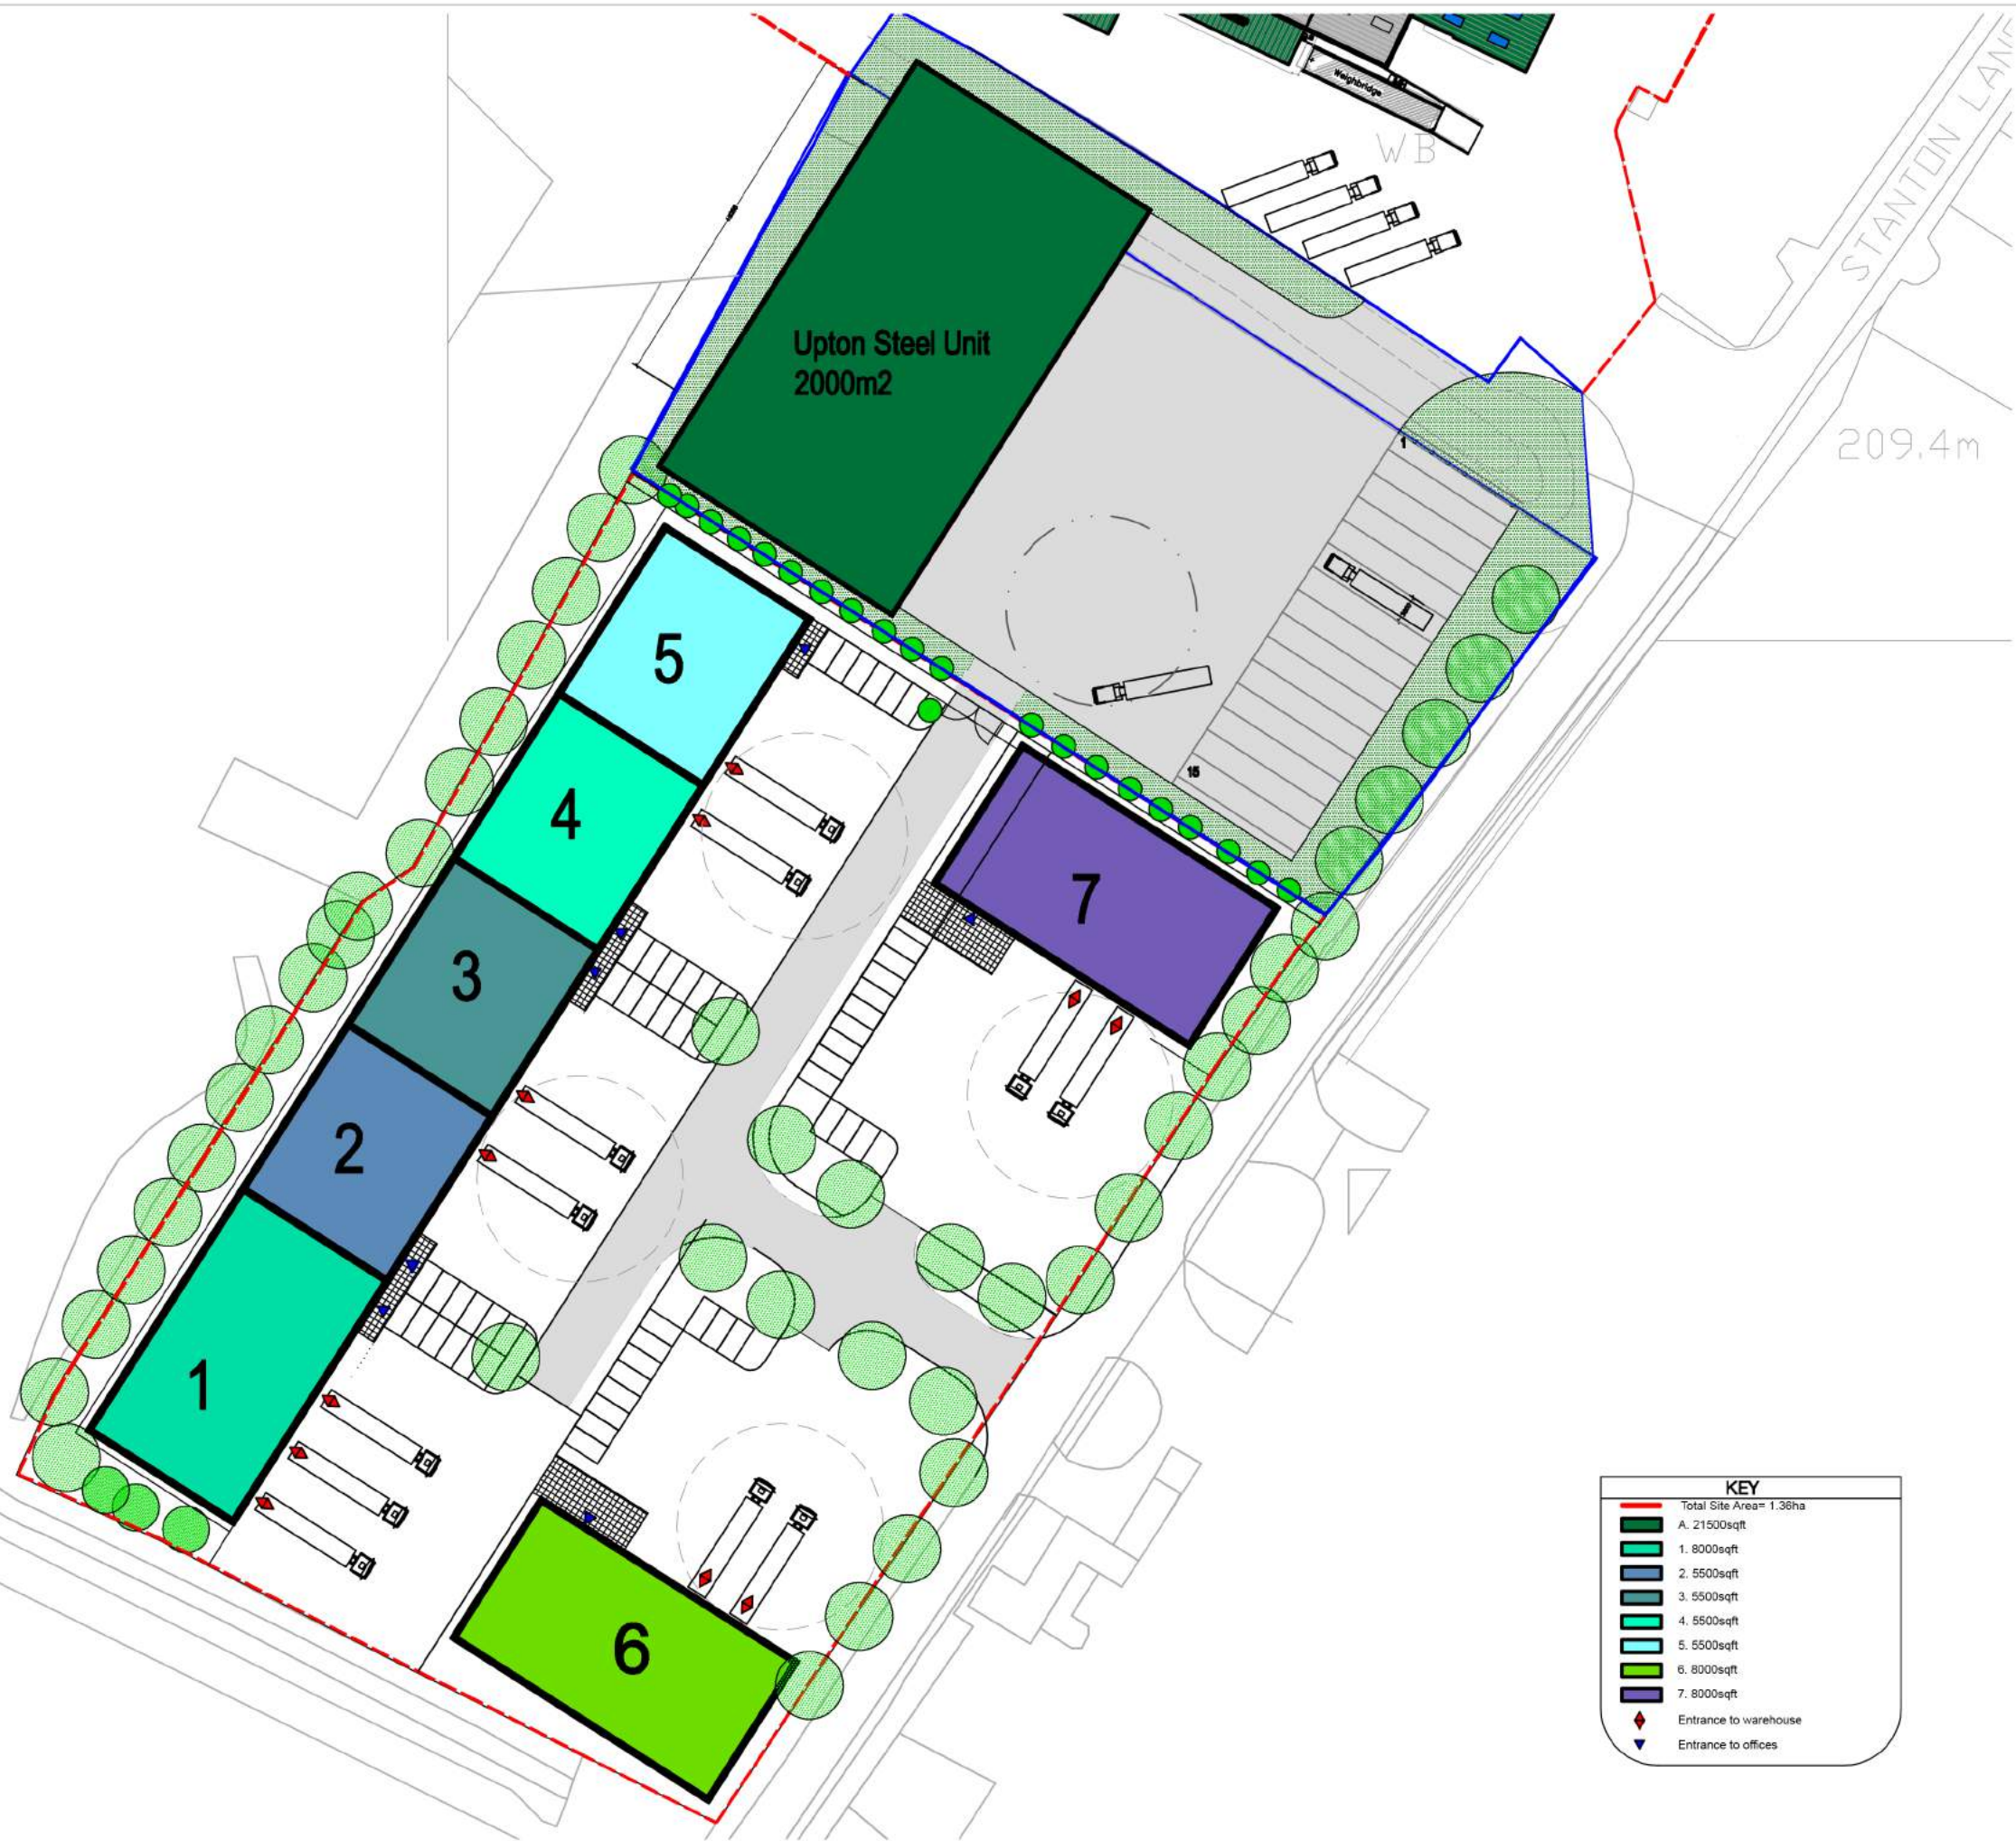
| SKETCH PLAN | | | |
|---|---|---|---|
| Drawing No.<br>6637P-203 | Revision:<br>A | | |

| KEY | |
|---|---|
| | Total Site Area= 1.36ha |
