# winvic

## Demolition, Construction Traffic and Environmental Management Plan (England & Wales)

Mountpark Hinckley (Padge Hall Farm) / E23-037

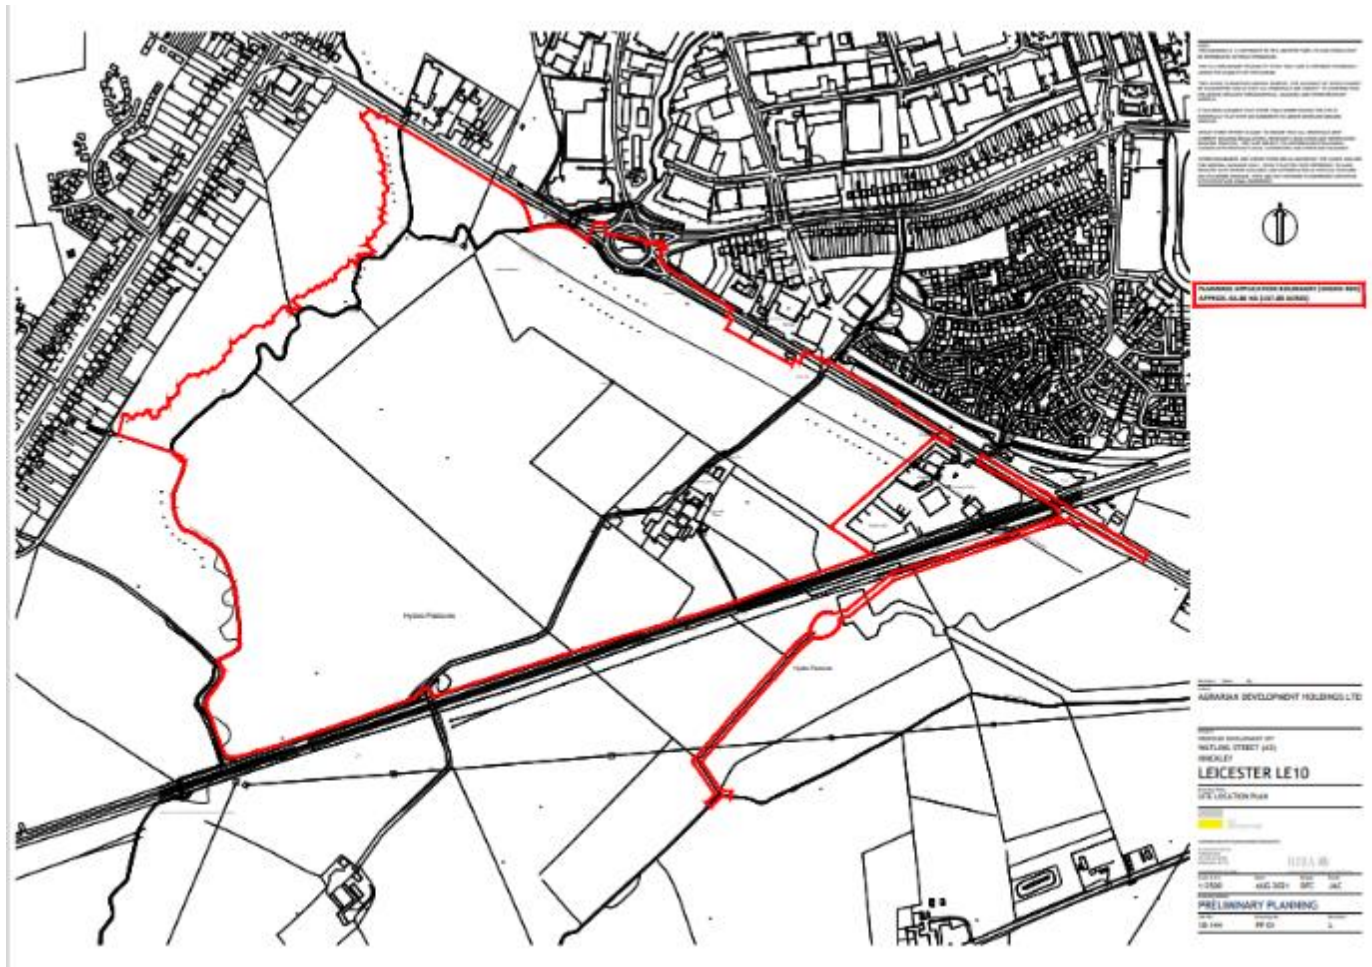
The area of the proposed development covers approximately 63.84ha and the national grid reference number for the site is SP 40011 92746. The scope of the construction site is subject to a number of environmental sensitivities (as shown in the Environmental Constraints Map / site drainage plan) as summarised below.

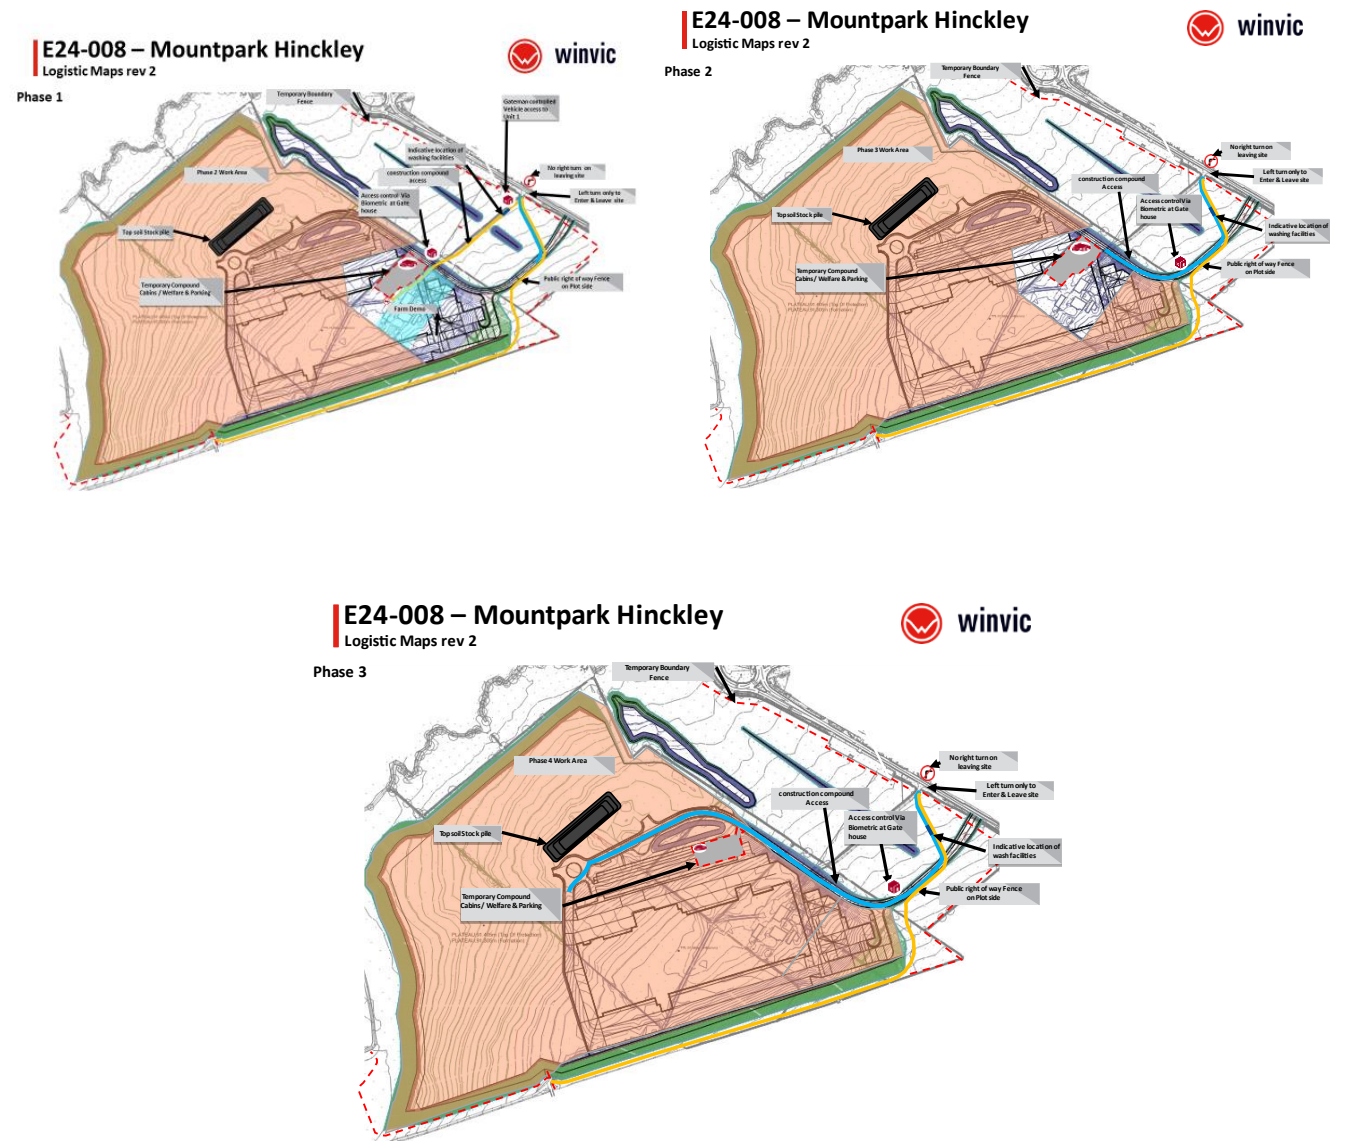
A logistic plan for the site can be seen below and in Appendix E. Note that this will change as works progresses. Note that washing facilities for vehicles will be located 10m away from the highway.

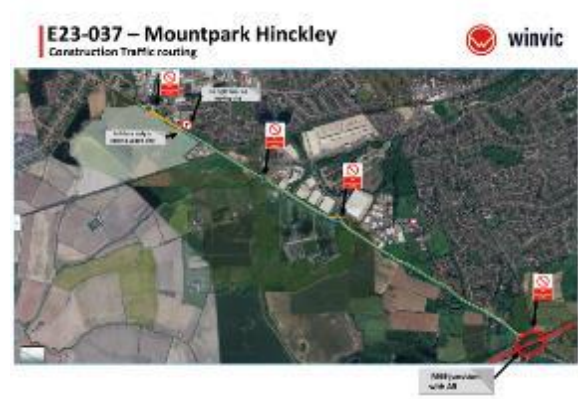
Below shows the routing of the traffic.

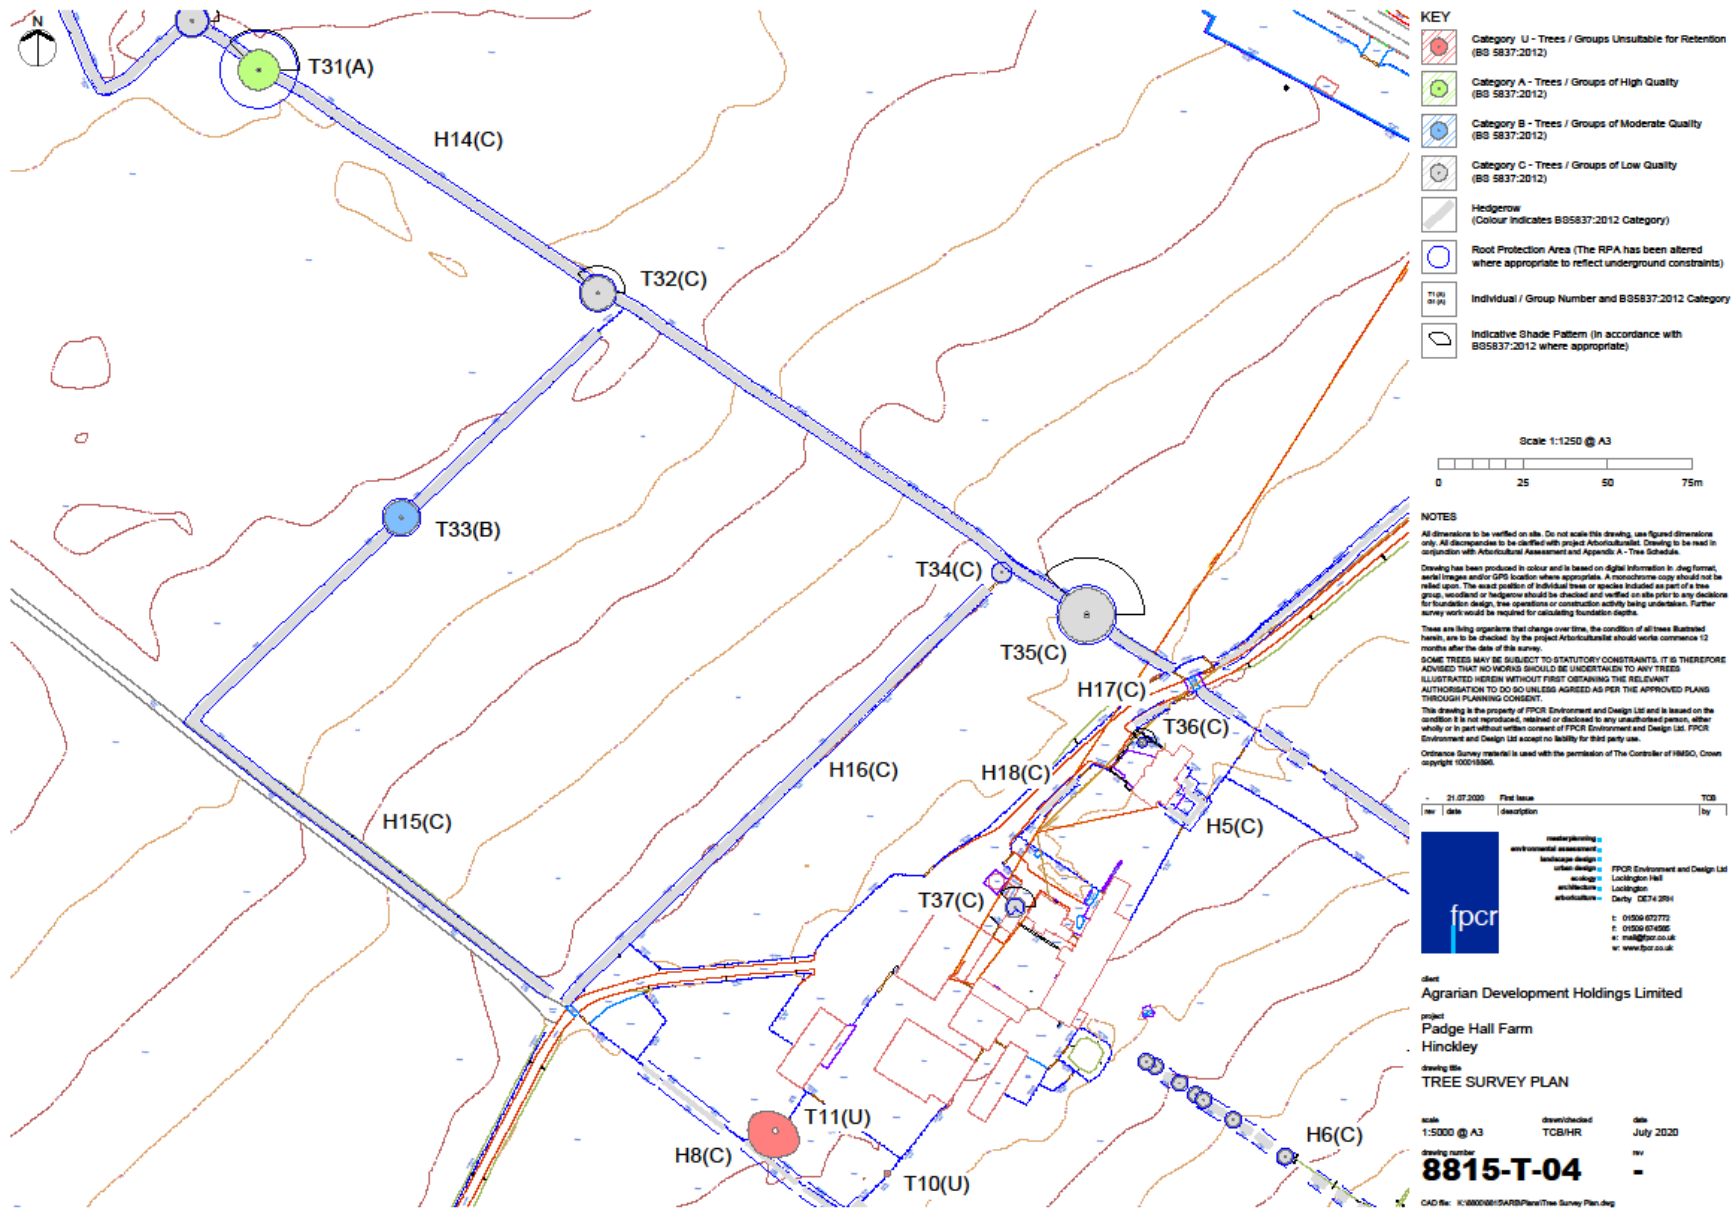
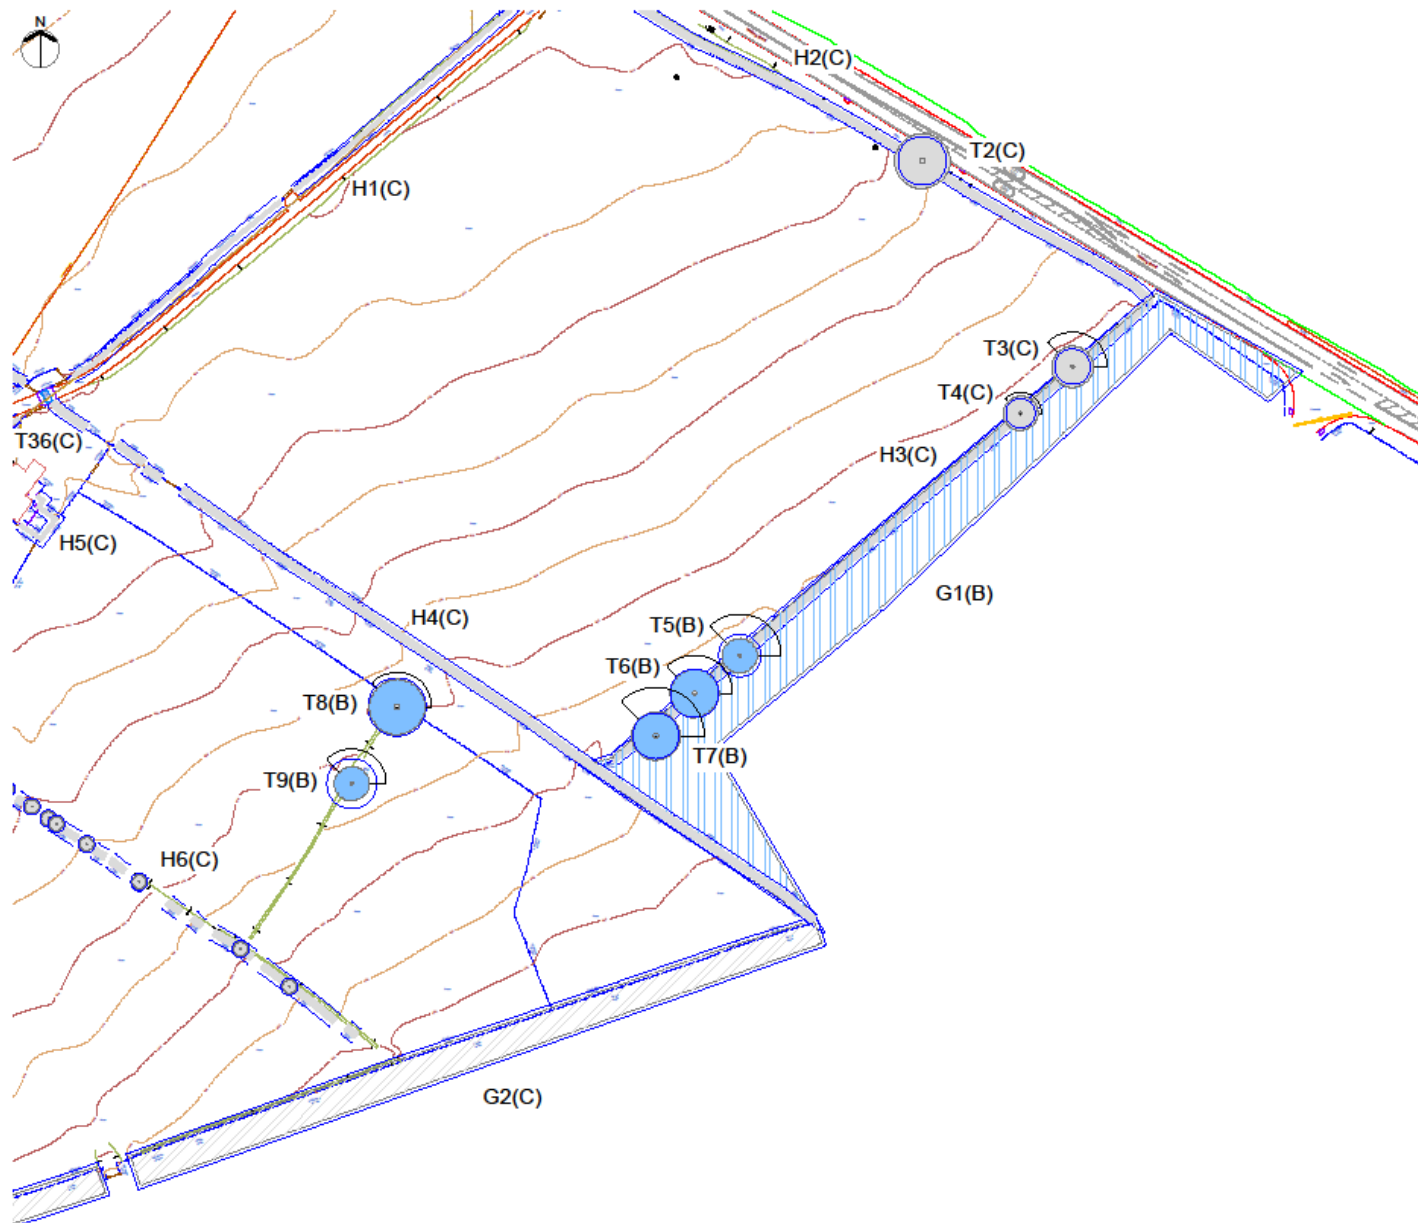
drawing number  
**8815-T-03**

- Category U - Trees / Groups Unsuitable for Retention (BS 5837:2012)
- Category A - Trees / Groups of High Quality (BS 5837:2012)
- Category B - Trees / Groups of Moderate Quality (BS 5837:2012)
- Category C - Trees / Groups of Low Quality (BS 5837:2012)
- Hedgerow (Colour indicates BS5837:2012 Category)
- Root Protection Area (The RPA has been altered where appropriate to reflect underground constraints)
- Individual / Group Number and BS5837:2012 Category
- Indicative Shade Pattern (in accordance with BS5837:2012 where appropriate)

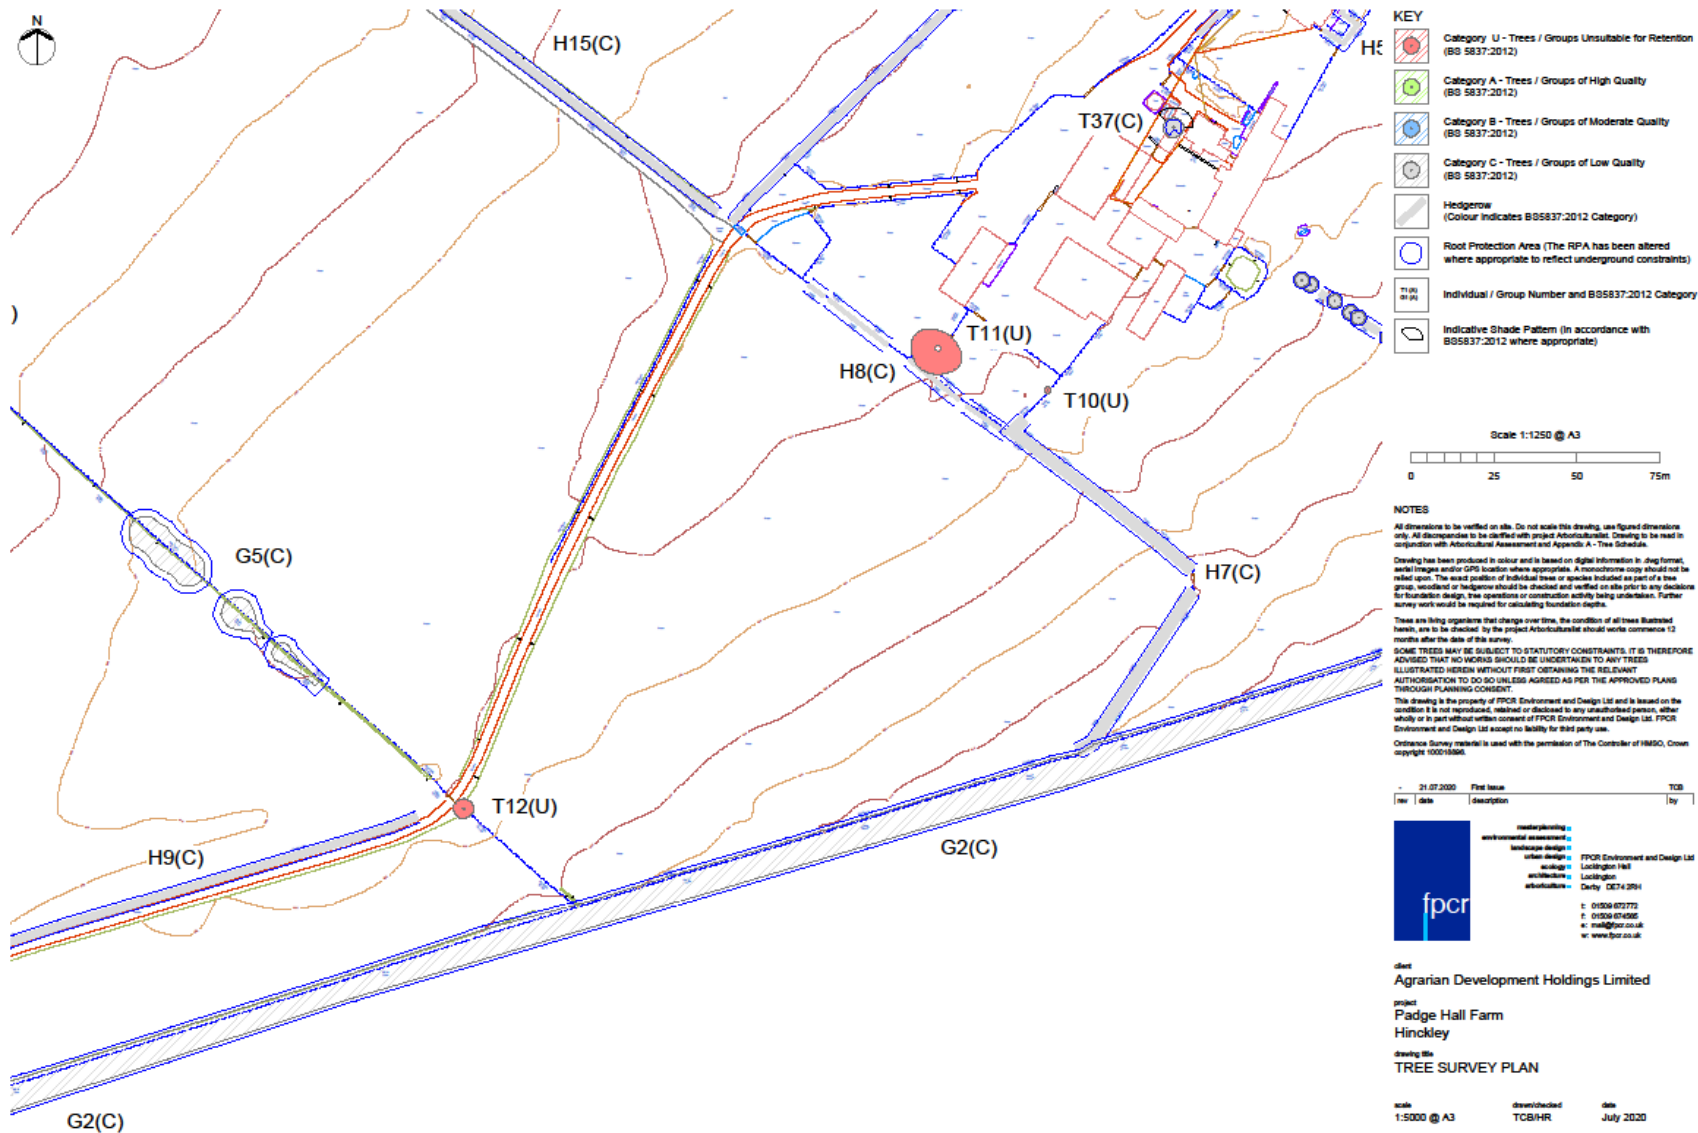
drawing number  
**8815-T-05**

- KEY**
- Category U - Trees / Groups Unsuitable for Retention (BS 5837:2012)
  - Category A - Trees / Groups of High Quality (BS 5837:2012)
  - Category B - Trees / Groups of Moderate Quality (BS 5837:2012)
  - Category C - Trees / Groups of Low Quality (BS 5837:2012)
  - Hedge Row (Colour Indicates BS5837:2012 Category)
  - Root Protection Area (The RPA has been altered where appropriate to reflect underground constraints)
  - Individual / Group Number and BS5837:2012 Category
  - Indicative Shade Pattern (in accordance with BS5837:2012 where appropriate)

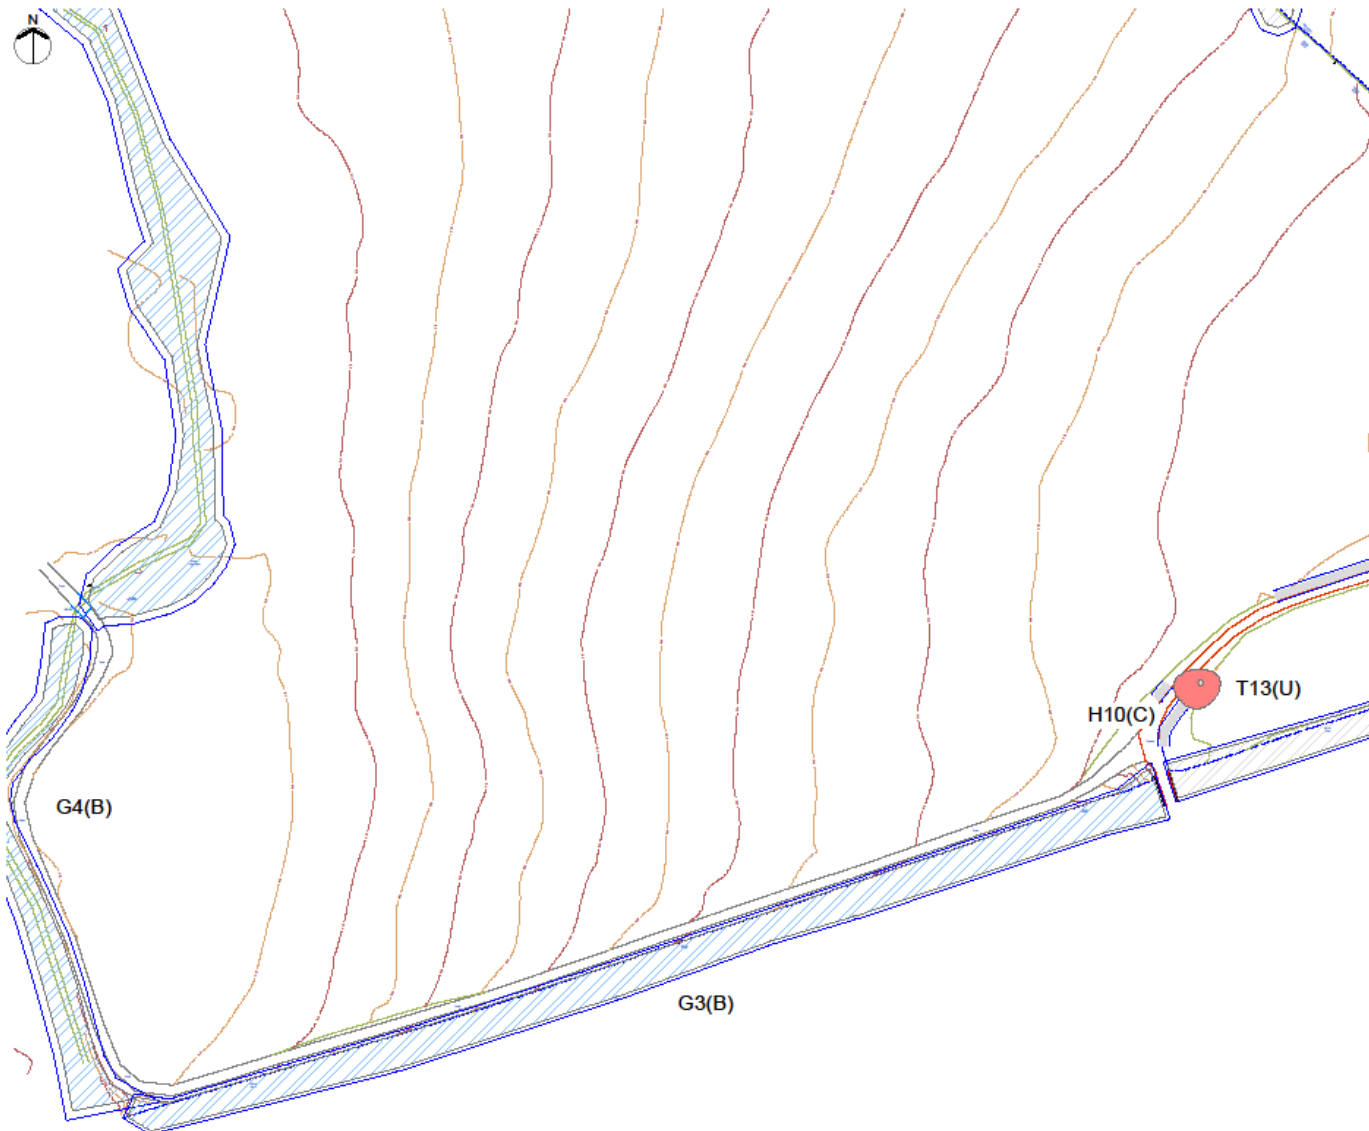
- KEY**
- Category U - Trees / Groups Unsuitable for Retention (BS 5837:2012)
  - Category A - Trees / Groups of High Quality (BS 5837:2012)
  - Category B - Trees / Groups of Moderate Quality (BS 5837:2012)
  - Category C - Trees / Groups of Low Quality (BS 5837:2012)
  - Hedgerow (Colour indicates BS5837:2012 Category)
  - Root Protection Area (The RPA has been altered where appropriate to reflect underground constraints)
  - Individual / Group Number and BS5837:2012 Category
  - Indicative Shade Pattern (in accordance with BS5837:2012 where appropriate)

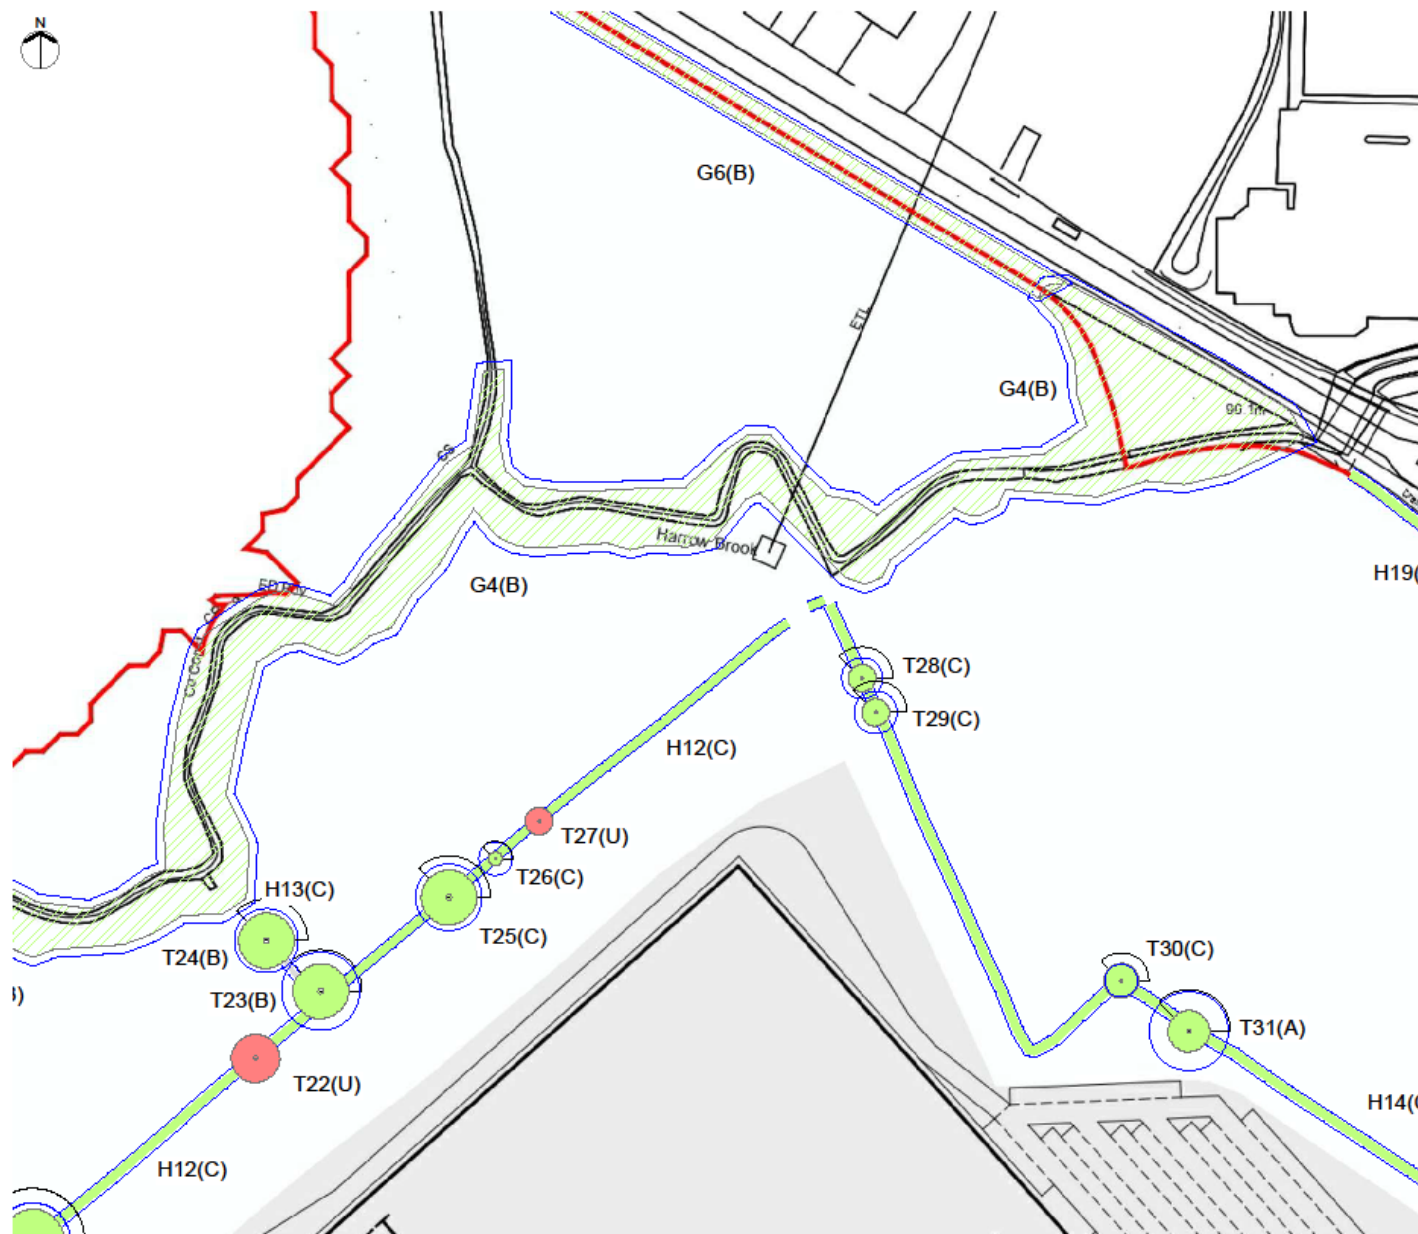
- Tree/Group to be Retained
- Tree/Group to be removed to facilitate the proposals
- Category U - Unsuitable for retention on arboricultural grounds
- Hedgerow Proposed to be Retained and Incorporated into the New Development
- Hedgerow Proposed to be Removed to Facilitate the Development upon Approval of the Application
- Root Protection Area (Shown for retained trees only)
- Individual / Group Number and BS Category
- Individual / Group Number to be Removed and BS 5837:2012 Category

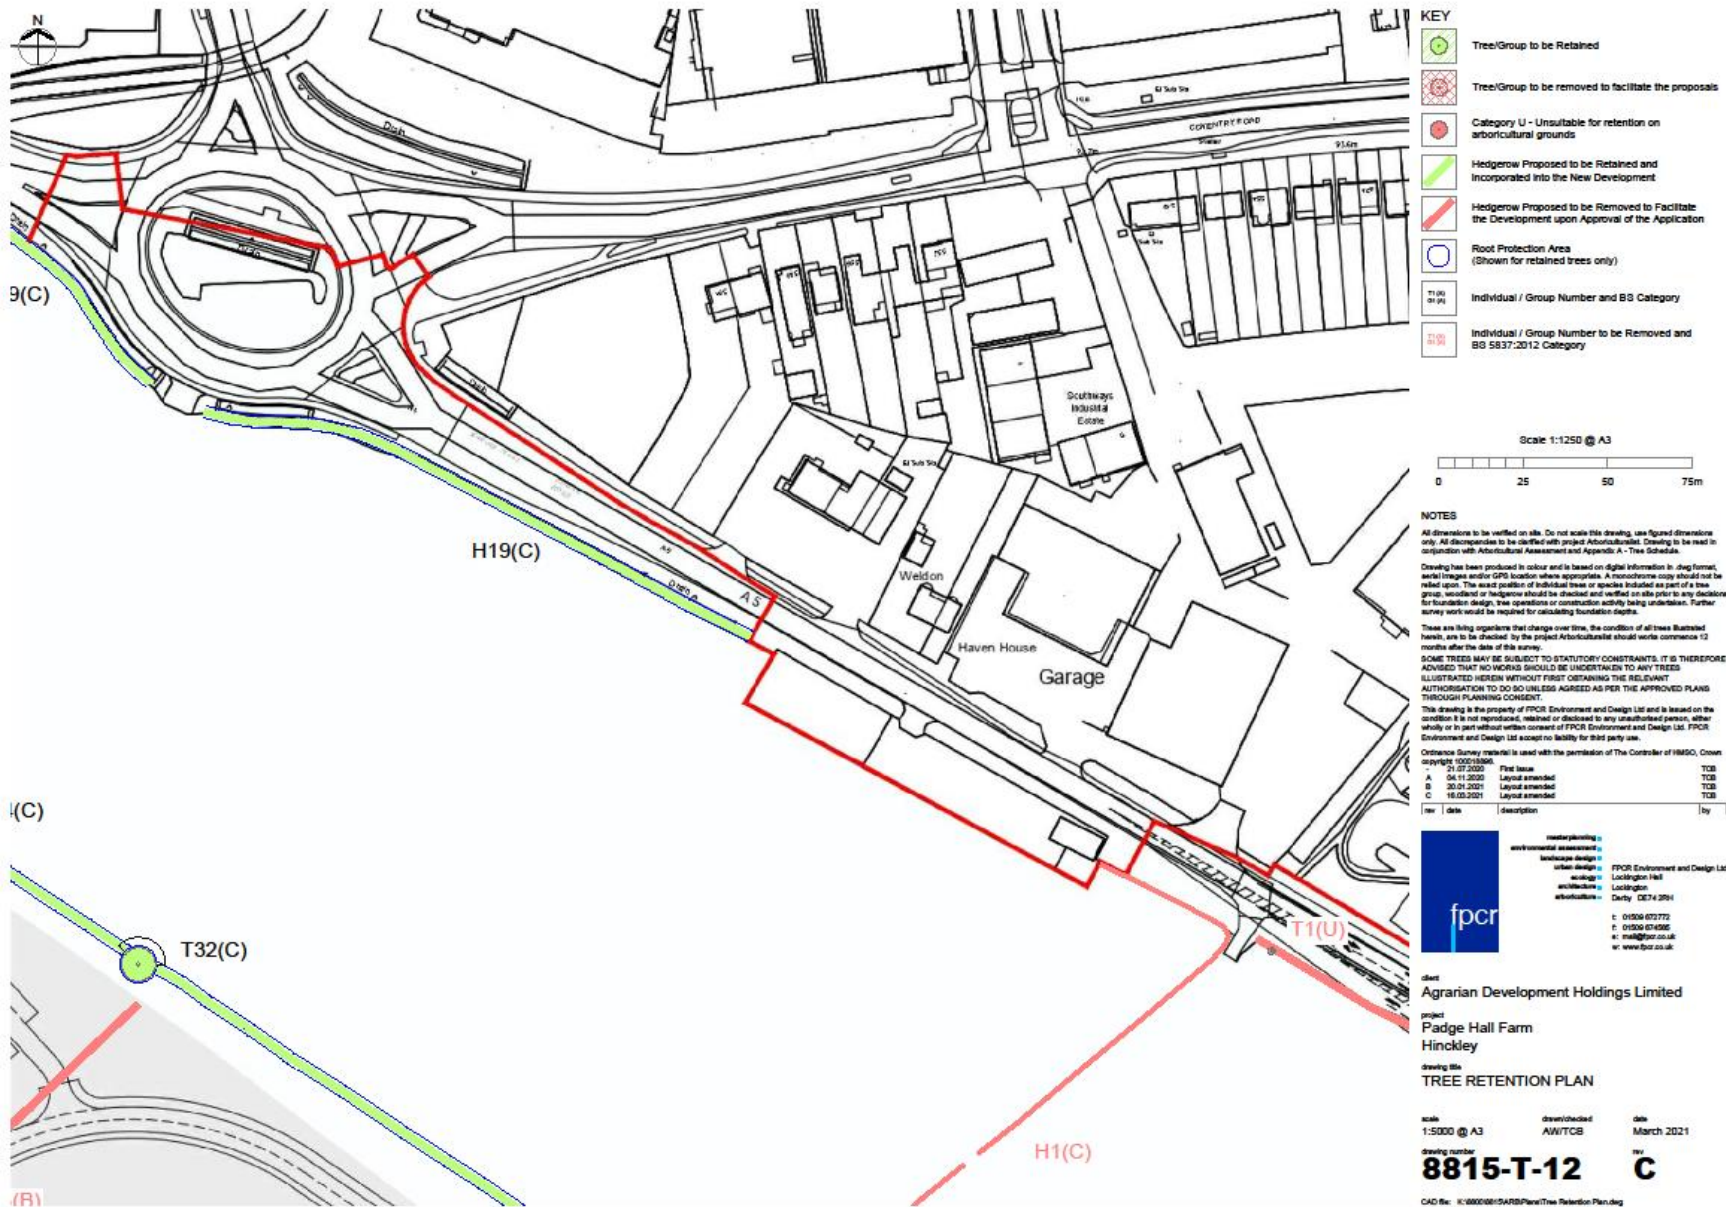
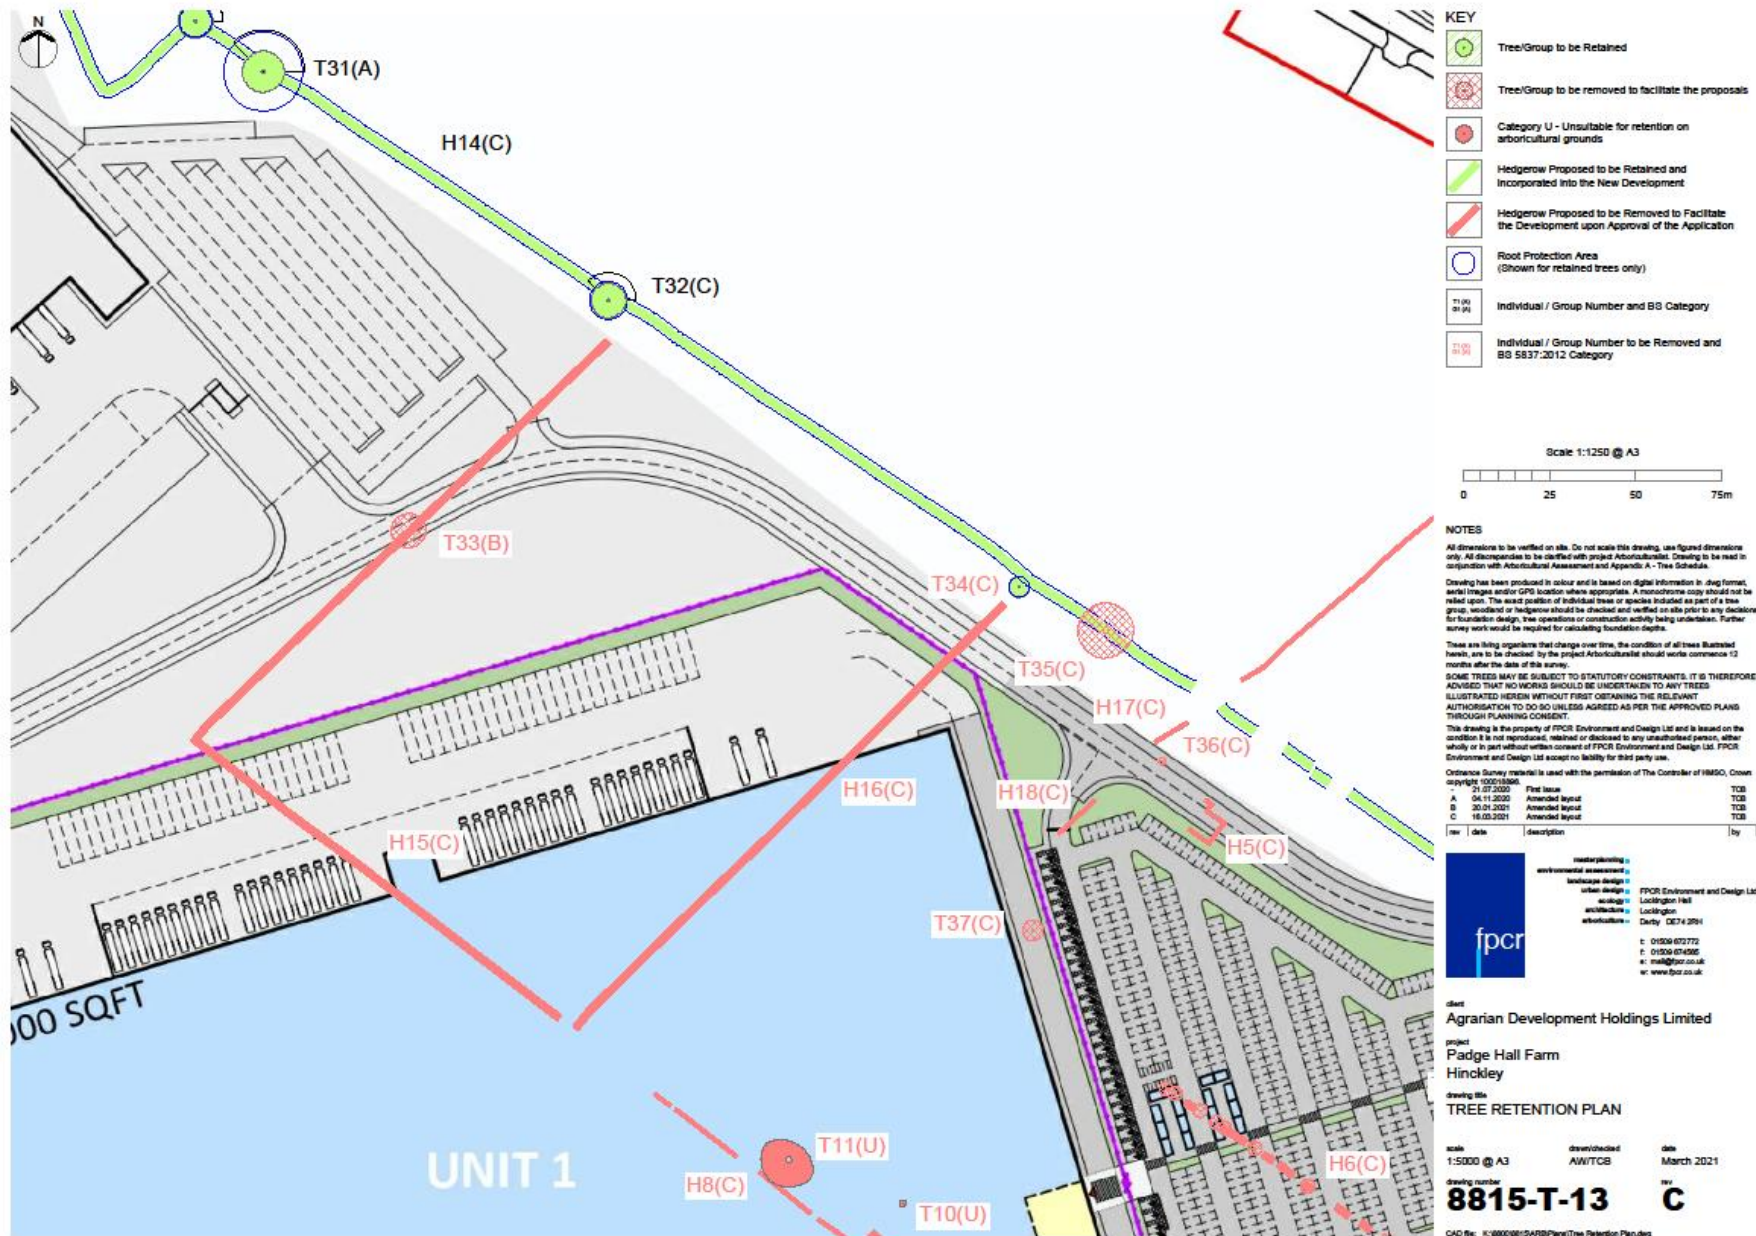
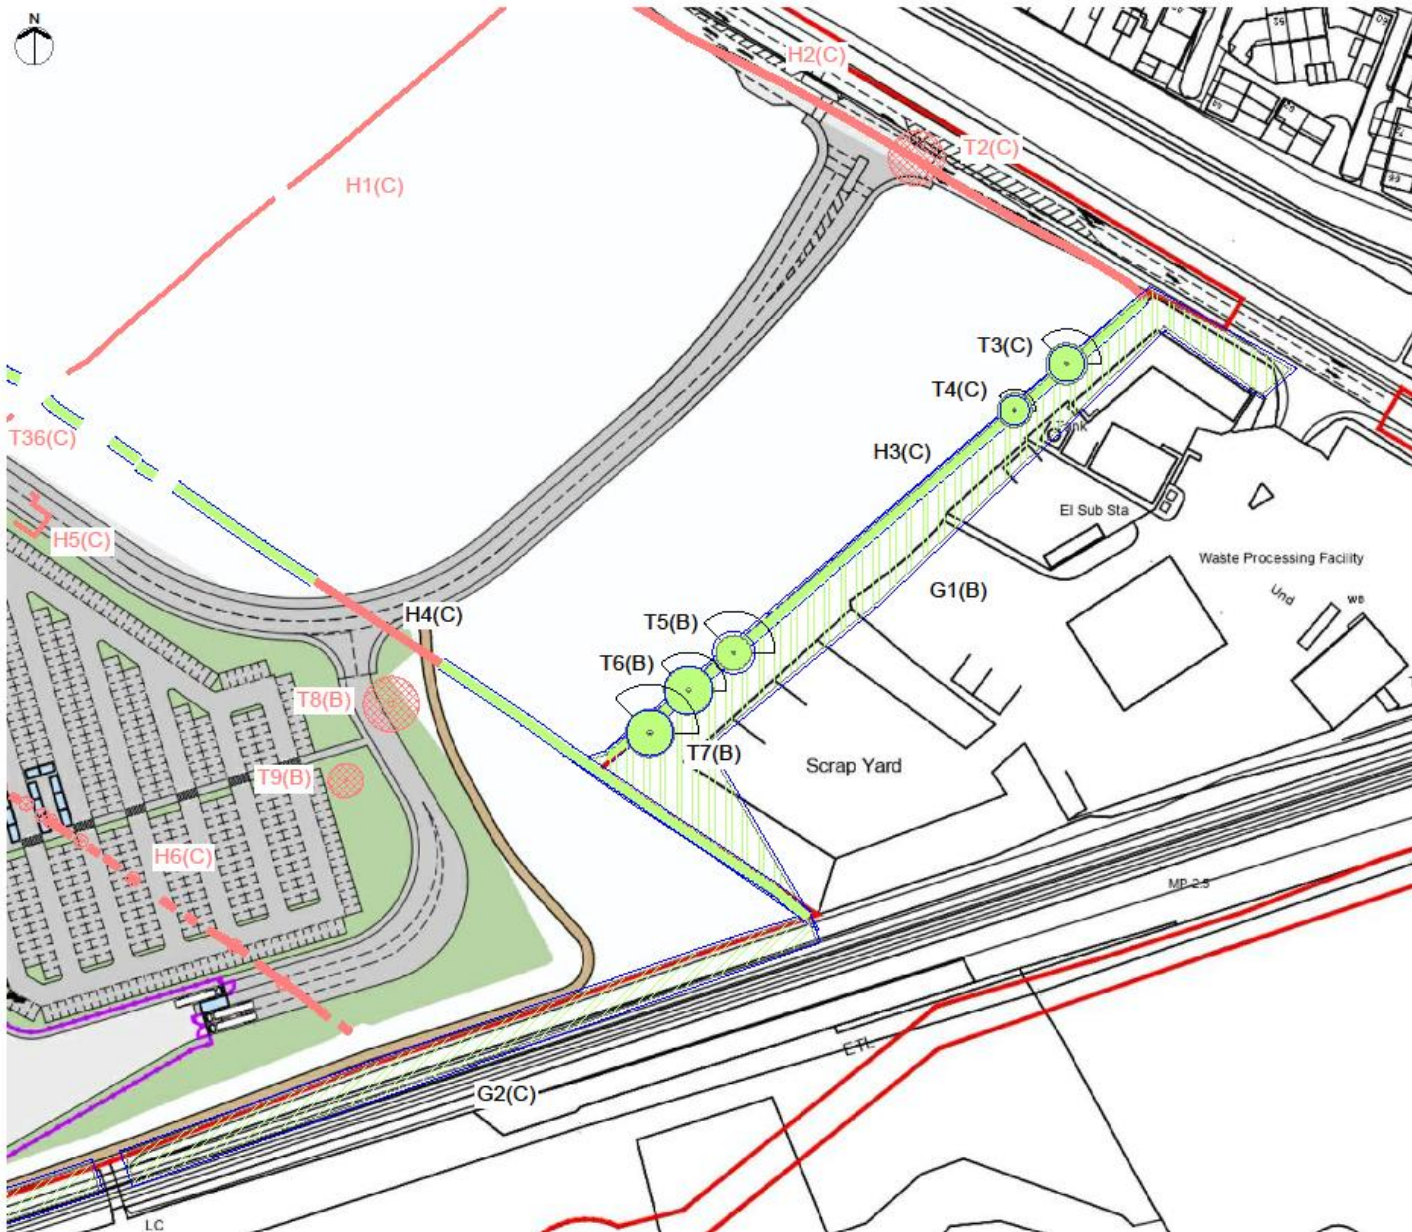
drawing number  
**8815-T-11**  
rev  
**C**

- KEY**
- Tree/Group to be Retained
  - Tree/Group to be removed to facilitate the proposals
  - Category U - Unsuitable for retention on arboricultural grounds
  - Hedgerow Proposed to be Retained and Incorporated into the New Development
  - Hedgerow Proposed to be Removed to Facilitate the Development upon Approval of the Application
  - Root Protection Area (Shown for retained trees only)
  - Individual / Group Number and BS Category
  - Individual / Group Number to be Removed and BS 5837:2012 Category

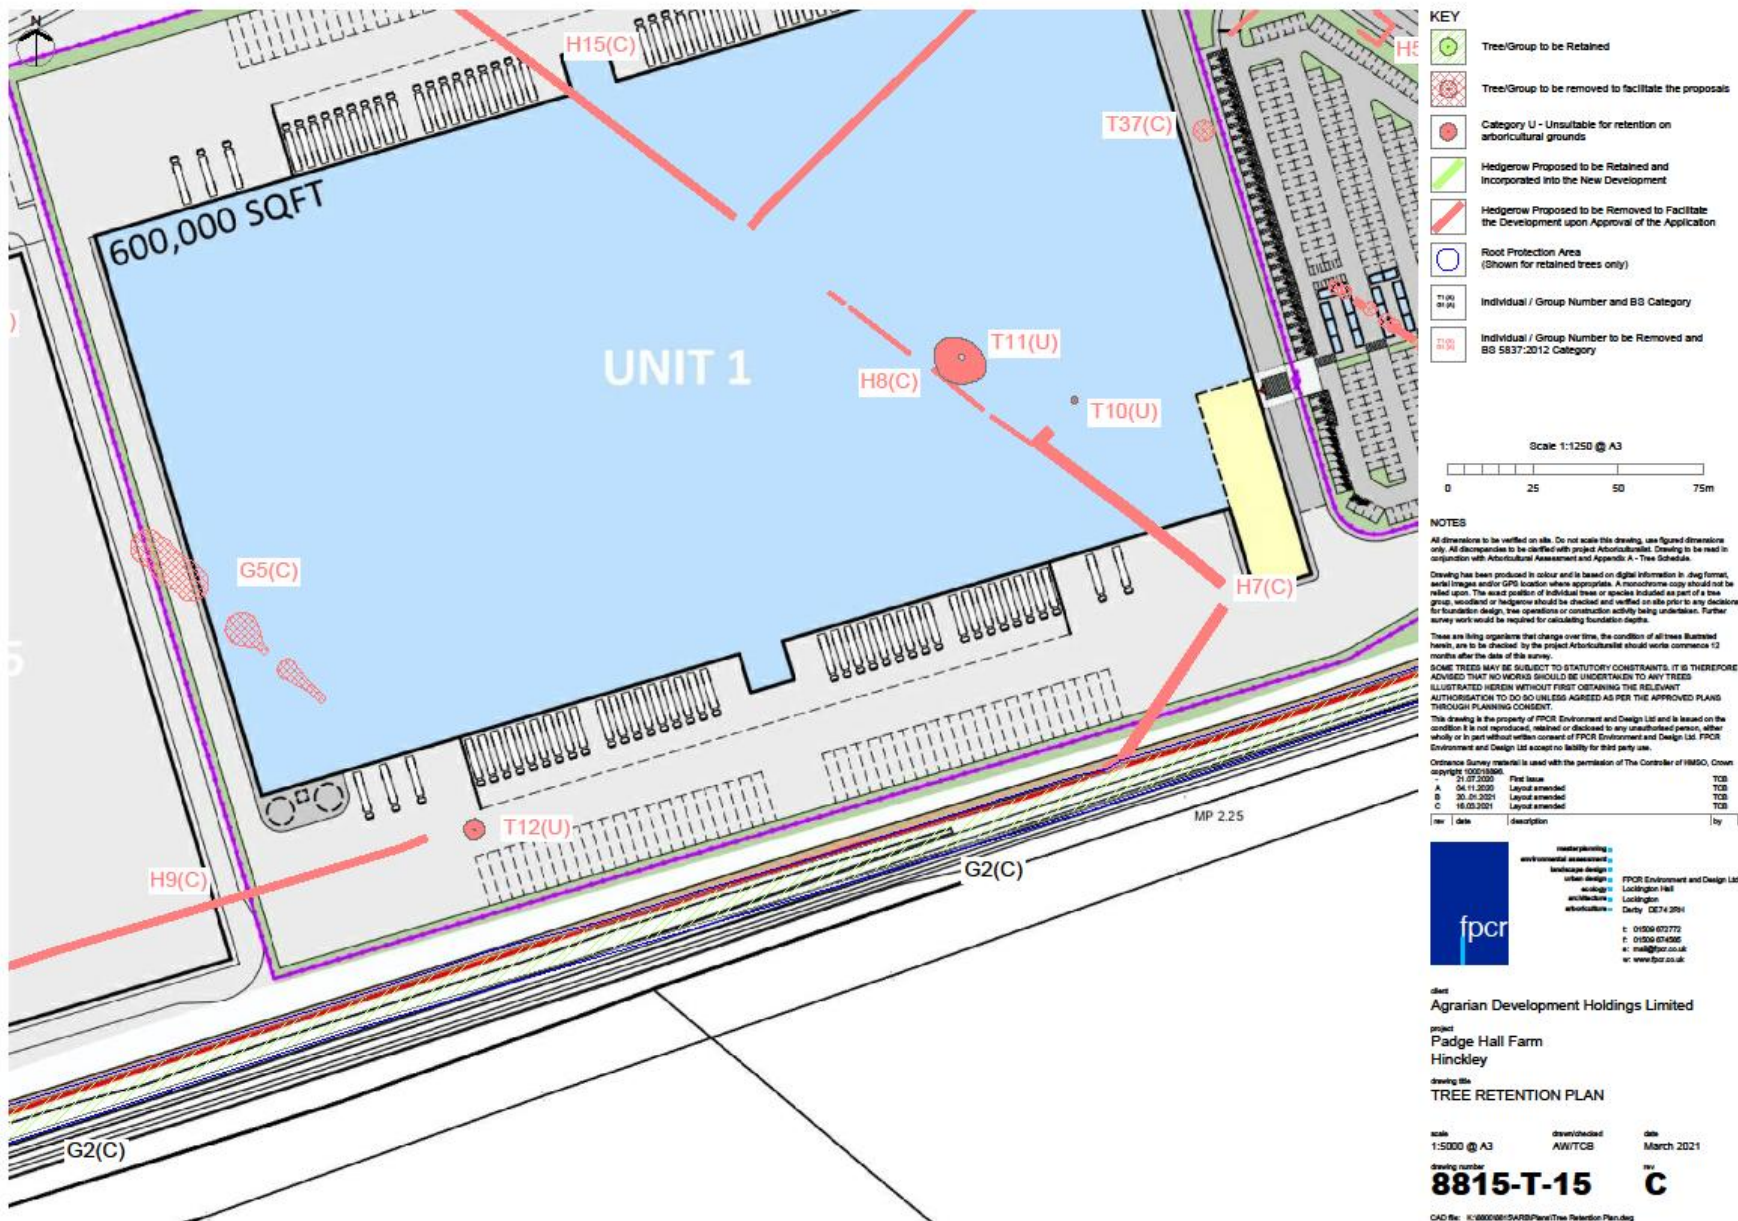
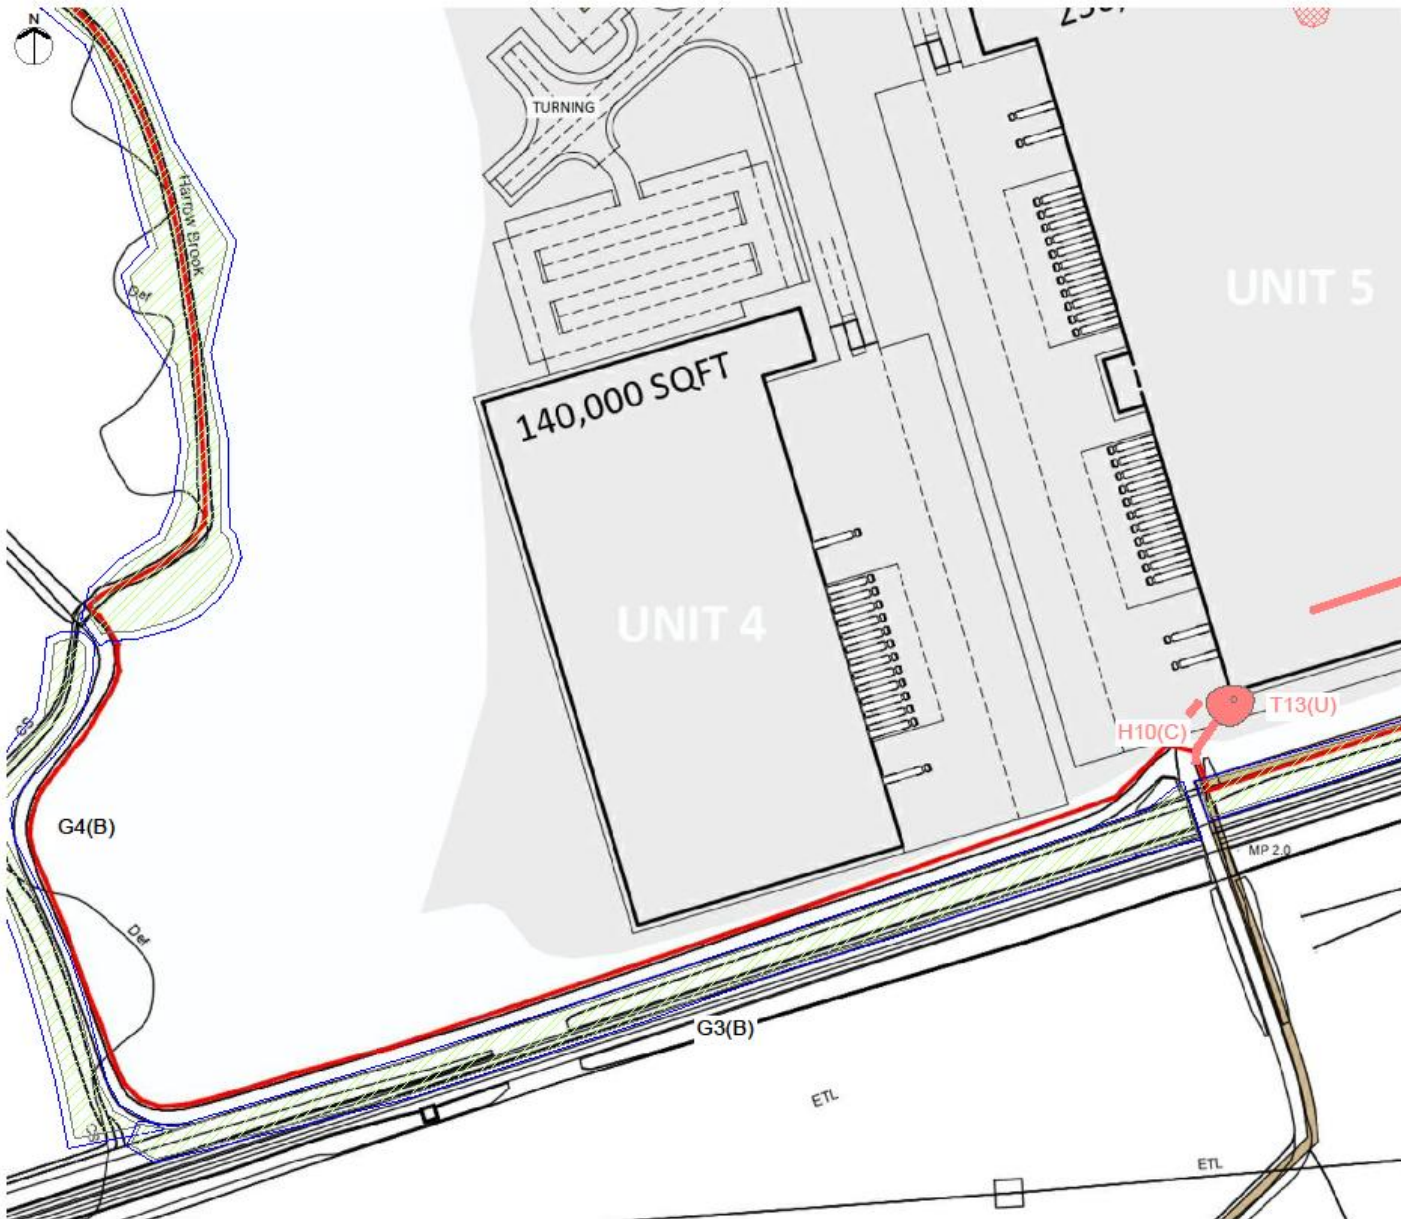
- KEY**
- Tree/Group to be Retained
  - Tree/Group to be removed to facilitate the proposals
  - Category U - Unsuitable for retention on arboricultural grounds
  - Hedgerow Proposed to be Retained and Incorporated into the New Development
  - Hedgerow Proposed to be Removed to Facilitate the Development upon Approval of the Application
  - Root Protection Area (Shown for retained trees only)
  - Individual / Group Number and BS Category
  - Individual / Group Number to be Removed and BS 5837:2012 Category
