# winvic

## Demolition, Construction Traffic and Environmental Management Plan (England & Wales)

Mountpark Hinckley (Padge Hall Farm) / E23-037

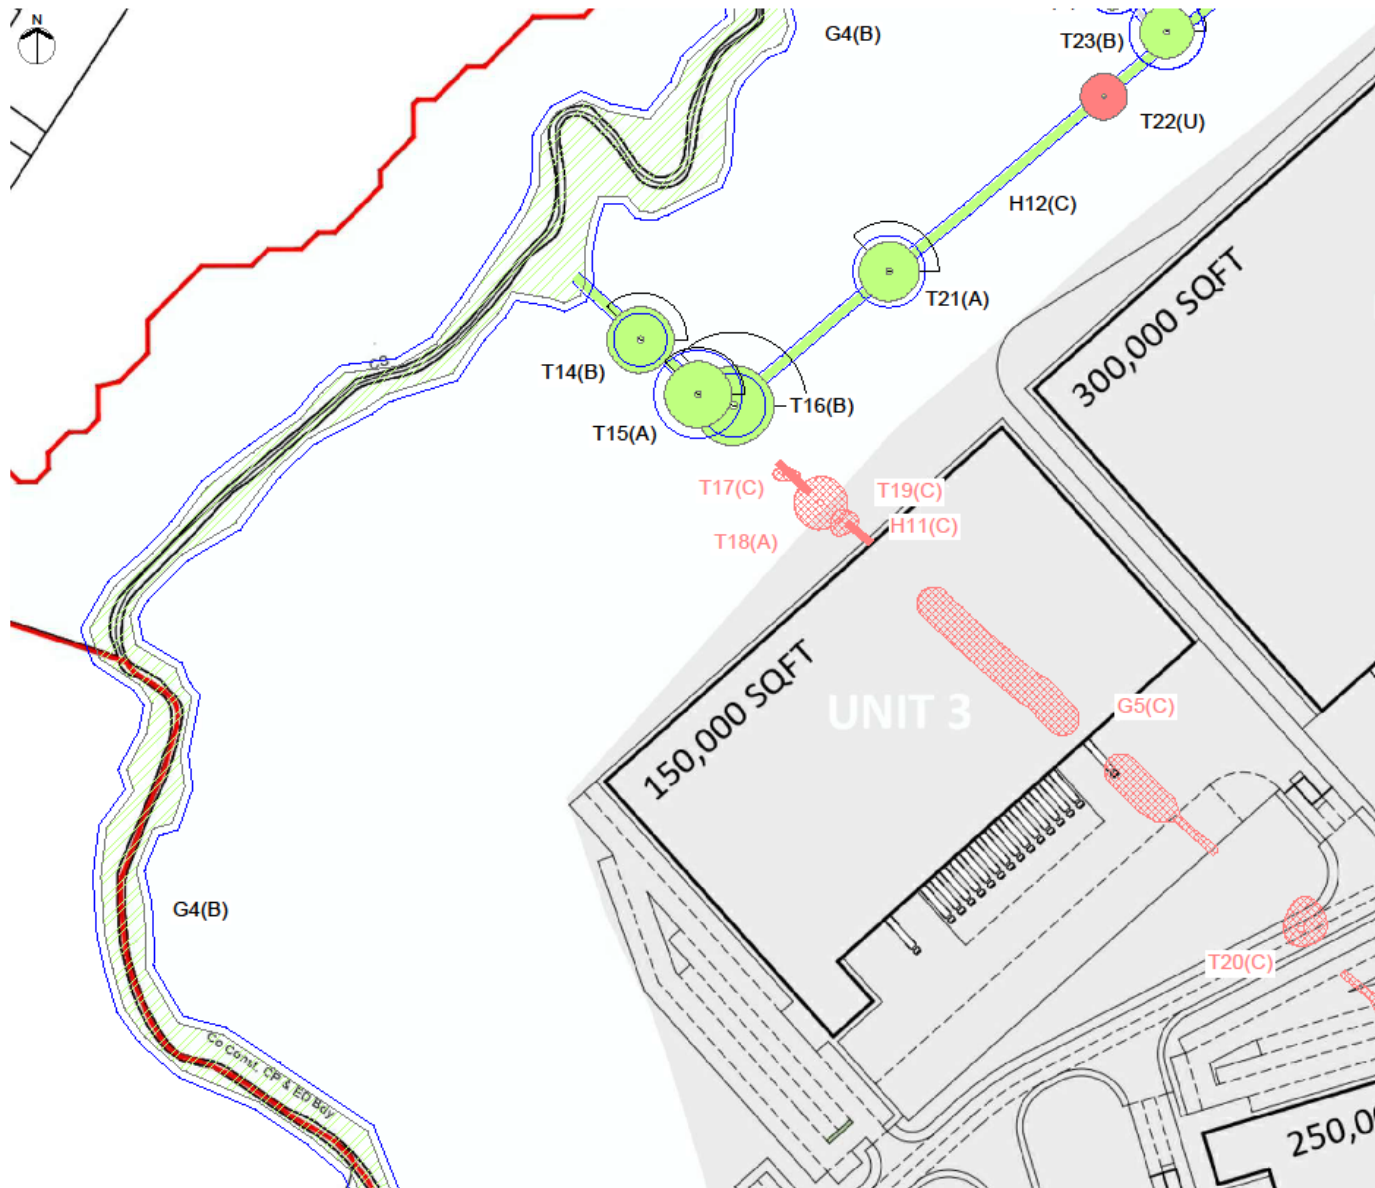
- KEY**
- Tree/Group to be Retained
  - Tree/Group to be removed to facilitate the proposals
  - Category U - Unsuitable for retention on arboricultural grounds
  - Hedgerow Proposed to be Retained and Incorporated into the New Development
  - Hedgerow Proposed to be Removed to Facilitate the Development upon Approval of the Application
  - Root Protection Area (Shown for retained trees only)
  - Individual / Group Number and BG Category
  - Individual / Group Number to be Removed and BG 5837:2012 Category

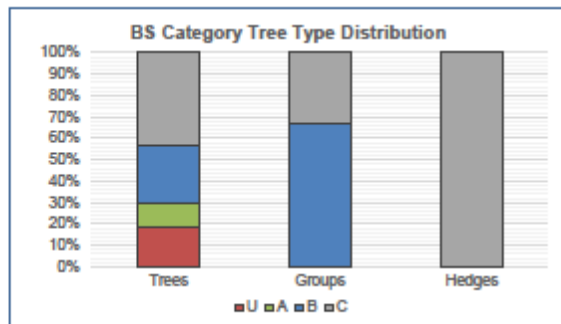
**BS Category Tree Type Distribution** displays the proportion of trees assessed in each type to enable a better understanding of the category distribution.

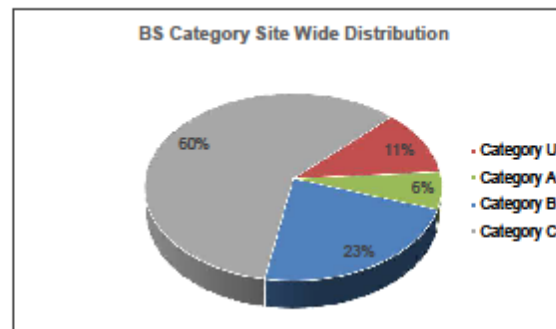
**BS Category Site Wide Distribution** shows the proportion of trees assessed in each category across the whole site which allows an interpretation of the site's overall quality.

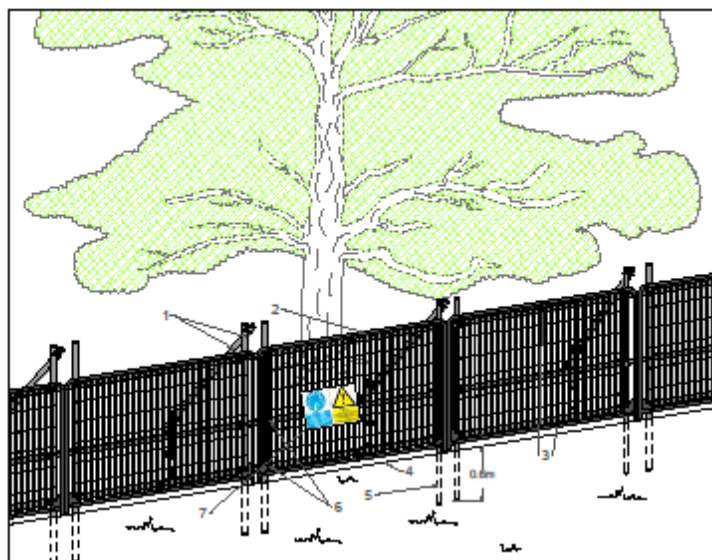
#### Standard specification for protective barrier

1. Standard scaffold poles
2. Heavy gauge 2m tall galvanized tube and welded mesh infill panels
3. Panels secured to scaffold frame with wire ties
4. Ground level
5. Uprights driven into the ground until secure (min depth of 0.6m)
6. Standard scaffold clamps
7. Construction Exclusion Zone signs

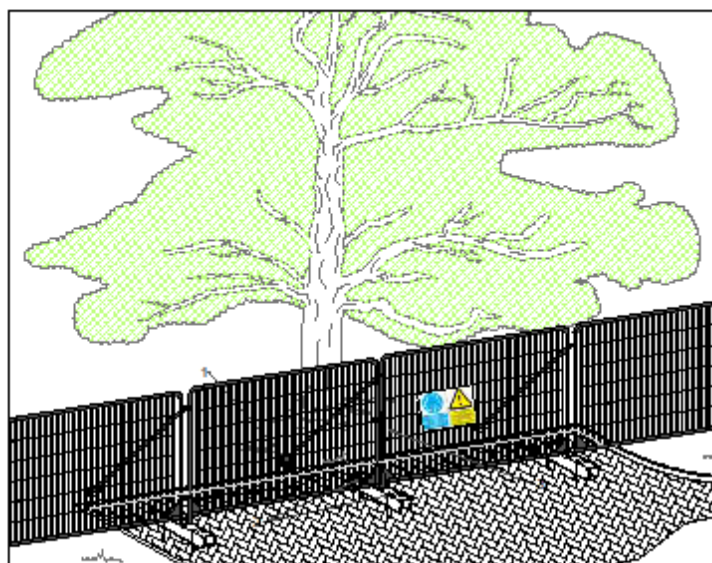
#### Above ground stabilising systems

1. Stabiliser strut with base plate secured with ground pins
2. Feet blocks secured with ground pins
3. Construction Exclusion Zone signs

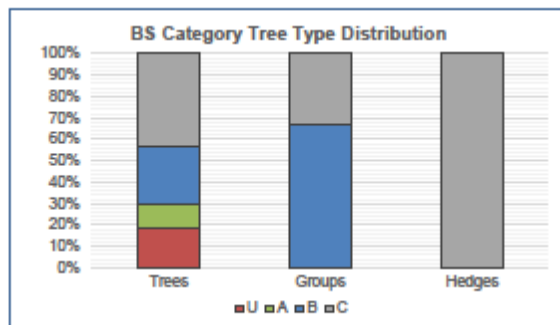
**BS Category Tree Type Distribution** displays the proportion of trees assessed in each type to enable a better understanding of the category distribution.

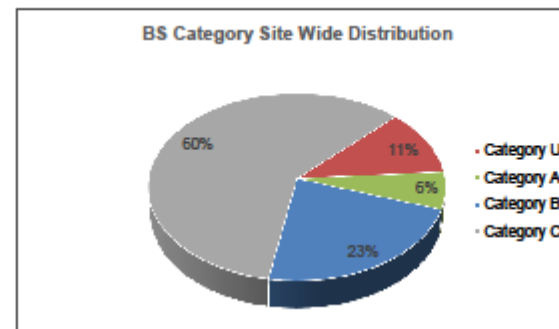
**BS Category Site Wide Distribution** shows the proportion of trees assessed in each category across the whole site which allows an interpretation of the site's overall quality.

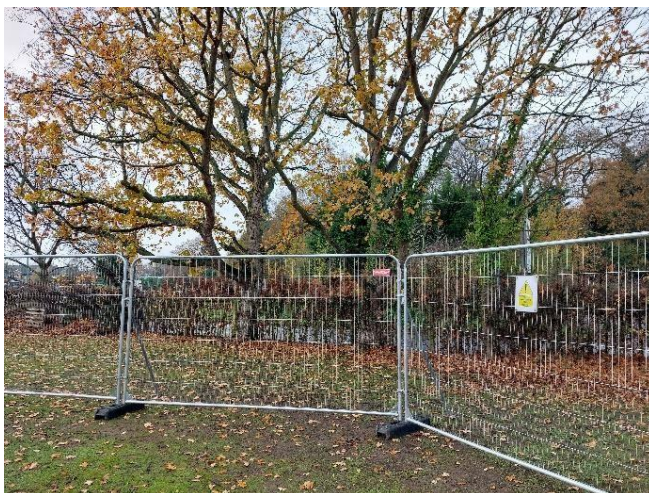
Photo 7: Heras fencing with base plate & sign. Strut (pinned)

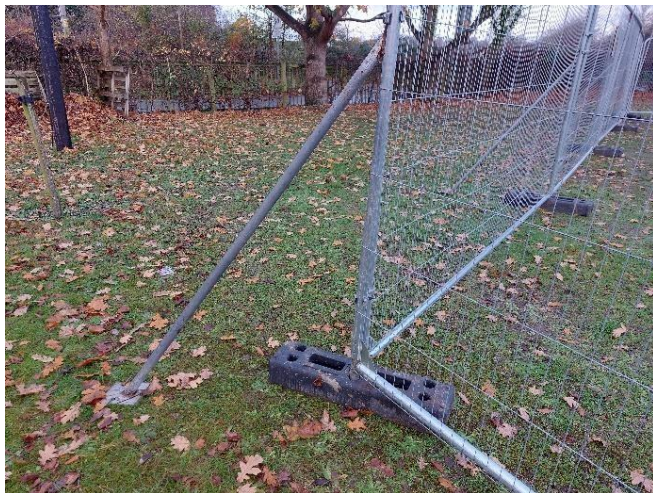
Photo 8: Block plat and stabilizer

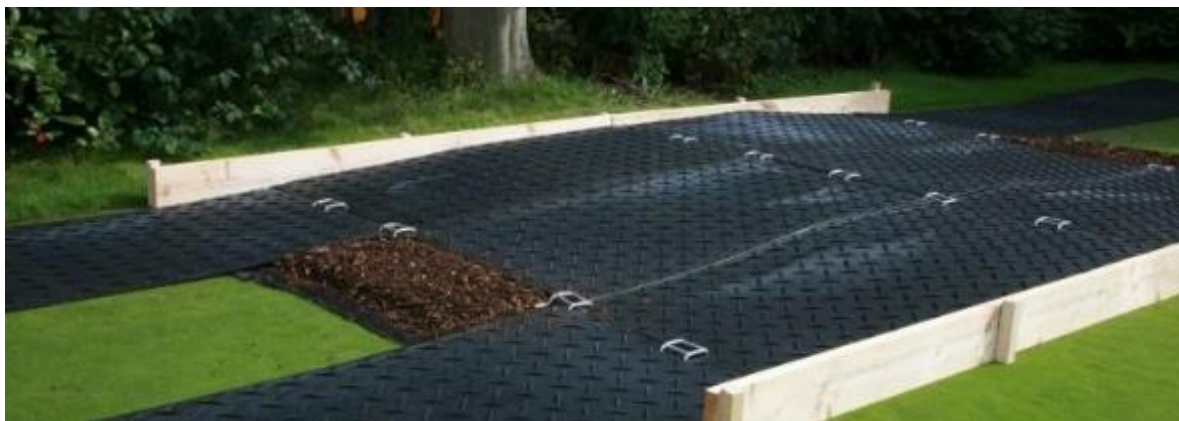
- *Pedestrian movements* – A single thickness of scaffold boards placed on top of a compression resistant layer, for example, 100mm depth of woodchip, laid onto a geotextile membrane.
- *Pedestrian operated machinery* (up to 2T gross weight) – inter linked ground protection boards placed on top of a compression resistant layer, for example 150mm depth of wood chip, laid on top of a geotextile membrane.
- *Wheeled or tracked construction traffic (exceeding 2T gross weight)* – Proprietary systems ([Brochure- Temporary-Ground-Protection.pdf \(geosyn.co.uk\)](#) or pre-cast reinforced concrete slabs to an engineering specification designed in conjunction with arboricultural advice, to accommodate the likely loading to which it will be subjected.

Image 1: Example of pedestrian operated machinery temporary ground protection

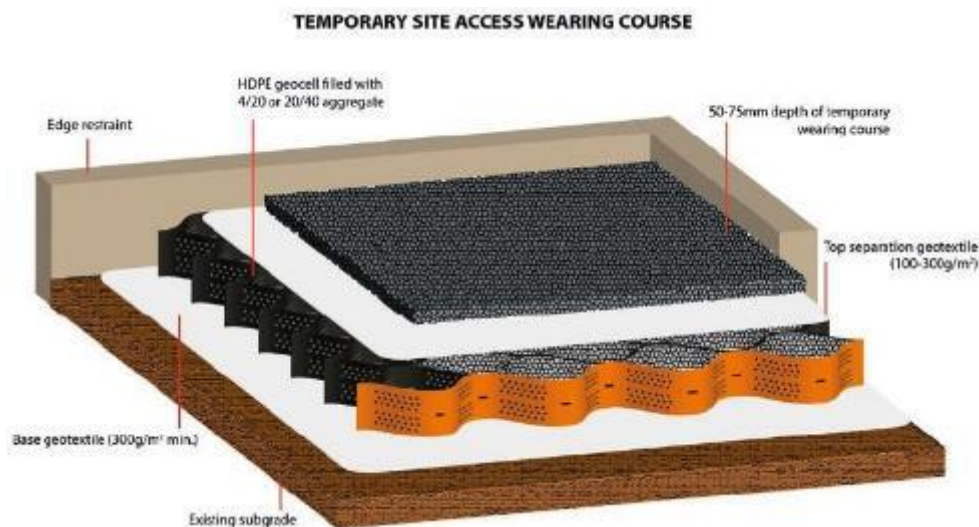
Image 2: Proprietary system – A geocell surface used during construction with a temporary hard wearing surface and a geotextile membrane to prevent mud from migrating down into infill (specifications and depths need to be confirmed by an engineer).

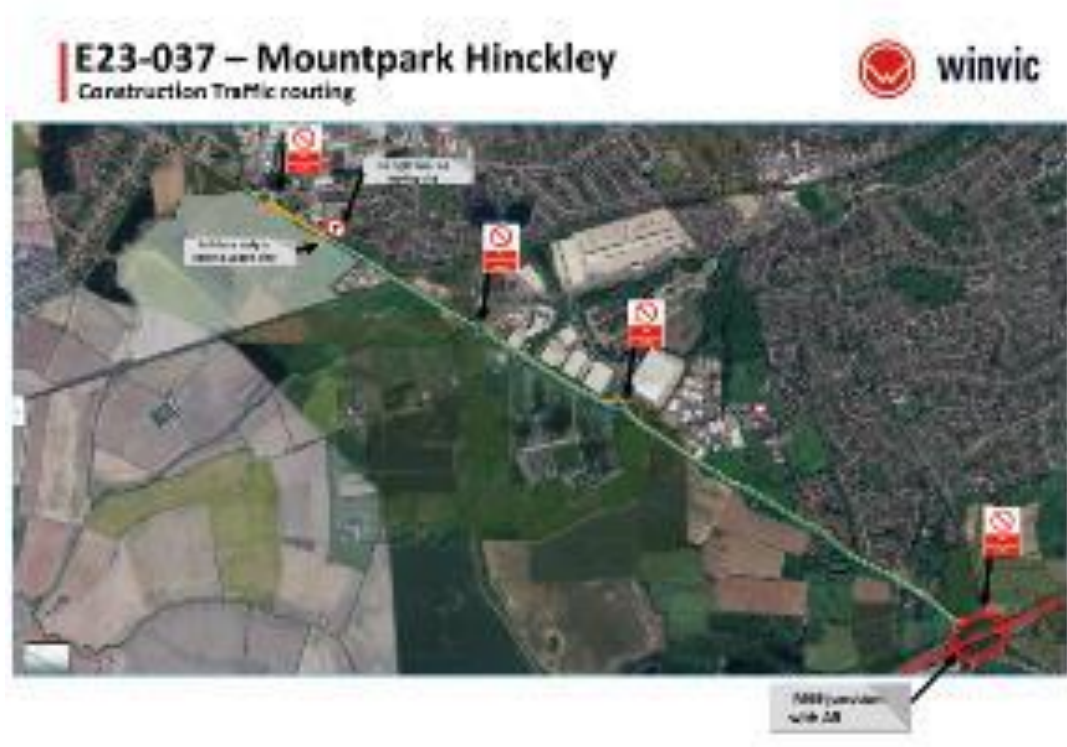
Below shows the routing of the traffic.
