# LANDSCAPE MANAGEMENT PLAN

**Jelson Ltd**

**Land at Lower Grange Farm – Phase 2**

**Markfield**

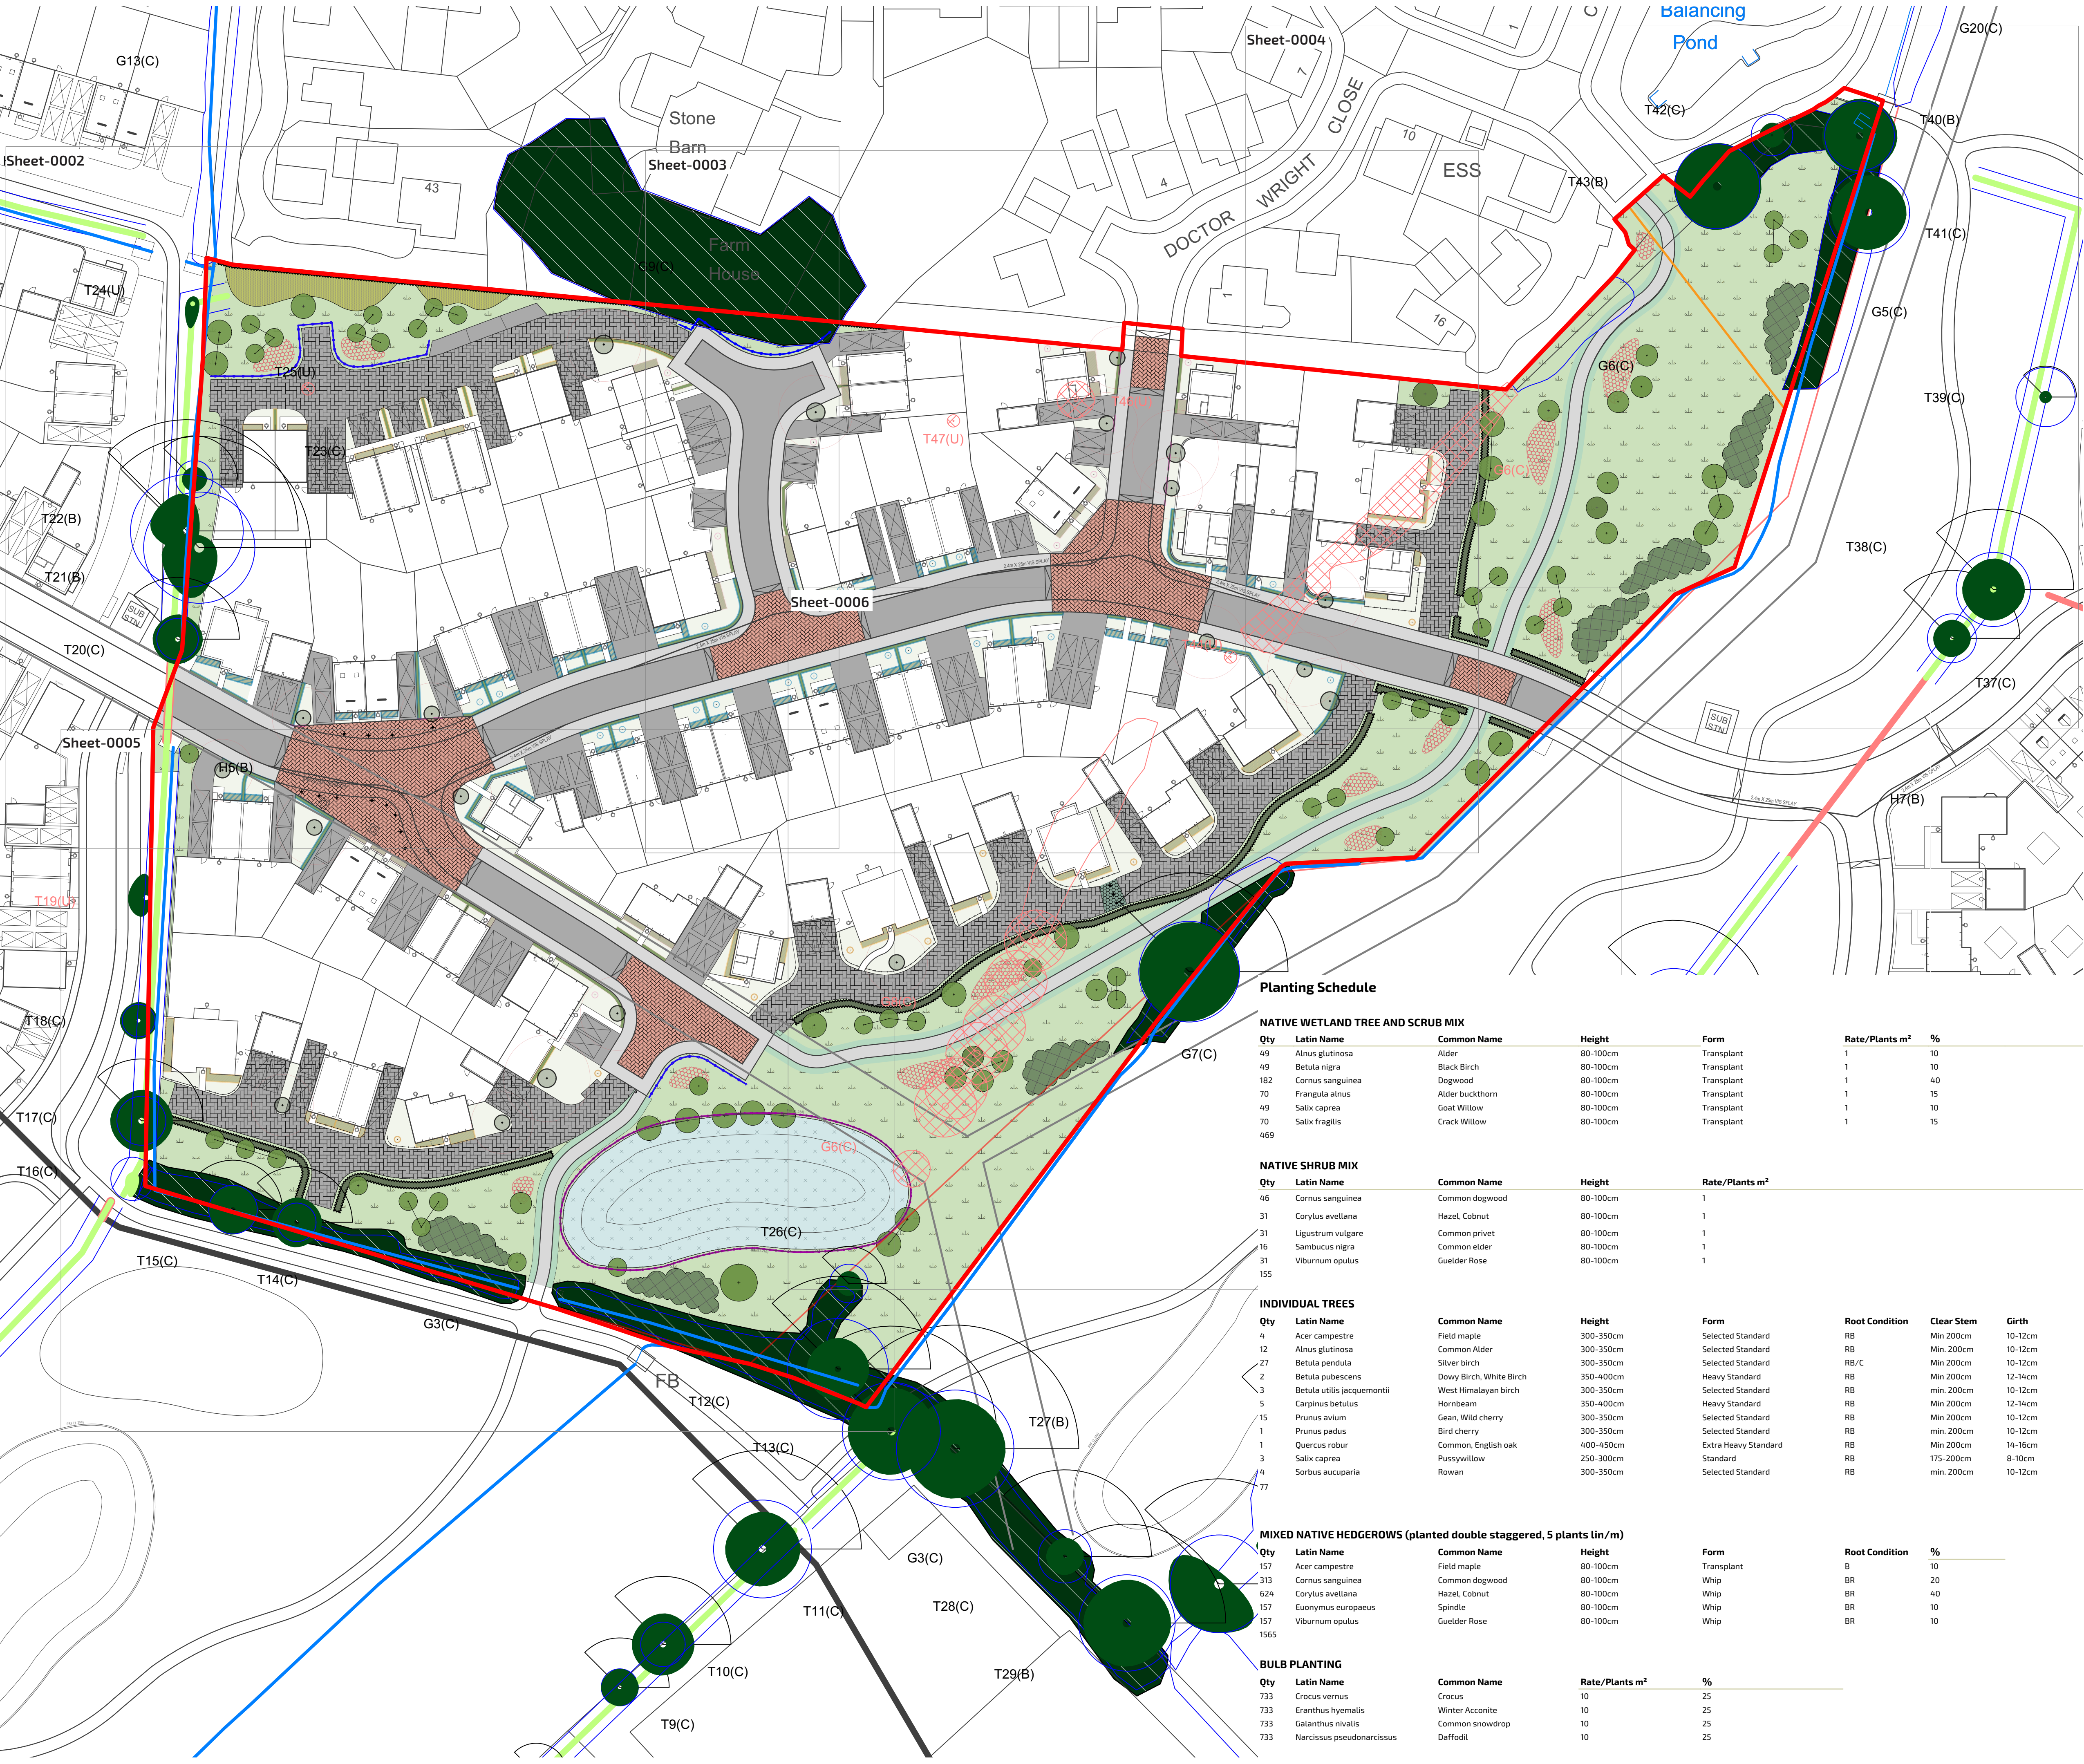
Planting Schedule

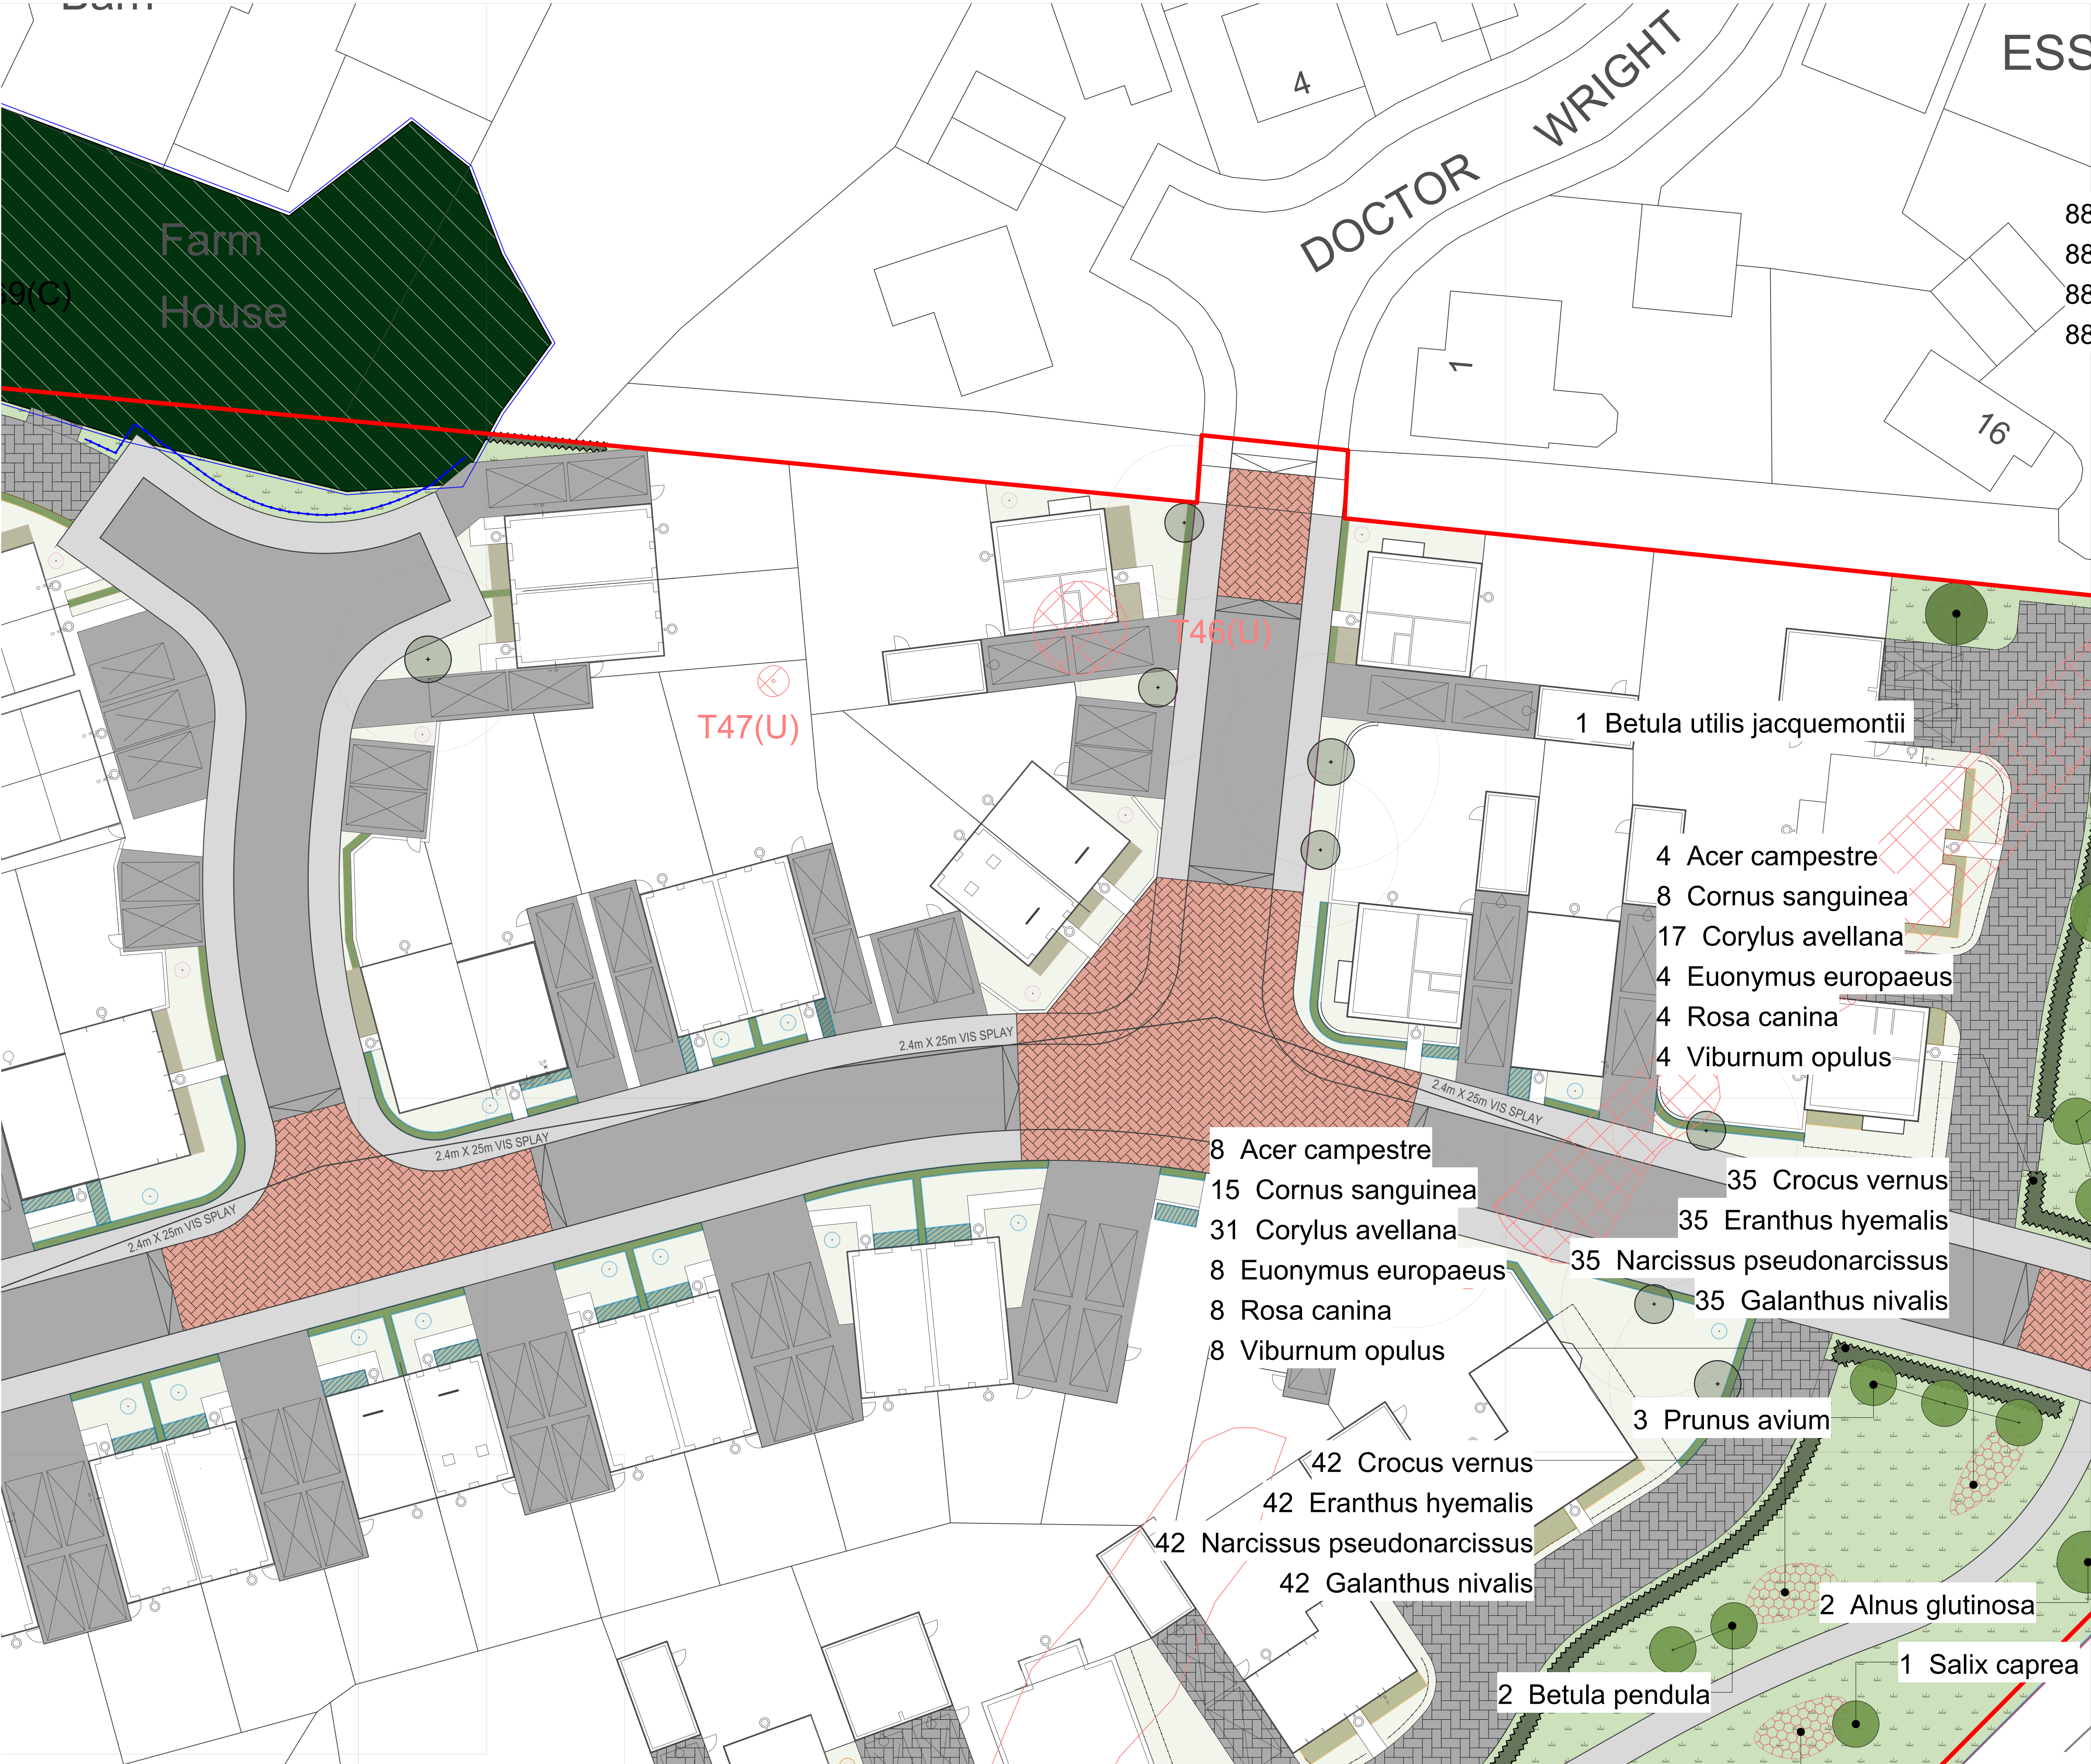
| title | | scale | |
|---|--|---|---|
| 6675-FPCR-ZZ-XX-DR-L-0003 | | S03 | P01 |

- Site Boundary
- Retained Existing Vegetation
- Retained Trees
- Removed Vegetation
- Native Shrub Mix
- Native Wetland Tree and Scrub Mix
- Amenity Grass  
(Emorsgate EG21 Fine Lawn Grass Mixture)
- Meadow Grassland  
(Emorsgate EM2 Standard General Purpose Meadow Mixture)
- Wetland Meadow Grassland Mix  
(Emorsgate EM8 - Meadow Mixture for Wetlands)
- Bulb Planting
- Proposed Trees
- Mixed Native Hedgerow
- Mown Grass Edges to Footpath  
(1m width)
- Easement
- HV Cable approx. line

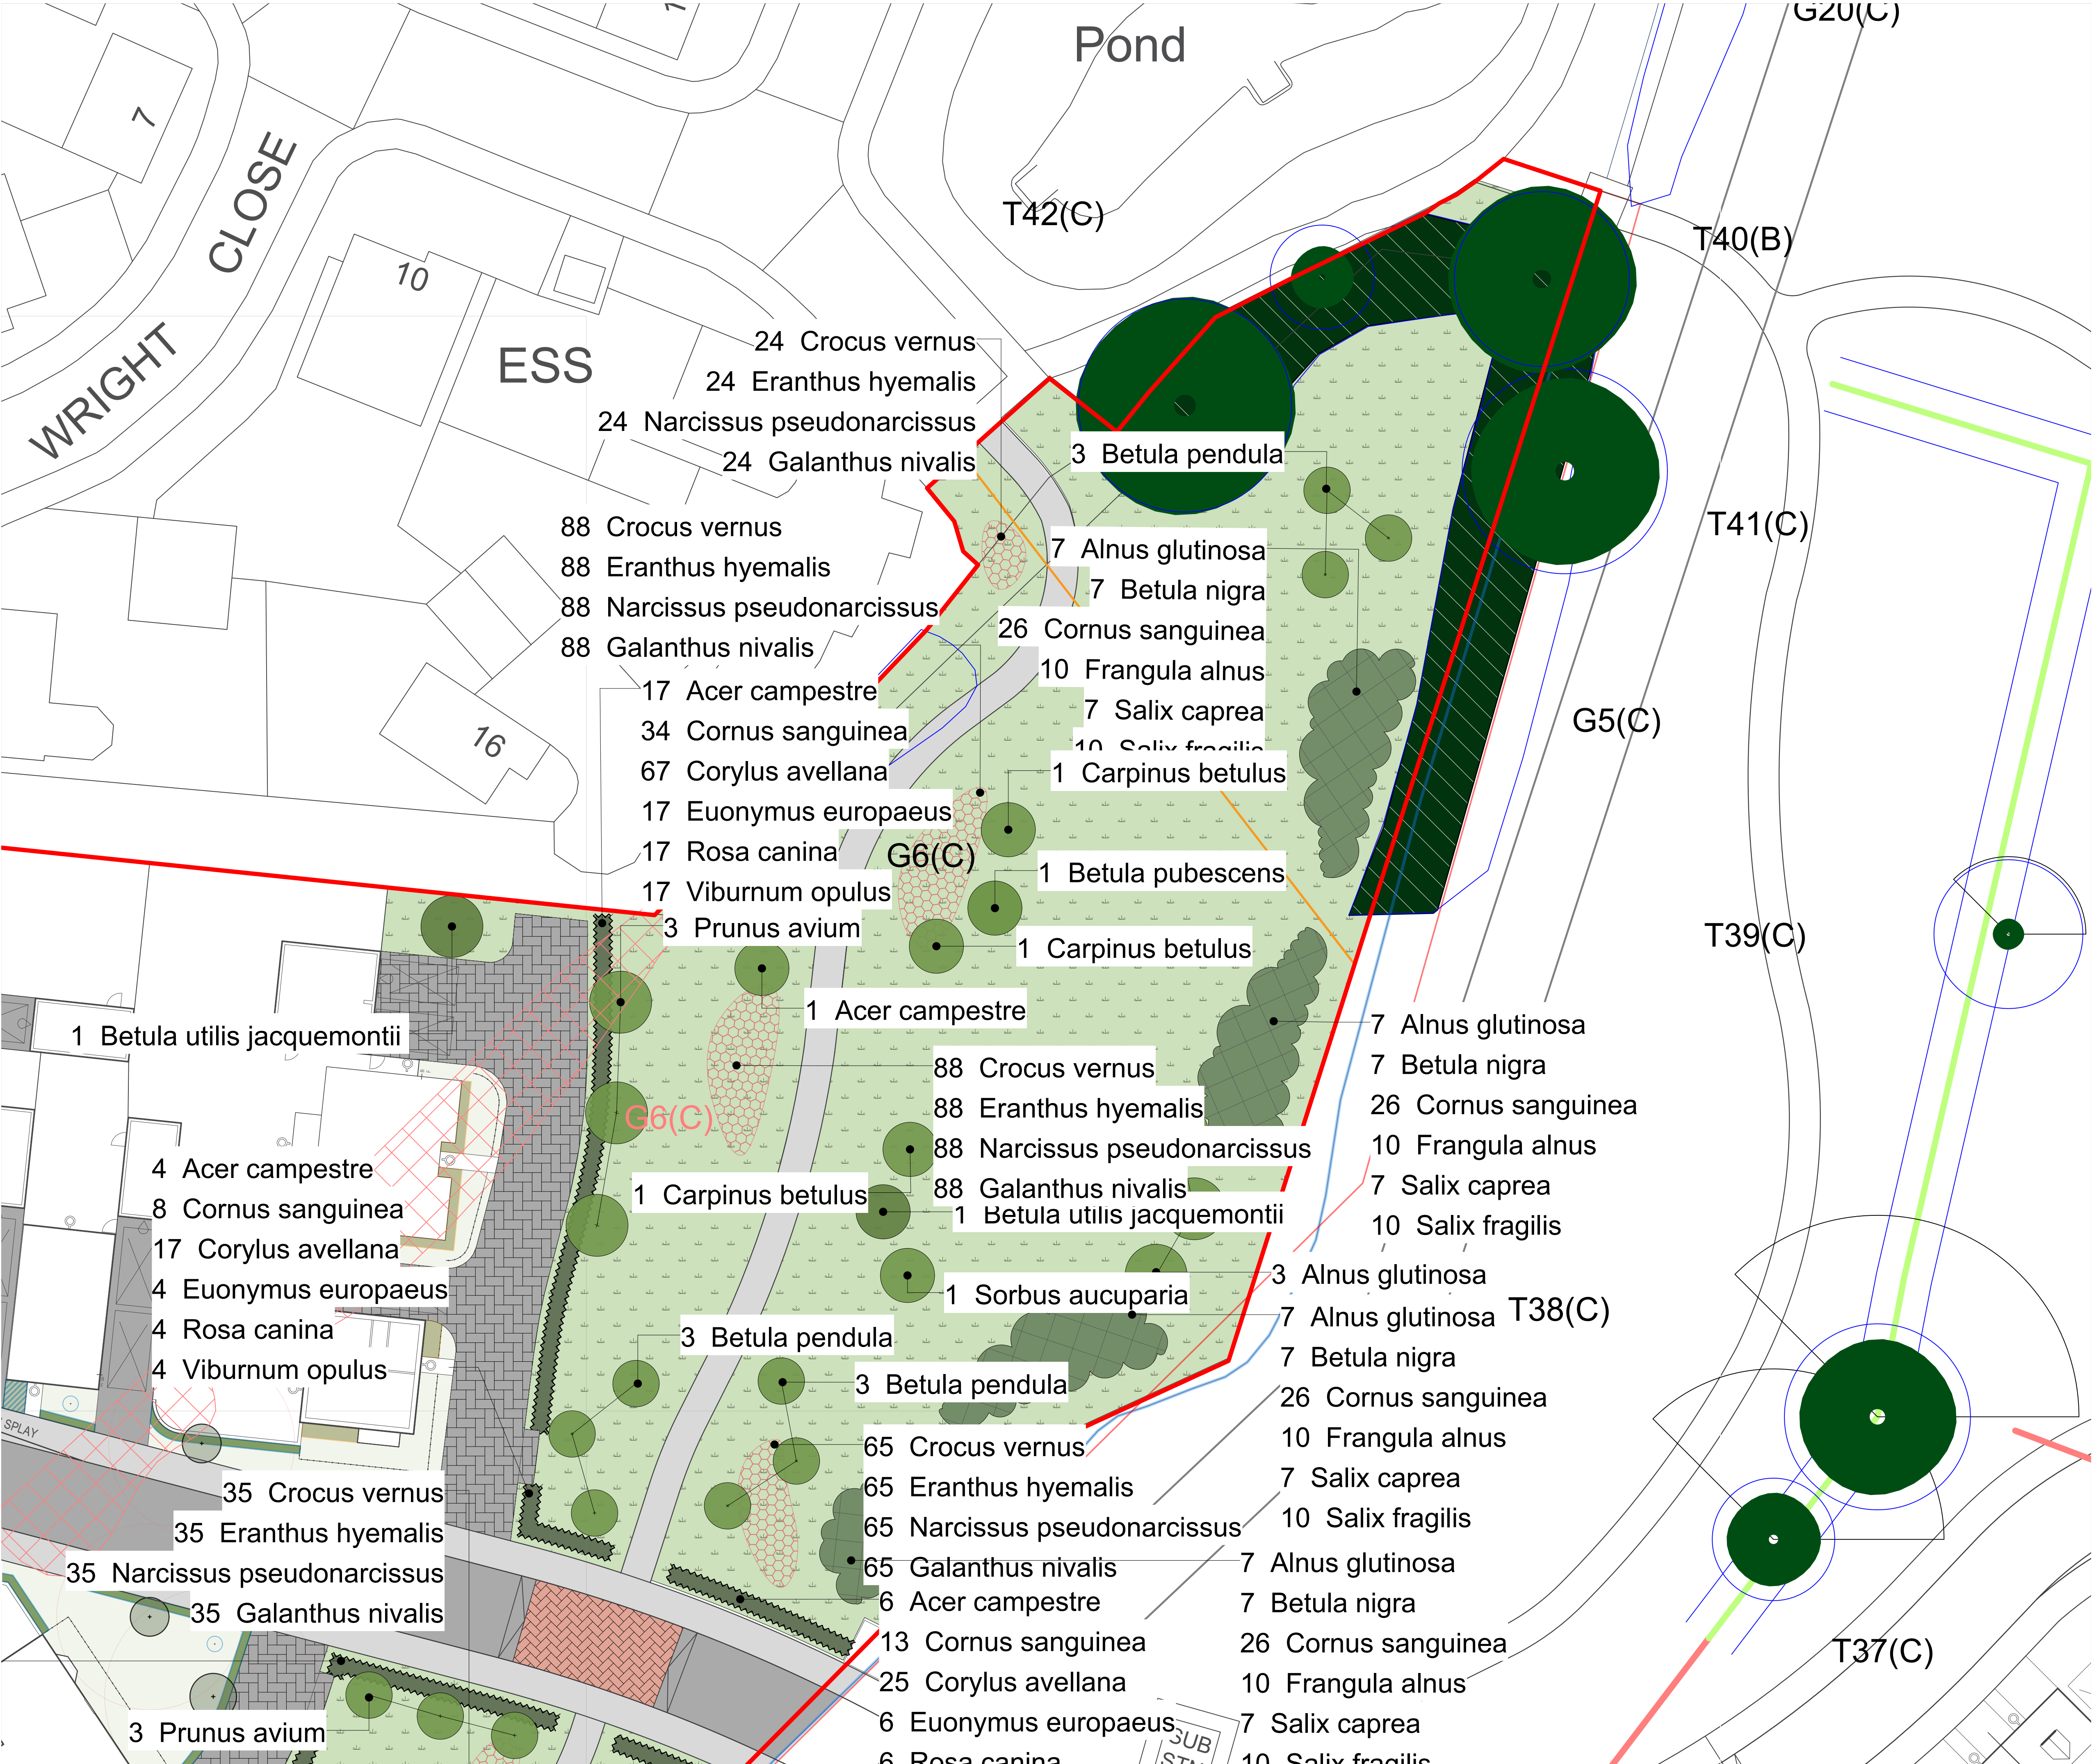
| title | scale | |
|---|---|---|
| 6675-FPCR-ZZ-XX-DR-L-0004 | S03 | P01 |

- Site Boundary
- Retained Existing Vegetation
- Retained Trees
- Removed Vegetation
- Native Shrub Mix
- Native Wetland Tree and Scrub Mix
- Amenity Grass (Emorsgate EG21 Fine Lawn Grass Mixture)
- Meadow Grassland (Emorsgate EM2 Standard General Purpose Meadow Mixture)
- Wetland Meadow Grassland Mix (Emorsgate EM8 - Meadow Mixture for Wetlands)
- Bulb Planting
- Proposed Trees
- Mixed Native Hedgerow
- Mown Grass Edges to Footpath (1m width)
- Easement
- HV Cable approx. line

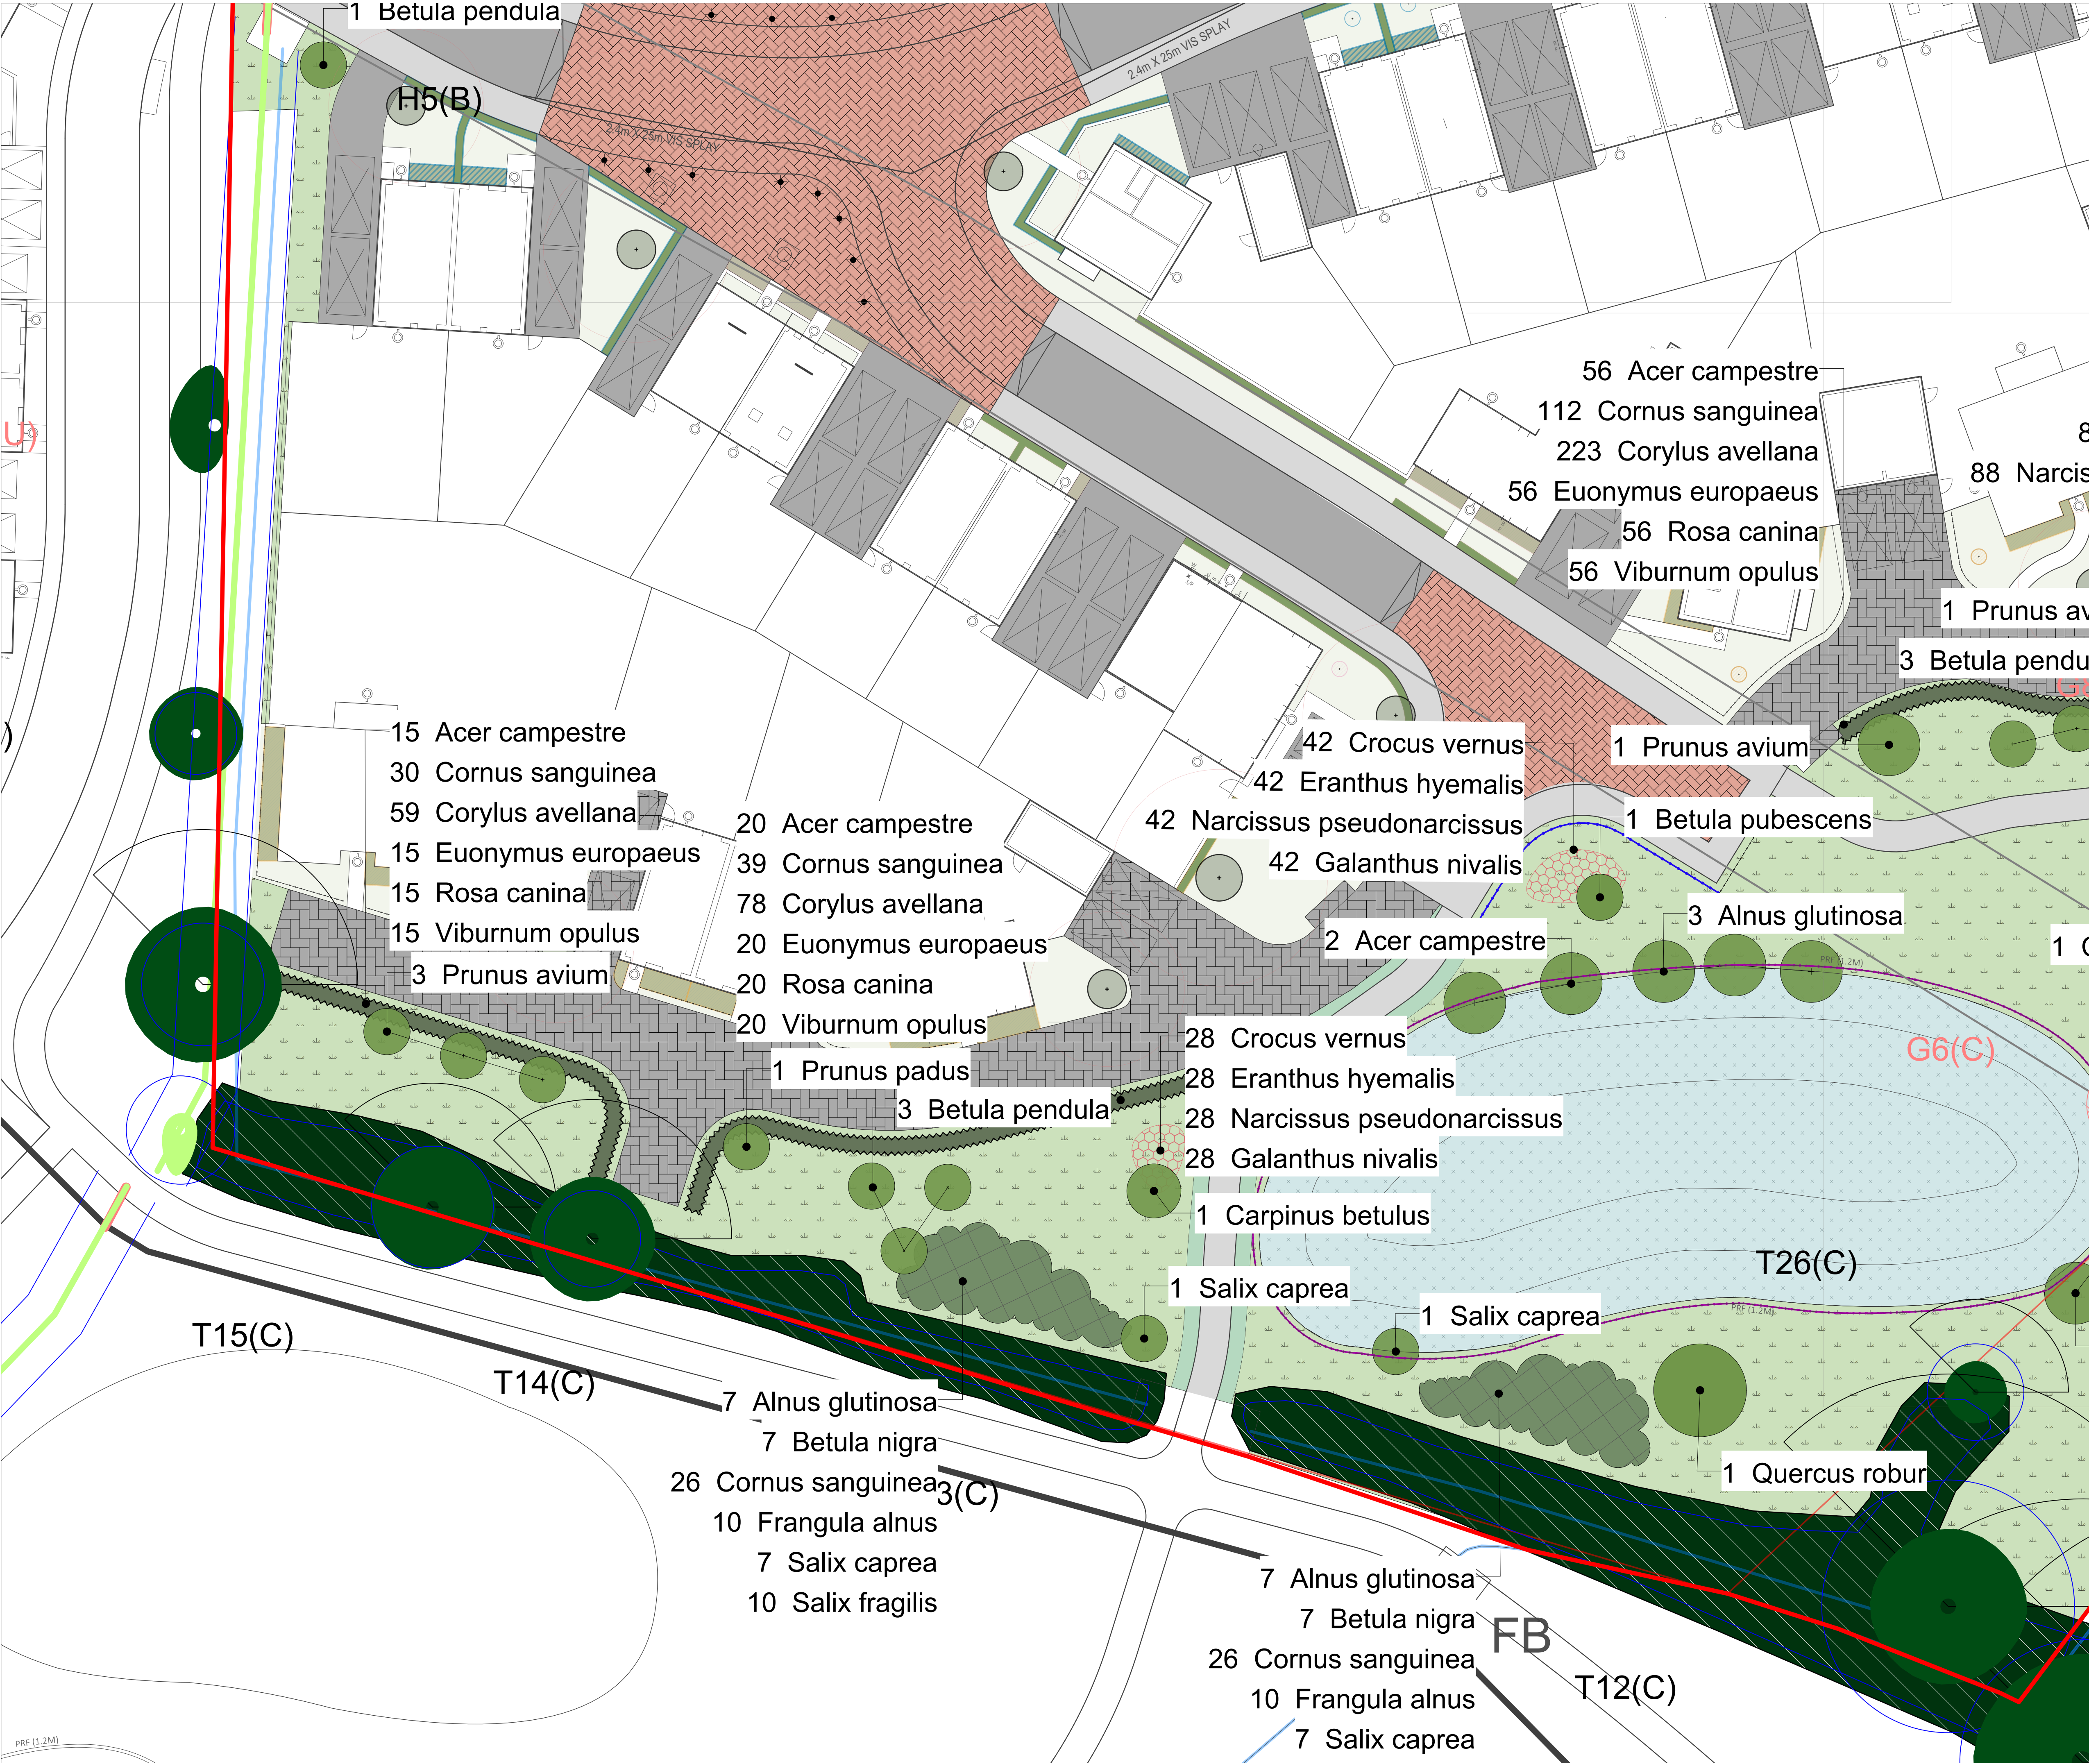
| title | | scale |
|---|---|---|
| 6675-FPCR-ZZ-XX-DR-L-0005 | S03 | P01 |

- Site Boundary
- Retained Existing Vegetation
- Retained Trees
- Removed Vegetation
- Native Shrub Mix
- Native Wetland Tree and Scrub Mix
- Amenity Grass (Enorsgate EG21 Fine Lawn Grass Mixture)
- Meadow Grassland (Enorsgate EM2 Standard General Purpose Meadow Mixture)
- Wetland Meadow Grassland Mix (Enorsgate EM8 - Meadow Mixture for Wetlands)
- Bulb Planting
- Proposed Trees
- Mixed Native Hedgerow
- Mown Grass Edges to Footpath (1m width)
- Easement
- HV Cable approx. line

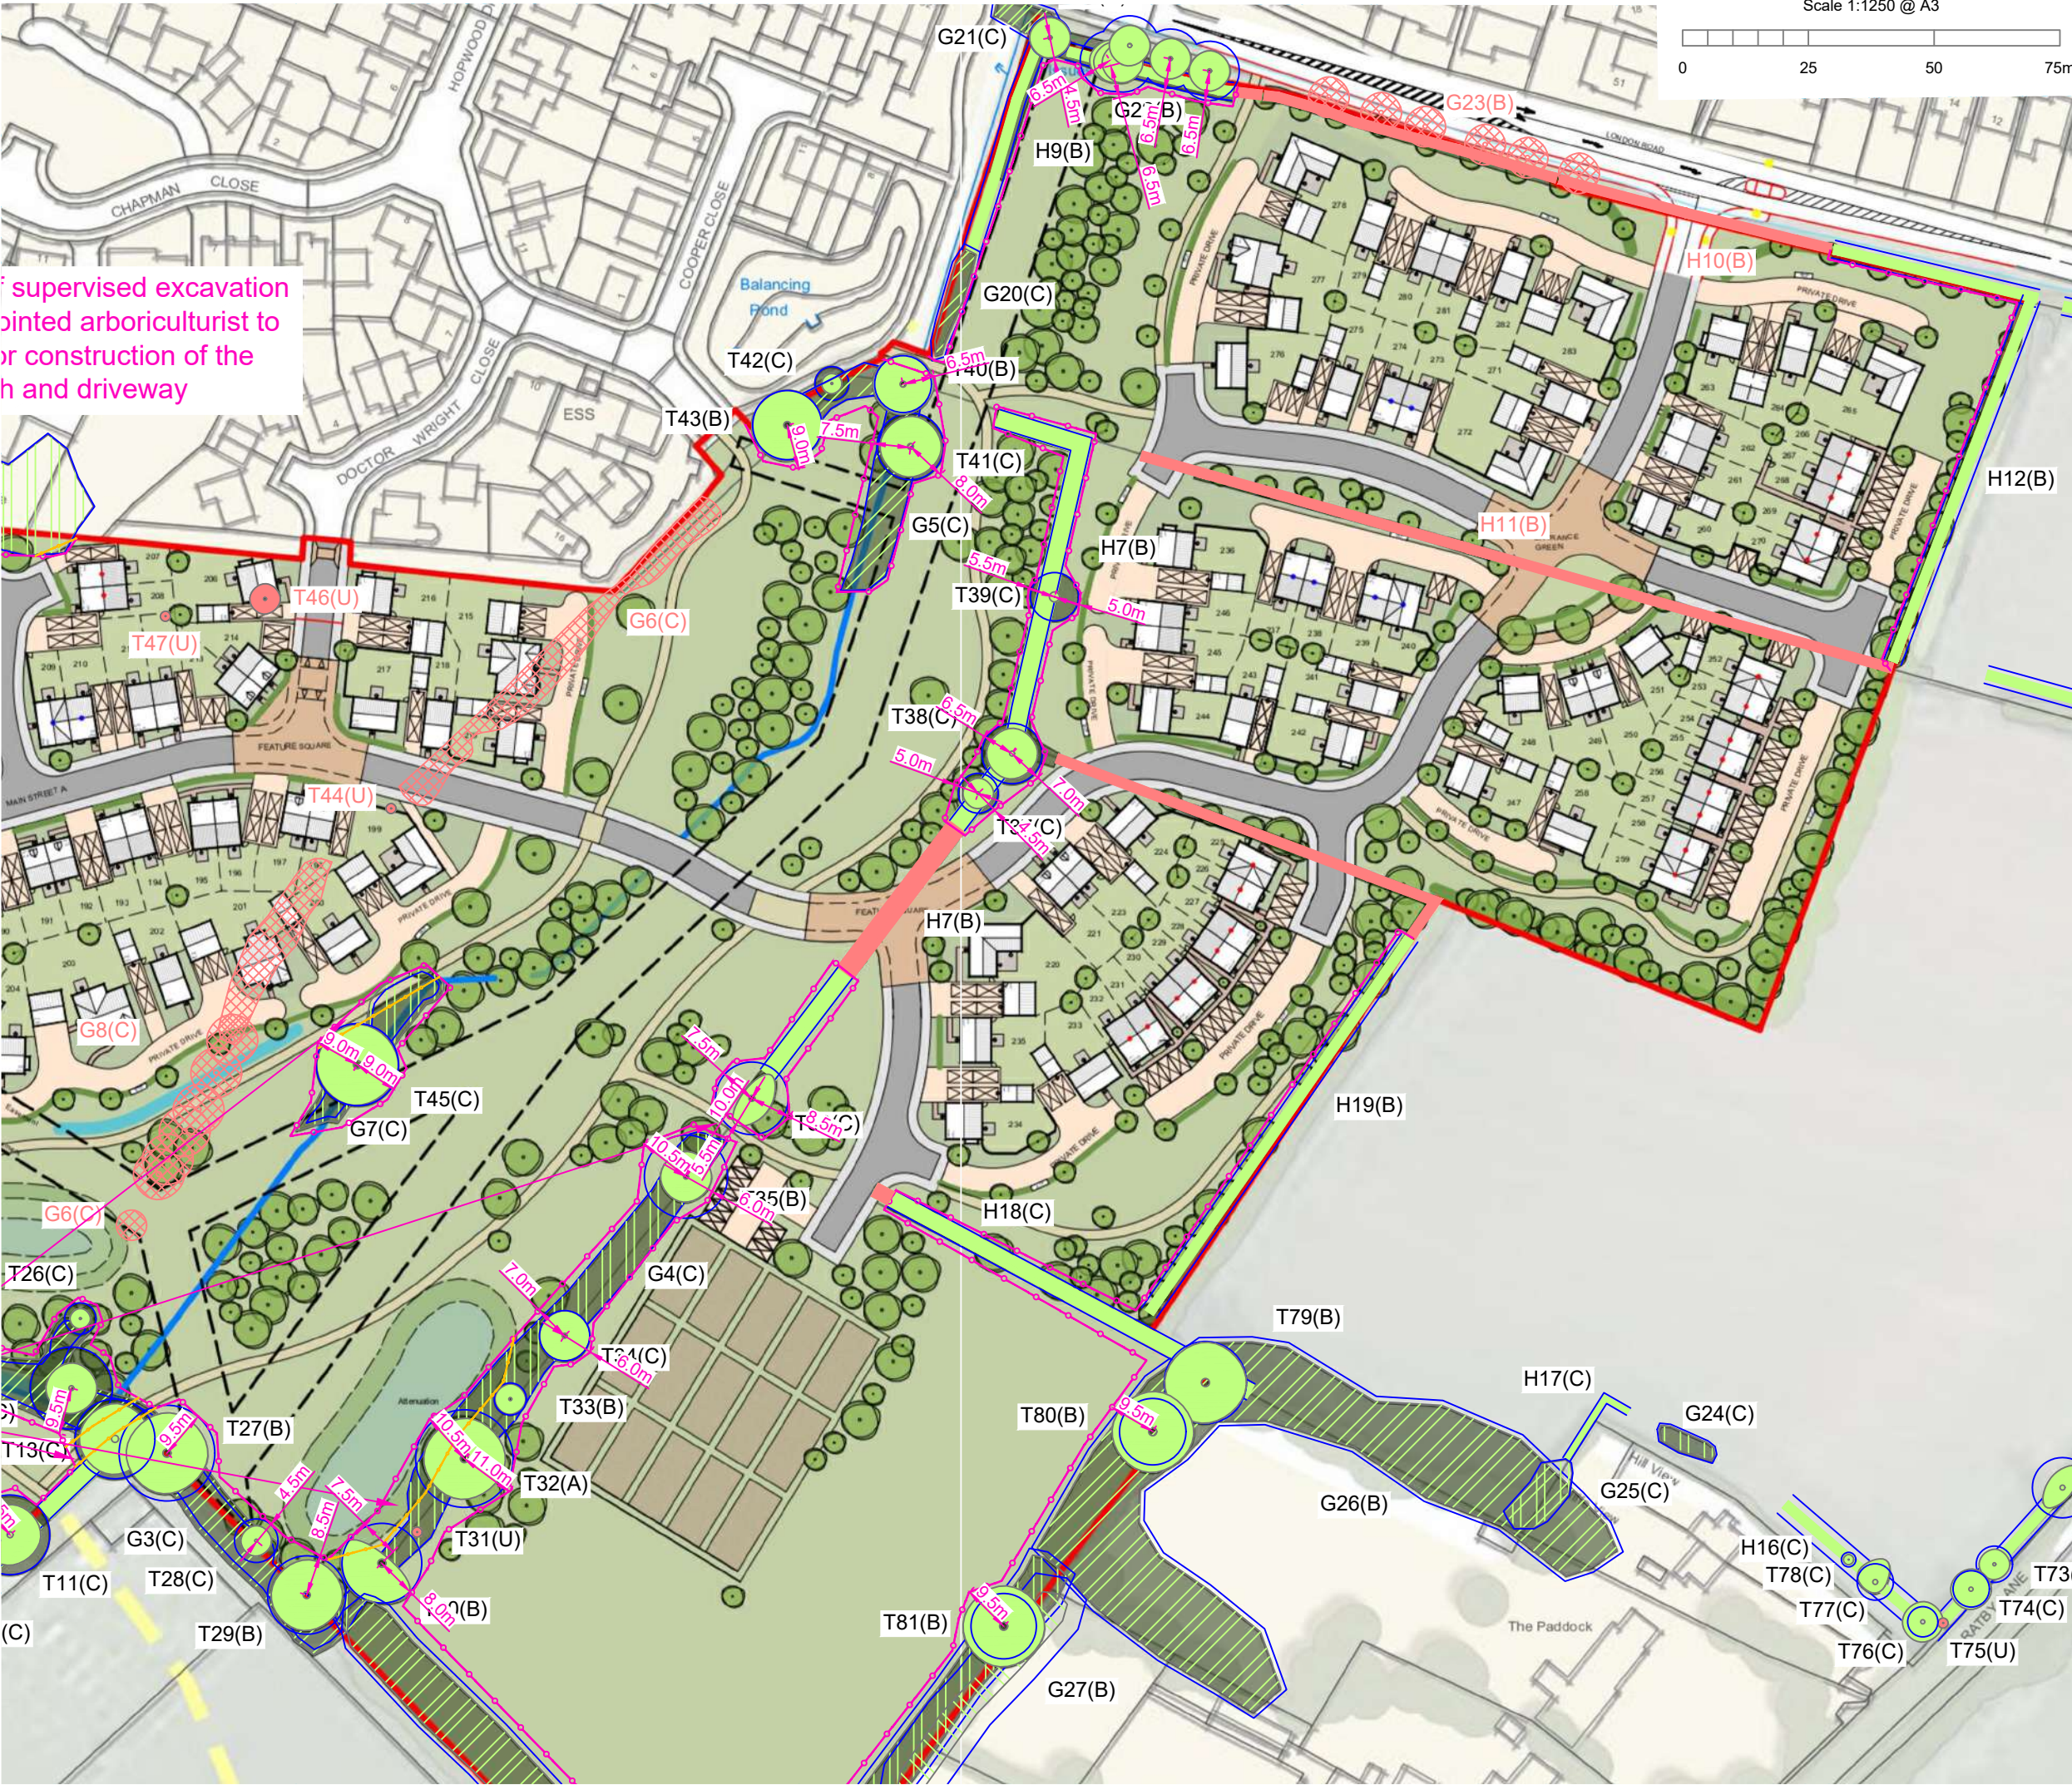
drawing number  
**6675-TPP-02 -**

supervised excavation  
jointed arboriculturist to  
or construction of the  
h and driveway

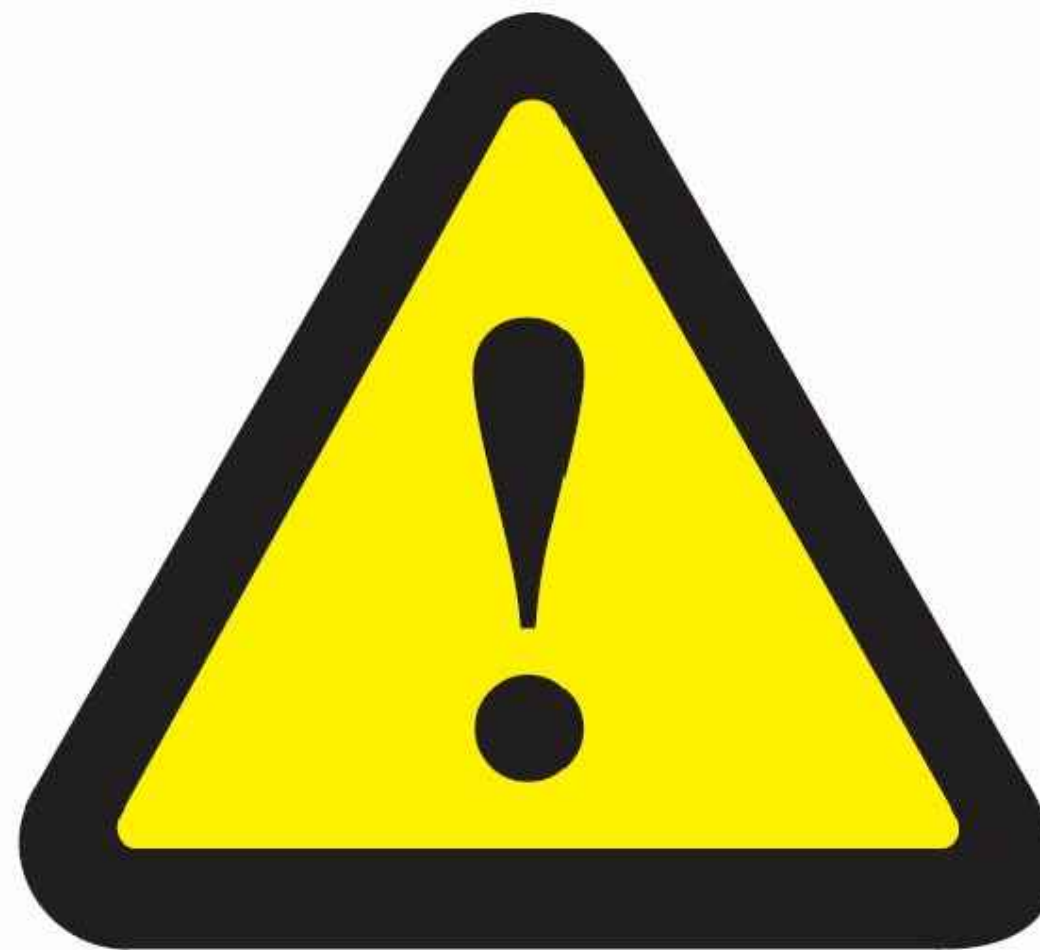
**PROTECTIVE FENCING. THIS FENCING MUST BE MAINTAINED IN ACCORDANCE WITH THE APPROVED PLANS AND DRAWINGS FOR THIS DEVELOPMENT.**

**TREE PROTECTION AREA  
KEEP OUT !**  
(TOWN & COUNTRY PLANNING ACT 1990)  
TREES ENCLOSED BY THIS FENCE ARE PROTECTED BY PLANNING CONDITIONS AND/OR ARE THE SUBJECTS OF A TREE PRESERVATION ORDER.  
CONTRAVENTION OF A TREE PRESERVATION ORDER MAY LEAD TO CRIMINAL PROSECUTION  
ANY INCURSION INTO THE PROTECTED AREA MUST BE WITH THE WRITTEN PERMISSION OF THE LOCAL PLANNING AUTHORITY

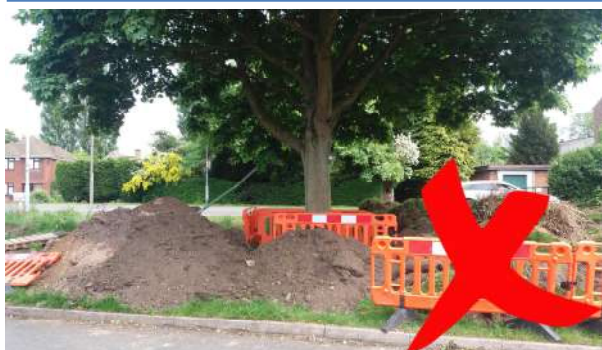
**Unacceptable** example of tree protection due to a lack of adequate fencing and poor site management. Note mounds of soil have been placed within the Root Protection Area.

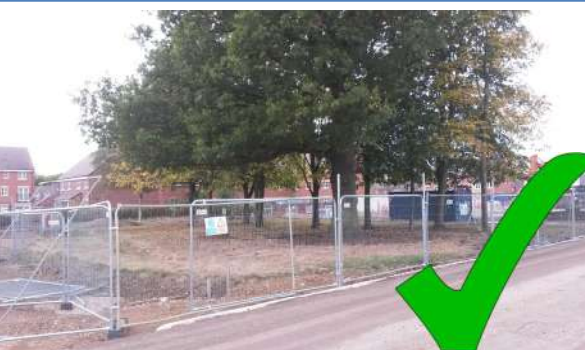
Tree Protection Fencing which has been erected prior to the commencement of any site works and the correct signage has been provided to clearly highlight that this is a protected zone.
