Geotechnical &  
Environmental  
Consultants

Station Road  
Earl Shilton

**Combined Phase I and Phase II Exploratory Investigation  
For  
Colin Burton Builders Ltd**

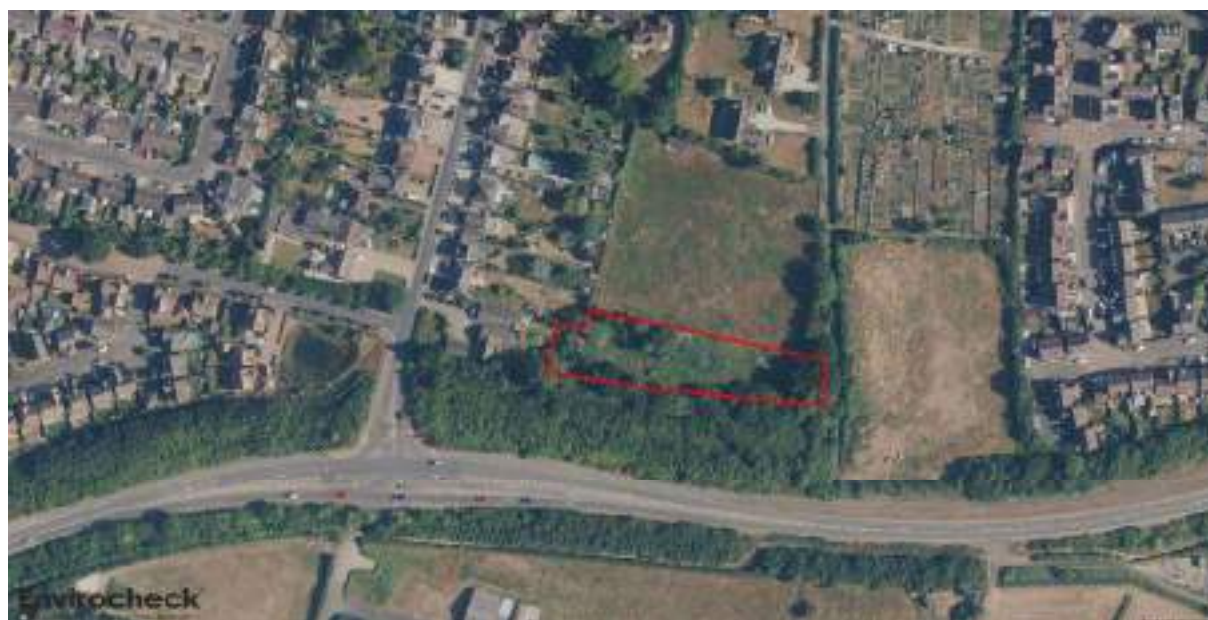
**Figure 1: 2023 Aerial Photograph (site demarcated in red).**

Figure 1 below shows the site in context in a 2023 aerial photograph. At the time of our site visit the field to the immediate north of site was being developed with residential properties.

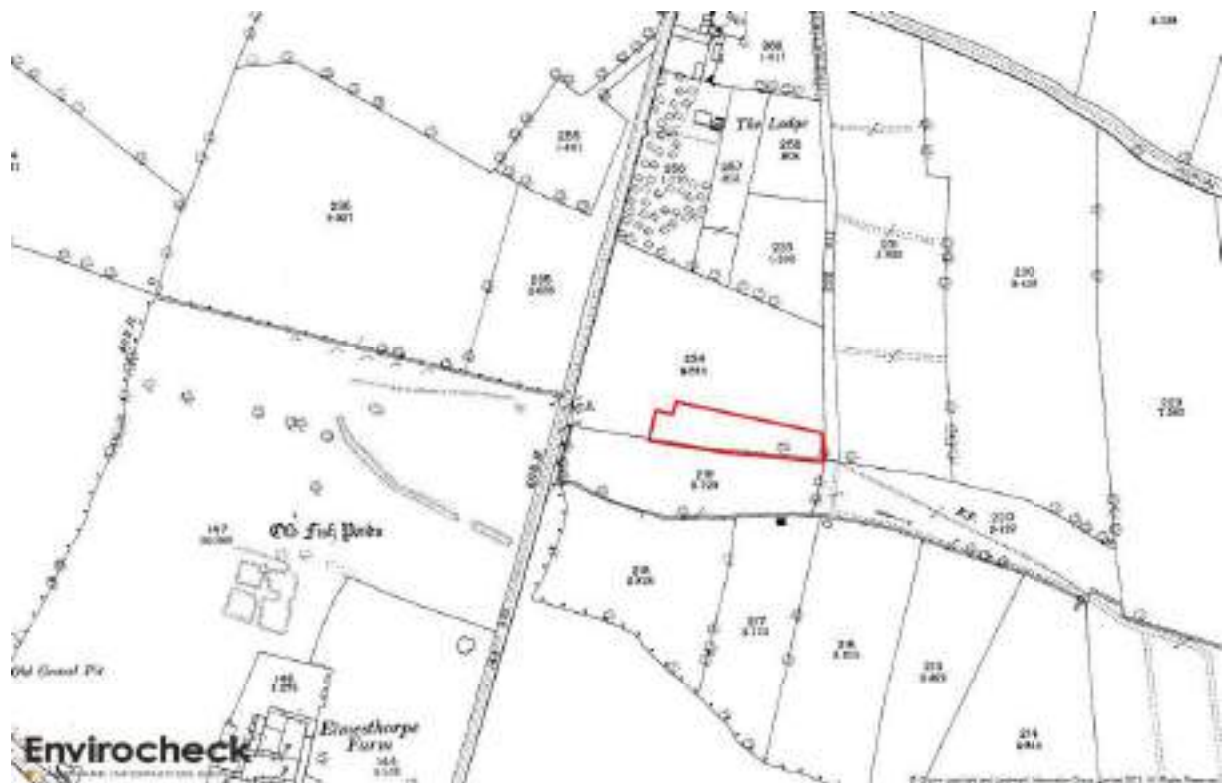
Figure 2: 1888 historical mapping (site demarcated in red).

Figures 2 to 5 below have been produced from Landmark Envirocheck Analysis software and show the progressive development of the site and surrounding area.

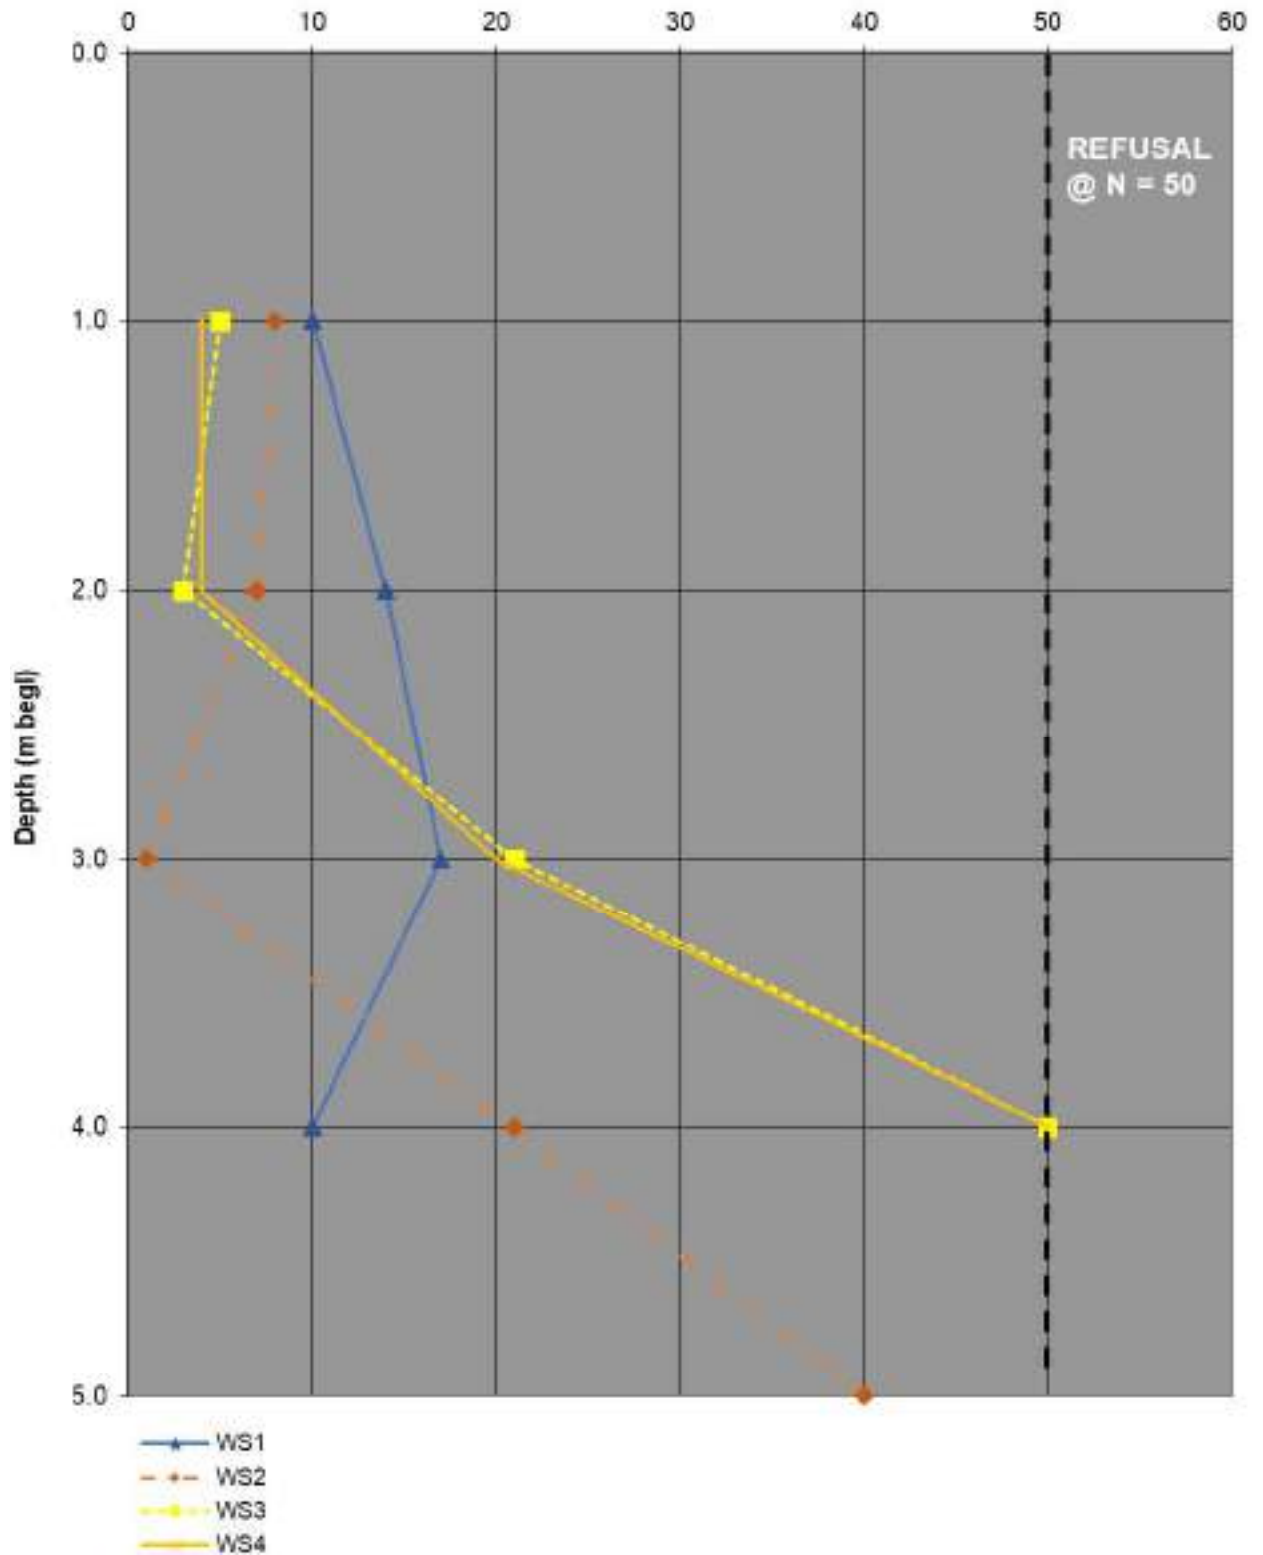
**Chart 43207/01**  
**Station Road, Earl Shilton**  
 SPT N Values Vs Depth (m begl)  
 SPT N (Uncorrected)

SPT test results are included in the chart on the following page.

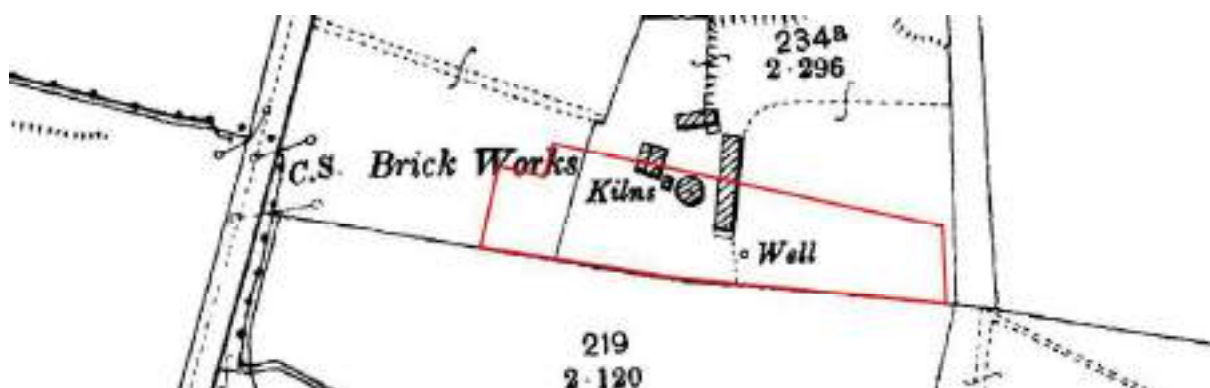
**Figure 6: Detail of 1903 Historical Map Data showing the former Brick Works buildings and the on-site well**

Historical mapping from 1903 and 1904 shows buildings associated with the former brick works in the north of the site and a well near the centre of the site. Figure 6 below is an extract from the 1903 historical map with the positions of the brick works buildings and the well indicated.

The well was not shown to be present after 1916 suggesting that it may have been filled or capped. No evidence of the well was found during our site investigation works but there is potential for the well to be present within the site.

The circular building shown on the 1903 map (see Figure 6 above) persists on maps until 1938, the other brickworks buildings were not recorded after 1916.

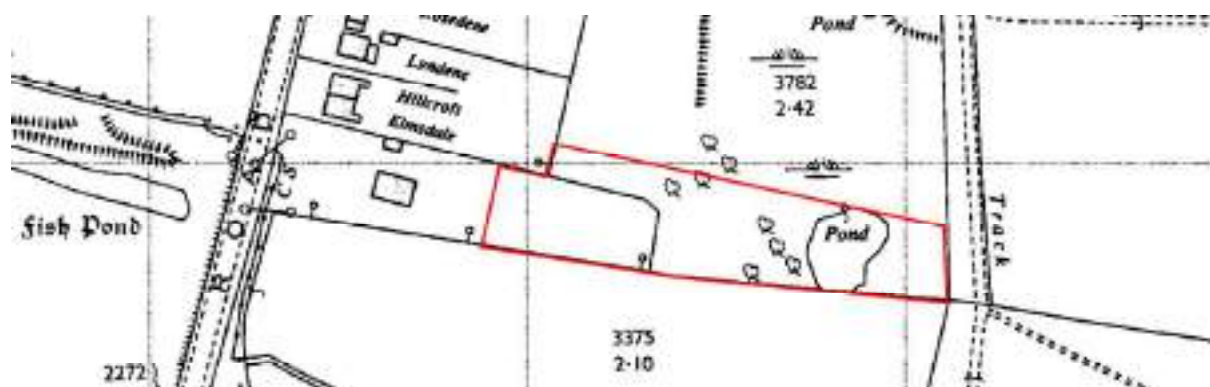
**Figure 7: Detail of 1963 Historical Map Data showing the former on-site pond**

Figure 7 below is an extract from the 1963 historical map which shows the position of a large pond in the east of the site.

During any construction works there is the potential for old foundations/infrastructure from historical buildings/structures or areas of disturbed ground to be encountered. The former pond may represent an area of deeper, potentially soft Made Ground.

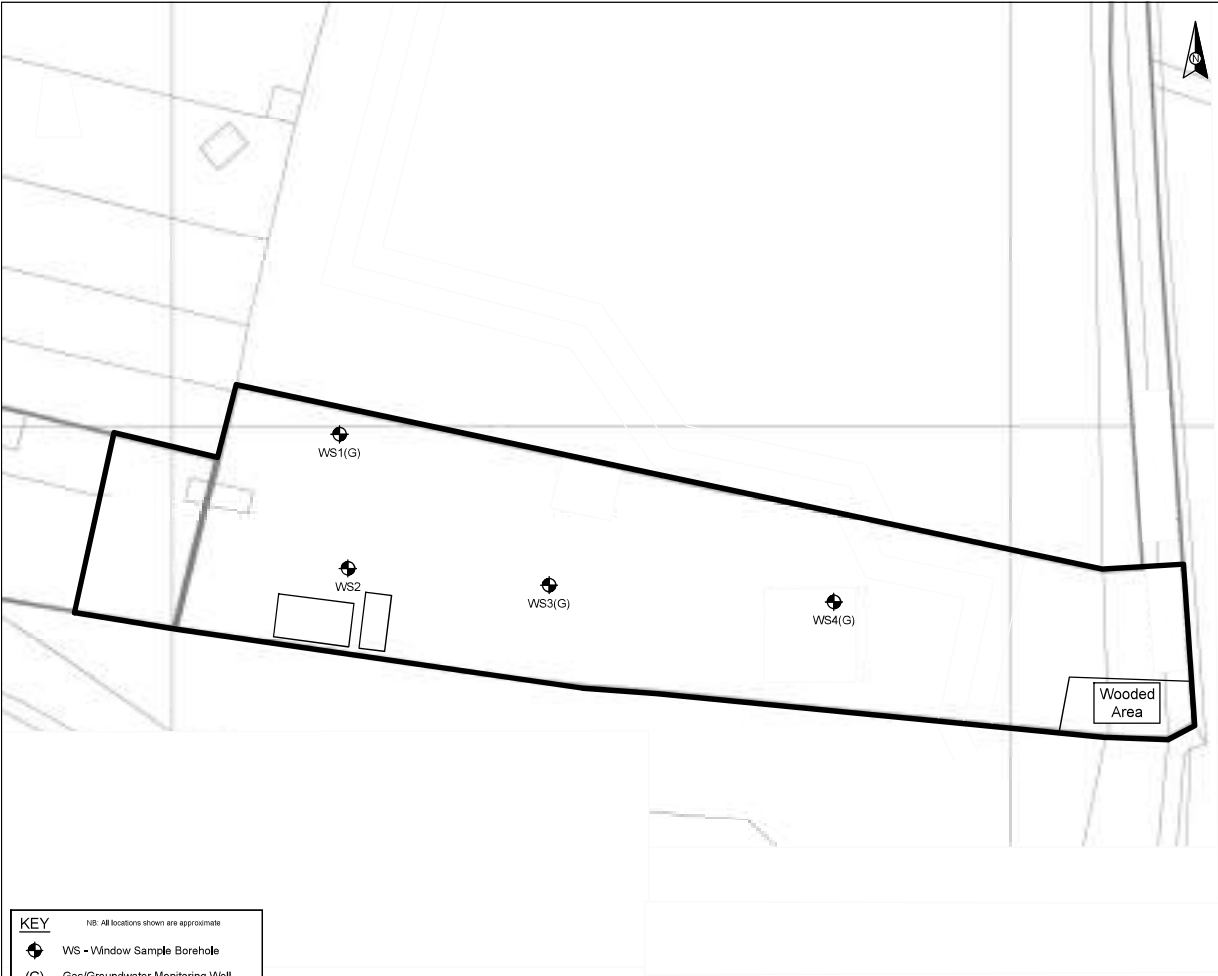
**Exploratory Hole Location Plan**

A programme of window sample boreholes, designated WS1 to WS4, were advanced at the site on 8<sup>th</sup> December 2023. The boreholes were positioned within the accessible areas of the site in order to obtain samples for geotechnical laboratory analysis and geotechnical data for foundation design. WS1 and WS2 were advanced to a depth of 5.00m below existing ground level (begl). WS3 and WS4 were terminated at 4.00m begl following SPT refusal.

Groundwater monitoring wells were installed to 4.00m in WS3 and WS4; because of blowing sand conditions in WS1 it was only possible to install a monitoring well to a depth of 3.70m in the 5.00m borehole.

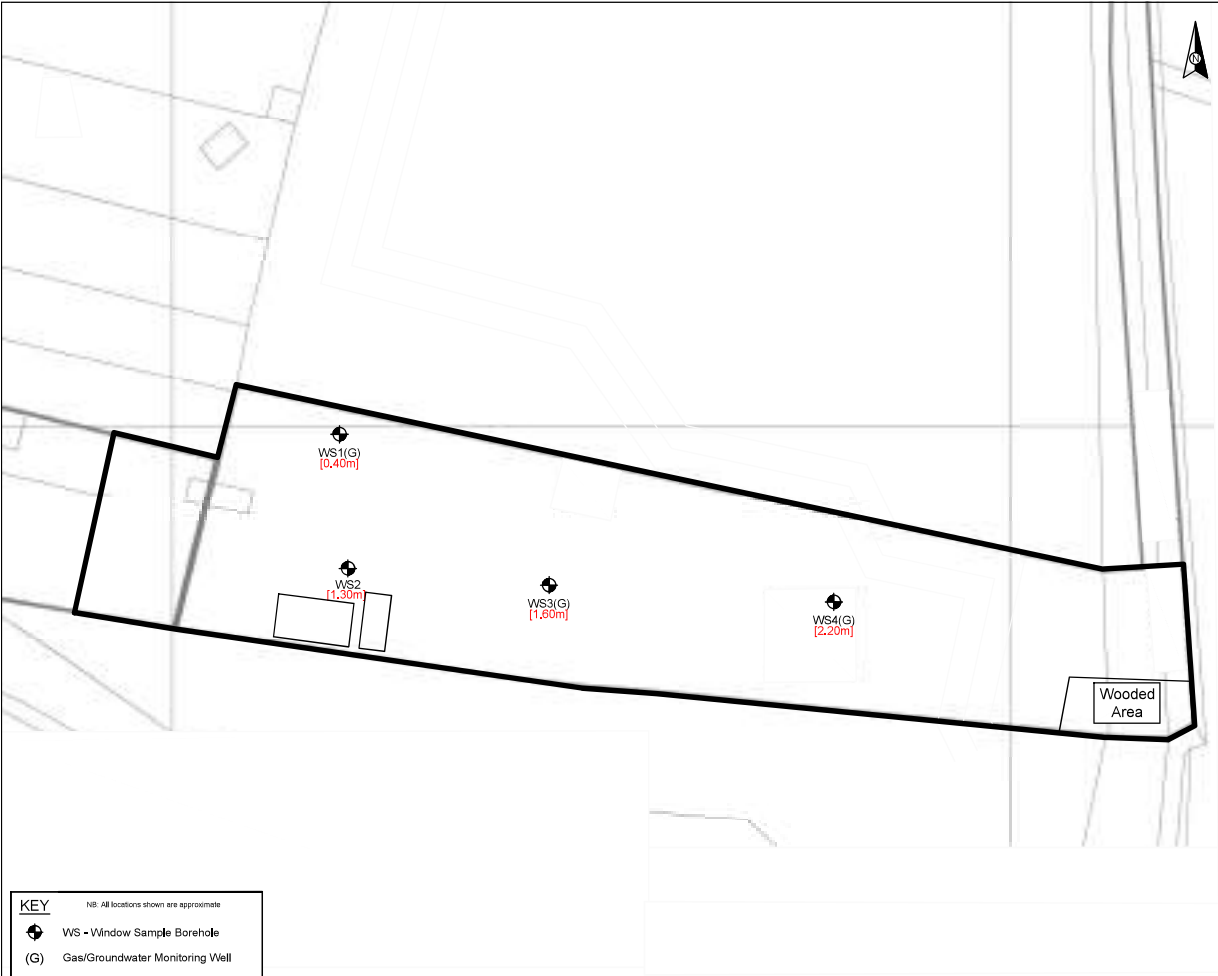
**Plan Showing Depth to Base of Made Ground**

| <b>Ground Conditions</b> | <p>Made Ground was encountered to depths of between 0.40m and 2.20m. The Made Ground varied considerably in composition. Organic plant remains were encountered in WS4 consistent with the location having been the site of a former pond.</p> <p>In WS1 to WS3 the Made Ground was underlain by the Bosworth Clay Member. This highly variable strata comprised interbedded soft, locally firm and firm to stiff red-brown silty sandy CLAY and loose to medium dense red-brown SAND. In WS4 the Made Ground was underlain by wet CLAY between 2.20m and 3.20m. Below 3.20m the Bosworth Clay Member was present as a very stiff silty CLAY.</p> |

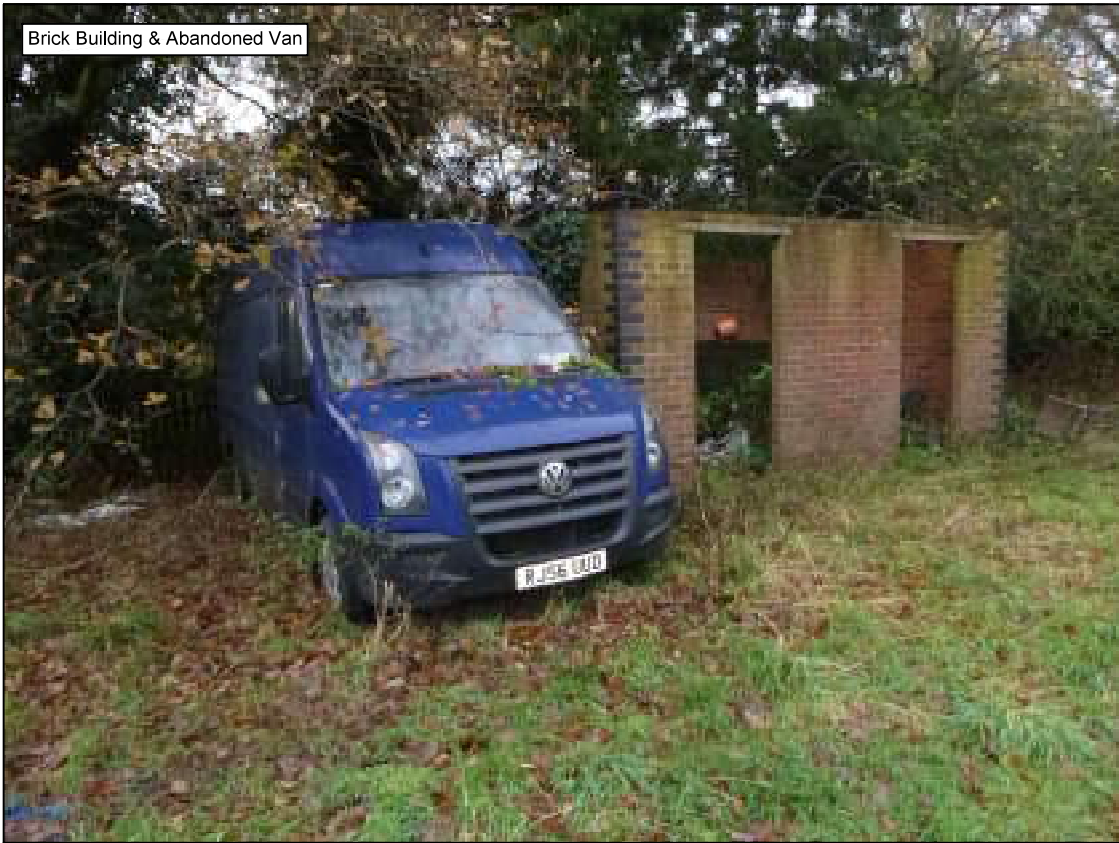
Brick Building & Abandoned Van

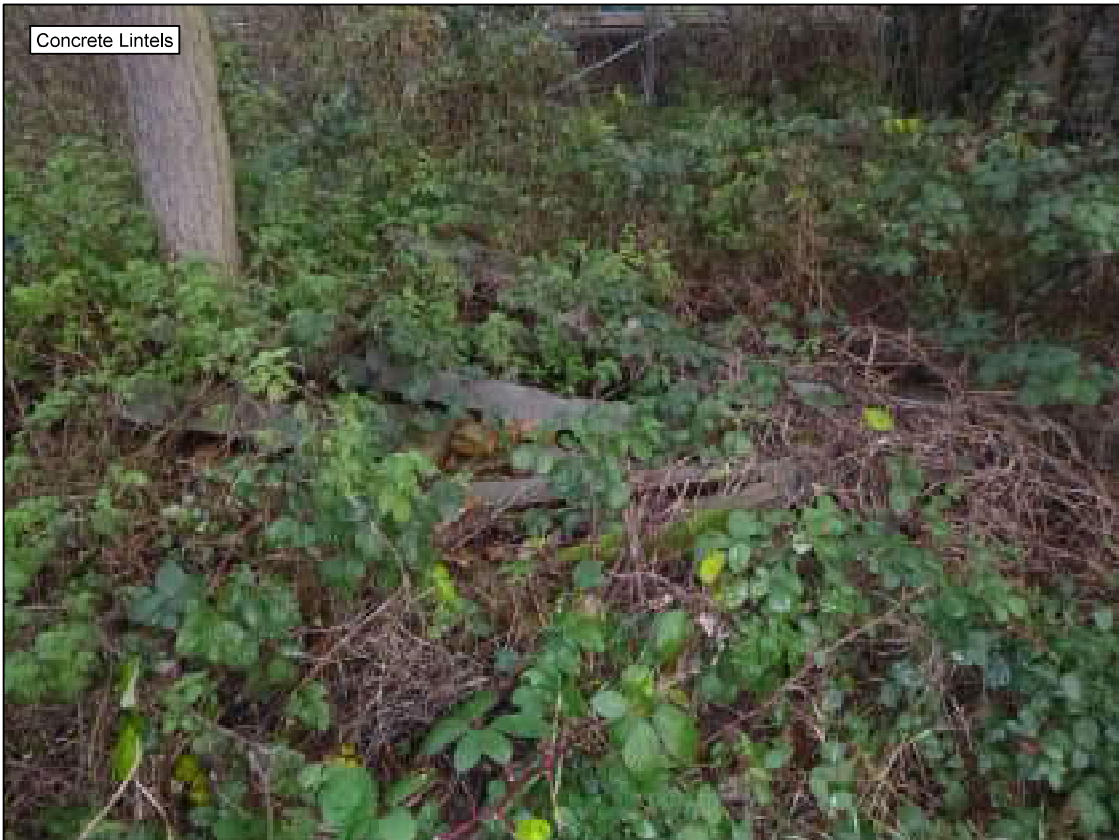
Concrete Lintels

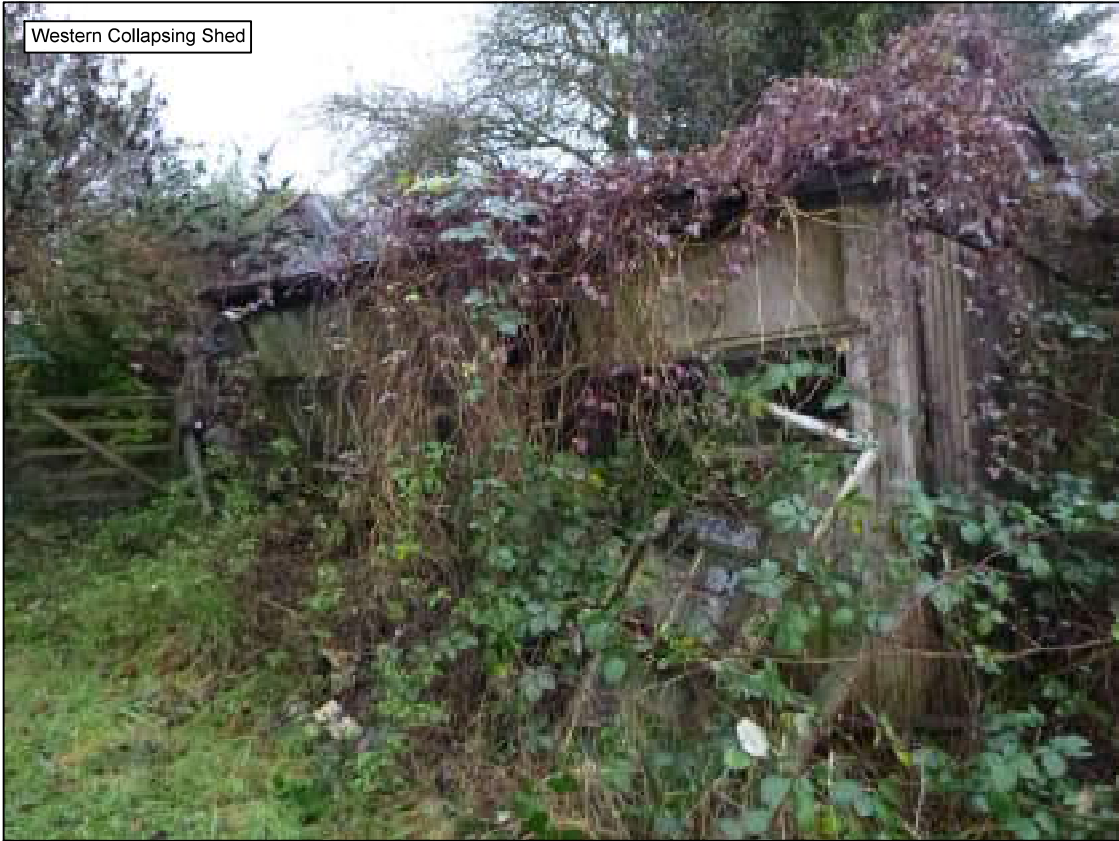
Western Collapsing Shed

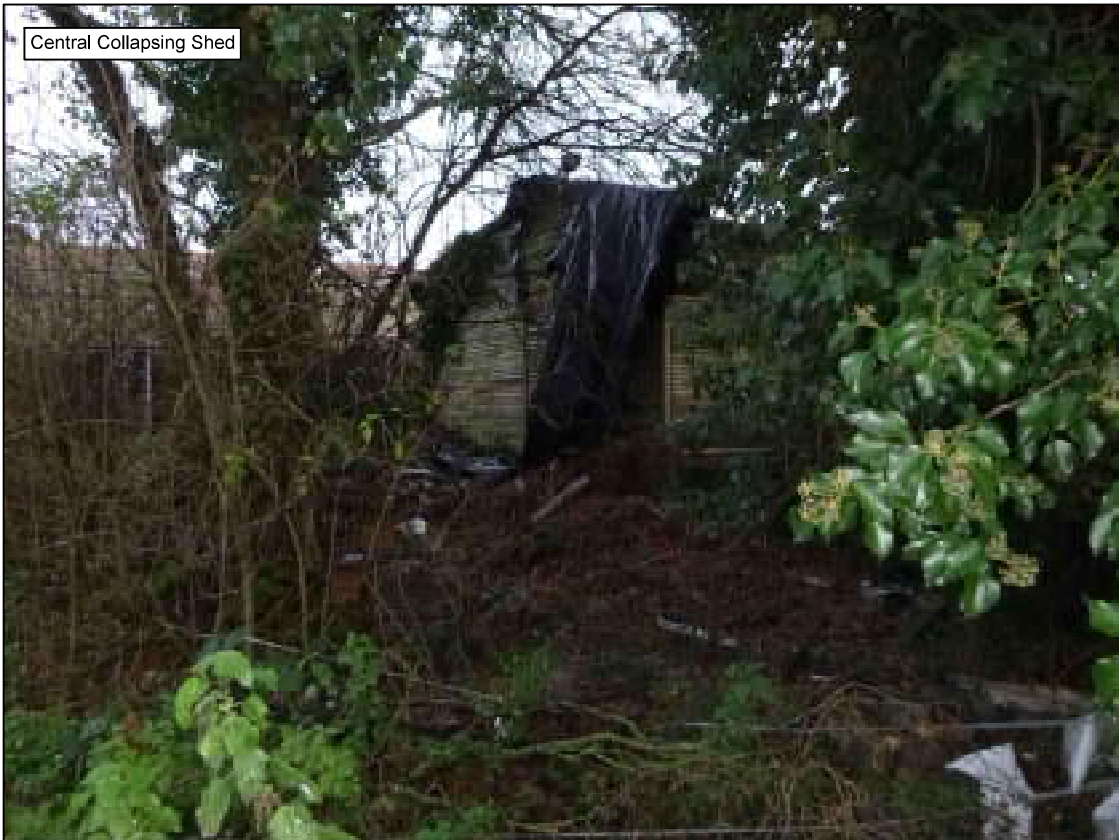
Central Collapsing Shed
