# 163 *The Park*

Market Bosworth, Nuneaton, Leicestershire, CV13 0LP.

Archaeological Strip, Map & Sample Excavation (ASMSE).

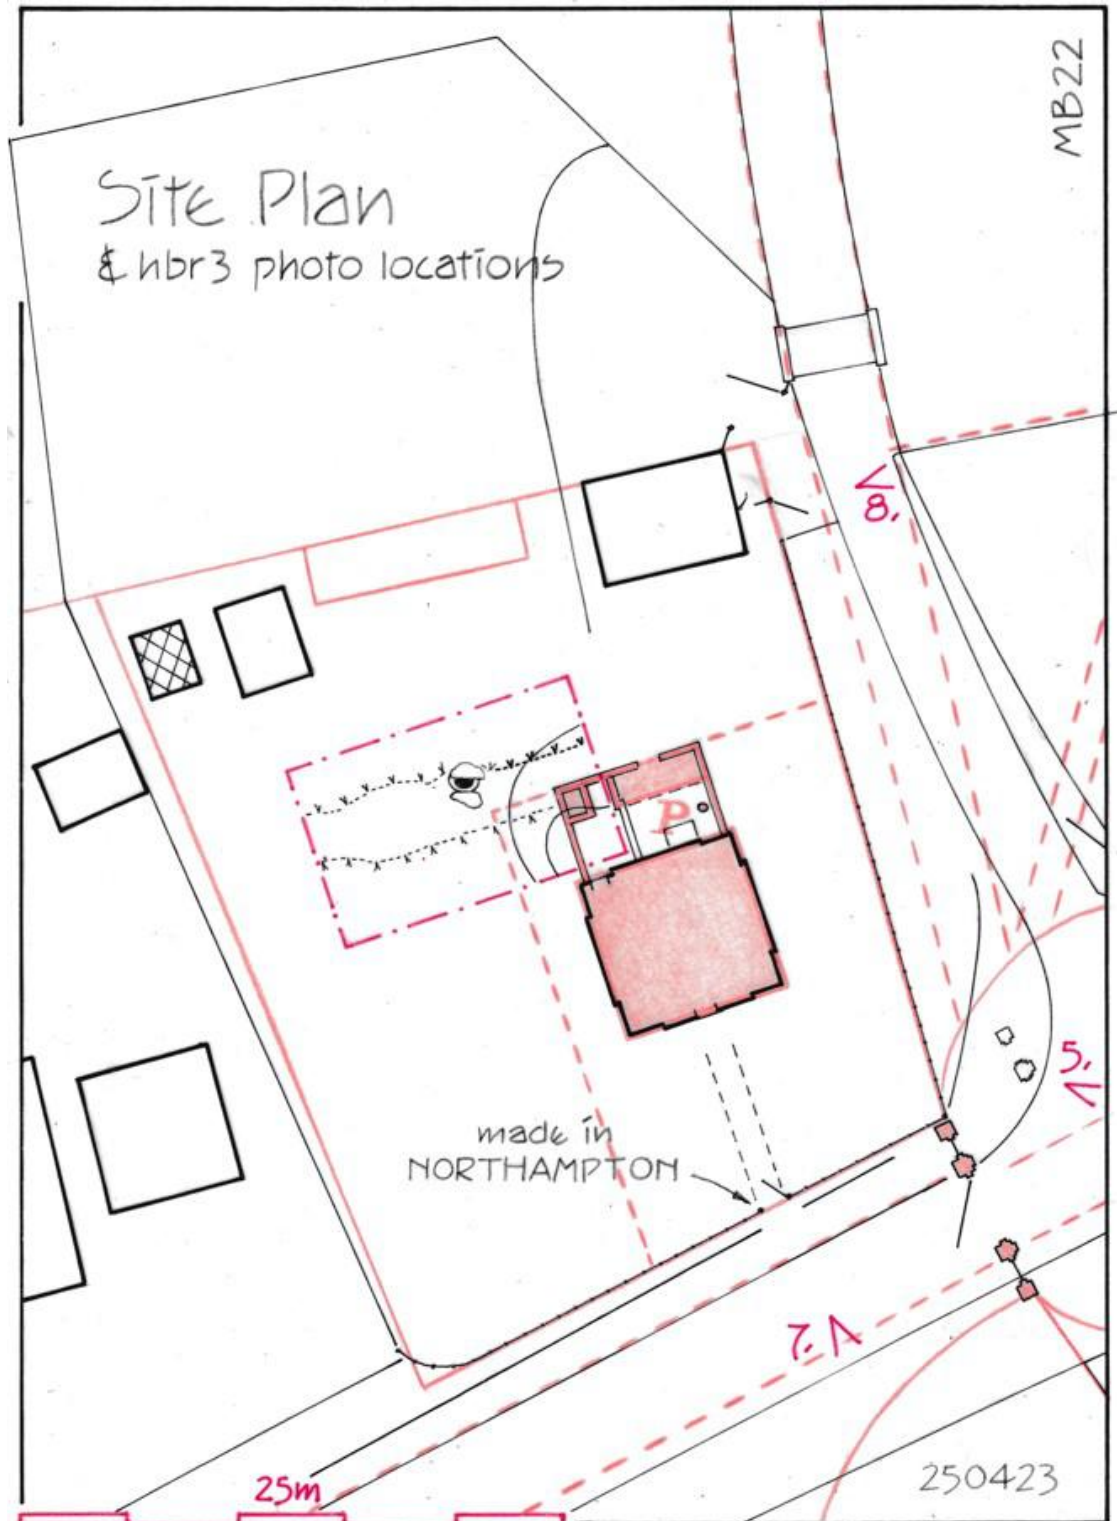
Fig. 5: site plan showing ASMSE area, also showing the main archaeological features (1903 OS features shown in pink).

The area of the proposed development was stripped of the overlying soil layers revealing the surface of the natural clay substrate (104) across the excavated area. Within this clay was a shallow (up to 0.30m deep and 3.0m wide), linear, hollow-like feature aligned northeast-southwest, with an undulating base. The nature and date of this feature is unclear, whether it is a natural feature or constructed could not be understood, but its alignment, coinciding with a boundary marked on the OS 1903 may be significant. Interestingly, the OS 1886 describes a footpath around the position of the feature, but this is not indicated with dashed lines in the way that footpaths are usually illustrated.

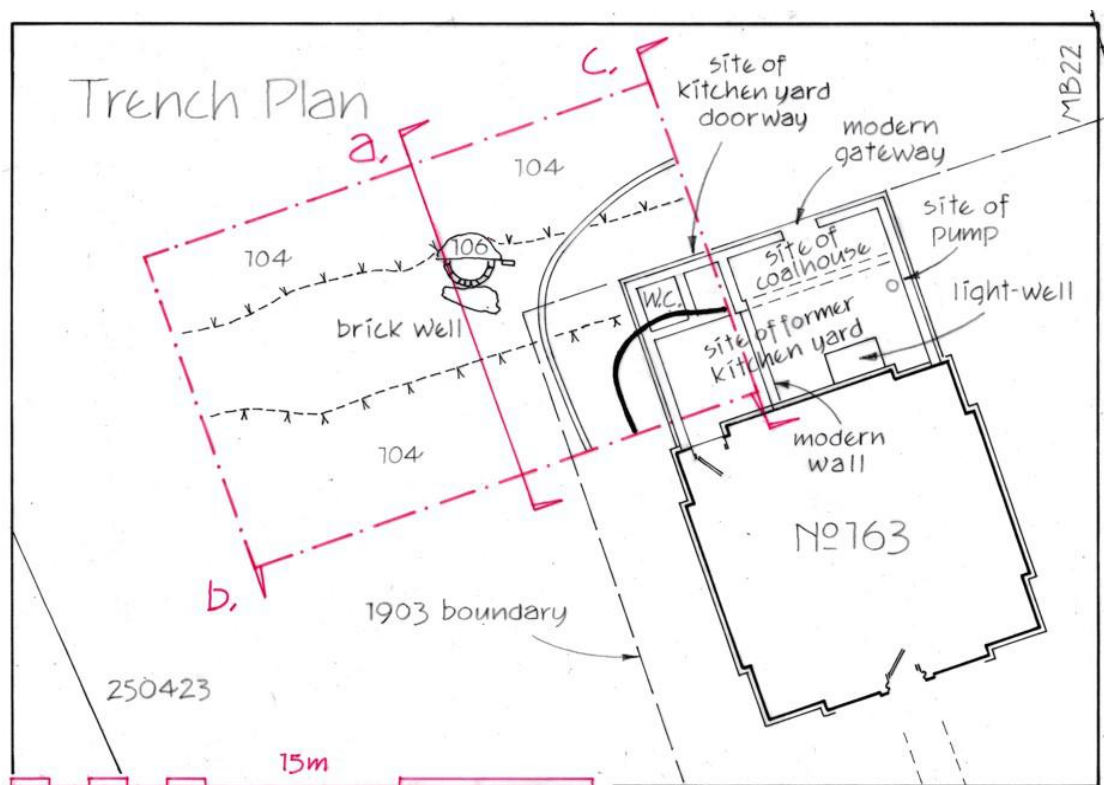
Fig. 6: trench plan showing the linear hollow-like feature, brick well, building foundations and services.

Truncating the soil layer (103) and located roughly within the central area of the excavation was a brick-built well (106). The wall of the well was constructed from a single course of bricks with an internal diameter of 1.18m. and an external diameter of 1.28m, it was at least 5m deep. Capping the well

beneath the overlying soil layer (101) were two large, almost semi-circular, flat pieces of lias stone, clearly shaped further so that each stone neatly covers one half of the top of the well. The well itself was unfilled and water was observed at its base. A single lead pipe leading to the bottom exited the east side of the well through a small hole between the two capping stones and continued towards the position of the well pump which was originally situated in the yard immediately on the north side of the house (OS 1886).

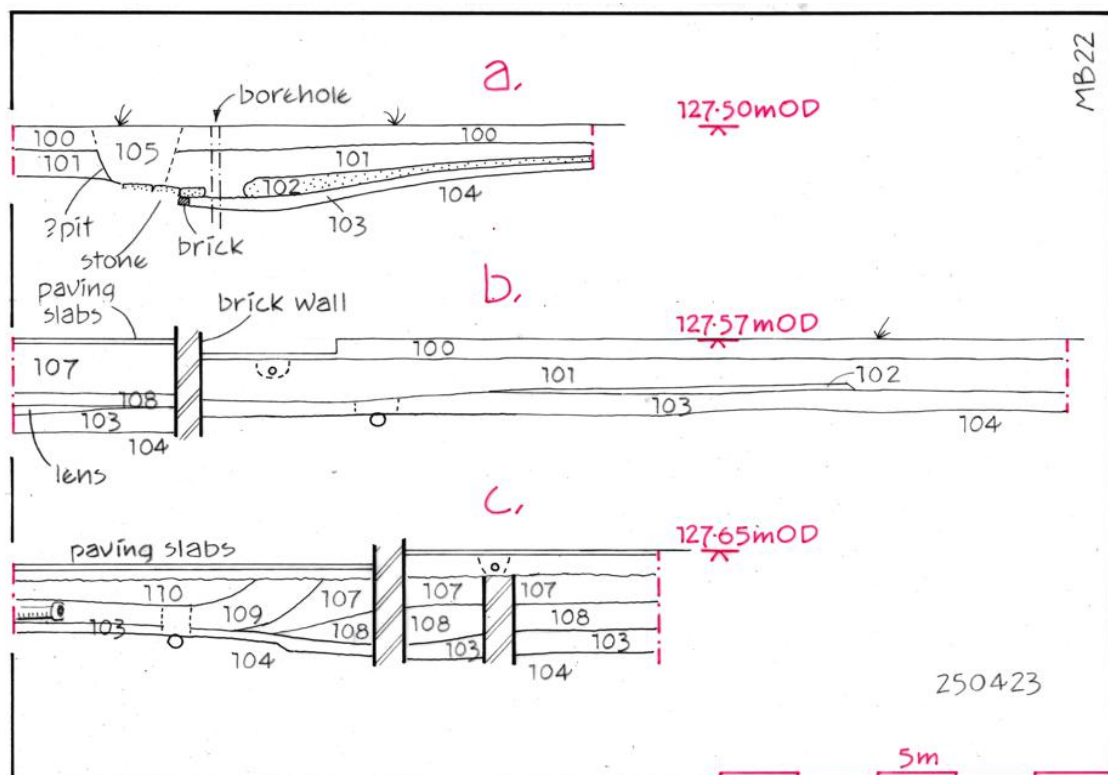
Fig. 7: trench sections.

Partly overlying the soil layer (103) within roughly the central area of the excavation was an undated isolated layer (102) of what was interpreted as 1885 construction debris, consisting of a creamy-white, lime mortar deposit, it was about 0.05m thick along the southern edge of the excavation increasing to about 0.25m thick towards the centre of the excavation (see Plates 7 & 8). Its east-west extent is recorded in the section (1b) along the southern edge of the excavation where it continues beyond the edge, whilst its northern extent ends about half a metre short of the location of the well (see section 1a).

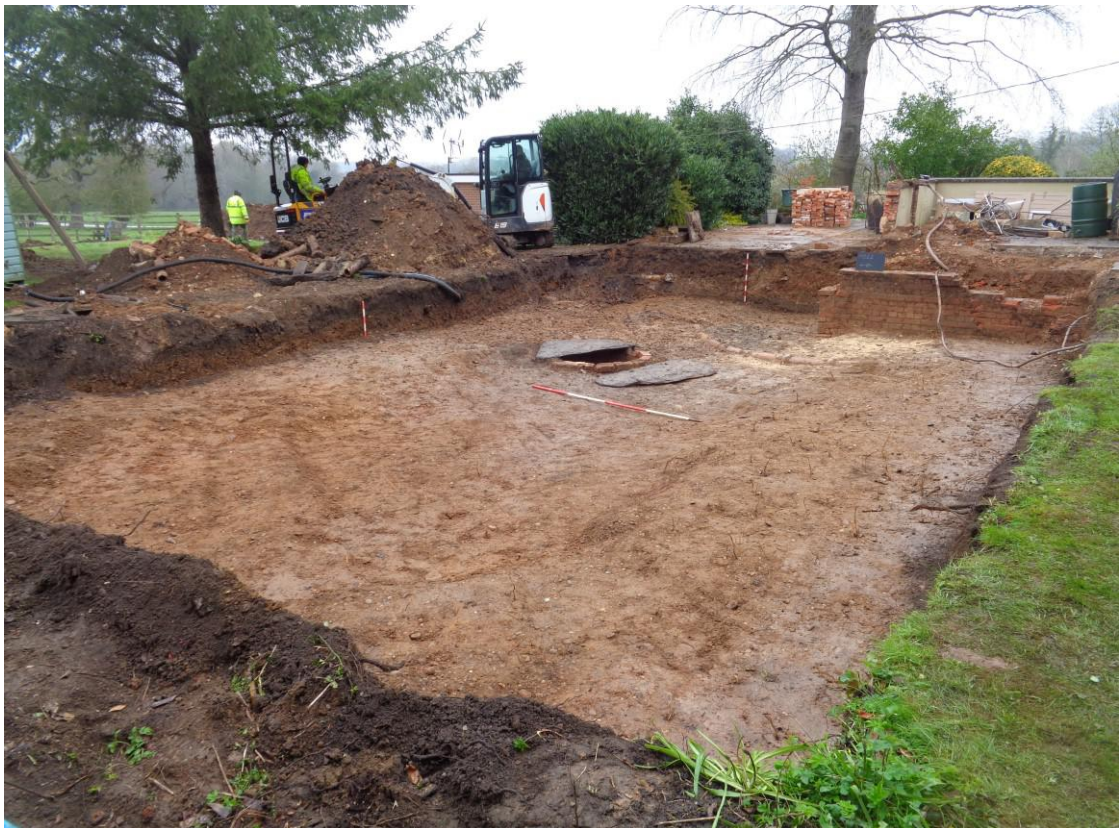
*Plate 2: ASMSE area, view northeast.*

The surface of the natural substrate (104) comprising a light orangey-brown, gravelly clay was observed throughout the entire ASMSE area. Along the southern and northern edges of the excavation, it was recorded at a level height of approx. 127m AOD. Within the surface of this deposit along the central area of the excavation, aligned east-west, was a shallow, linear hollow-like feature about 3.0m wide and up to 0.30m deep at its centre. The bottom of this feature was noticeably undulating throughout most of its length, and it appears to continue beyond both edges of the excavation (see Plates 2, 3, 4 & 12).

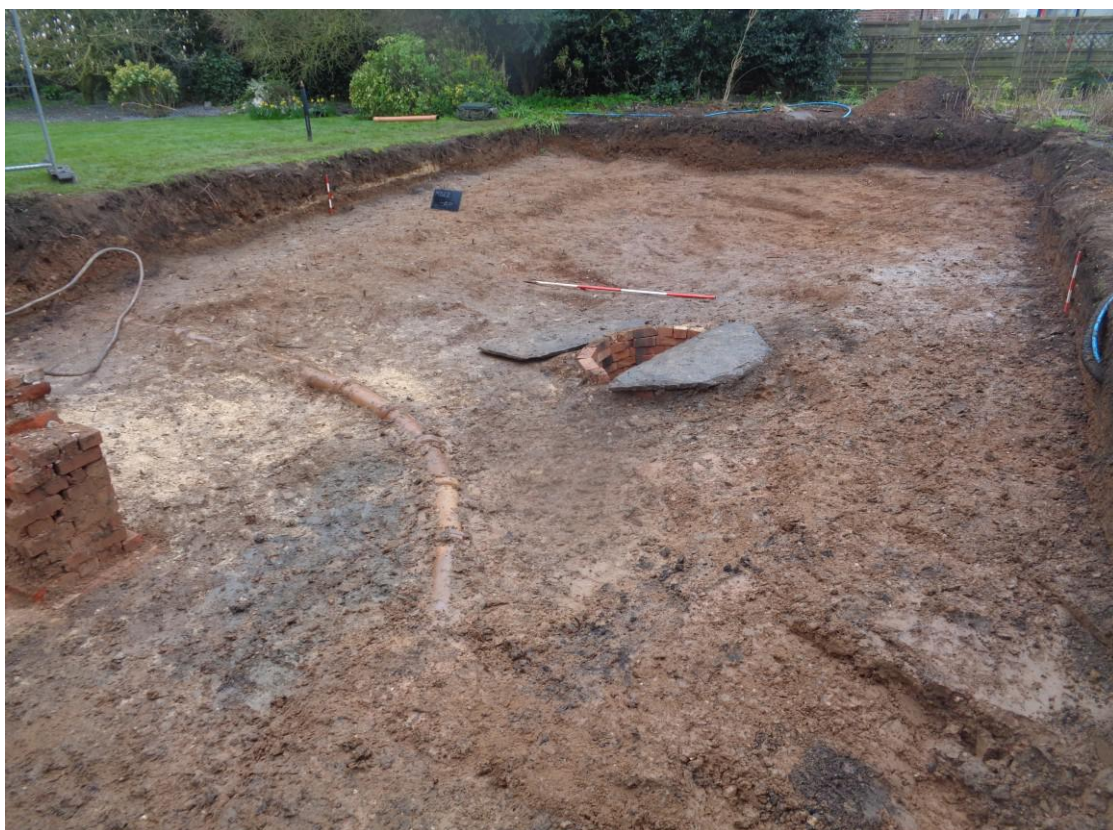
*Plate 3: ASMSE area, view west.*

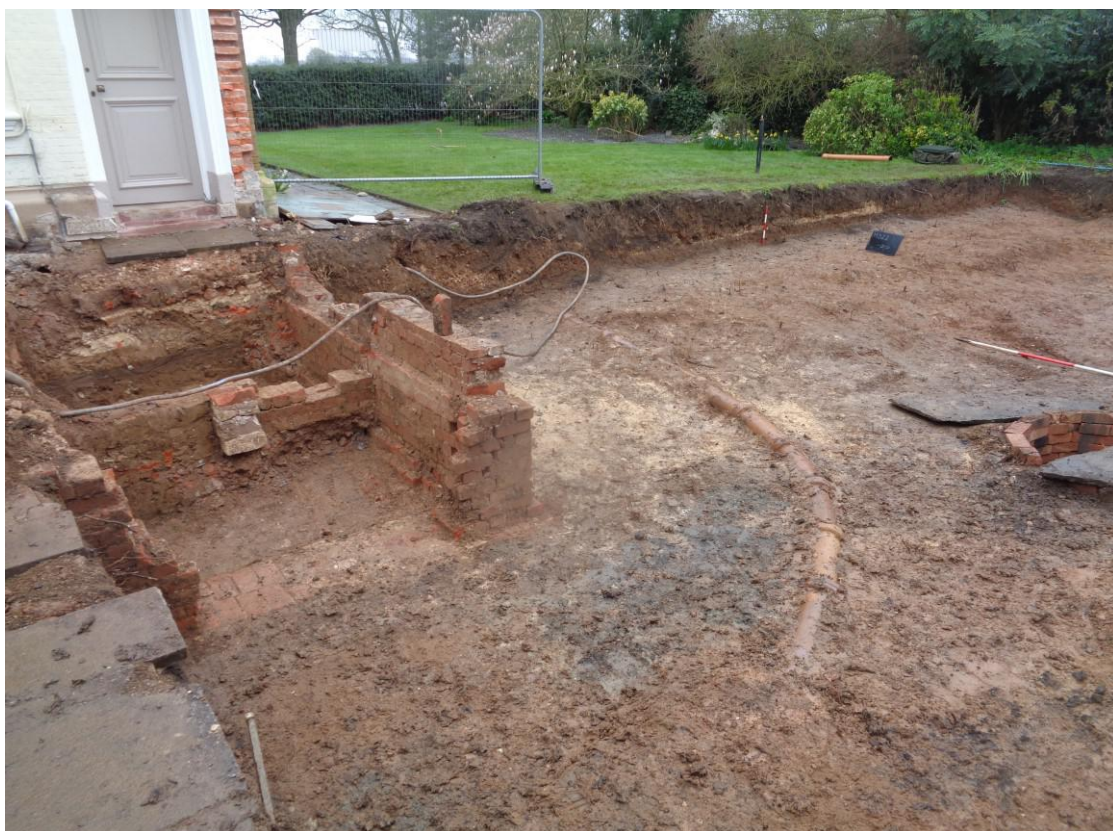
*Plate 4: remains of former outbuildings, view southwest.*

In the southeast corner of the excavation in the area are a series of brick walls and their concrete foundations representing the former outbuildings, a series of redeposited soil layers (107, 108, 109 & 110) associated with their construction and subsequent service pipes were recorded. The earliest of these deposits (108) consisted of a 0.50m thick yellowish-brown gravelly-clay which tapers off just beyond the most northern wall of the former outbuilding. This is overlain by (107), a layer of re-deposited construction debris as evidenced by the frequent inclusion of red brick fragments. The soil layers (109 & 110), consisting of a brown clay and a mixed soil and building debris relate to a former drainage pipe trench aligned north-south along the east side of the excavated area.

The walled remains of the former outbuildings marking the site of the former kitchen yard and WC were partly revealed in the southeast corner confirming the outline configuration of the yard area as shown on the OS 1886 map. Services associated with the house were also revealed in this area mainly a salt-glazed ceramic pipe linked to the roof gutters on the west side of the house, this pipe, truncating the clay, curves eastwards continuing beyond the edge of the excavation. Another disused lead pipe, similar to the pipe associated with the well was also observed in the southeast corner of the excavation.

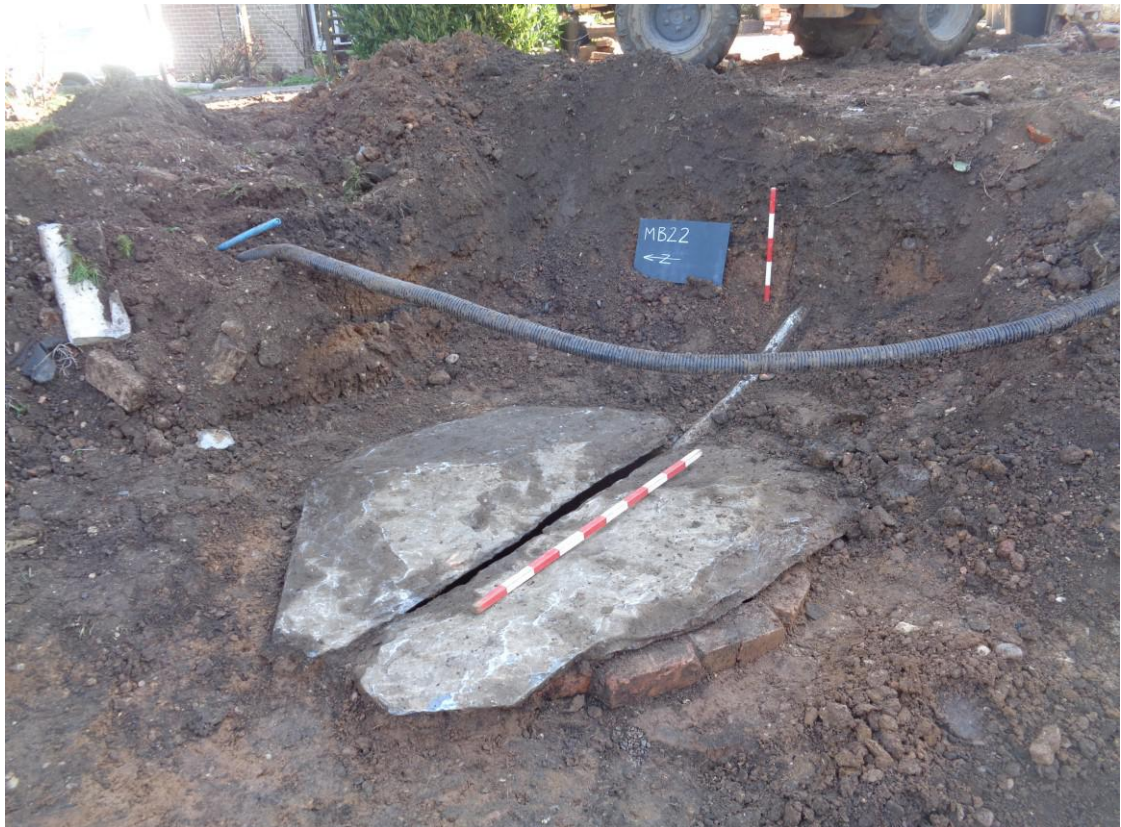
*Plate 5: stone capping for brick well (106). Note lead pipe to pump exiting on far side.*

How the well appears to have functioned in relation to the ground conditions in 1885 can perhaps be explained by the archaeological evidence, this suggests that rather than the well structure consisting of a well wall standing above ground level, with perhaps a wooden cover, the well was capped below ground, sealed by the thick layer of redeposited soil (101) with water drawn through a lead pipe exiting through a hole between the two capping stones which then continued eastwards beyond the excavation connecting with the pump in the former yard area. The stones appeared shaped to create a firm cover and placed in a manner that would prevent soil from above entering inside the well.

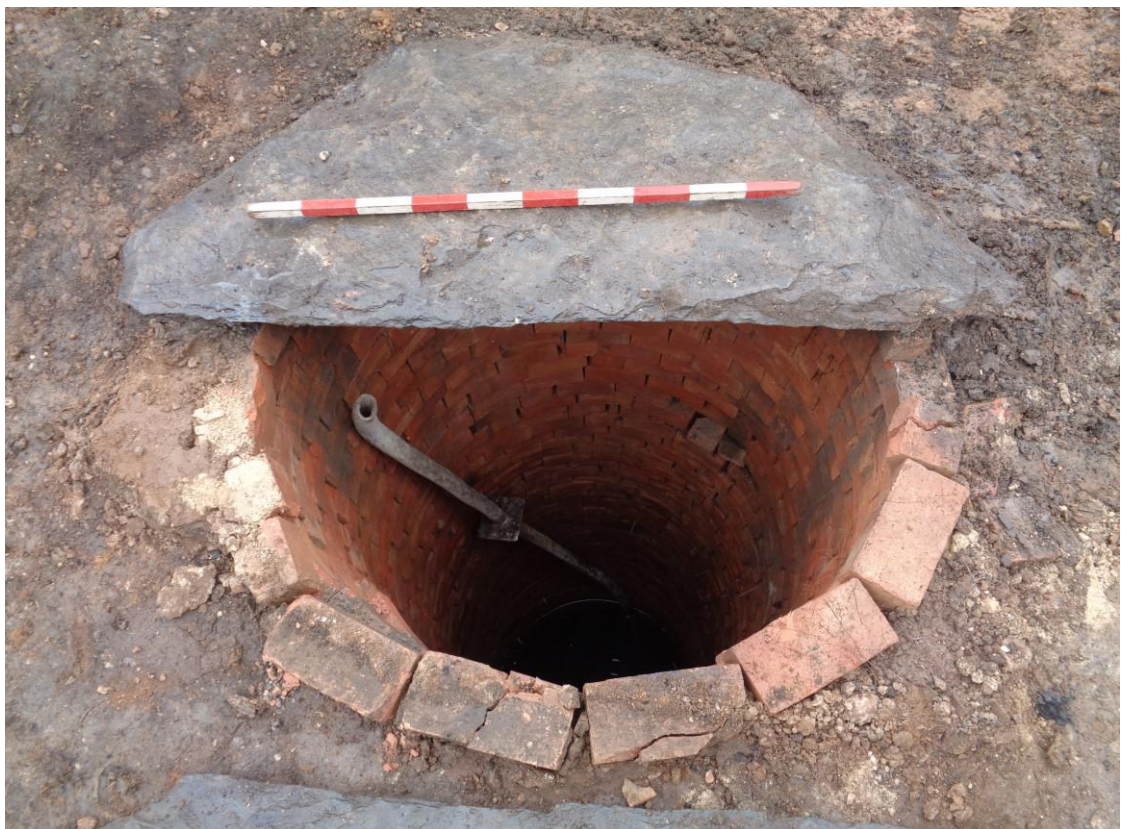
*Plate 6: detail of brick well and lead pipe*

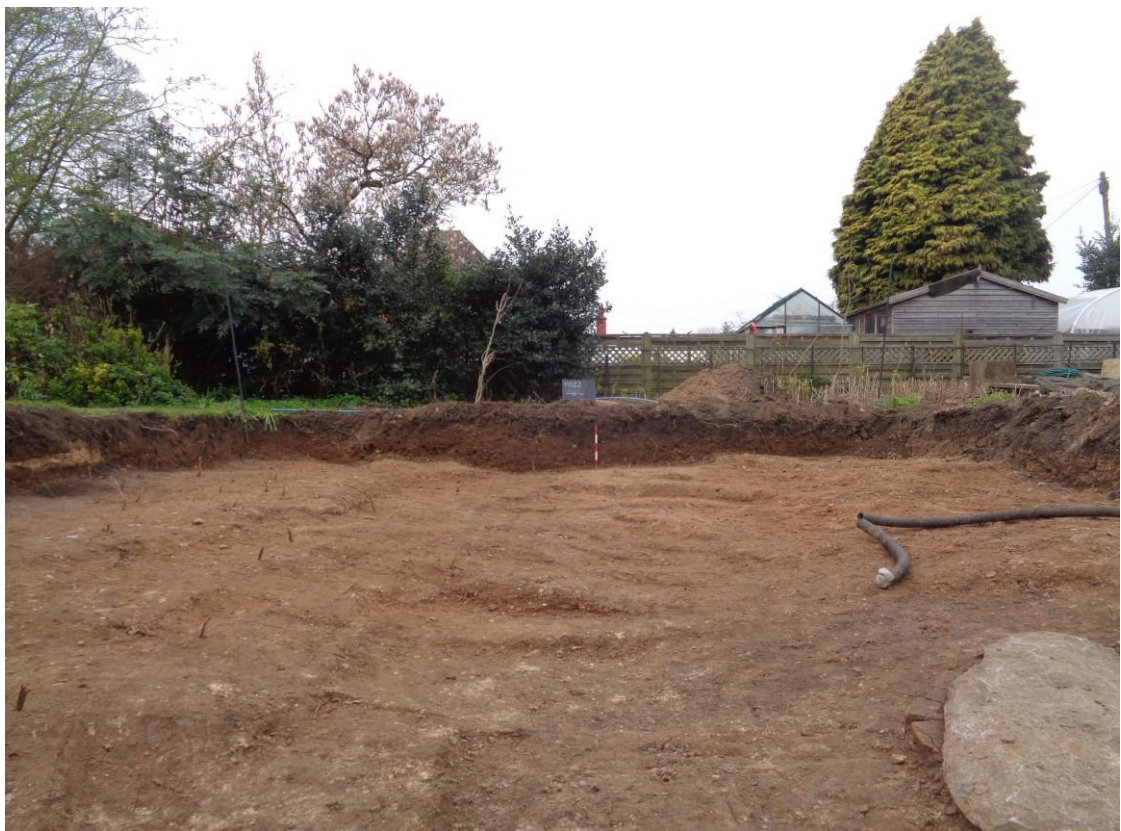
*Plate 12: ASMSE area, view west.*
