## Preliminary Roost Assessment

4a Druid Street, Hinckley, Leicestershire LE10 1QG

This proposal can be described as: Adding additional storey to existing single-storey extension

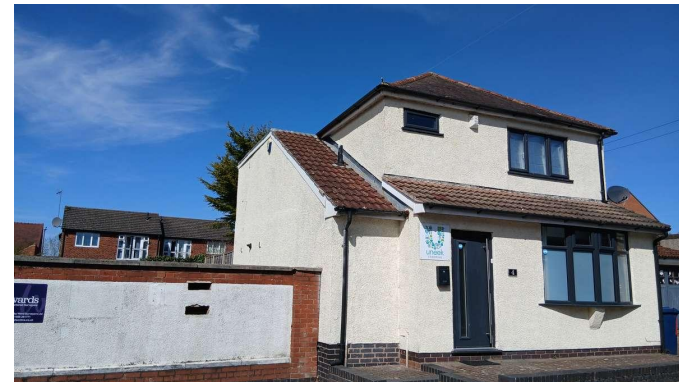
B1 is a brick-built school building. The main roof is hipped and constructed of slate tiles and curved clay ridge tiles, with a section of flat roof on the southwestern elevation, and an adjoining single storey extension with a gabled roof clad in clay tiles. Two internal voids were recorded within the building. No bat evidence was found during the survey.

In line with Good Practice Guidelines (Collins, J (Ed) 2023), B1 is assessed to have **low** habitat value for roosting bats due to the presence of external crevice roosting features and access points into internal voids.

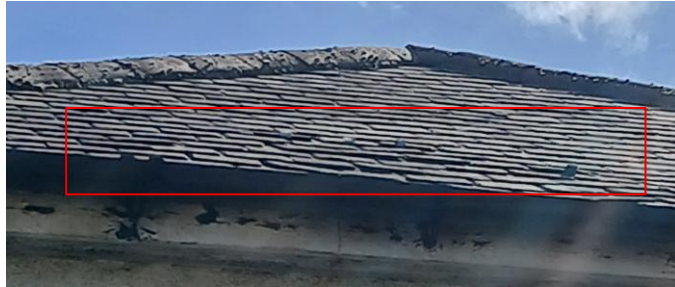
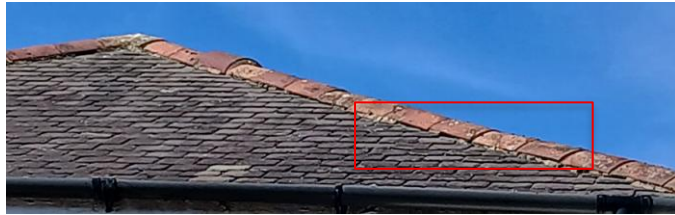
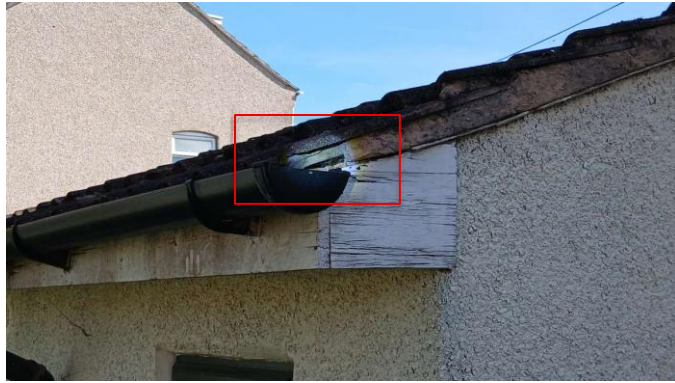
| | Roof | Clay & slate tiles | <p>The two-storey part of B1 features a hipped roof clad in slate tiles and curved clay ridge tiles, with a section of flat roof on the southwestern elevation. Minor defects were noted, including slipped or loose tiles on the southeastern, northwestern and northeastern elevations, which provide direct access into internal void 1 for roosting bats.</p> <p>There are areas of missing mortar beneath the curved tiles along the roof ridge on the southeastern and southwestern elevations which could allow access beneath the ridge tiles, which would present a roosting opportunity for crevice-dwelling bats species. Additionally, there are areas of missing mortar on the roof verge, and gaps under roof tiles at the verge of the single-storey section on the northwestern and northeastern elevation, allowing access in between the tiles and the roof lining, presenting a high-suitability crevice feature for roosting bats. No evidence of bats was identified externally, however recent rain would wash this away externally, and evidence could be concealed beneath the tiles, if present.</p> | <p><i>Loose or lifted tiles on northwestern elevation</i></p> <p><i>Missing mortar on southeastern elevation</i></p> <p><i>Missing mortar on northwestern elevation</i></p> | |

| <p><b>Impacts</b></p> <p>The roof of the single-storey part of B1 will be removed and replaced, and the northeastern wall will be altered as part of the proposed works. This could result in destruction of any bat roosts present within the building and could cause disturbance, death or injury to bats.</p> <p><b>Recommendations</b></p> <ul style="list-style-type: none"> <li>• One bat emergence/re-entry survey will be required on B1, requiring 3 surveyors with night vision aids (NVA) to provide full coverage of the building's elevations. If bat roosts are confirmed in the building two additional surveys may be required to characterise the roost and to inform an EPSL application to Natural England.</li> </ul> <p>These surveys must take place during the active bat season (May – September) to confirm presence/likely-absence of bats roosting in or on the building.</p> <p>These survey visits should be completed during the optimal survey period mid-May to August inclusive and the survey visits should be at least three weeks apart. Completing surveys in the sub-optimal season, early May and September, would require greater justification of timing e.g., weather conditions, known local bat activity.</p> <p>Lighting mitigation may be required based on the outcome of the night bat survey(s).</p> | | | | | |

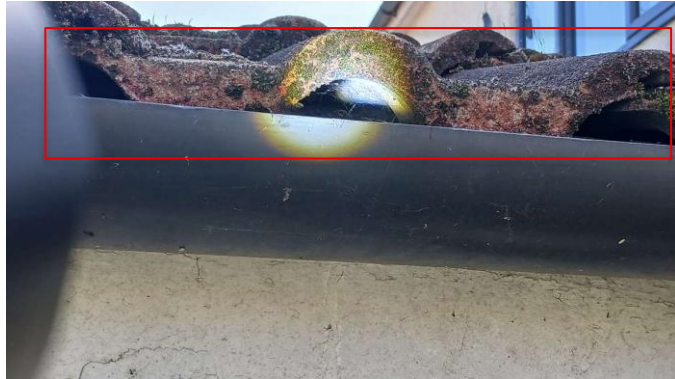
| | | | | <p><i>Gaps under roof tiles at verge of single storey section on northwestern elevation</i></p> | |

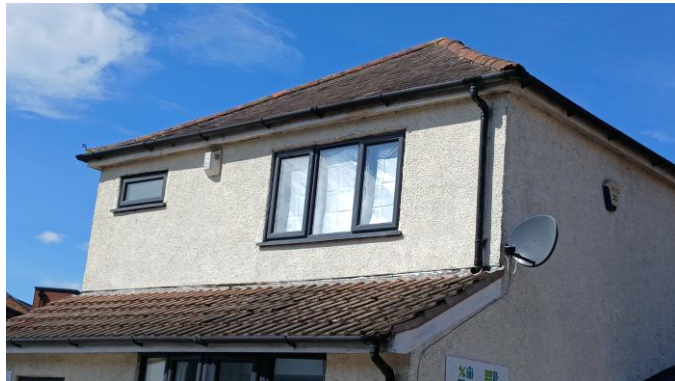
| | Windows & Doors | uPVC & timber | <p>A visual inspection revealed no significant degradation, gaps, or perimeter sealing failures that would provide potential ingress points or crevice roosting opportunities for protected bat species. No evidence of bats was identified externally; however recent rain would wash this away externally.</p> | <p><i>uPVC windows on southeastern elevation</i></p> | |

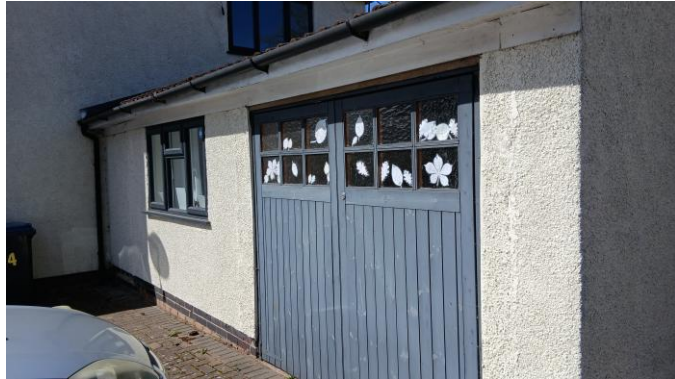
| | | | | <p><i>Timber doors and uPVC windows on southeastern elevation</i></p> | |

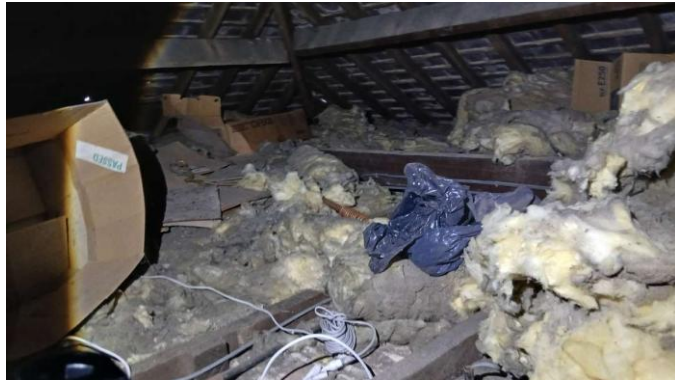
Internal void 1 in B1 was not fully accessible due to the absence of boarding on the floors to allow safe access. The view from the loft hatch was considered sufficient to inspect the void which revealed no direct or indirect sign of bat presence (e.g., droppings or staining).

| | Voids | <p>Void 1 – timber rafters and no roof lining</p> <p>Void 2 – Timber rafters and plastic roof lining</p> | <p><u>Void 1</u><br/>Dimensions: ~1.5m (height) X ~6m (width) X ~9m (length)<br/>Internal void 1 is located within the main two-storey section of B1. Void 1 could not safely be entered due to the absence of boarding on the floor. A visual inspection from the hatch revealed no roof lining and several areas of light ingress along the ridge lines and underneath the roof tiles. These gaps would allow access into the void for roosting bats. There are no crevice features within the void, however the timber rafters would provide suitable roosting habitat for void-dwelling bat species. A visual inspection inside the void revealed no direct or indirect sign of bat presence (e.g., droppings or staining).</p> | <p><i>Internal Void 1</i></p> | |

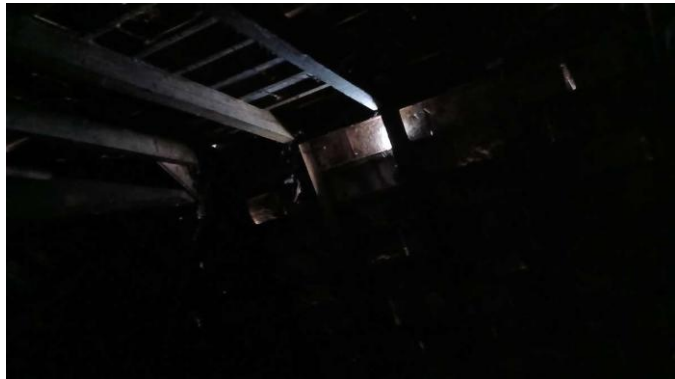
| | | | <p><u>Void 2</u><br/> Dimensions: ~1m (height) X ~7m (width) X ~7m (length)<br/> Internal void 2 is located in the single-storey section of B1. Void 2 was not fully accessible due to the small height of the loft space and hatch. The void features plastic roof lining which appears to be in good condition, with no gaps or areas of damage that would allow access into the void. The small height of the void reduces its suitability for void-dwelling bat species, which typically require unobstructed access while in flight. A visual inspection from the hatch revealed no evidence of light ingress and no direct or indirect sign of bat presence (e.g., droppings or staining).</p> | <p><i>Light ingress along northeastern ridge line within void 1</i></p> <p><i>Light ingress along central ridge line within void 1</i></p> | |

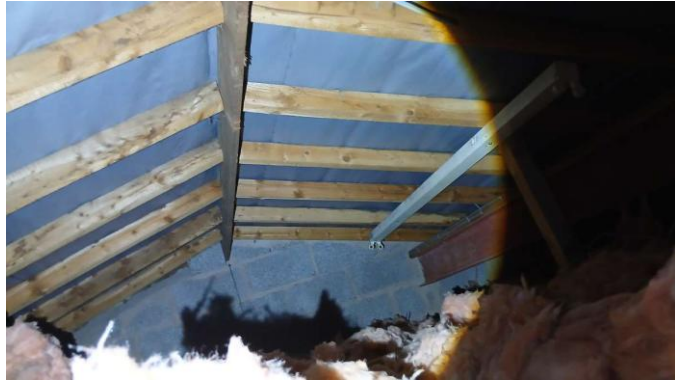
Internal void 2 in B1 was not fully accessible due to the small height of the loft space and hatch. The view from the loft hatch was considered sufficient to inspect the void which revealed no evidence of light ingress or any direct or indirect sign of bat presence (e.g., droppings or staining).

| | | | | <p><i>Internal Void 2</i></p> | |
