## Site Photographs – 1 Markfield Lane, LE9 9FH, Botcheston, Leicester

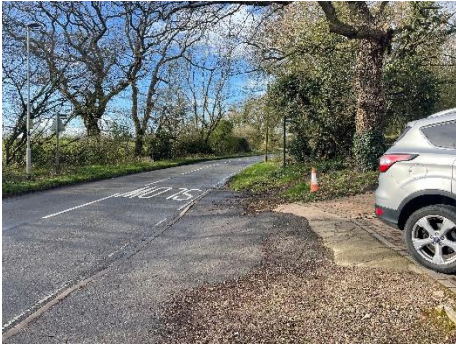
**Site Photograph 1:**

- Current dropped kerb has poor visibility, exiting and entering on C road (40 mph) bend.
- Proposed kerb would extend the visibility for users of the highway and proposed driveway.

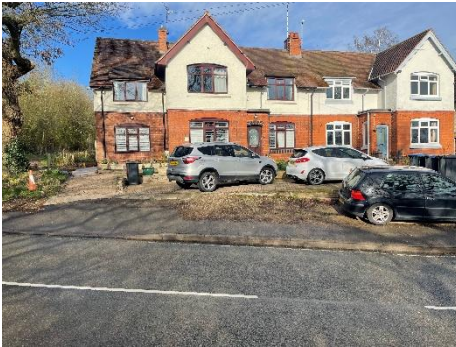
**Site Photograph 2:**

- Current gradients are steep, not as accessible for users with limited mobility.
- Proposed kerb and driveway would allow for more accessibility for users with limited mobility, as outlined within the cover letter.

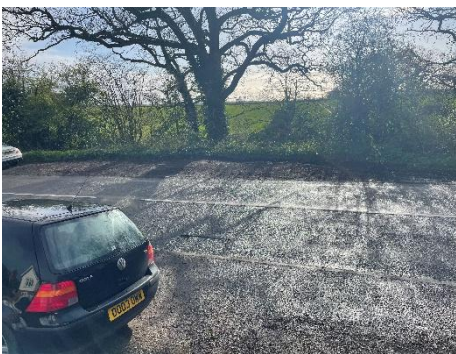
**Site Photograph 3:**

- Existing public layby fills up when all occupants are parked at the property.
- The proposed plans would allow more parking on the private property, reducing strain on public parking.

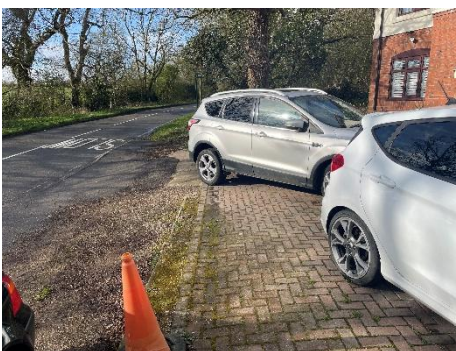
**Site Photograph 4:**

- Current driveway provisions are steep, affect parking and users' mobility, reversing from this driveway on to a corner can be dangerous.
- Proposed kerb and driveway allow for greater room, visibility and parking, allowing users to front and reverse park on to the proposed driveway, via proposed dropped kerb.

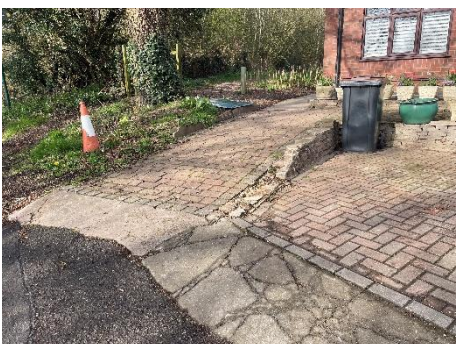
**Site Photograph 5:**

- Current ramp provisions are too steep and not level.
- The proposed driveway allows for a steadier and longer gradient to help users with limited mobility. The proposed works would also allow for level thresholds across the site.
