A Photographic Survey of Outbuildings At Groby Old Hall Farm, Markfield Road, Groby, Leicestershire (NGR SK 5241 0757)

ULAS Report No 2011-009
©2011

Planning Application No's: 10/00267/LBC

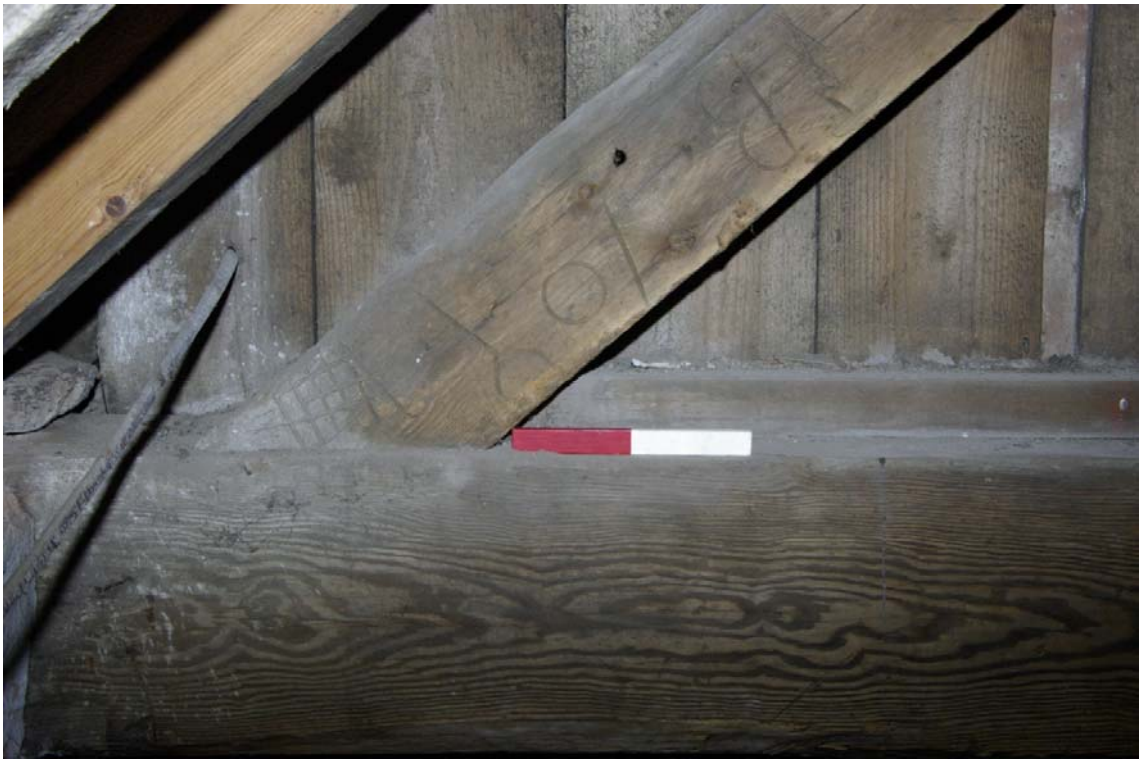
which is a cat hole, suggesting it was originally a granary. There is a single bolted king-post truss with raking struts within the bay, once again there are shipping marks incised into the principal rafter (*Figure 12*), again the letter B is clearly identifiable as well as a perfect circle, this circle is made with a scribing iron and again is part of the marking process. As well as the usual stokes there is an area strokes creating a grid pattern, the exact purpose and origin of which is unknown. A second group of rase marks can be seen on the northern purlin; once again the letter B is clearly identifiable along with other strokes.

Figure 14 Rase or shipping marks on truss within A3 (059-060).

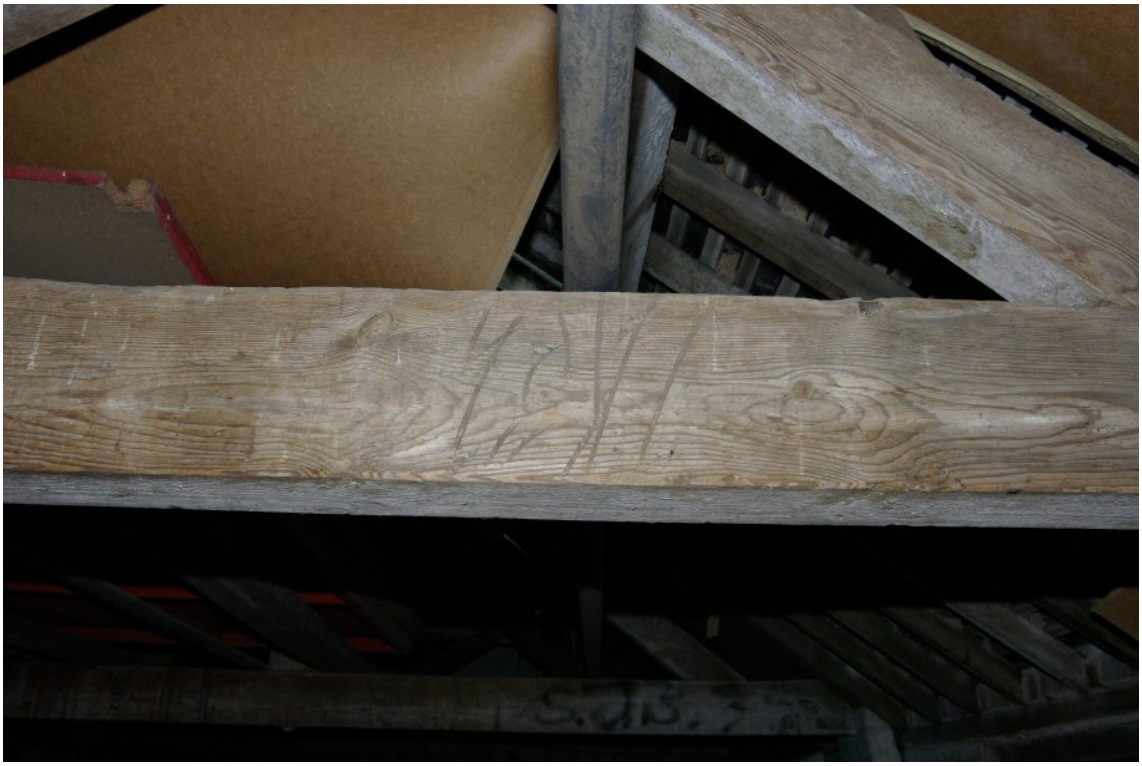
First floor access was via a stair within A3 and consists of a single room with loading doors on the north and west walls, with a hoist over the west door. The room appears largely unaltered and original. The roof is carried on three bolted king-post trusses with raking struts, again in soft wood. There are shipping or rase marks incised in the tie beam of the easternmost truss. Such marks were incised into Baltic pine before being shipped to the United Kingdom. It is known that the port of Gdansk used the letters K (first quality), B (second quality) and BB (third quality); subsequently other marks were added by buyers. The clearly identifiable letter B on this beam may suggest the timber originated as second quality pine out of Gdansk.

Figure 15 Rase marks or shipping marks on truss within A2 (081-082).
