Version: 1.0
27th February 2010

The Elms: West Range of Farm Buildings, Historic Building Report

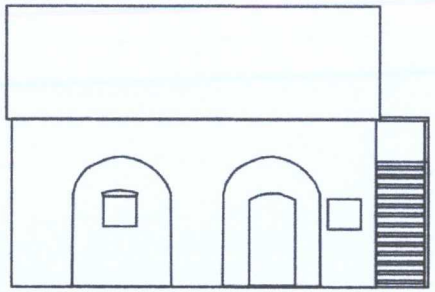
Stage 1: c.1790
Single Barn/Stable
with external stairway

Field side of stables open as per typical stable detail. Likely to have had brick pillars to support roof along frontage.

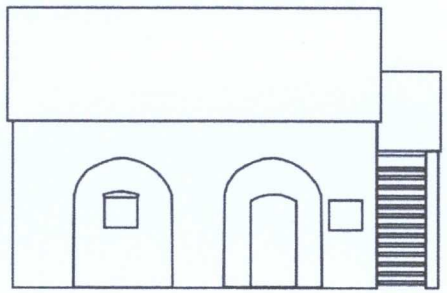
Stage 2: c.1800-1830
Single Barn/Stable
with covered stairway
and rear store

Circular opening created to provide natural light to top of stairway and hay loft.

Hay loft doorway had to be dropped under new pitched roof. New step created to hay loft floor level.
