HINCKLEY & DISTRICT MUSEUM, LOWER BOND STREET, HINCKLEY.

Structural Engineers Report

Job No 08425

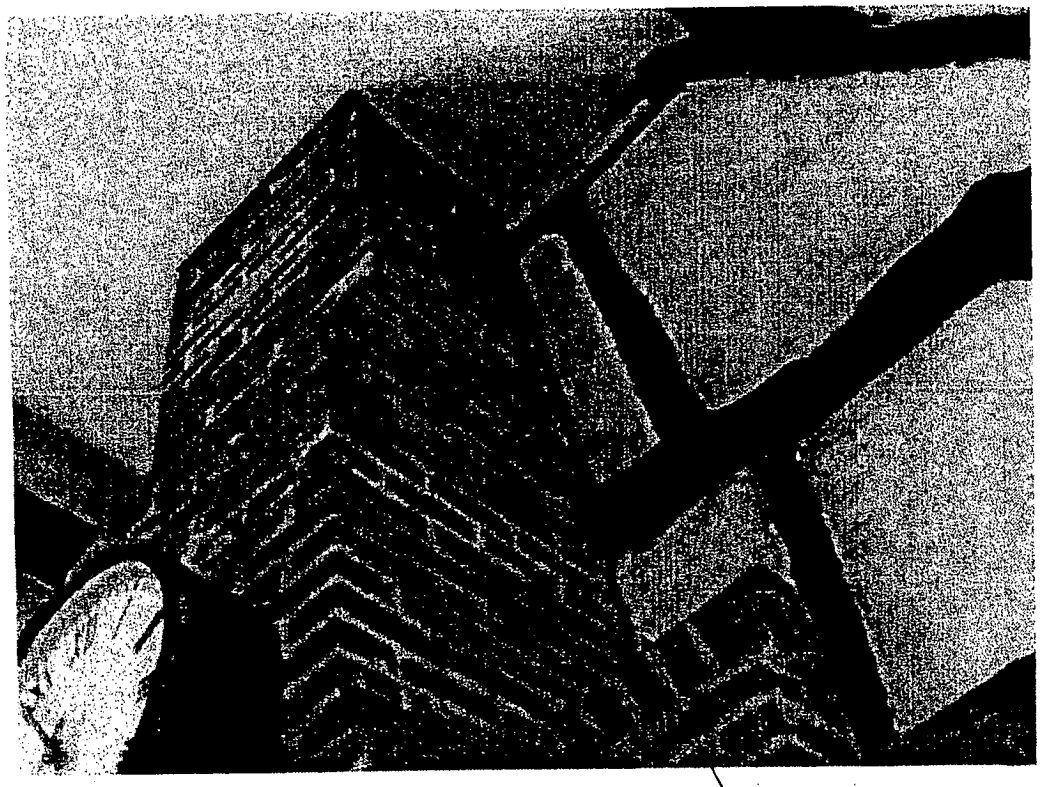
30mm gap between chimney and gable wall

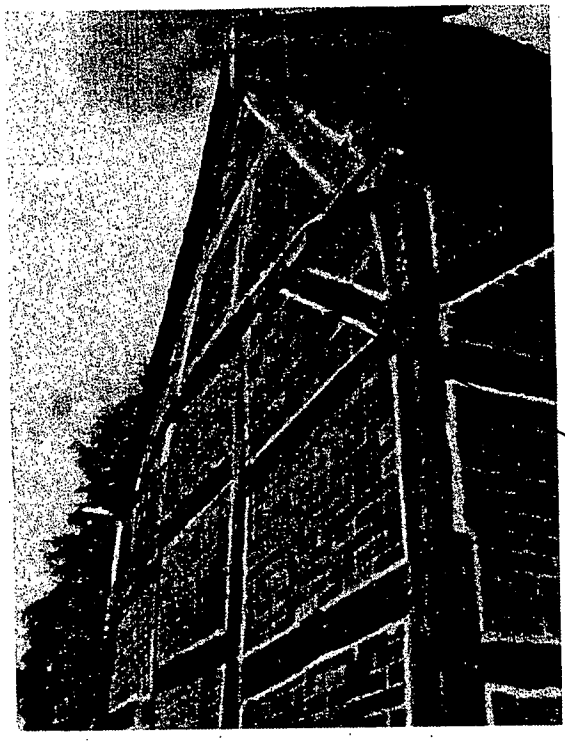
2003 repointing evident but continued bulging.

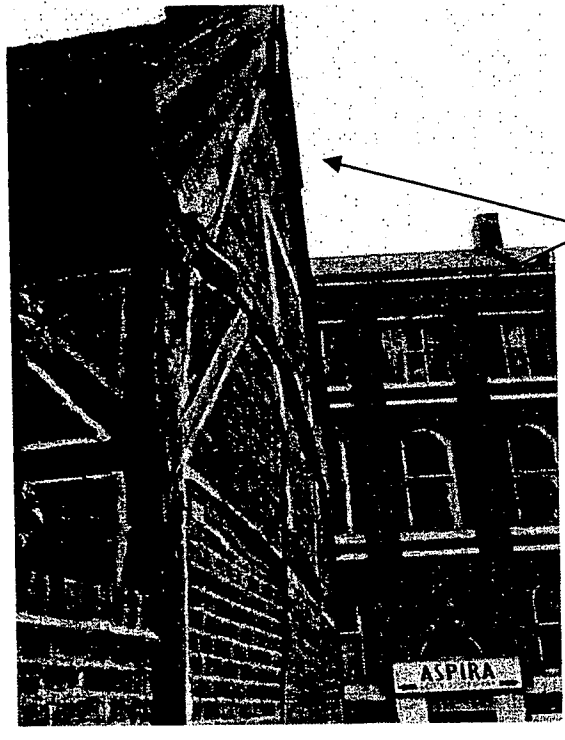
Bulging in line with former attic and first floors.

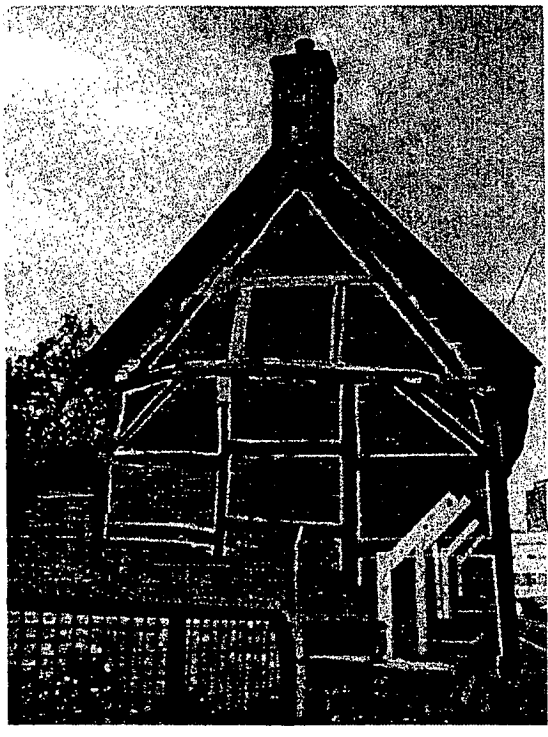
Lime mortar beginning to come out on panel periphery.

Bulging end gable.
