Version: 1.0
20th January 2010

The Elms, Nailstone
Historic Building Report

David Hickie Associates
Heritage Planning
Arlington House, 7 Hunters Walk
Witherley, Atherstone, Warwickshire
CV9 3SU
Tel: 01827 722153

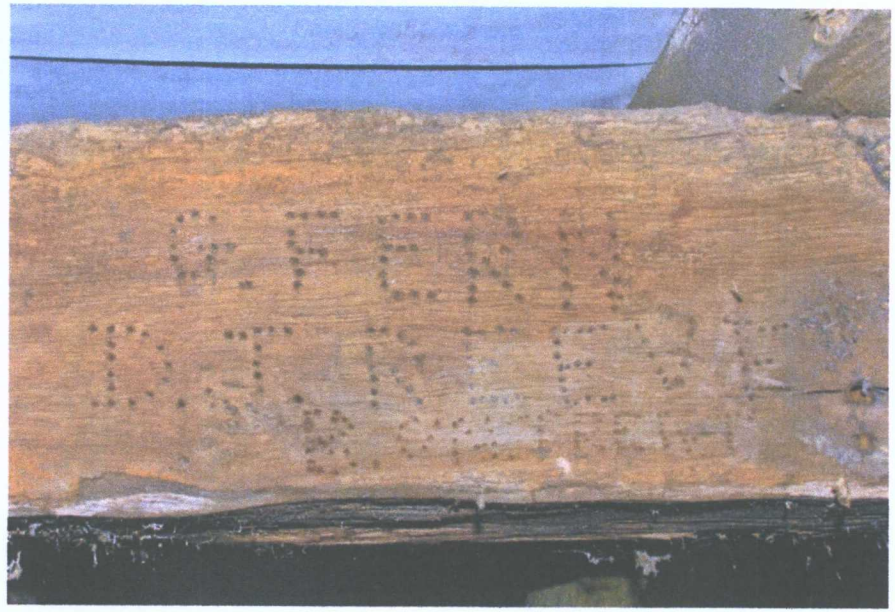
4.2 Roofs

The roof construction of the main house can be seen where ceilings have been removed. It is a fairly low pitch, with wall plates, hips and purlins of oak, and rafters of softwood. It was always intended to be covered in plasterwork, so the construction is utilitarian.

Sections of hips and purlins not covered by lath and plaster have been limewashed.

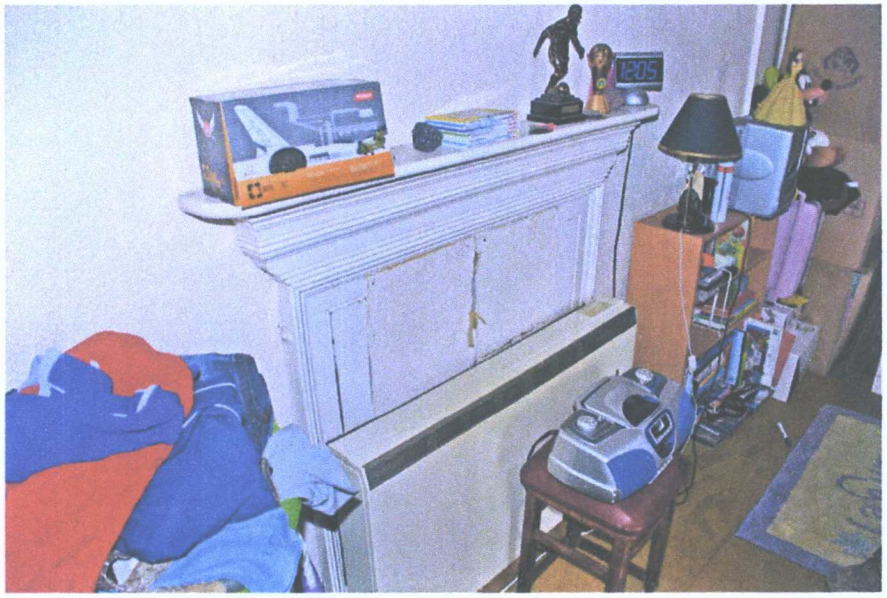
5.2 The upper floors

The two main bedrooms at first floor are relatively unchanged. The original doors and joinery remain. The fireplaces have unsurprisingly been "modernised". The room on the east side has had a large casement window added in the side wall, whereas the western room originally had a window set centrally in the side wall, which has since been blocked.

The rear room on the east side under the tiled lean-to roof was once a bedroom and now a large bathroom. It has a casement window in the side wall, probably not original. The original window would probably have been in the rear wall, now obscured by external render and internal tiling.

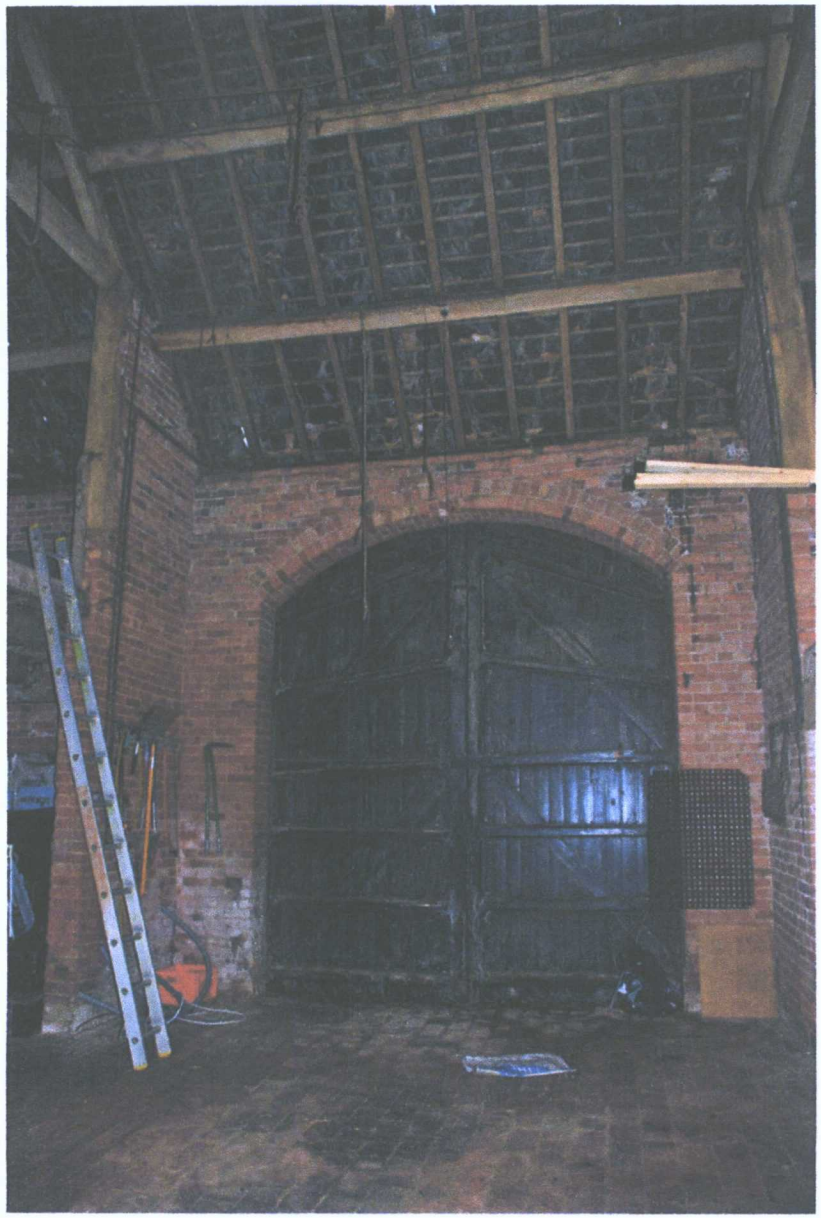
Outbuilding 5: Large arched doorway to right of picture
