BS5837:2012 Tree Survey  
Land off Barton Lane  
Congerstone  
Leicestershire  
NGR SK36996 05611

Survey by  
Christopher Barker CEnv dipHort ACIEEM

# **BS5837 Tree Survey, Land off Barton Lane, Congerstone**

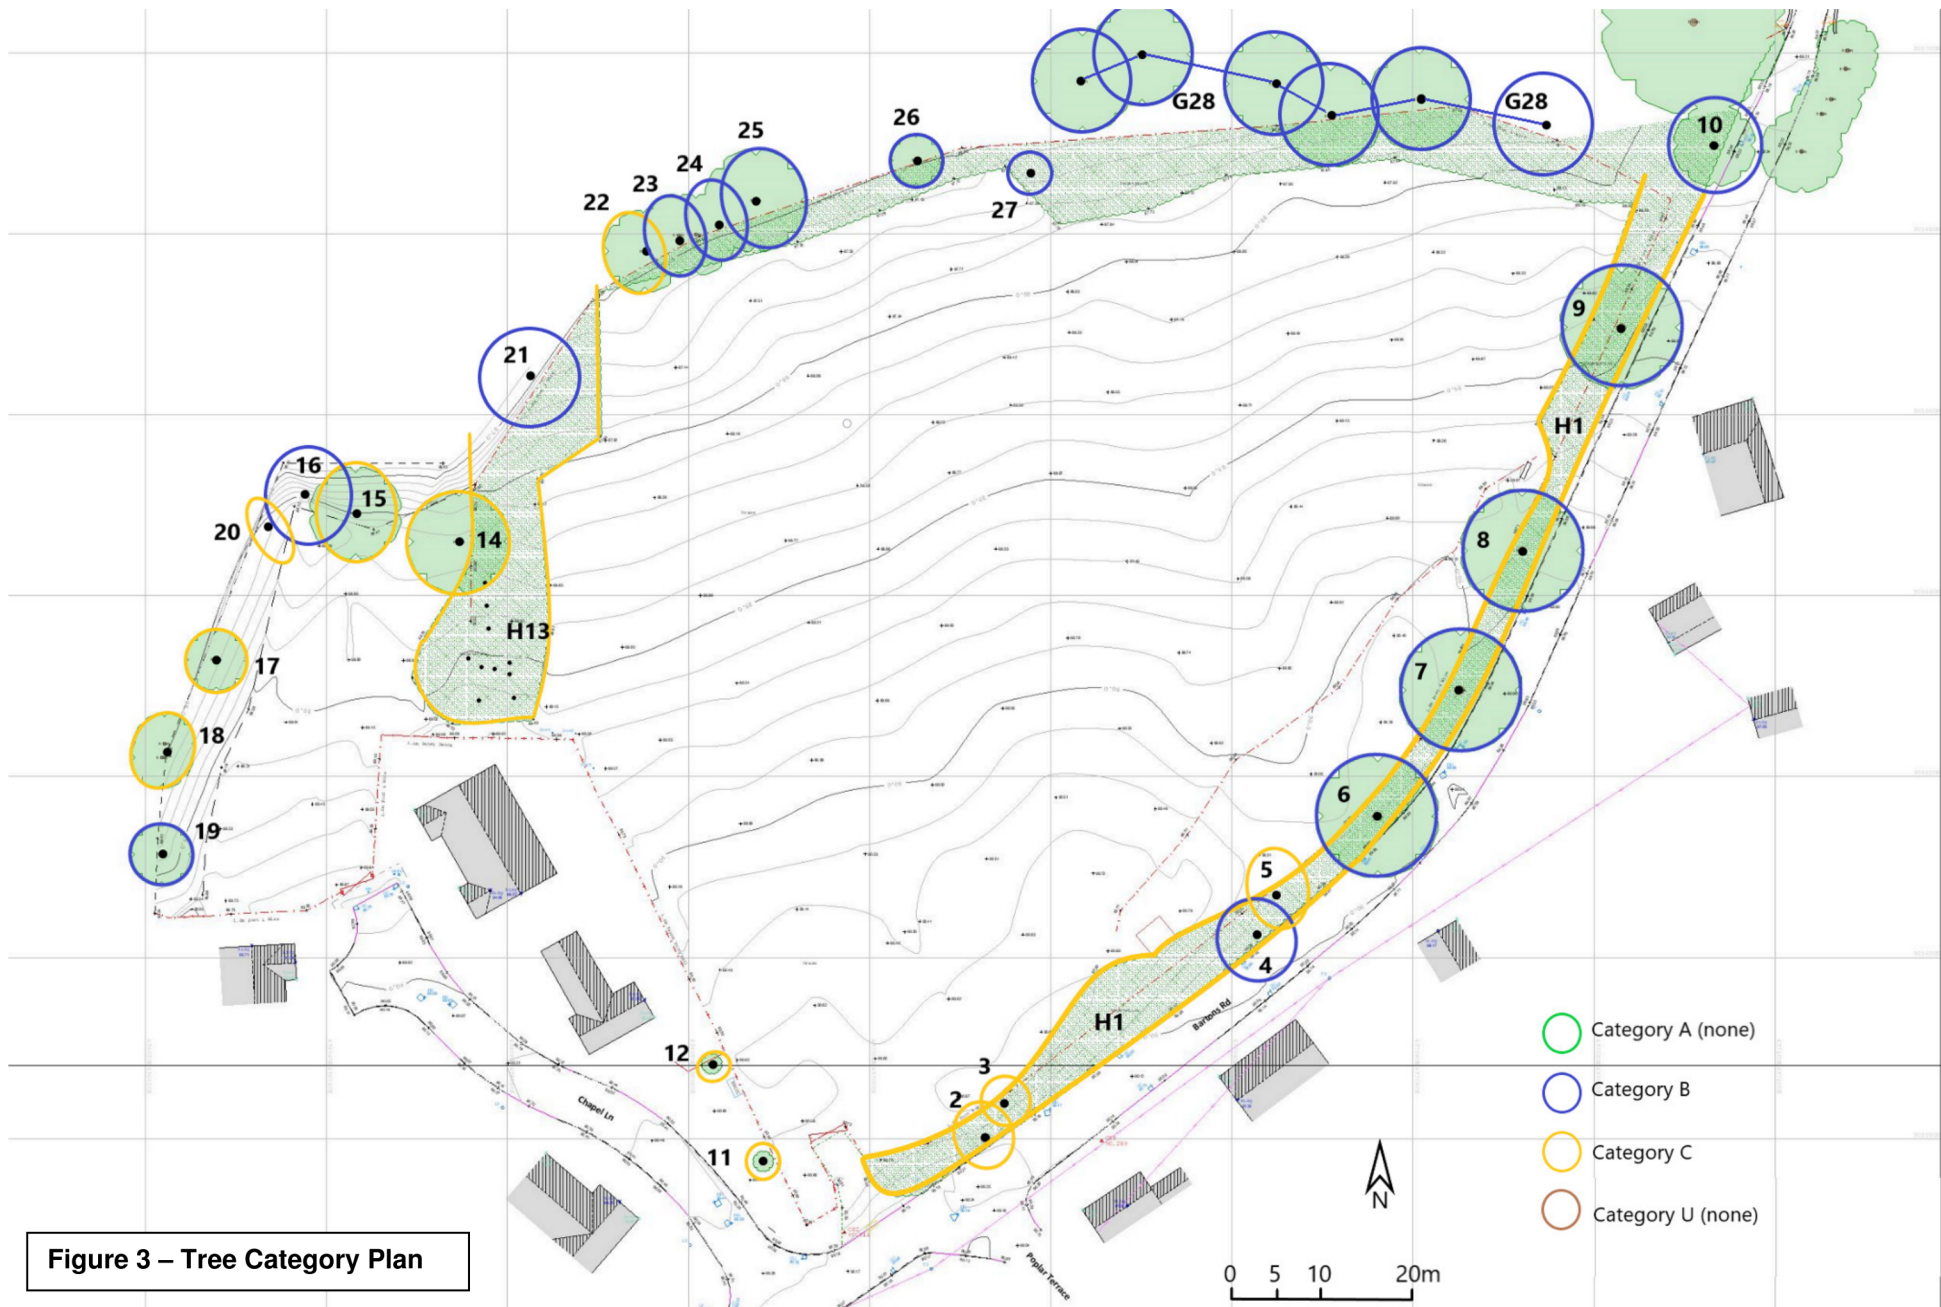
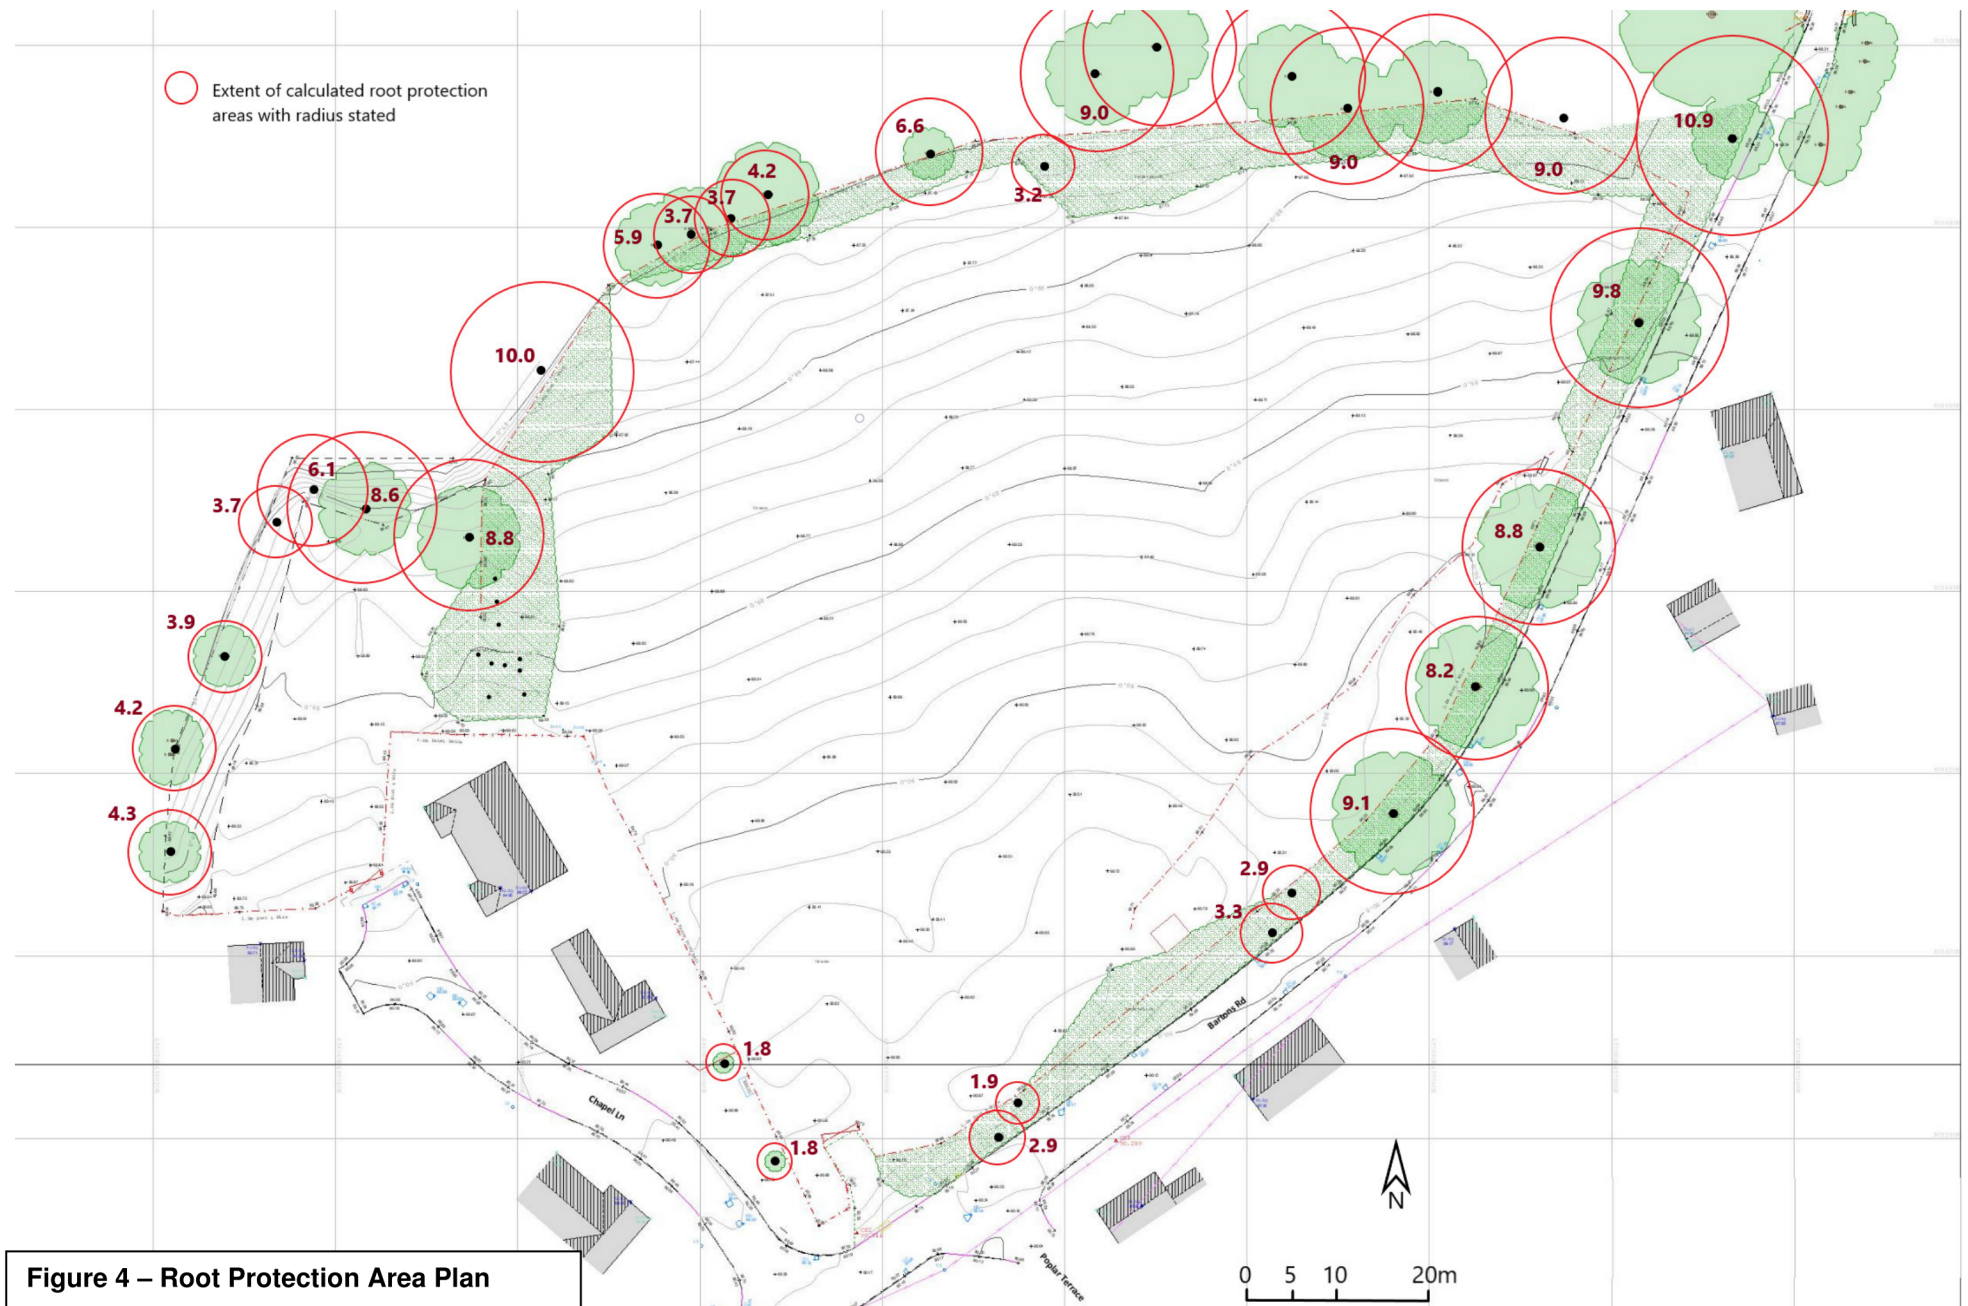
Along the north eastern edge of the field is a line of dense **Crack Willow G28**. These trees have significant fallen timber and the crown along the south side has dropped to ground level and extend some distance into the field interior.
