# Site Inspection Report

Land off Brascote Lane, Newbold Verdon

<b>Site Inspection reference</b>	SI-8338-01	<b>Date of inspection</b>	13.03.2025
<b>Inspected by</b>	<p>Josh Birchall BSc (Hons) MCIEEM, Bat Class Survey Licence WML CL17 (Level 1), Senior Ecologist</p> <p>Joshua Sadler BSc (Hons), Arboricultural Consultant</p>		
<b>Task description</b>	<p>Brooks Ecological were instructed to carry out a further survey of T7 at the proposed entrance to new development at Brascote Lane, Newbold Verdon. This survey was commissioned in response to the local authority (Leicester County Council) statement as follows;</p> <p><i>'The report states that T7 which is due for removal contains potential roosting features and requires further surveys. I cannot see details of this survey/s within the addendum therefore please can this be provided. I notice in the table T7 is categorised as PRF-I, I think it would be challenging to categorically say the features are only suitable for a small number of bats without further inspection. As this relates to site access this information is required prior to determination.'</i></p> <p><u>A climbed endoscope inspection</u> of all potential roost features w

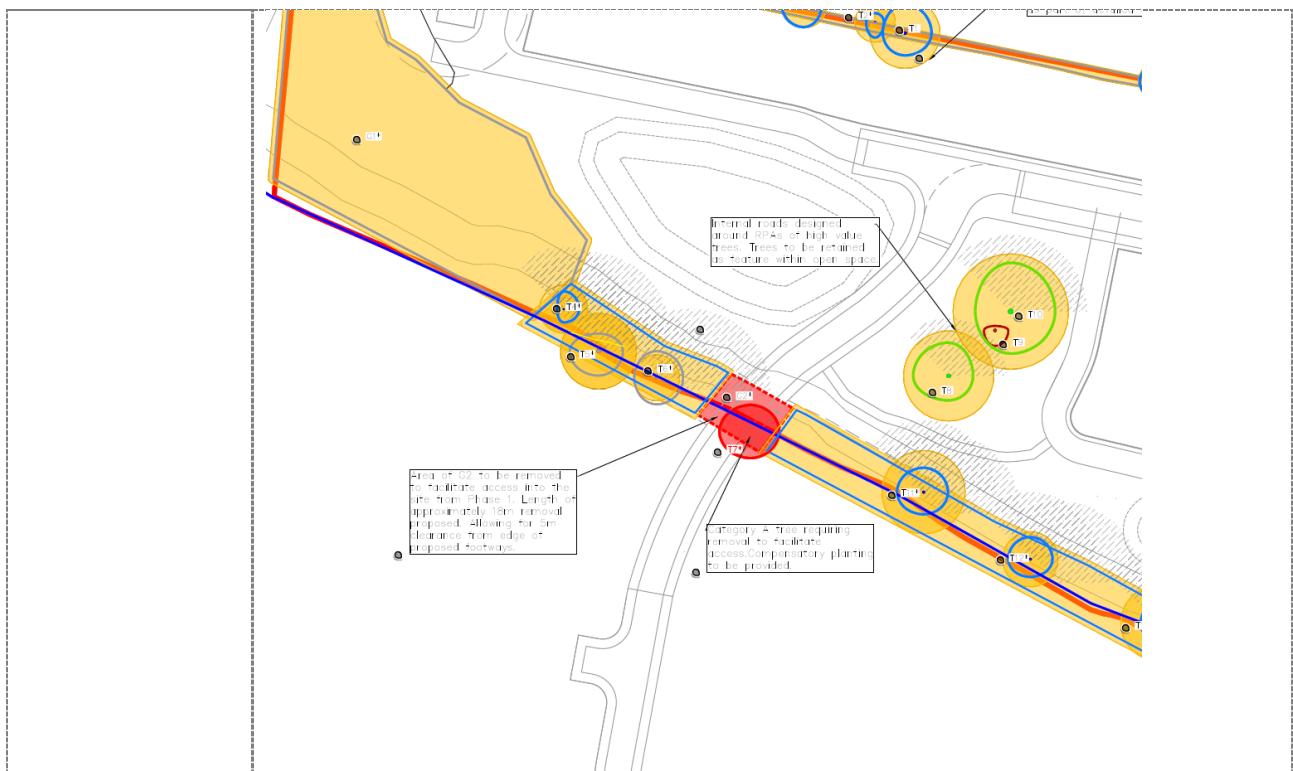
<b>Figure 1</b>	<p>Tree 7 location taken from aerial imagery and from Tyler Grange Tree retention and removal plan drawing 16602P011</p>

<b>Report</b>	<p>T7 (location shown in Figure 1) is a mature oak, adjacent a small stream, with light ivy covering. It has been identified as PRF-I in Tyler Grange Report 'TG Report No. 16602_R04a_EJ' due to 'some fallen limbs leaving potential crevice features' and 'some ivy potentially obscuring further features'.</p> <p>Inspection was carried out initially by eye and where required with the aid of a high-powered torch. Following this, if required, endoscope inspection was also carried out to ensure all areas of the cavity were closely inspected. This process was repeated from each of the access holes to allow inspection from various angles.</p> <p>Several smaller dead limbs were inspected and found to support no suitable PRFs. Shallow rot holes on the southern facing limb high up in canopy though these were found to be facing upwards so susceptible to water ingress thus precluding it as a suitable PRF. A small hazard beam on the northern elevation, this was found to be an open and shallow features c.15cm wide by c. 5cm deep, again open to inclement weather and unsuitable to support roosting. Occluded bark around a larger dead limb on the southeastern aspect, this was found to be too shallow to act as a PRF. Ivy cover was in general found to be fairly light and not supporting suitable stem diameters/ overlapping stems to support roosting bats, likewise no features that were otherwise hidden from ground level were observed.</p>
