## **ENGINEERS REPORT**

### **Report on a visual inspection of:**

TWO BARNS AT  
MANOR FARM  
CARLTON ROAD  
BARTON IN THE BEANS  
LEICESTERSHIRE  
CV13 0DE

24S01/02 December 2024

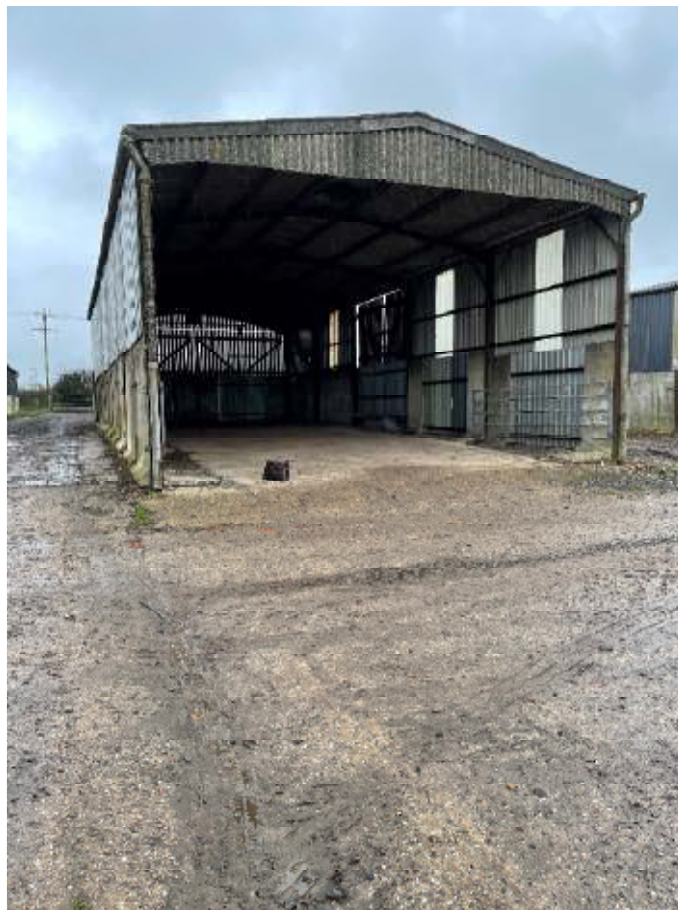
**Figure 1:** Barn A - Front elevation

There was evidence of impact damage to the front left hand side portal frame column.

- Provide additional 50x50x5 RSA rafter stays.
- Replace the front left hand side corner portal frame column with a similar sized section.
- Surface preparation and corrosion protection of the steel frame
