**A Historic Building Photographic Survey at**

**102 Main Street,**

**Nailstone,**

ULAS Report No 2025-005

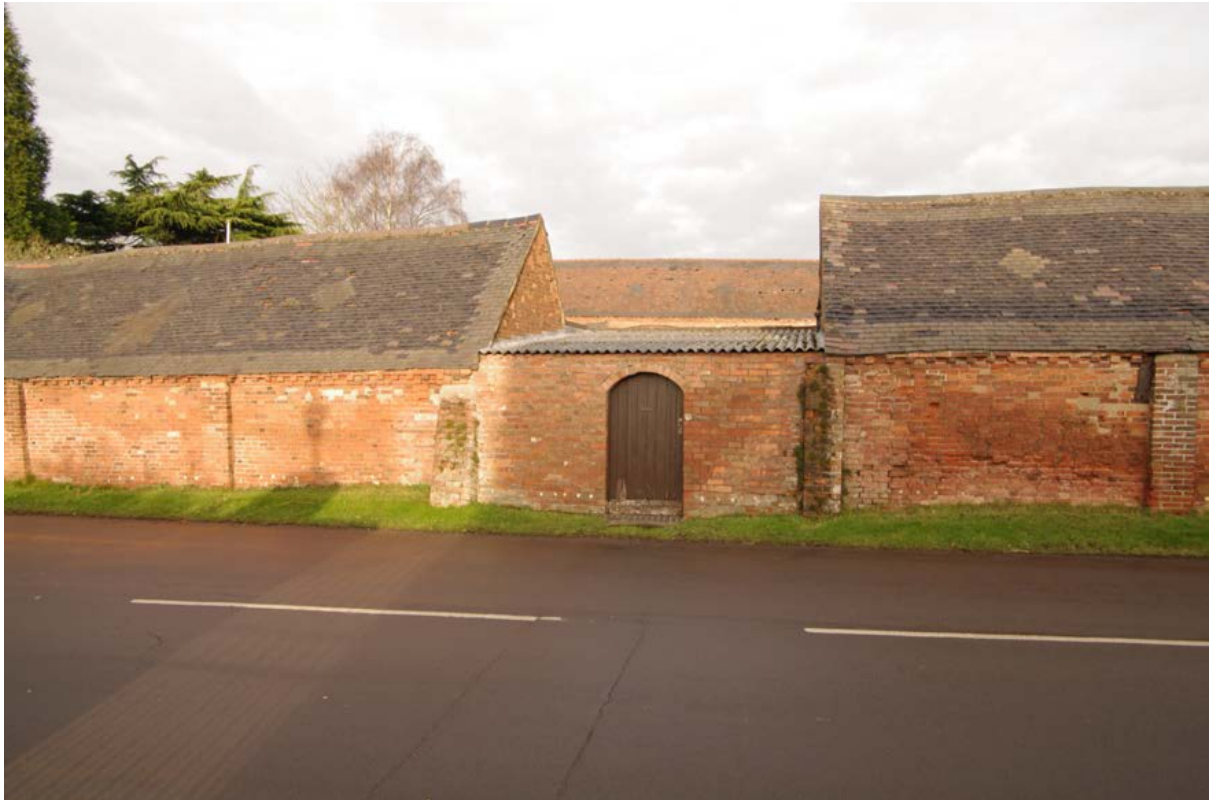
Figure 17: Area of roof to be raised between the barns on Main Street  
*Looking north-west*

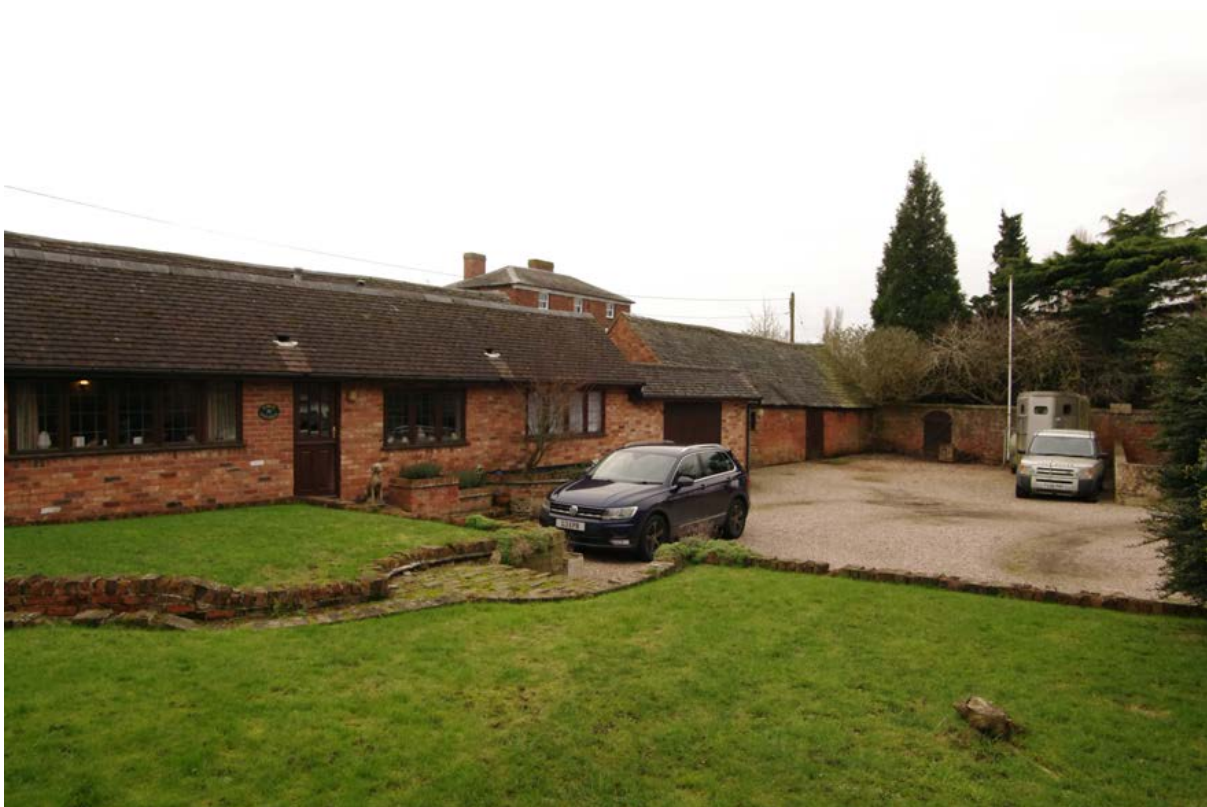
Figure 22: View of the yard looking south-west  
*Note the low roofline above the black car which will be raised. Main Street runs behind these buildings*

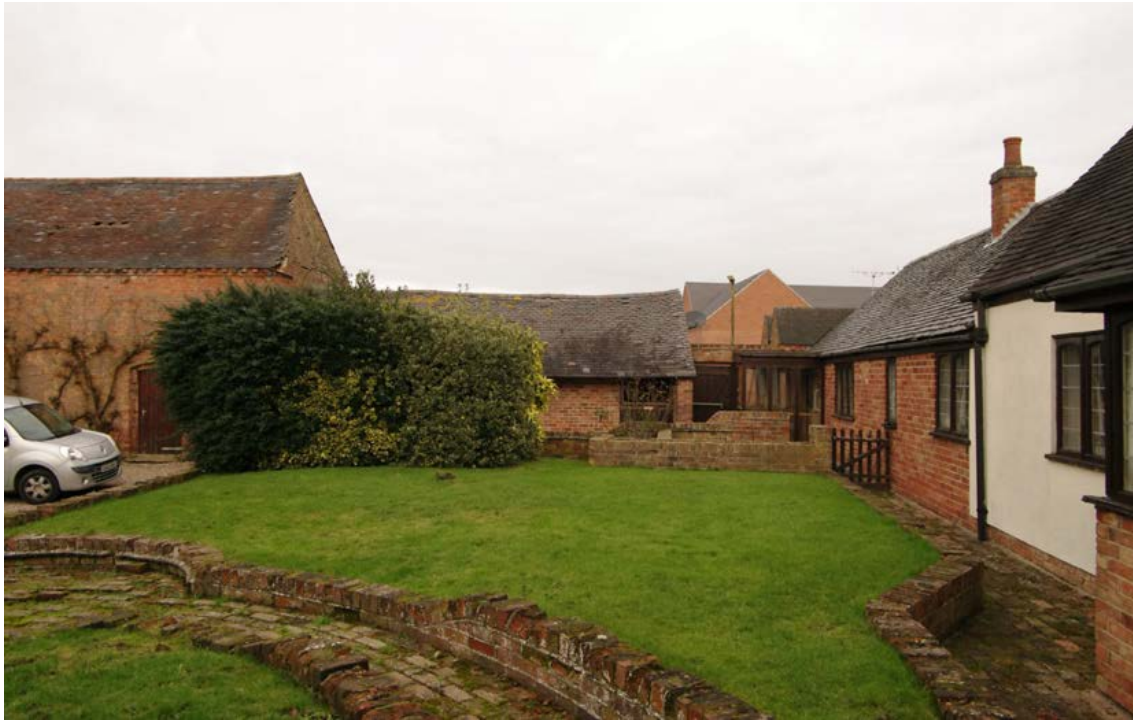
Figure 23: View of the yard looking NNE

*Threshing barn on the left with attached stable in the centre. The porch mid-right will be removed and the gabled roofline of the office annex behind this will be altered*

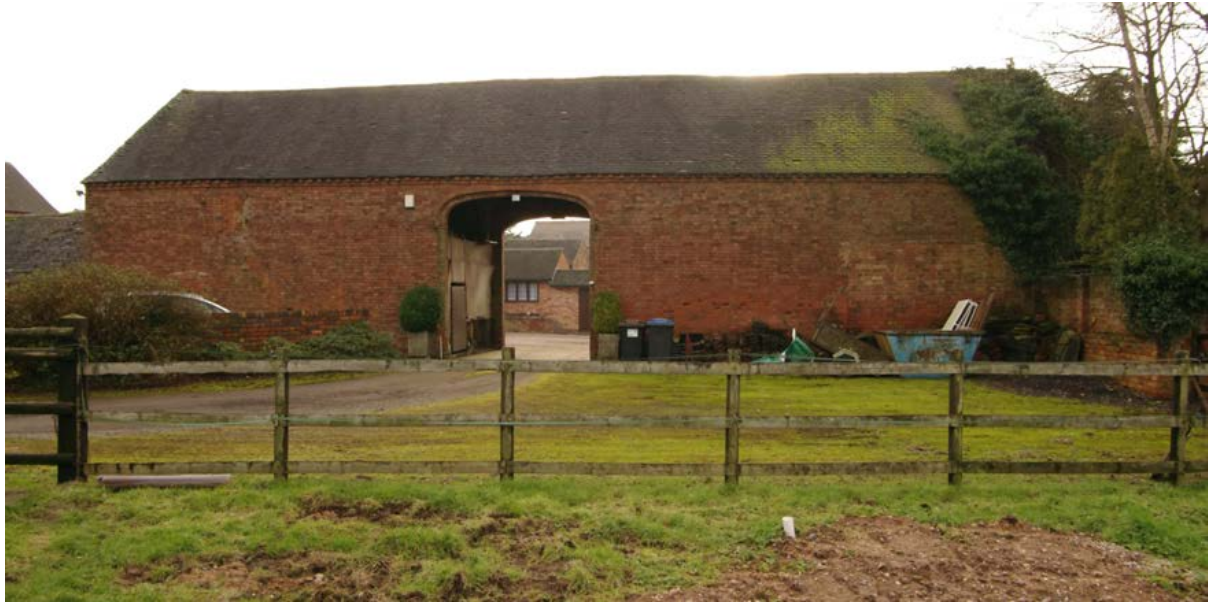
Figure 25: North-west facing elevation of the threshing barn  
*Looking southeast*

The threshing barn lies on a roughly north-east to south-west alignment. It is slightly more NNE to SSE than the other buildings on the eastern and southern sides of the yard which may suggest a different phase of laying out the footprints of the buildings. The threshing barn uses mid-19th century red bricks laid in courses of three stretchers to one header. Alternating projecting brick headers along the eaves form a decorative break to the gutterless eaves. 20th century ceramic roof tiles are used with numerous patches and repairs especially on the southern side. A full-height doorway runs across the centre of the barn on the northern and southern sides. Iron pintles for the doors remain but no doors survive.

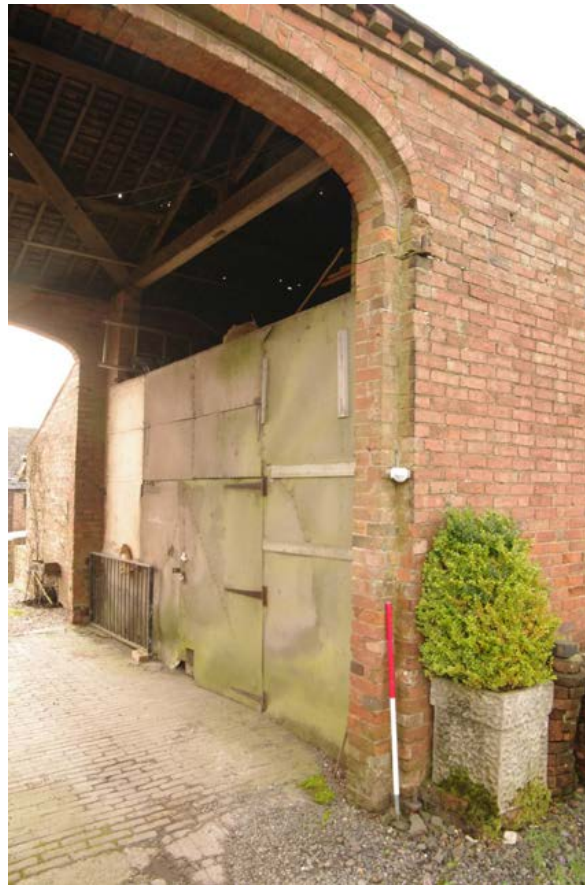
Figure 29: Threshing barn. North-west facing elevation doorway detail  
*Note the door pintles. 1m scale*

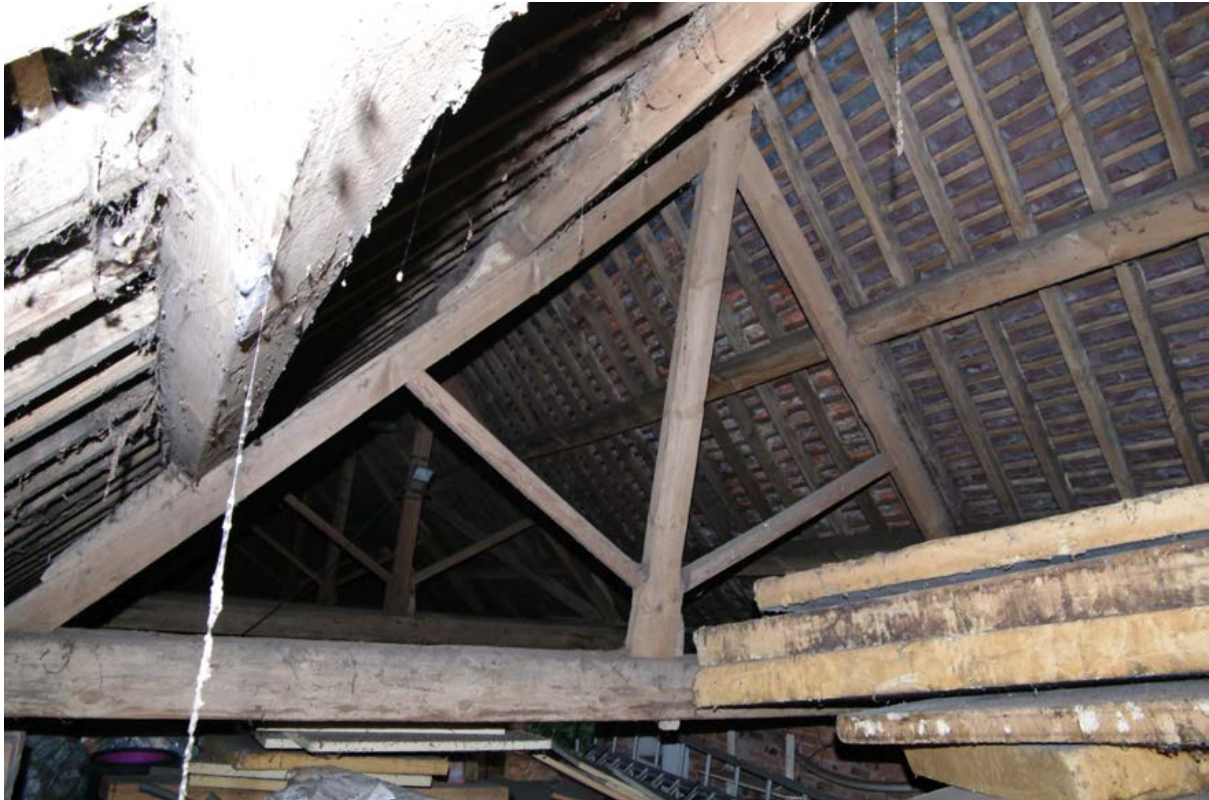
Inside the threshing barn the walls have been lined with 20th century concrete breeze blocks, probably added to support failing brickwork. This masks the earlier fabric of the building. To the west of the central doorway the ground floor room is an open single room with a low ceiling supported by modern RSJ girders (Figure 34). Modern steps lead up to the first floor to reveal the roof structure (Figure 35). The roof trusses appear to be of early to mid-19th century in date and consist of pegged (rather than bolted) king posts with cleated purlins resting on the backs of the principal rafters.

Figure 35: Threshing barn roof structure  
*Looking north-east. Taken from stairs at the western end of the building*

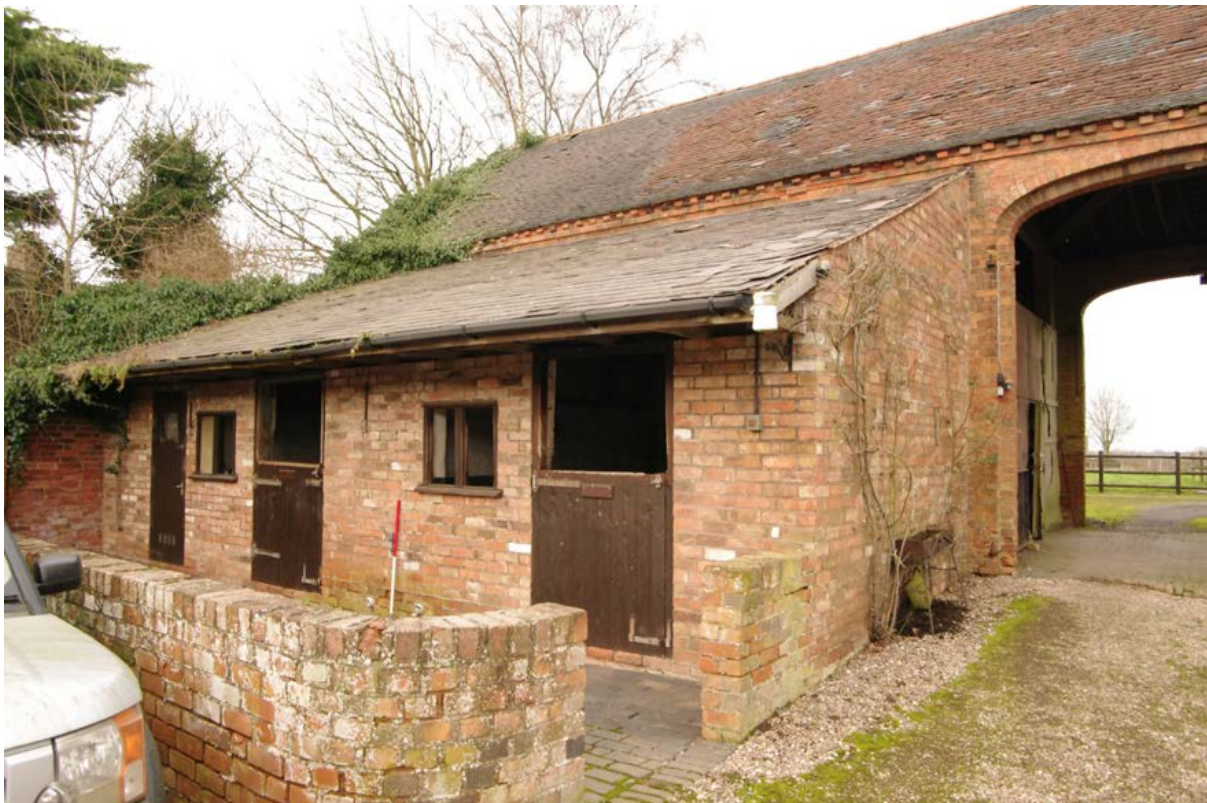
This stable forms a lean-to type structure built against the south-east facing elevation of the threshing barn (Figure 38). A small brick-paved and walled yard has been built in front of the stable (Figure 39). This is not shown on any maps so is likely to be fairly recent in date. The north-east facing elevation of the stable has no openings, blocked or otherwise (Figure 40). The south-west facing elevation is obscured by vegetation. The building contains two loose boxes and a small store room at the western end. The store room has brick dividing walls (Figure 41). Both loose boxes have the same layout and the posts supporting the purlin lean-

Figure 38: Stable built against the south-east facing elevation of the threshing barn  
*Looking north-west. 1m scale*

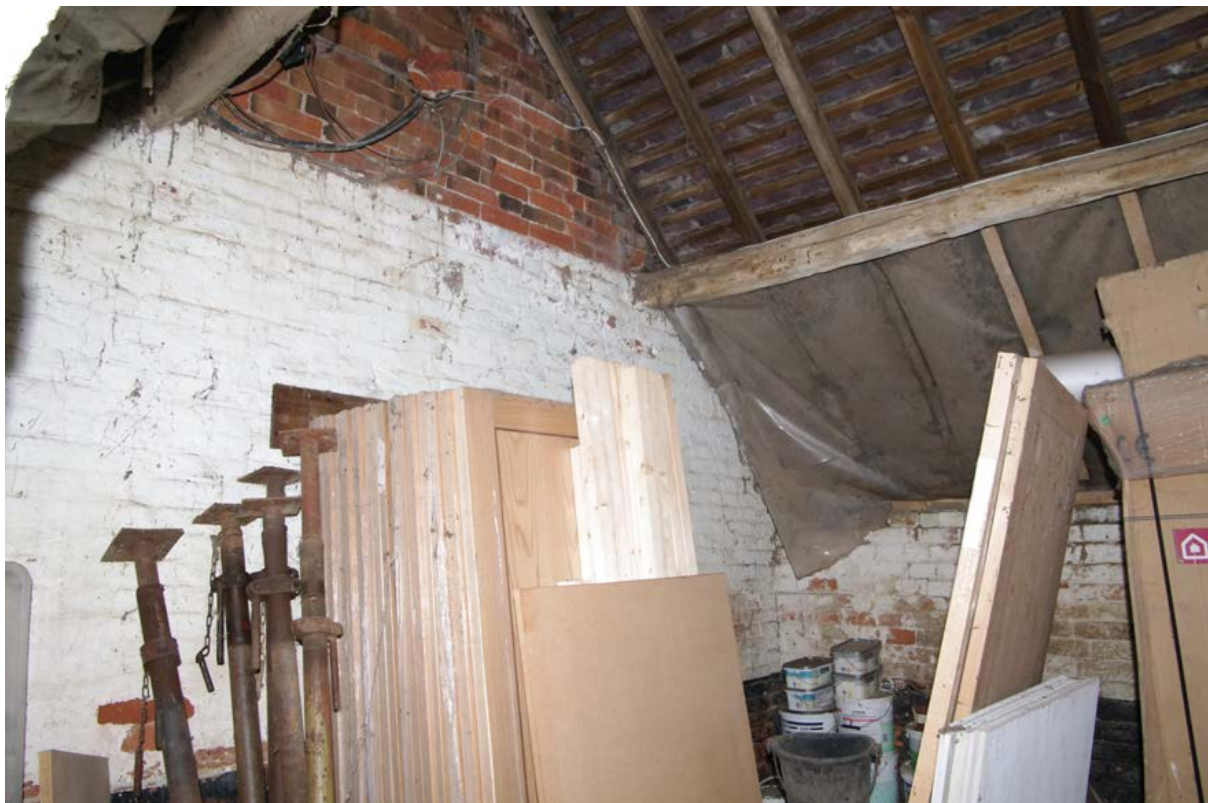
Internally, the north-eastern stable building has been divided into three similarly sized loose boxes which have concrete breeze-block dividing walls but no skinning blockwork on the outer walls (Figure 48). The roof is supported by a king post with the purlins resting on the backs of the common rafters and is typical of agricultural buildings from the second half of the 19th century in this region (Figure 49).

Figure 48: North-eastern stable, end wall with the threshing barn  
Looking north-west

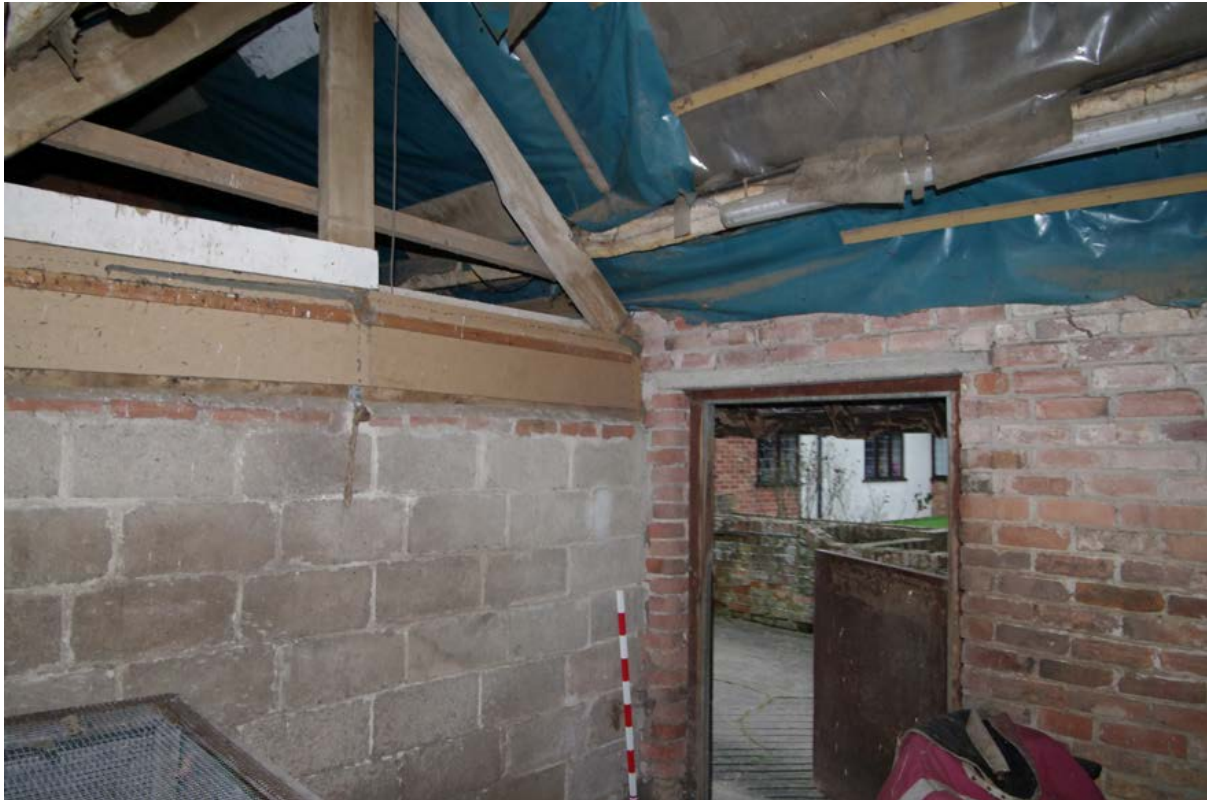
Figure 49: North-eastern stable, dividing wall and roof structure  
*Looking east. 1m scale*

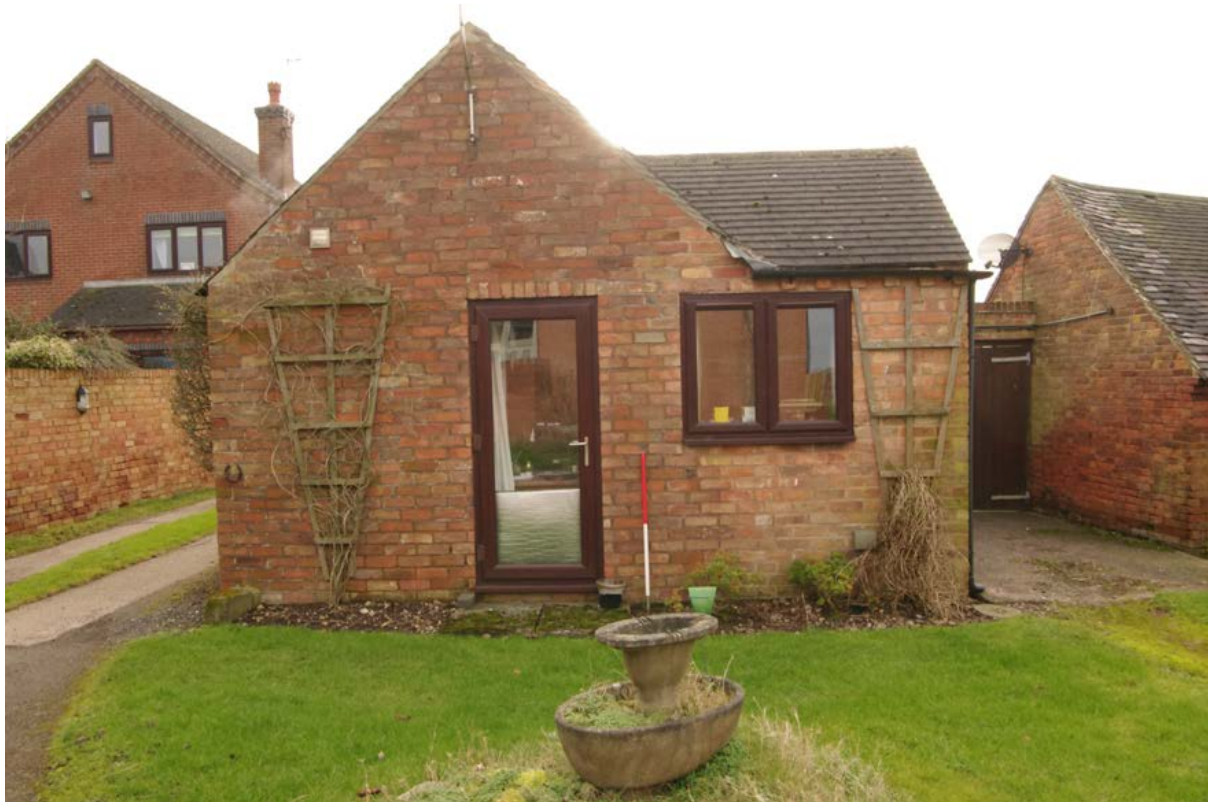
The north-east facing elevation is covered with thick vegetation but it is possible to see a single-width doorway and window (Figure 51). The window lights a small toilet and shower room. The north-west facing elevation has a small window and doorway (Figure 52). Another window and door are located on the south-west facing elevation (Figure 53). Attached to the south-west corner of the office annex is a modern timber and glass porch which will be removed during the proposed works (Figure 54).

Figure 52: North-west facing elevation of the office annex  
Looking south-east. 1m scale. The north-eastern stable building is on the right

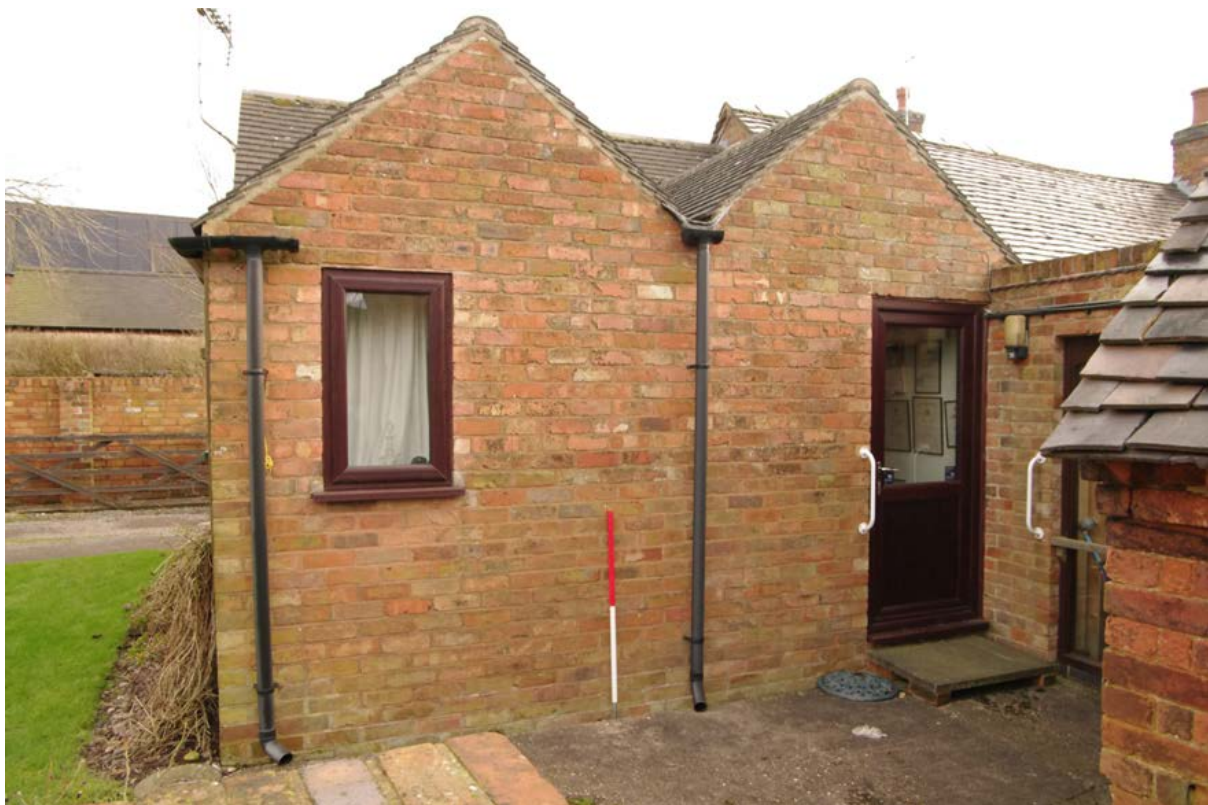
Figure 53: South-west facing elevation of the office annex  
Looking north-east. 1m scale

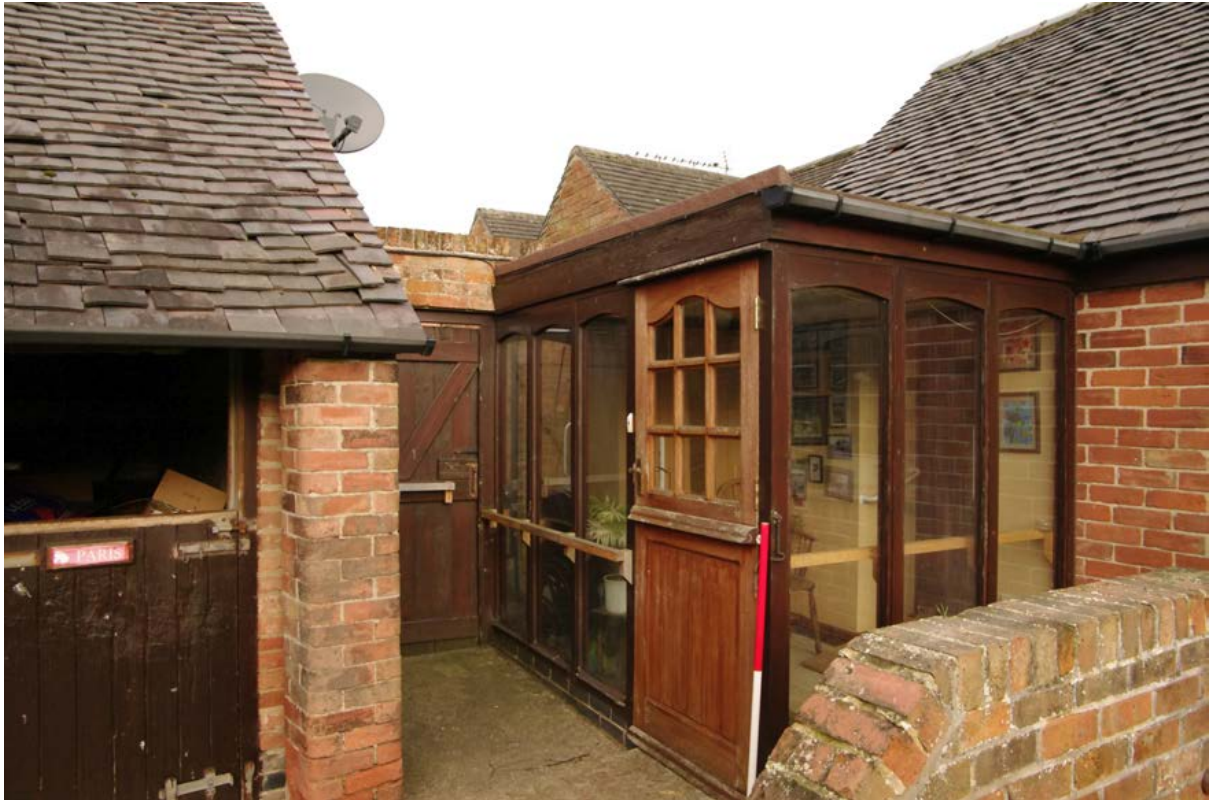
Figure 54: Porch attached to the south-west corner of the office annex  
*Looking north-east. 1m scale. The small gables of the office can be seen above the porch. The corner of the north east stable is on the left*

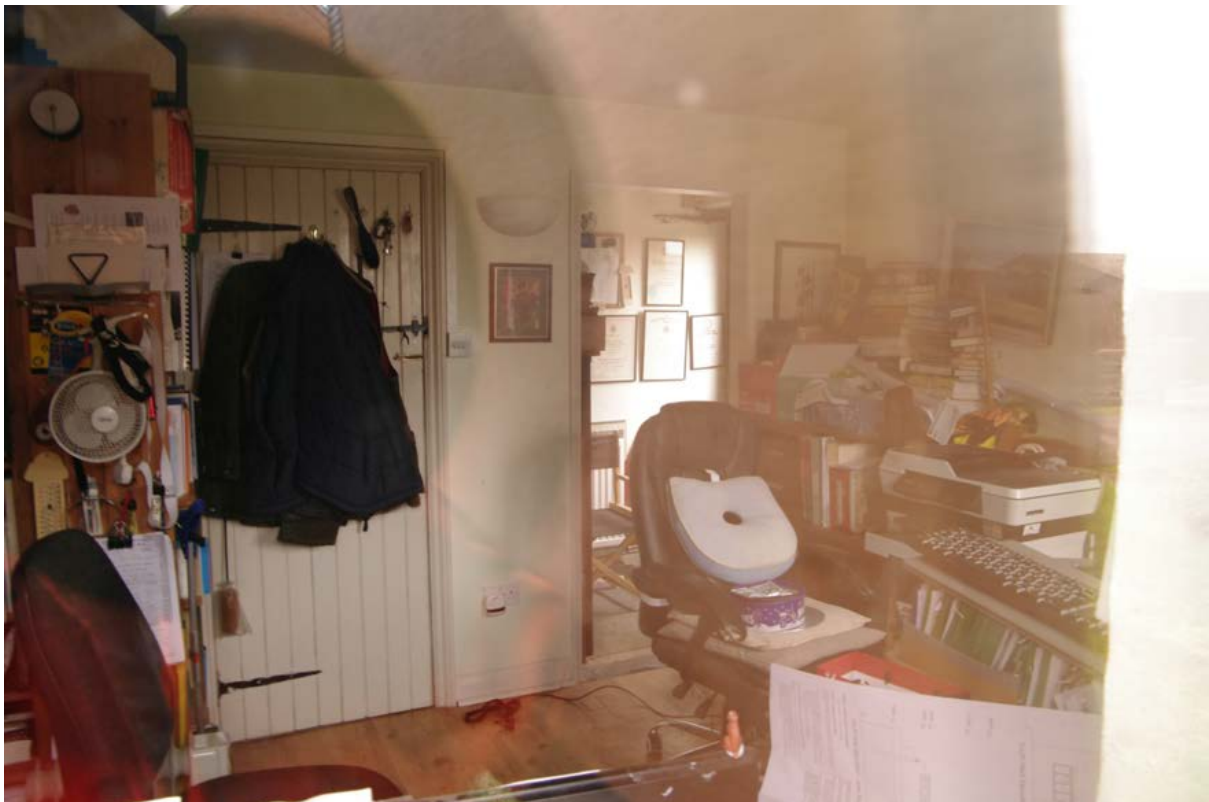
Internally, the office annex is modern with plastered walls and ceiling forming a small office and bathroom (Figure 55). At the time of the survey this was in use as part of the dwelling to the south-east and was only inspected through the windows. No brickwork or structural components were visible.

Figure 55: Inside the office annex  
*Looking south-east. The doorway on the left leads to the small bathroom and the dwelling beyond*
