## Preliminary Ecological Appraisal and Roost Assessment

Land at Hinckley Road Burbage, Leicestershire LE10 2AQ

11<sup>th</sup> November 2025

The demolition of six existing buildings and the construction of six new residential dwellings in their place.

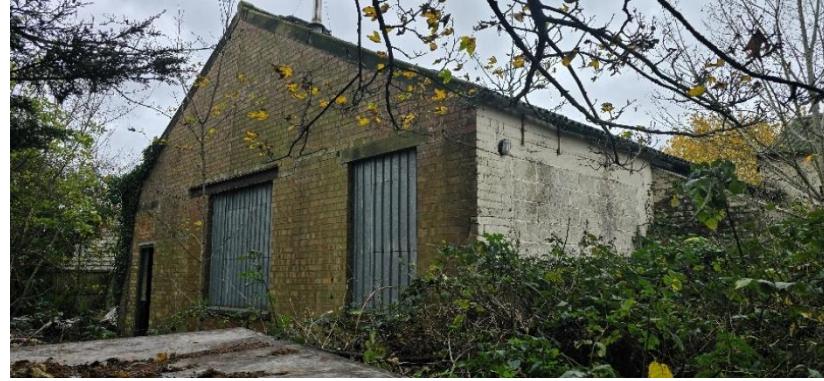
Bats		
Summary of Survey Findings	EPSL applications	
	<p>There is 1 EPSL application within 2km of the site for bats, ~1.8 km southeast for the destruction of a common pipistrelle and brown long-eared roost.</p> <p><b>Foraging and commuting habitat</b></p> <p>Habitats recorded on site are assessed to provide foraging and commuting opportunities for bats in the form of bramble scrub and trees. These habitats are likely to provide micro-climatic conditions that support invertebrates that will in turn provide foraging opportunities for local bat populations.</p>	
B1- Description	Photo	
A brick built structure with metal and timber doors, metal framed windows, and boarded up window openings. The building has an asbestos sheet roof with a single UPVC skylight and a metal frame. B1 is attached to B2 and B3. There is open access to B2 within B1, whereas access to B3 is through a closed garage door in good condition.

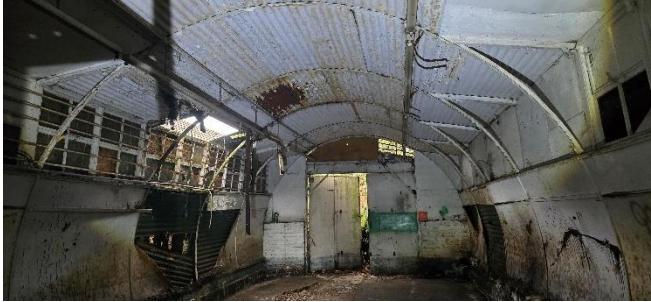
Internal	The internal cavity of B1 is structurally constrained by its predominant metal construction, which severely limits roosting potential as it lacks exposed timber or suitable brick surfaces for bats to cling to. Although no direct evidence of bat activity (e.g., droppings) was observed, the internal microclimate is compromised by significant light ingress through holes in the roof and damage above the door frame, and the construction results in unstable temperature and humidity fluctuations, rendering B2 itself unsuitable for a stable, long-term bat roost. B2 is connected to B1 internally, which also provides negligible bat roosting habitat.

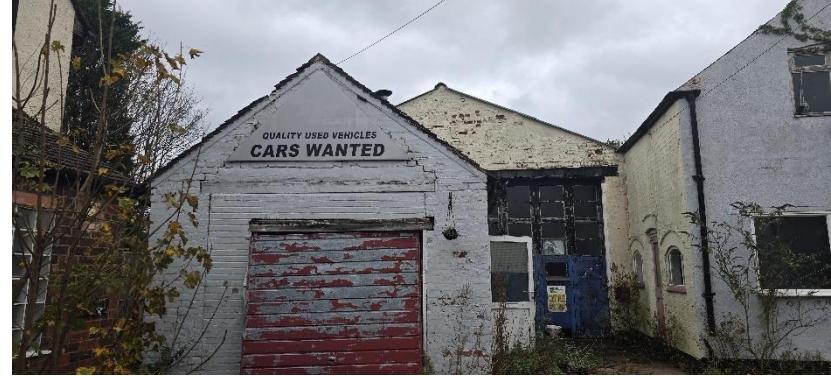
would be difficult, B3 is connected to B4 and B6a and B6b which have roosting potential.	
<b>B4- Description</b>		<b>Photo</b>
<p>A single storey brick building with a clay tile roof, metal garage door, and UPVC door. The timber frame is in poor condition. The roof void is unlined. Brickwork and mortar are in poor condition.</p> <p>This building has been given a <b>high habitat value</b>. As a stand alone building this would have moderate habitat value, but given the surrounding building and their features, it has the potential to be connected to a larger roost.</p>

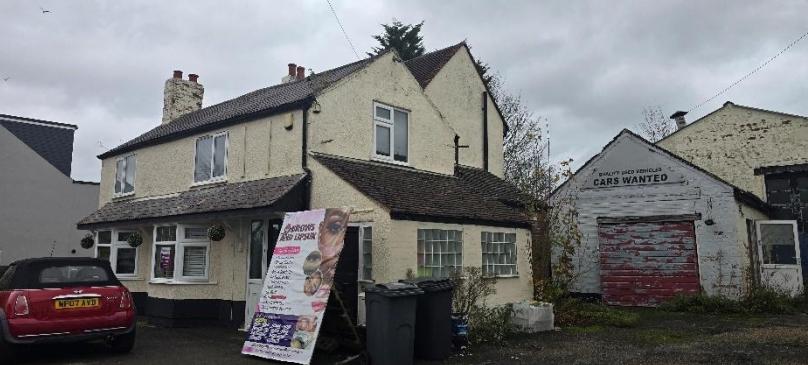
<p>of loft hatch, however the value of the building remains unchanged due to the number of suitable bat features.</p>	
<b>B5- Description</b>		<b>Photo</b>
<p>A 2-storey brick building with UPVC windows, with the main roof composed of slate and clay tiles. The roof of the single storey facing southeast has a clay tiled roof, and the single storey roof facing southwest is a slate roof. B5 has timber soffits.</p> <p>B5 has a <b>high habitat value</b> due to the large number of roosting features and given no internal inspection was completed.</p>

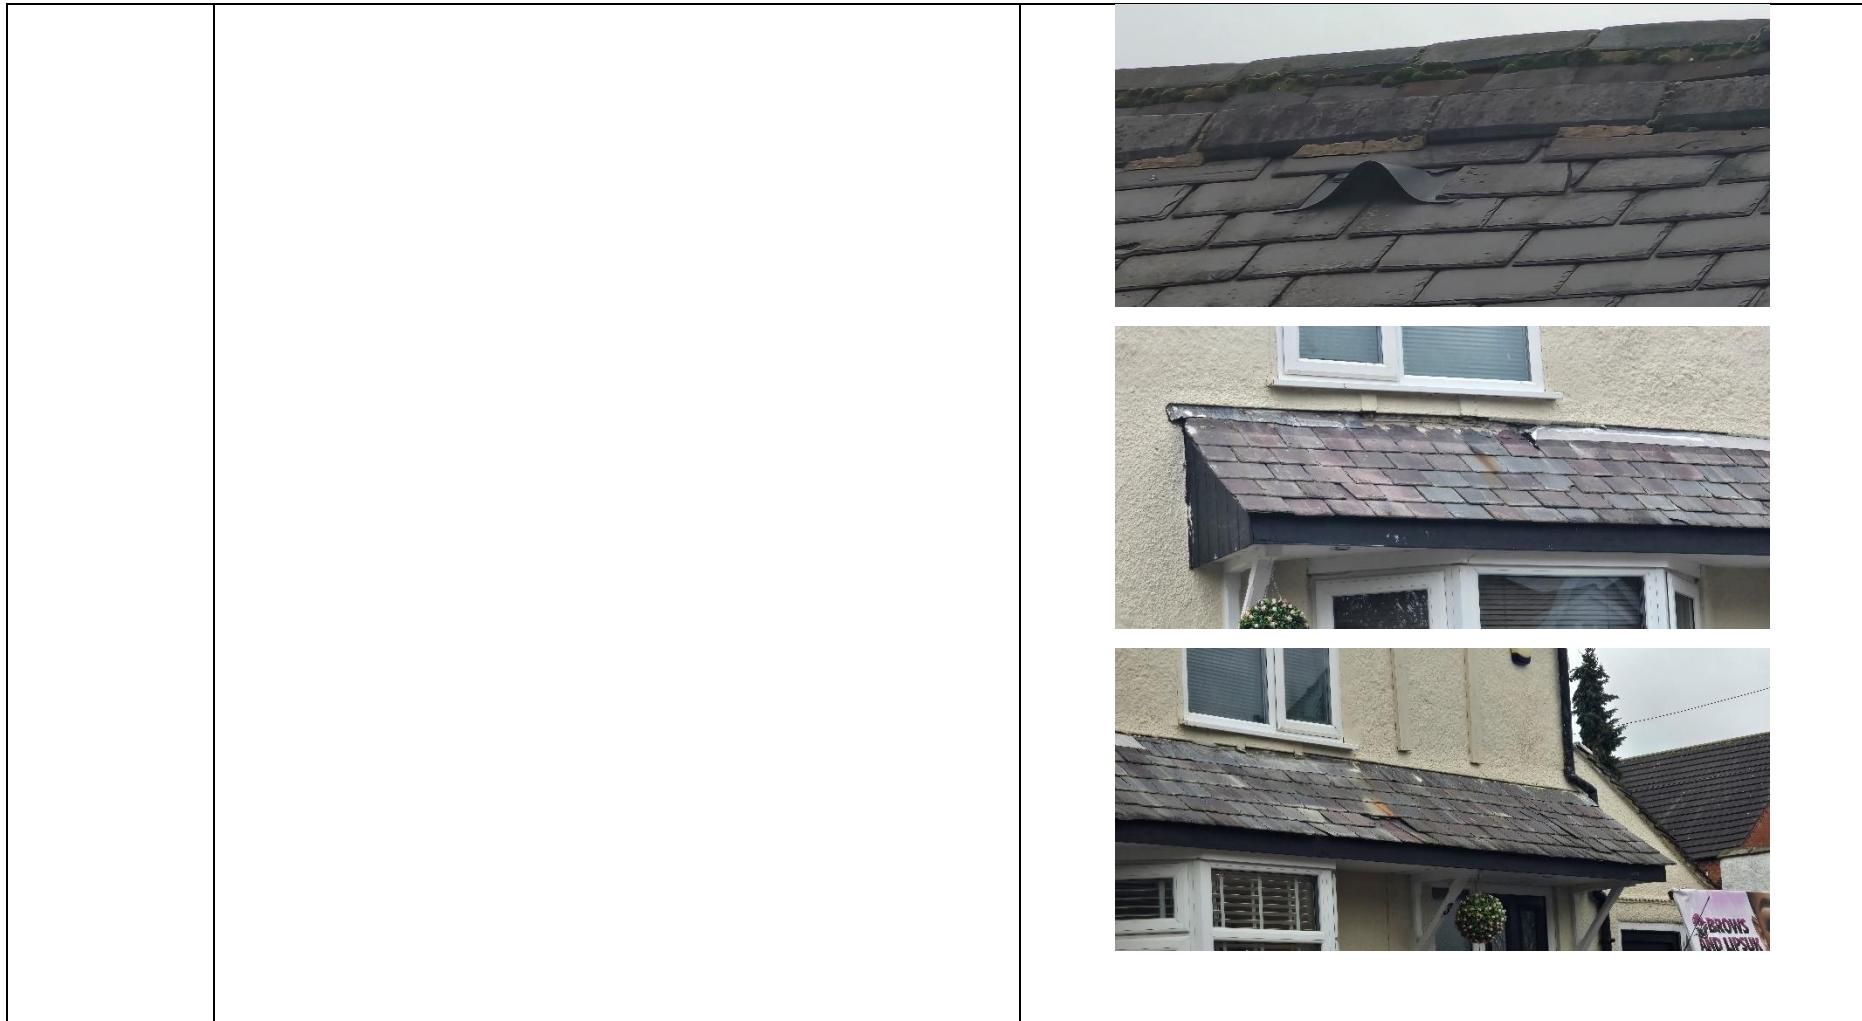
<p>and some lifted clay tiles, with vegetation growing out of the chimney and the roof. The vegetation is Buddleia, also seen in the introduced scrub onsite.</p> <p>The slate roof on the southwest facing single storey extension is also in poor condition, with loose and missing tiles. The roof of a second southwest facing single storey element similarly displays lifted tiles.</p> <p>Given the extent of lifted and missing tiles across all roof sections, B5 provides multiple potential access points and suitable habitat for crevice dwelling and void dwelling bats. As a result, the roof is assessed as <b>high suitability</b> for roosting bats.</p>

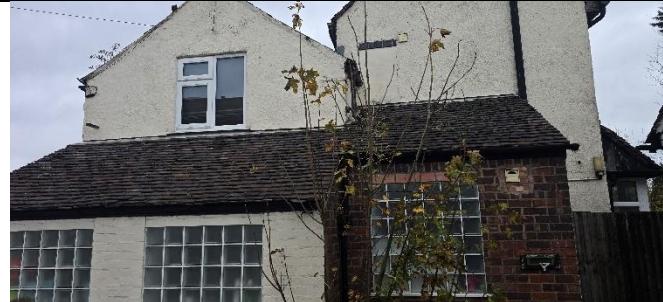
Walls	The walls of B5 are brick built with cladding as an external layer. The walls and cladding are in good condition with no habitat for crevice or void dwelling bats.

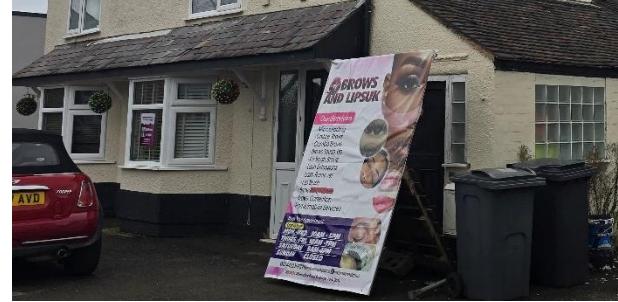
Doors	The doors of B5 are UPVC and are in good condition, providing no habitat or access for bats.

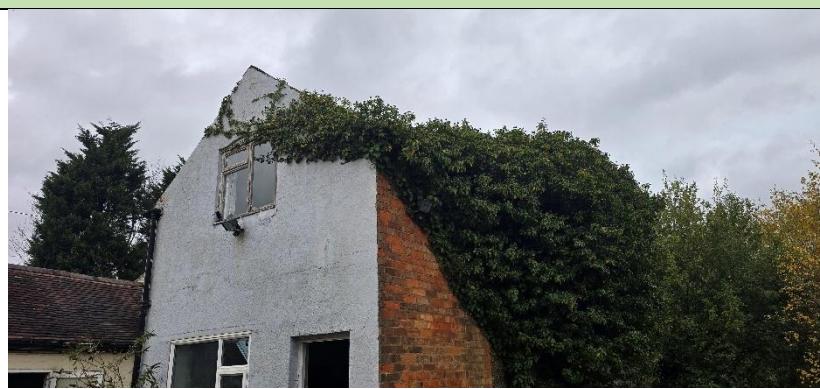
Internal	The internal inspection could not be completed; however the building has been given a <b>high</b> habitat value, which allows for further surveys and an internal inspection.	
B6- Description	Photo	
B6 comprises a two-storey brick-built structure (B6a) with an attached single-storey metal shed (B6b). Together, these form a single collective unit.  B6a – B6a is a brick built, two storey structure. The exterior is extensively covered with mature ivy growth, obscuring many architectural features and limiting the ability to assess potential access points. The roof is clad with slate tiles. Due to the

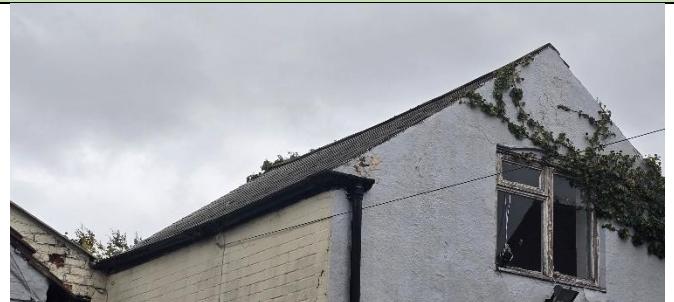
<p>vegetation cover, the condition of the roof and upper elevations could not be fully evaluated.</p>		
<p>B6b – B6b is a single-storey outbuilding constructed from corrugated metal sheeting. Evidence of fire damage is present throughout this section. Internal access is available from adjoining buildings, with connectivity through B4 → B3 → B6, as well as directly between B6a and B6b.</p>		
<p>Due to some visible roosting features present, the thick ivy blocking any further inspection, and the lack of internal inspection, due to evidence of fire damage, this <b>B6a</b> has been given <b>high habitat value</b> for bats as a precaution, and B6b is negligible.</p>		
Structure B1a	Suitability	Photo
Roof	<p>The roof of B6a could not be fully inspected due to the thick ivy blocking any features. The half of the roof visible showed slate tile with some lifting, giving potential roosting for crevice dwellers.</p>

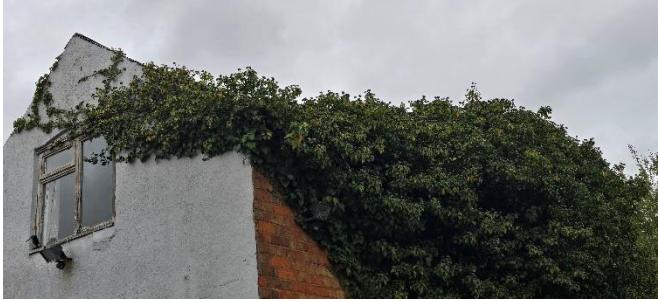
Walls	The walls of B6a are brick built, with the southwest facing gable end having cladding. The cladding has damage but is structurally sound, and the bricks are in good condition, although ivy could be hiding potential roosting features.

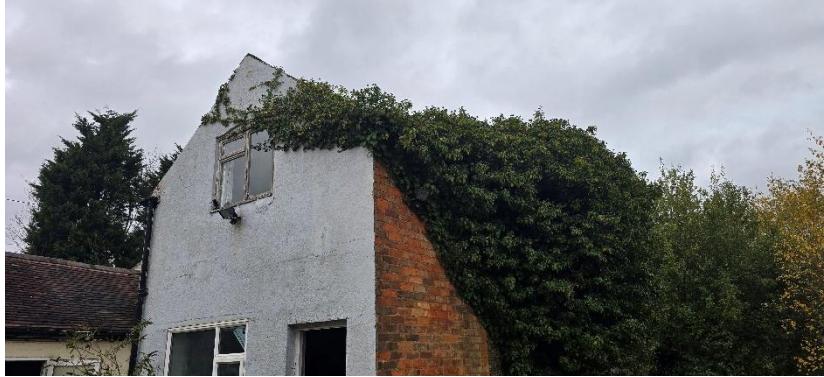
Doors	The windows and doors of B6a are made of timber, they are weathered but in good structural shape, meaning there is no habitat for crevice dwelling bats.

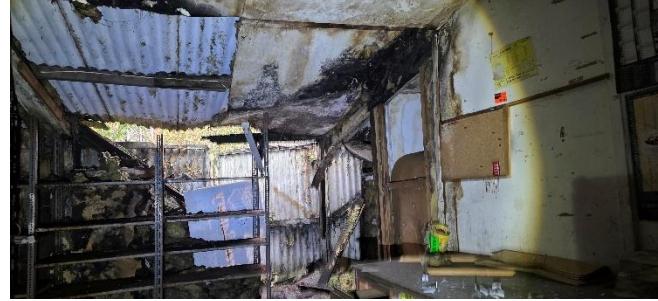
Doors	The doors to B6b are internal and therefore are not external access points for bats.	
Internal	The internal area in B6b shows lots of structural damage, as well as no stable habitat for a bat roost. Therefore, this building has been given a negligible habitat value.

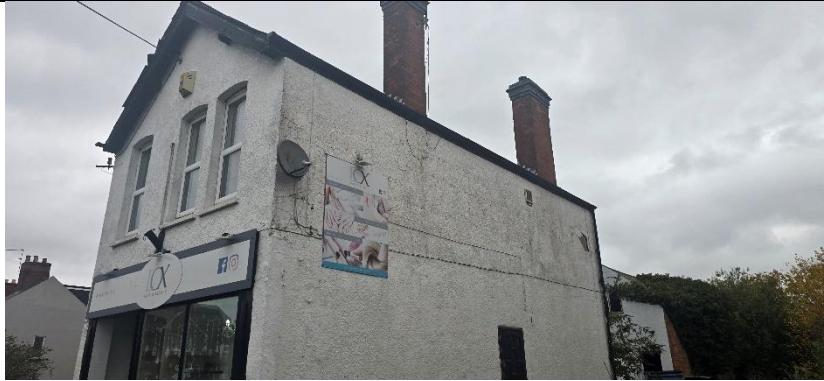
<b>B7- Description</b>		<b>Photo</b>
<p>A brick structure with a slate roof in poor condition, featuring three chimneys and raised lead flashing. It has a timber door, window and fascia, which are all weathered but structure all in good condition. The first floor windows are UPVC. The cladding is weathered but remains structurally sound.</p> <p>B7 consists of three connected sections (B7a, B7b and B7c) with B7c in particularly poor condition.</p> <p>B7 has been given <b>high habitat value</b> due to the roosting features present. As the building is not a stand alone feature, but part of a bigger complex of building with many roosting features, there is a high chance bats are using multiple buildings on site for roosting.</p>

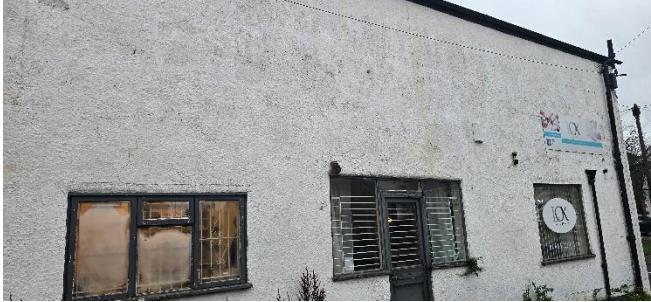
Walls	<p>The walls of B7a are cladded and are in good condition; providing no habitat for roosting crevice dwelling species</p>

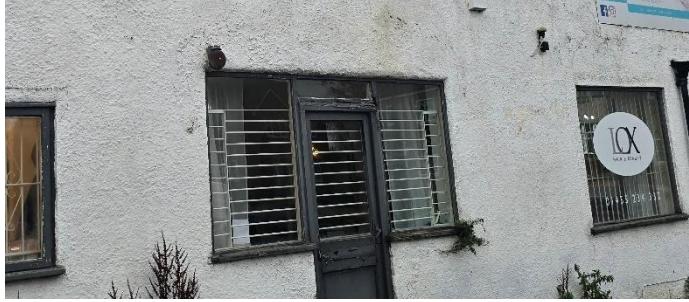
Doors	The timber doors of B7a are weathered but are in good condition and do not provide habitat for crevice dwelling bats.

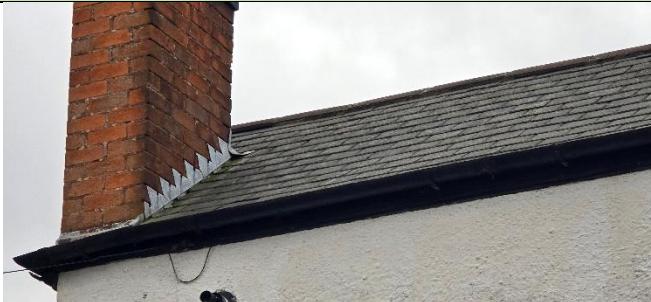
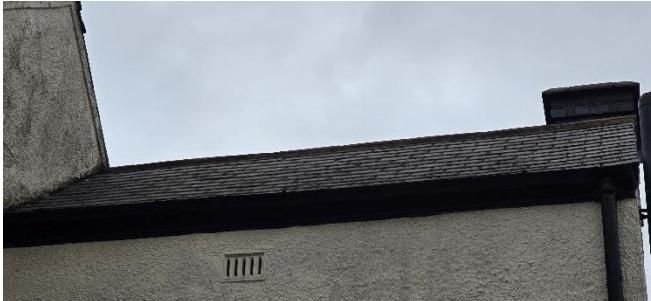
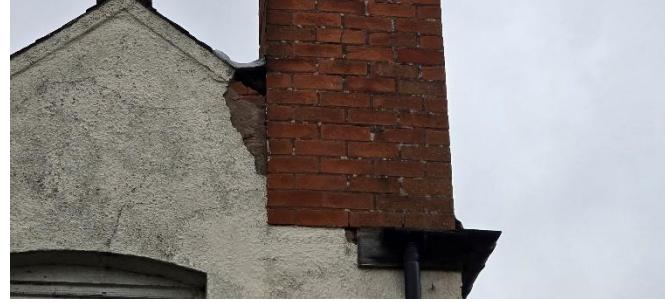
Internal	An internal inspection was not possible at the time of the survey.	
Structure B7b	Suitability	Photo
Roof	The roof of B7b is in good condition, however it is connected to B7a so any bats access the void or the tiles will gain access to B7b too. There is one chimney on B7b with lifted lead flashing allowing access to the roof tiles and potentially the void.

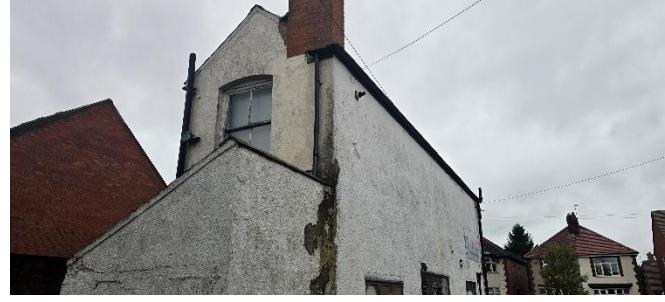
Walls	The walls of B7a are cladded, they are weathered but are in good condition.

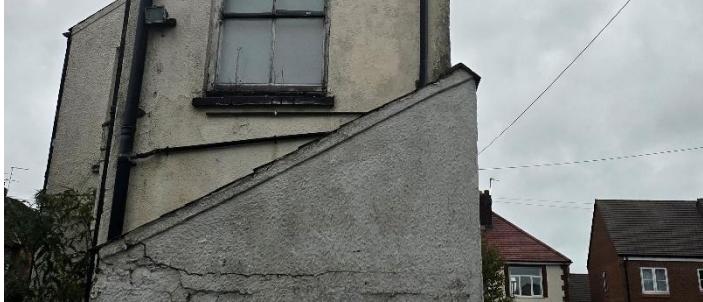
Walls	The walls of B7c are brick built with cladding. They are weathered but structurally in good condition.

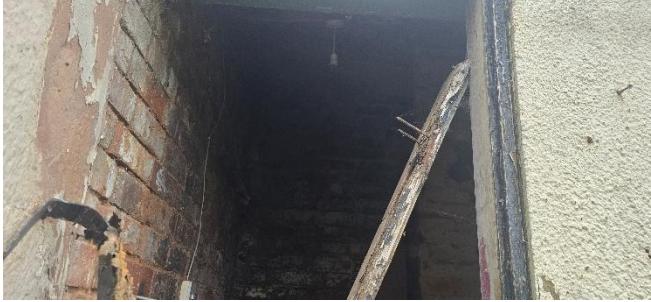
Doors	There is an open door frame to B7c allowing access.	
Internal	The internal area inside B7c is open, and the roof does not have any lining. Although bats can easily enter into B7c, the temperature will fluctuate. Although the timber roof frame can allow habitat for void dwellers to hang.
