# **ARBORICULTURAL SURVEY**

**CROWN HILL CLOSE  
STOKE GOLDING  
NUNEATON  
CV13 6EW**

**Prepared by  
M J Boddy *F Arbor A, FICFor, CEnv***

**18<sup>th</sup> August 2025**

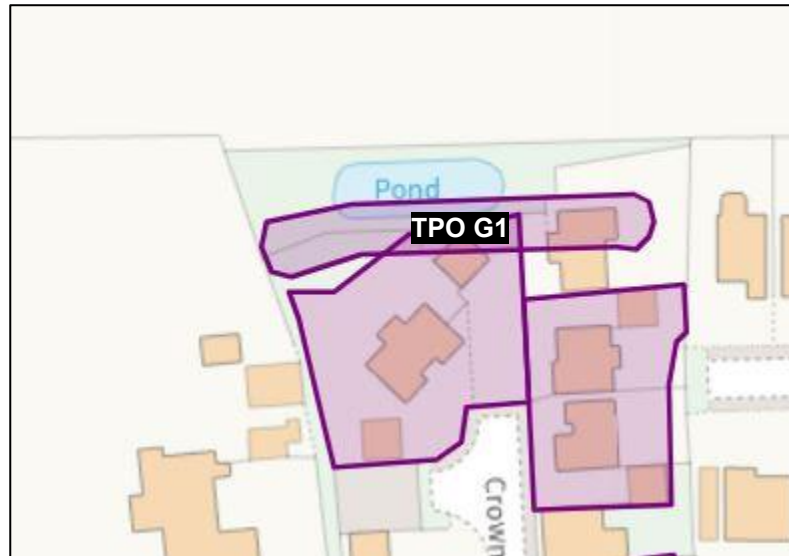
- 6.1 A group of trees (an oak, two ash & four multi-stemmed white willow) which were growing on the southern side of the pond prior to the land being developed were protected by the Hinckley and Bosworth Borough Council Stoke Golding - Land rear of 26 - 32 Station Road Tree Preservation Order 1998. It appears that these trees were removed at the time of the development and that none of the existing trees are protected by the TPO – see extract from the Council web site below.

- 6.2 However, as the balancing pond is situated within the Stoke Golding Conservation Area, a Section 211 notification giving the Council six weeks' written notice will be required prior to the recommended pruning of the willow being implemented. The removal of the dead trees are exempt from this requirement but a minimum of five day's written notice needs to be given that these works are to be carried out.

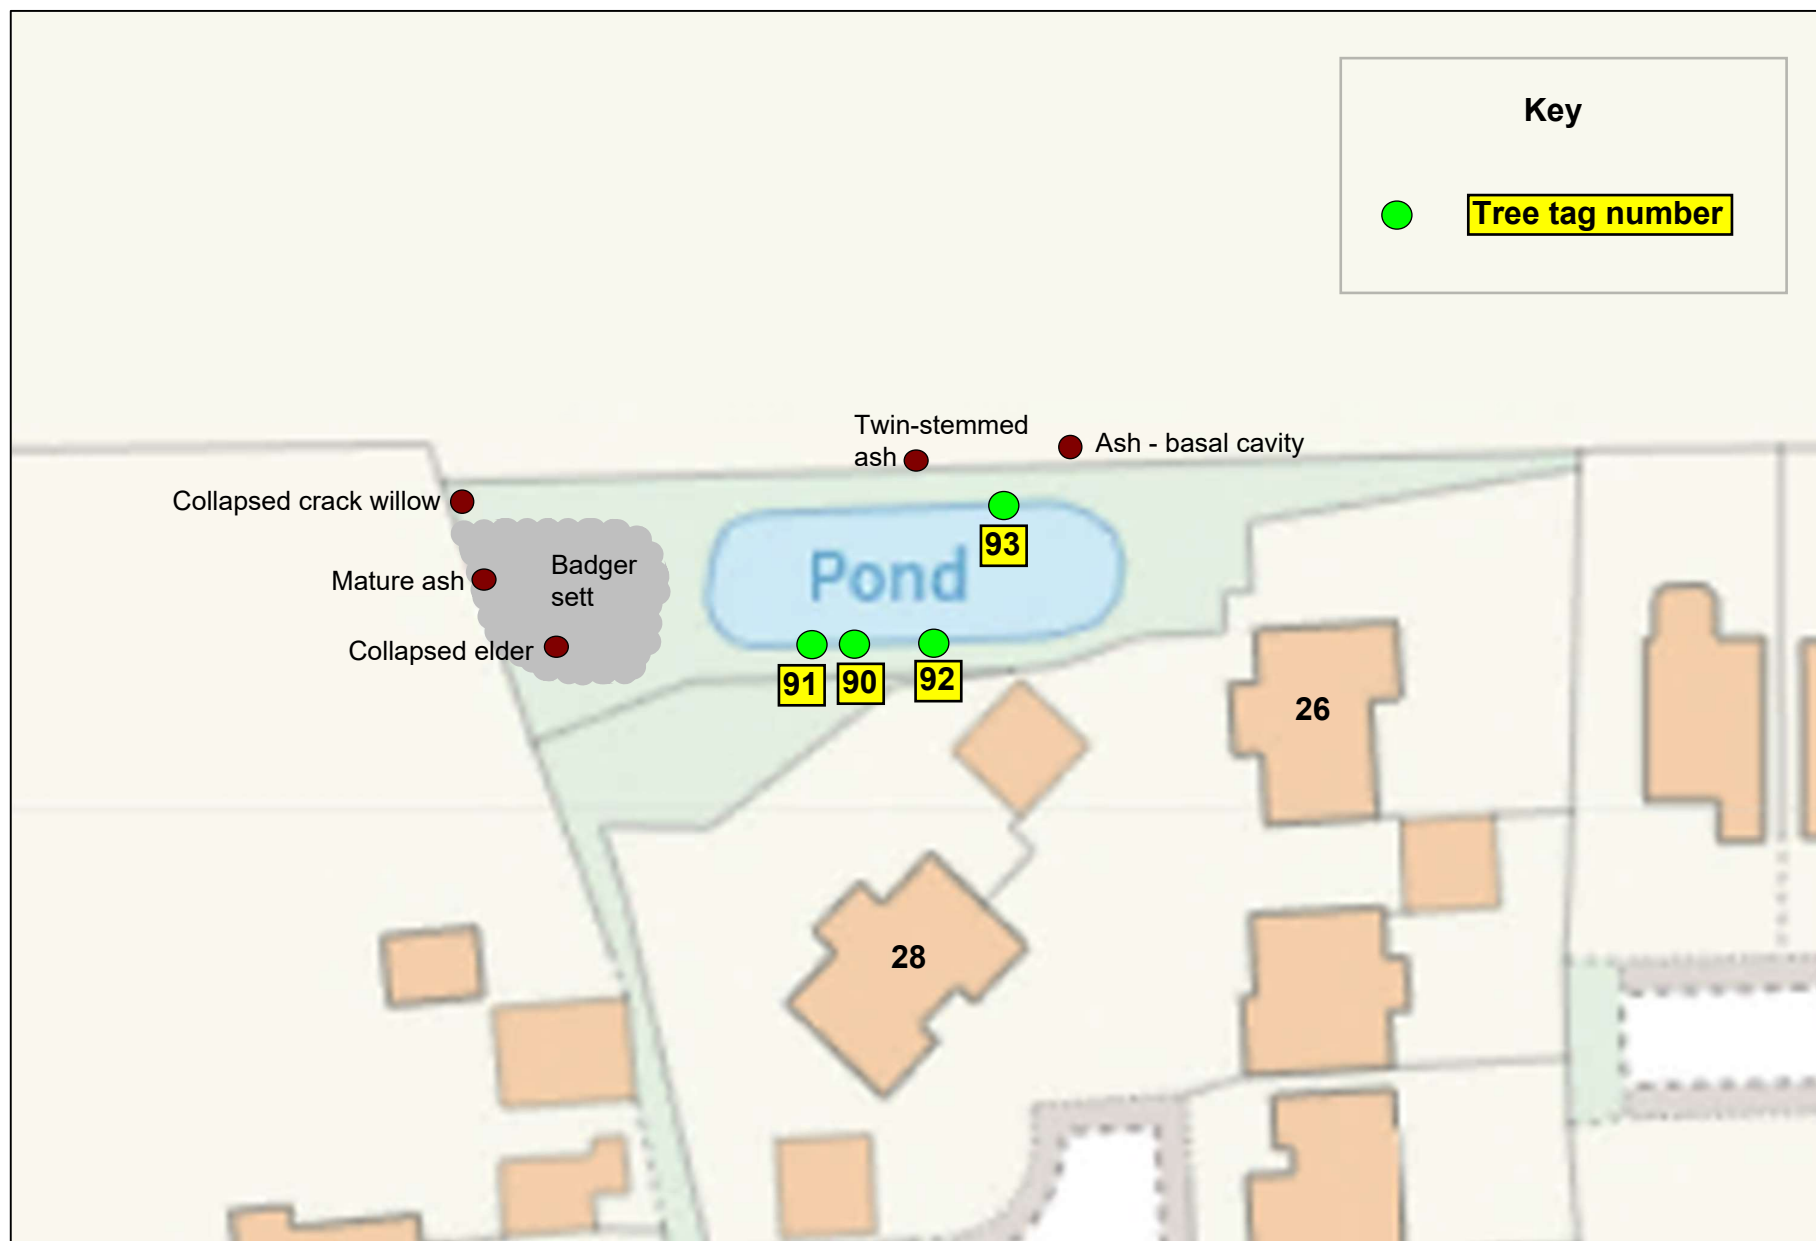
# INDICATIVE TREE LOCATION PLAN

- 3.1** The approximate stem positions and tag numbers of the scheduled trees are shown on the annotated plan at Appendix 2.
