Our Ref: BSL-2025-058

**Re: 28 Spinney Drive, Kirby Grange, Leicestershire LE9 9FG**

Thank you for your instructions to carry out a Specific Defect Survey of the above property. We can confirm that the property was inspected by Andrew Gamble on Friday 6 December 2024.

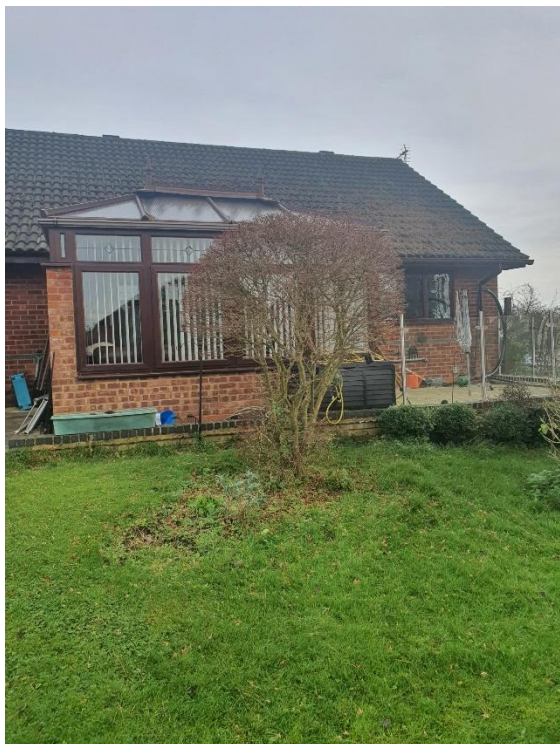
Rear Elevation

- 2.2.1. Externally, to the rear elevation wall of the property, we noted a raking/diagonal crack leading down from soffit level for approximately 8-10 brick courses. This cracking was not visible internally.
- 2.2.2. To the adjacent road we noted extensive cracking to the surface, most likely due to the tree roots.

- 3.1.4. To the rear elevation of the property, the minor cracking can be raked out and repointed in a mortar colour match as closely as possible.
