BS5837:2012 Tree Survey  
Land off Barton Lane  
Congerstone  
Leicestershire  
NGR SK36996 05611

Survey by  
Christopher Barker CEnv dipHort ACIEEM

# **BS5837 Tree Survey, Land off Barton Lane, Congerstone**

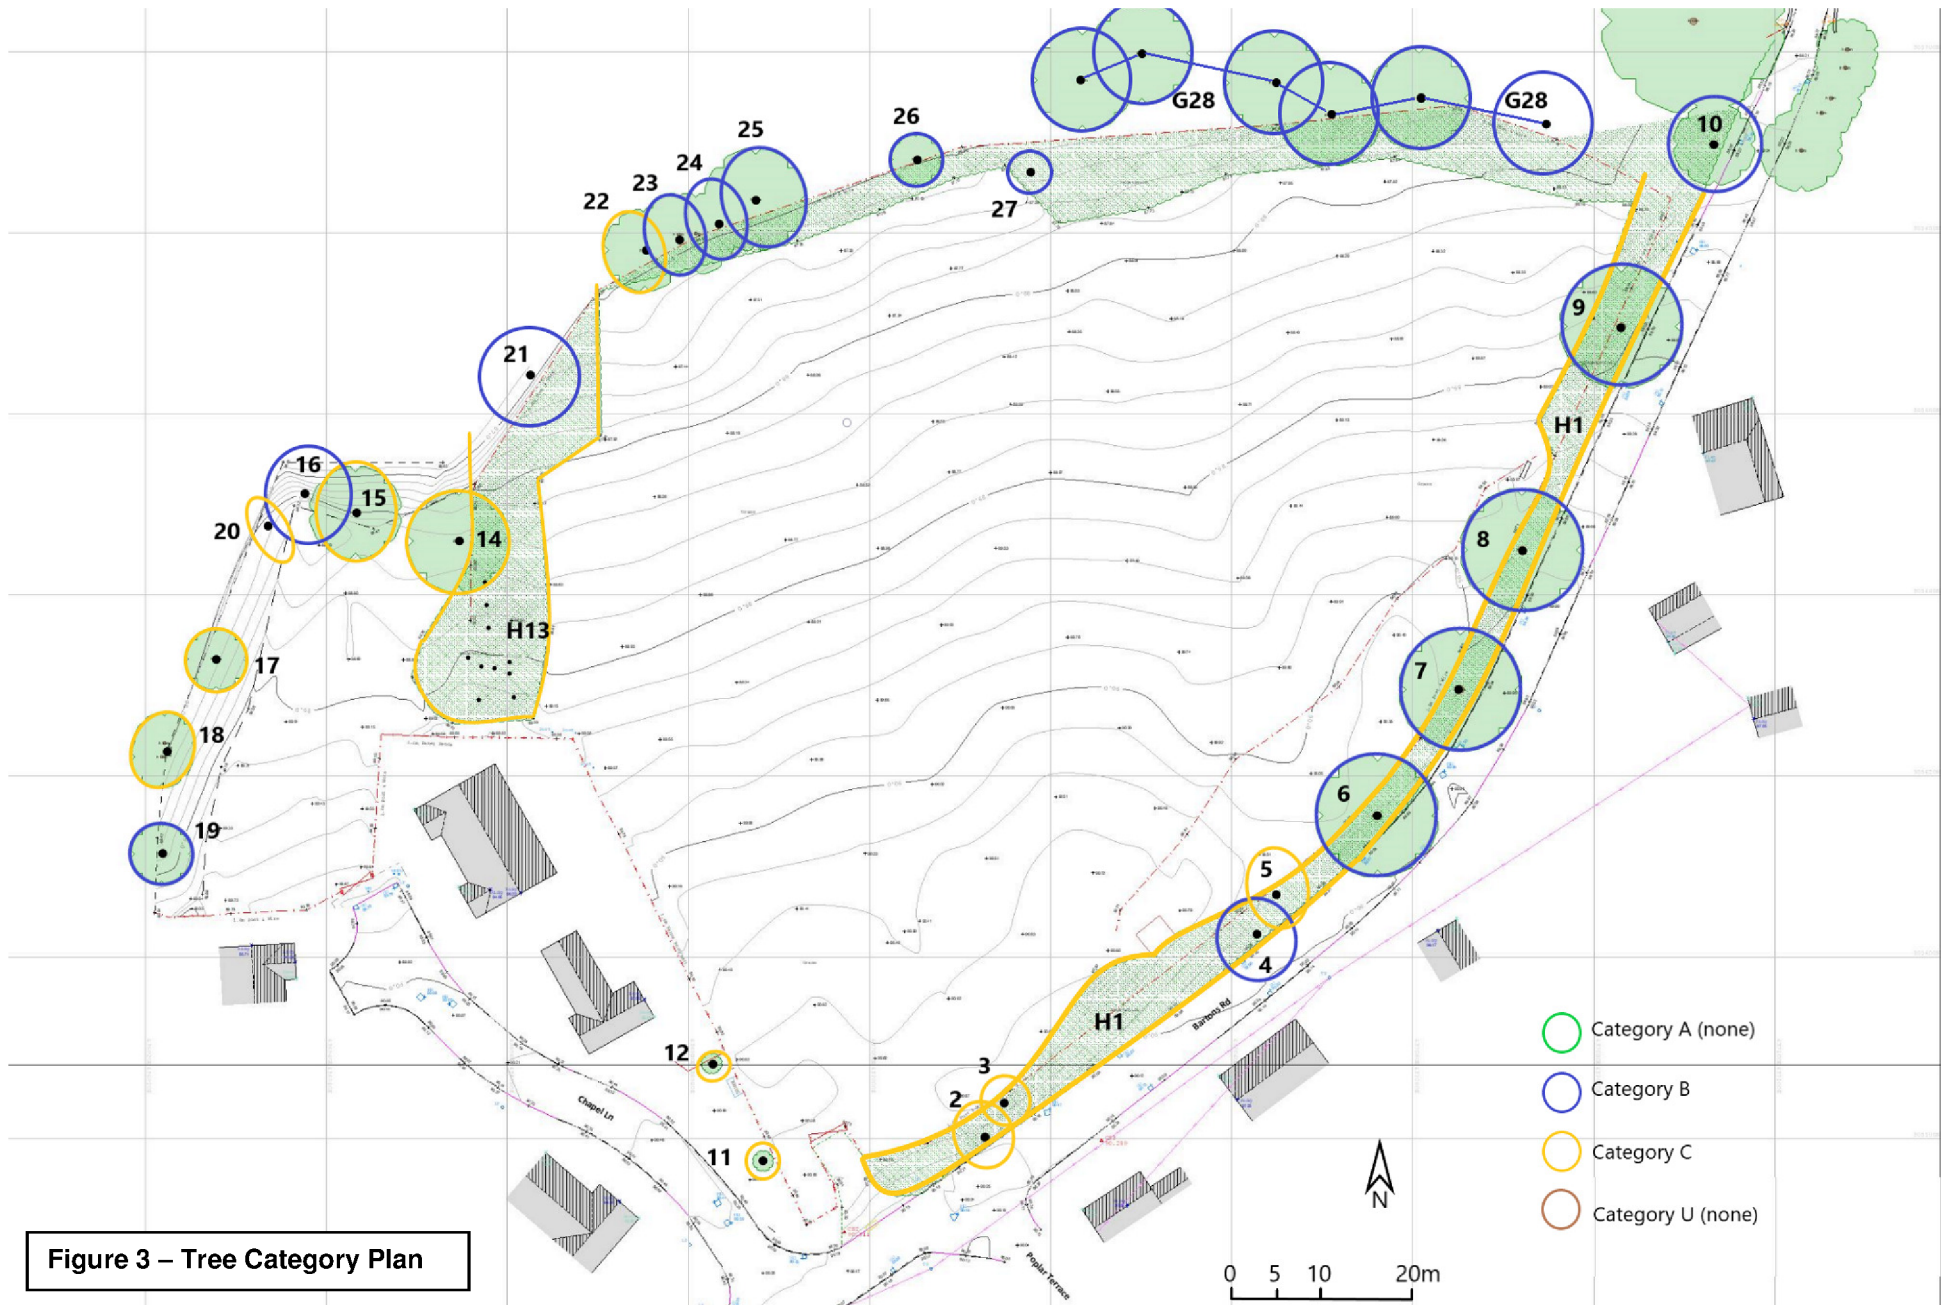
Figure 3 – Tree Category Plan

**Hedgerow H1 – T10** form a linear canopy along Barton Road with the larger Oak dominating the eastern end. A number of the Oak are large mature specimens in good condition but are choked by dense ivy.

**Hedge H13 and Ash T14** are positioned in the interior of the survey area at the north end of Chapel Lane extending toward the small stream on the northern boundary. H13 comprises untrimmed Holly and Hawthorn forming a dense thicket. Ash T14 is a very large tree with a broad crown. This tree has a very deep stress fracture running through the centre of the trunk to the main crown junction which is a cause for concern as it is a point of weakness which may result in structural failure of this tree.

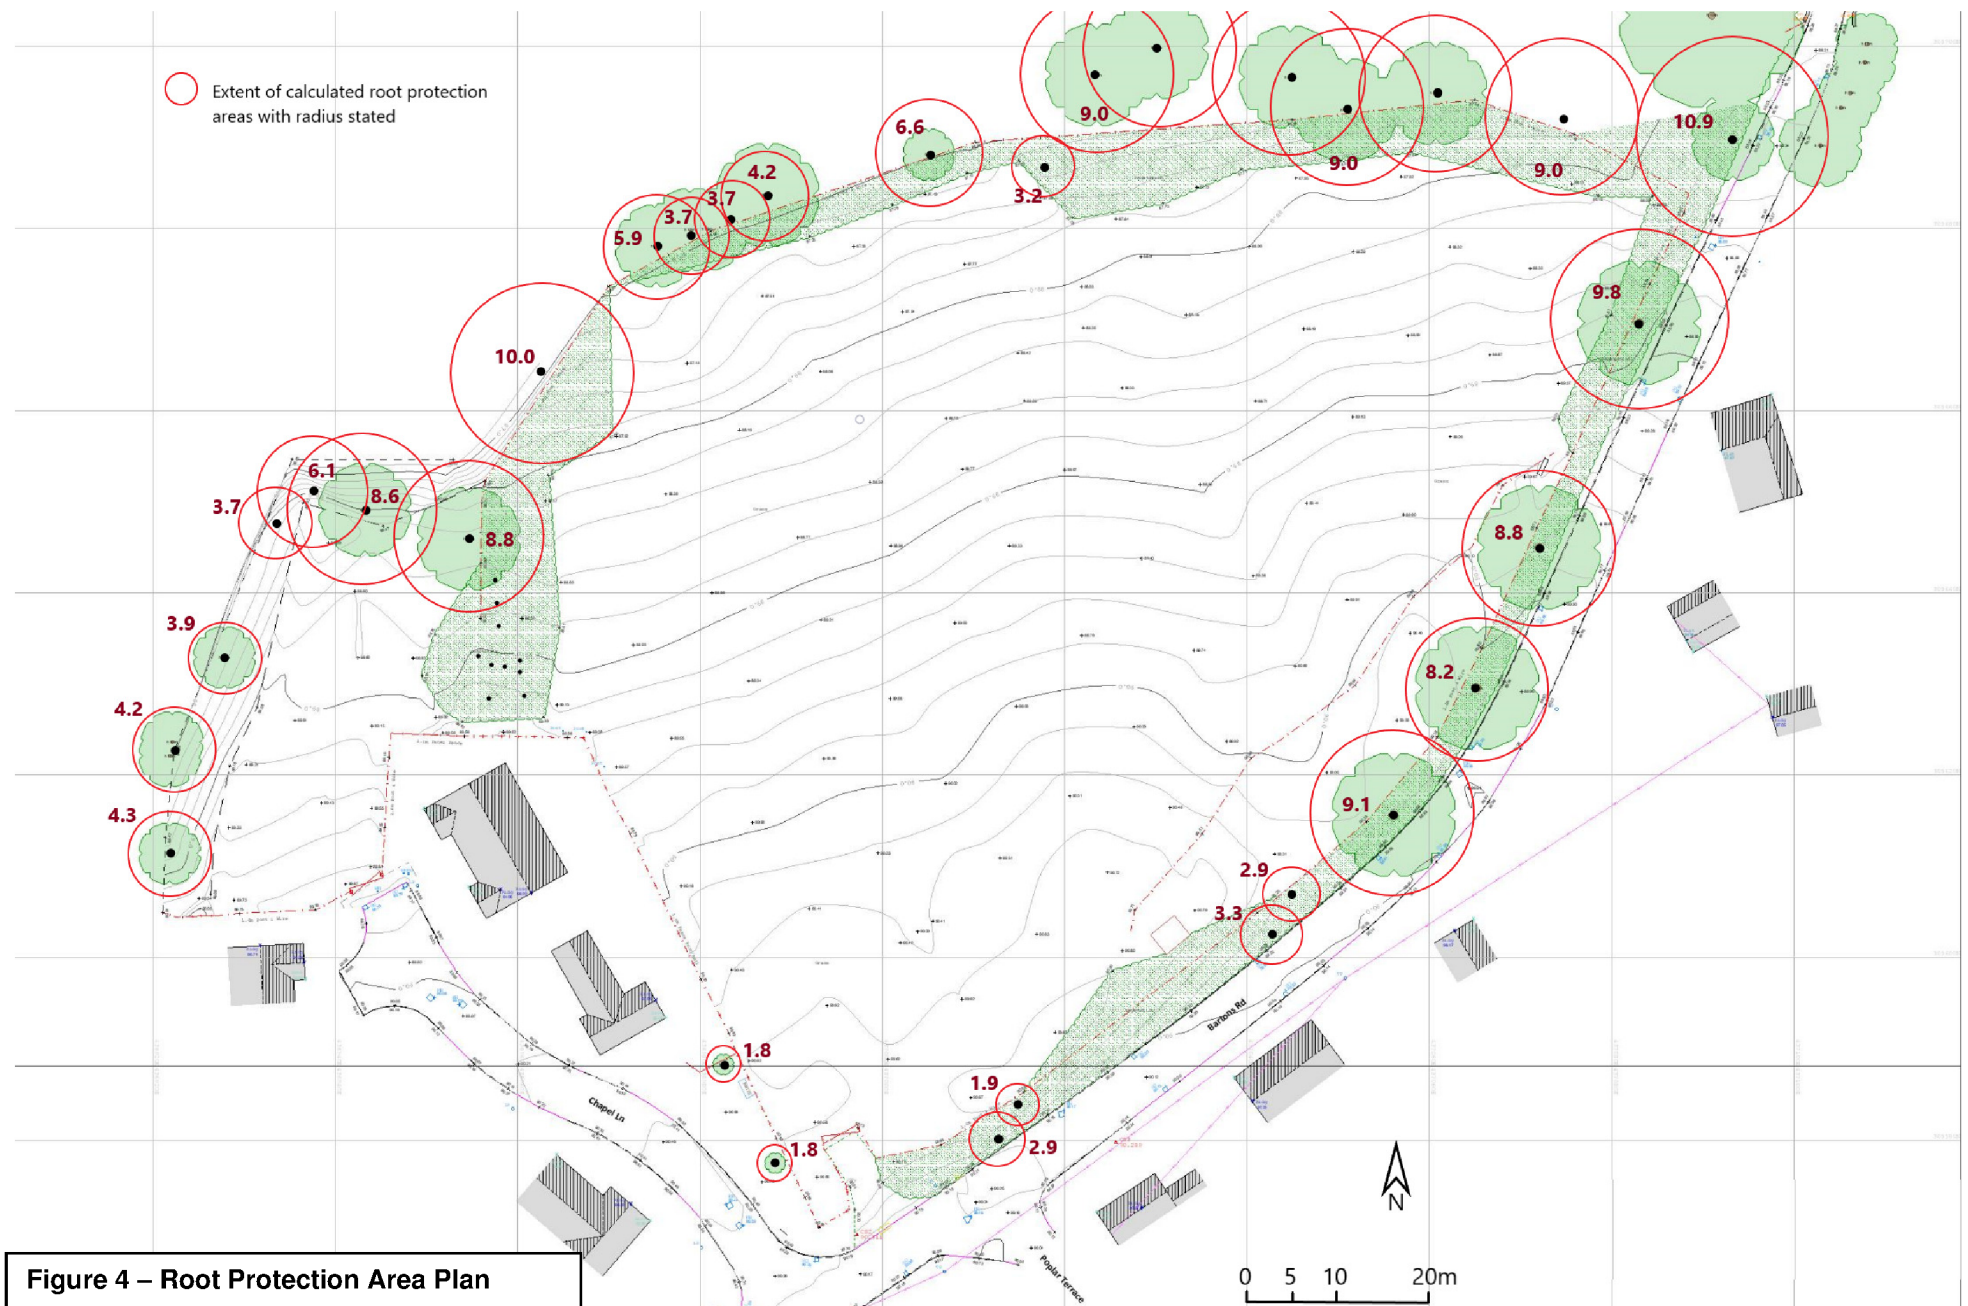
Figure 4 – Root Protection Area Plan

The position of significant individual trees or groups of trees measured out on the site is shown on the Tree Location Plan **Figure 3** which is based on a topographical survey of the site area. Within the summary table (**Appendix 1**) a calculated corresponding radius of the circle for each RPA has been calculated. The Root Protection Areas are formulated to assist when designing layouts in relation to trees and the calculated RPAs in Appendix 1 should be used to inform the design layout of this site. The calculated RPAs are shown within **Figure 4**.

- Pre-development works may be undertaken prior to the installation of fencing with the agreement of the local planning authority.
- All tree works should follow best practice procedures as set out in BS 3998 (2010). All trees should be maintained in good condition on site and be inspected annually (where overall condition requires) or every 2 years and after any major storm events, with safety a priority.
