**MIRA TECHNOLOGY PARK SOUTH SITE  
WATLING STREET, WARWICKSHIRE**

**BAT SURVEYS**

Report No: RT-MME-154920-04 Rev B

Date: August 2022

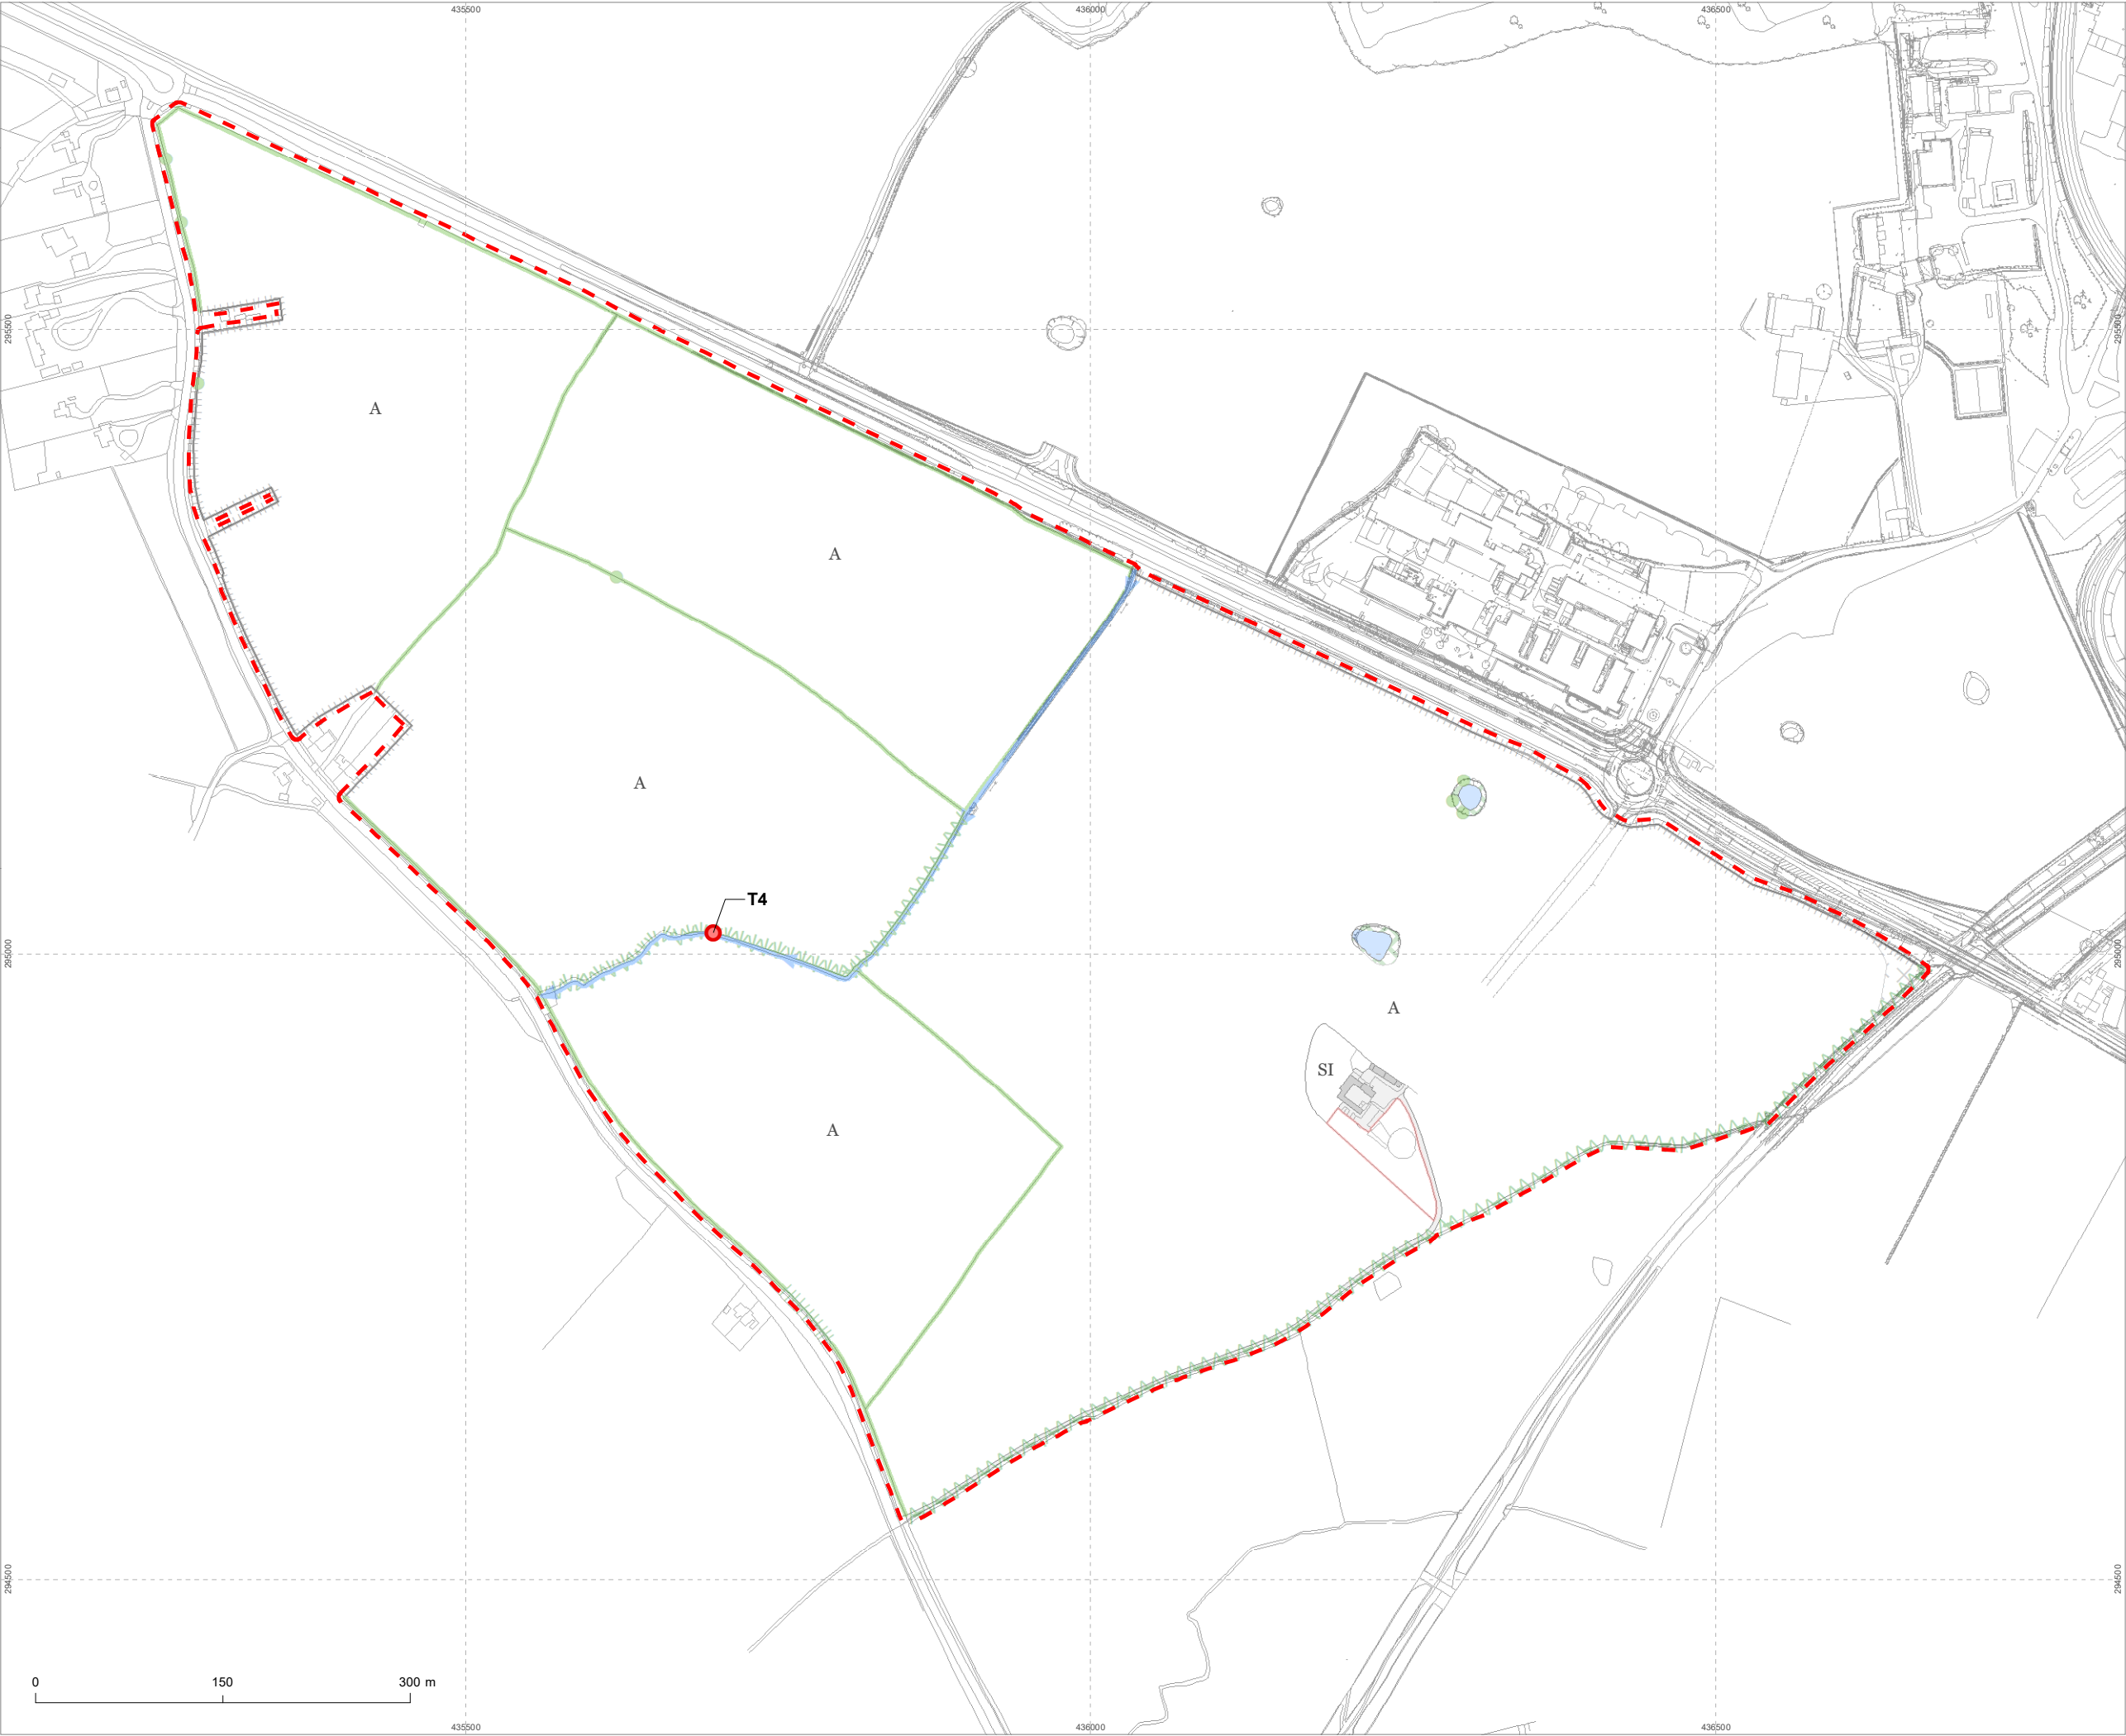
C154920-04-04

A common pipistrelle roost has been identified in Tree T4. The most recent site plans include the retention of Trees T3 and T4 and the field boundary in which they are located. There is potential for the identified roost in Tree T4 and roosts in other high and moderate potential trees to be disturbed by inappropriate lighting or other construction impacts such as noise, fumes, vibrations and accidental damage. It is anticipated that impacts can be readily avoided through the implementation of an appropriate lighting scheme and other protection measures. As such, recommendations have been made to avoid these impacts on known and unidentified roosts in trees.

All trees with moderate or high potential to support roosting bats should be retained and protected during construction and in the long term. A Construction Ecological Management Plan (CEcMP) should be prepared that controls any work that might damage/disturb bat roosts within these trees, such as inappropriate noise, vibrations or lighting.
