# Preliminary Roost Assessment

23 Newbold Road  
Desford  
Leicestershire  
LE9 9GT

For  
Uzima Limited

# Gritstone Ecology

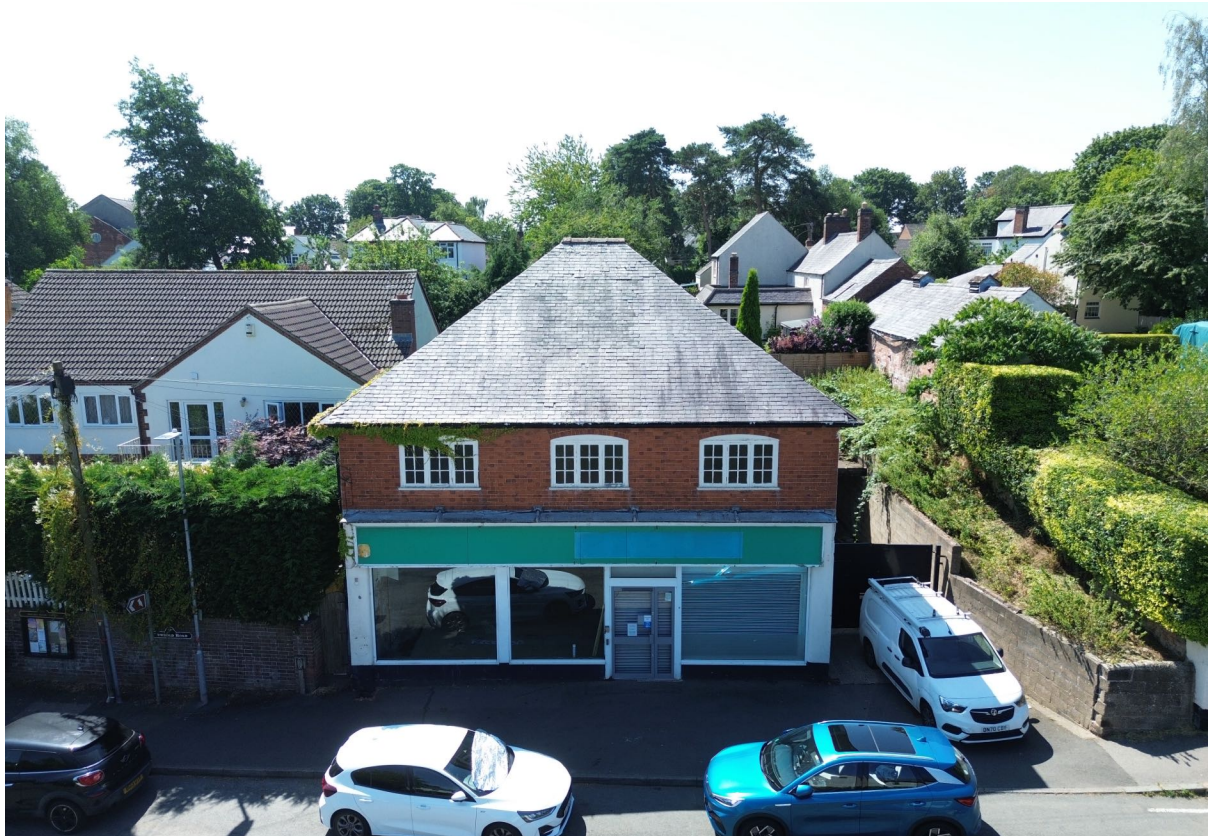
The building is well maintained, and in good condition. Ridge tiles are fixed tightly, there are no damaged or missing ridge tiles. There are no missing roof tiles. Roof tiles are tightly fitted, with no viable gaps between tiles. Fascia boards and boxed soffits are fitted tightly against the walls with no viable gaps. Walls are in good condition, with no missing mortar or cracks.

1 – The front of the building.

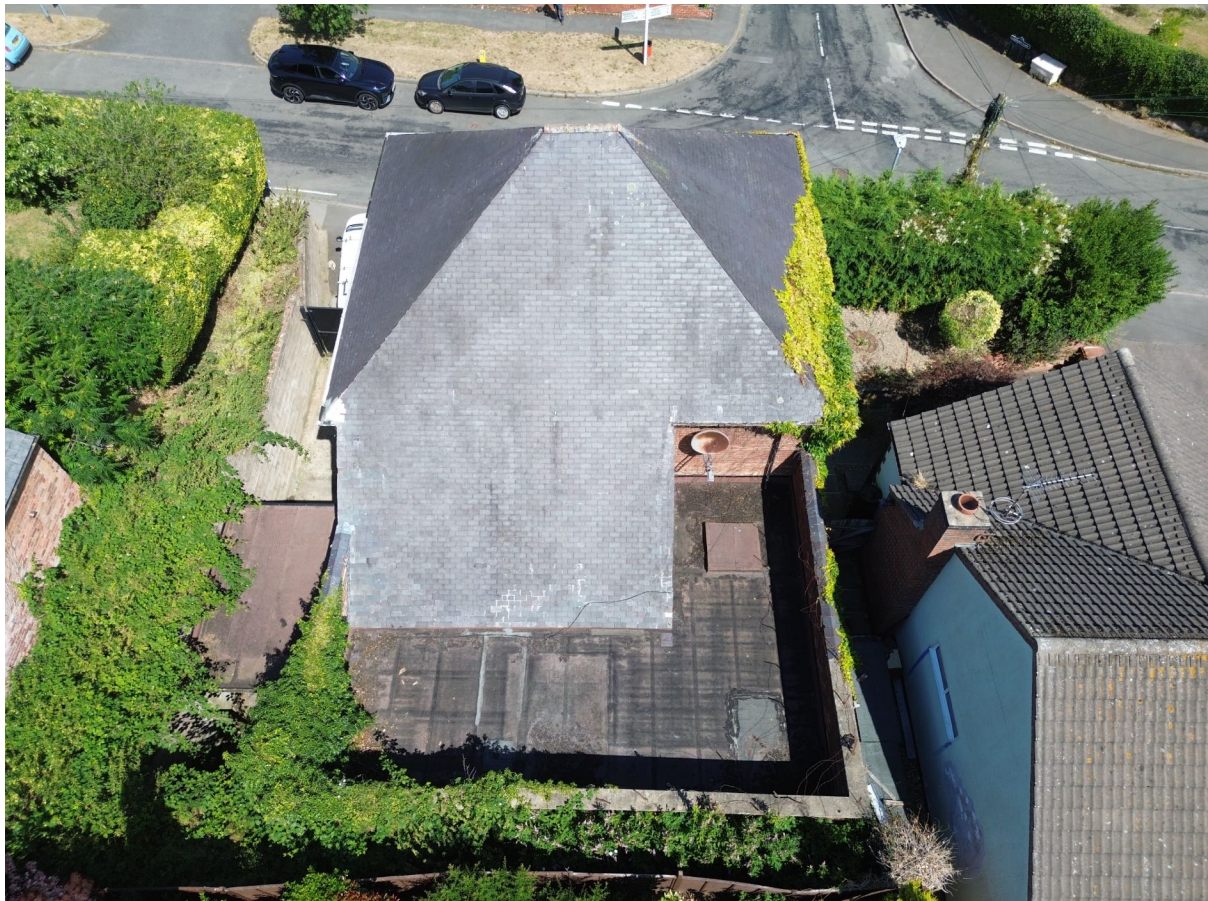
2 – The rear of the building.
