# GeoShield Verification Report 01

PROJECT REFERENCE: GEO104923

PROJECT: Land off Sapcote Road

SPECIFICATION: Verified in accordance with CIRIA 735.

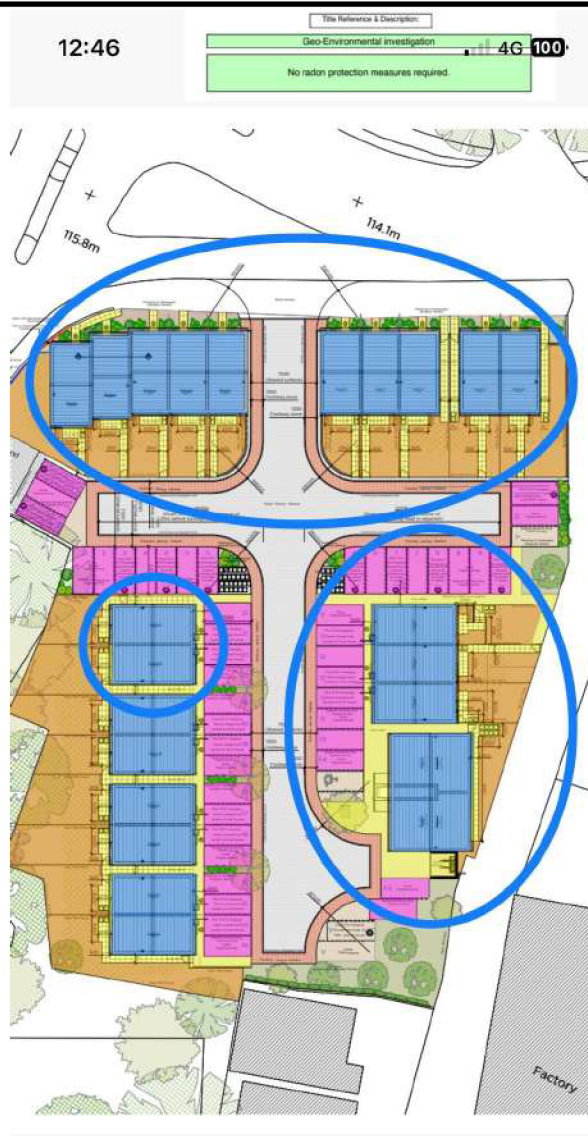
## Verification Layout

The photograph above shows a plan layout of the site. The area highlighted in blue shows where the verification inspection took place on site today.
