# GeoShield Verification Report 01

GEO105396

R4 Civils,  
Barlestone,  
Barton Road,  
Osbaston  
Nuneaton,  
CV13 0EU

JUTA GP1 Gas Barrier  
JUTA GP1 SAM

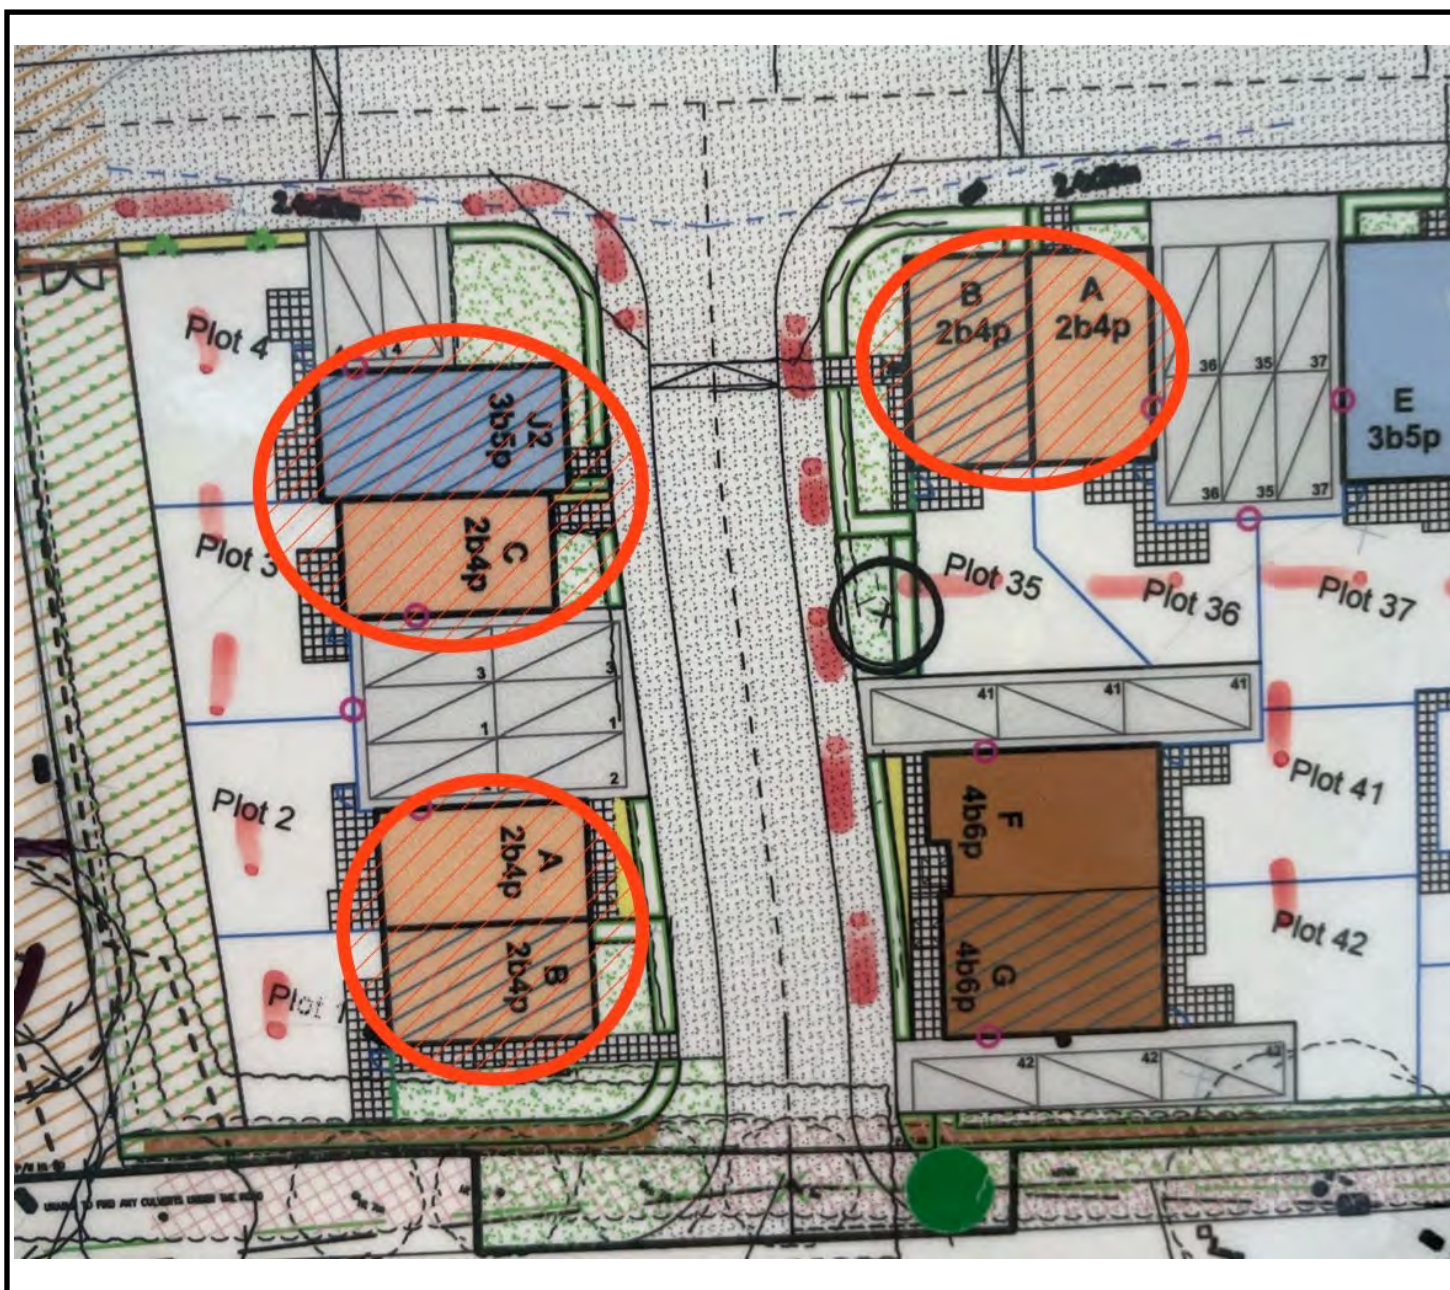
## VERIFICATION LAYOUT

The photograph above shows a plan layout of the site. The areas highlighted in red show where the verification inspection took place on site today.
