# GeoShield Verification Report 02

GEO105396

R4 Civils,  
Barlestone,  
Barton Road,  
Osbaston  
Nuneaton,  
CV13 0EU

Plots 41 & 42 - Full Line Out

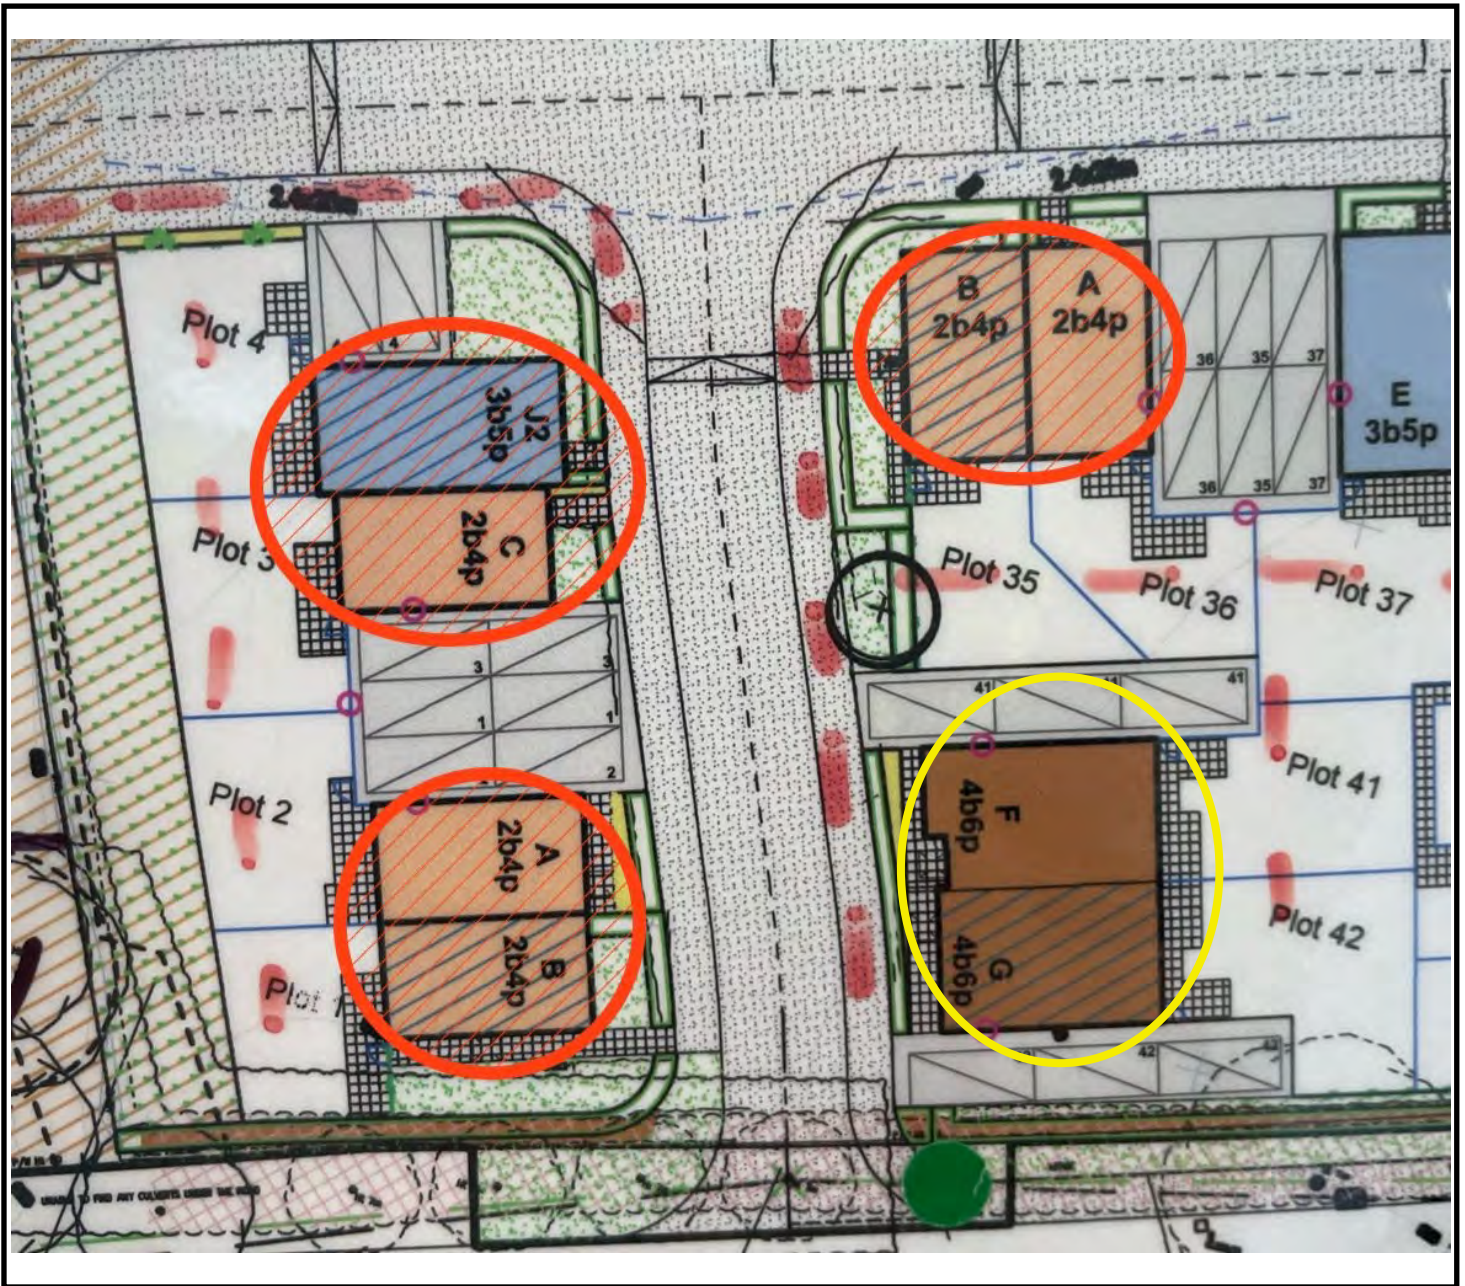
## VERIFICATION LAYOUT

The photograph above shows a plan layout of the site. The area highlighted in yellow shows where the verification inspection took place on site today.
