# GeoShield Verification Report 5

GEO105396

R4 Civils,  
Barlestone,  
Barton Road,  
Osbaston  
Nuneaton,  
CV13 0EU

Plots 12, 13, 14, 15, 16, 17, 18, 19, 20, 21, 22, 23, 24, 25, 43, 44 & 45 - Full Line Out

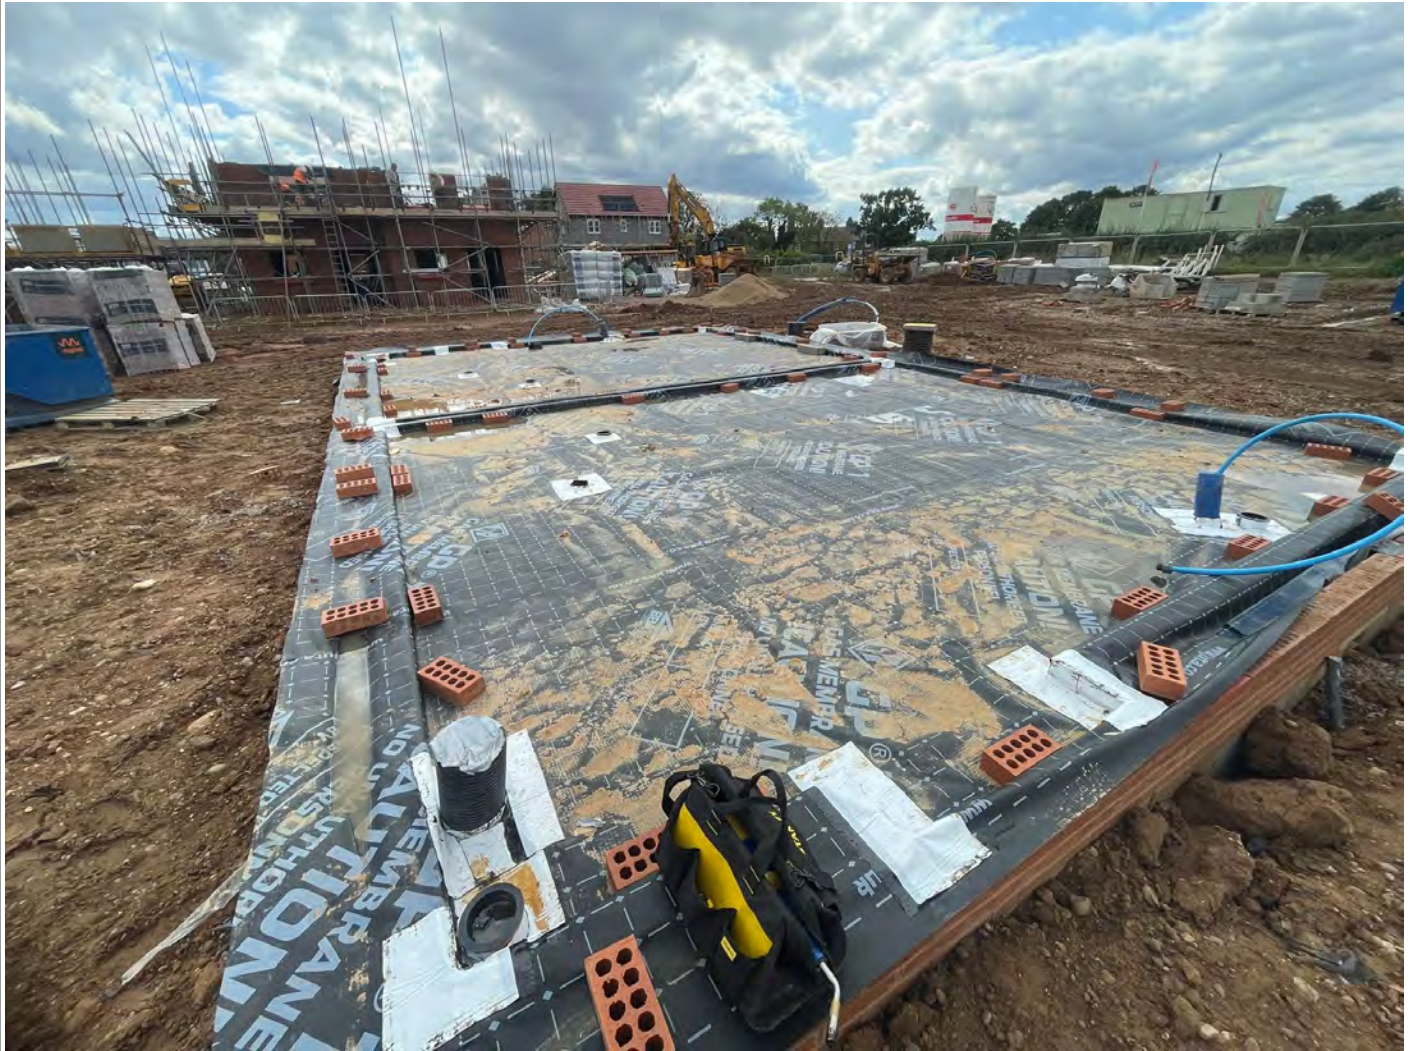
## OVERVIEW

The photograph above displays an overview of the area where today's verification inspection took place on site.

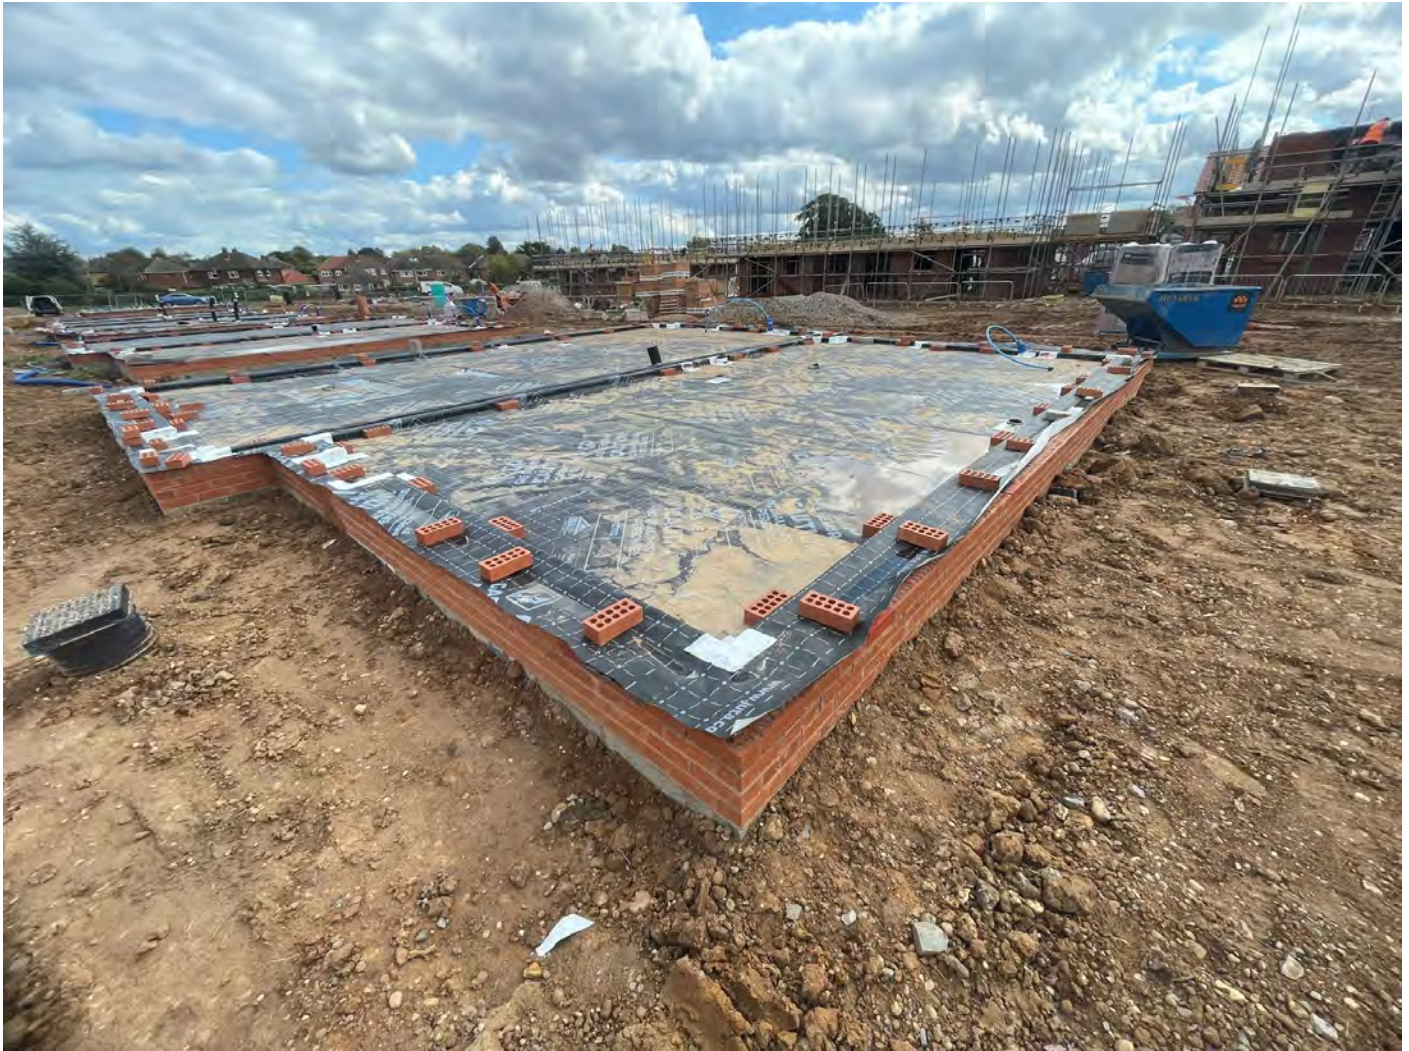
## OVERVIEW

The photograph above displays an overview of the area where today's verification inspection took place on site.

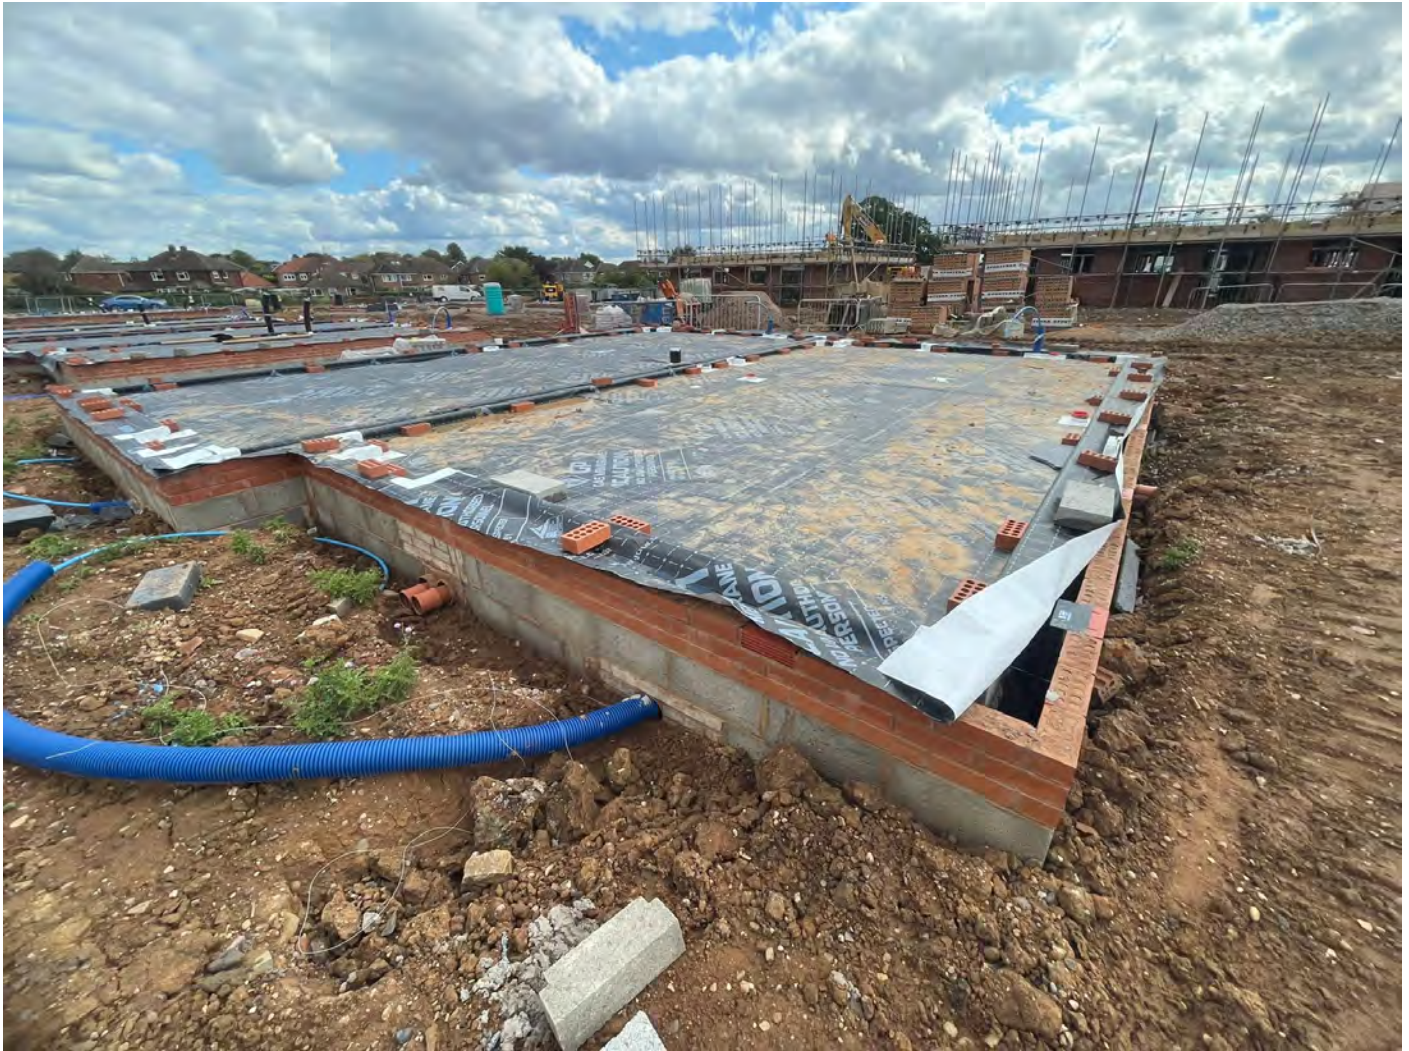
## OVERVIEW

The photograph above displays an overview of the area where today's verification inspection took place on site.

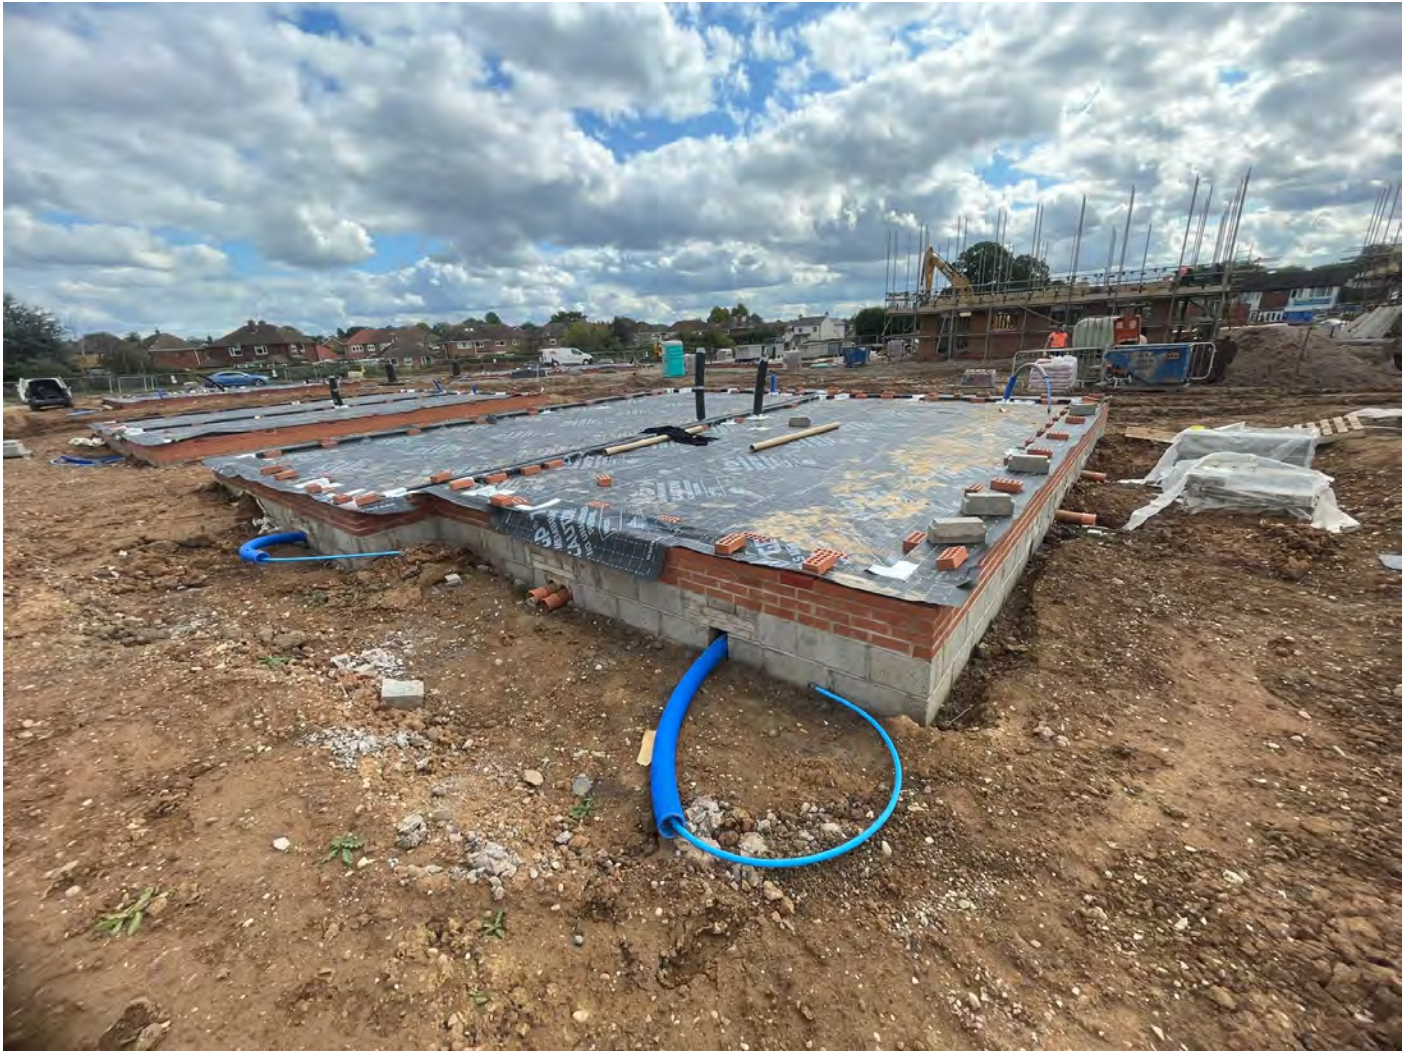
## OVERVIEW

The photograph above displays an overview of the area where today's verification inspection took place on site.

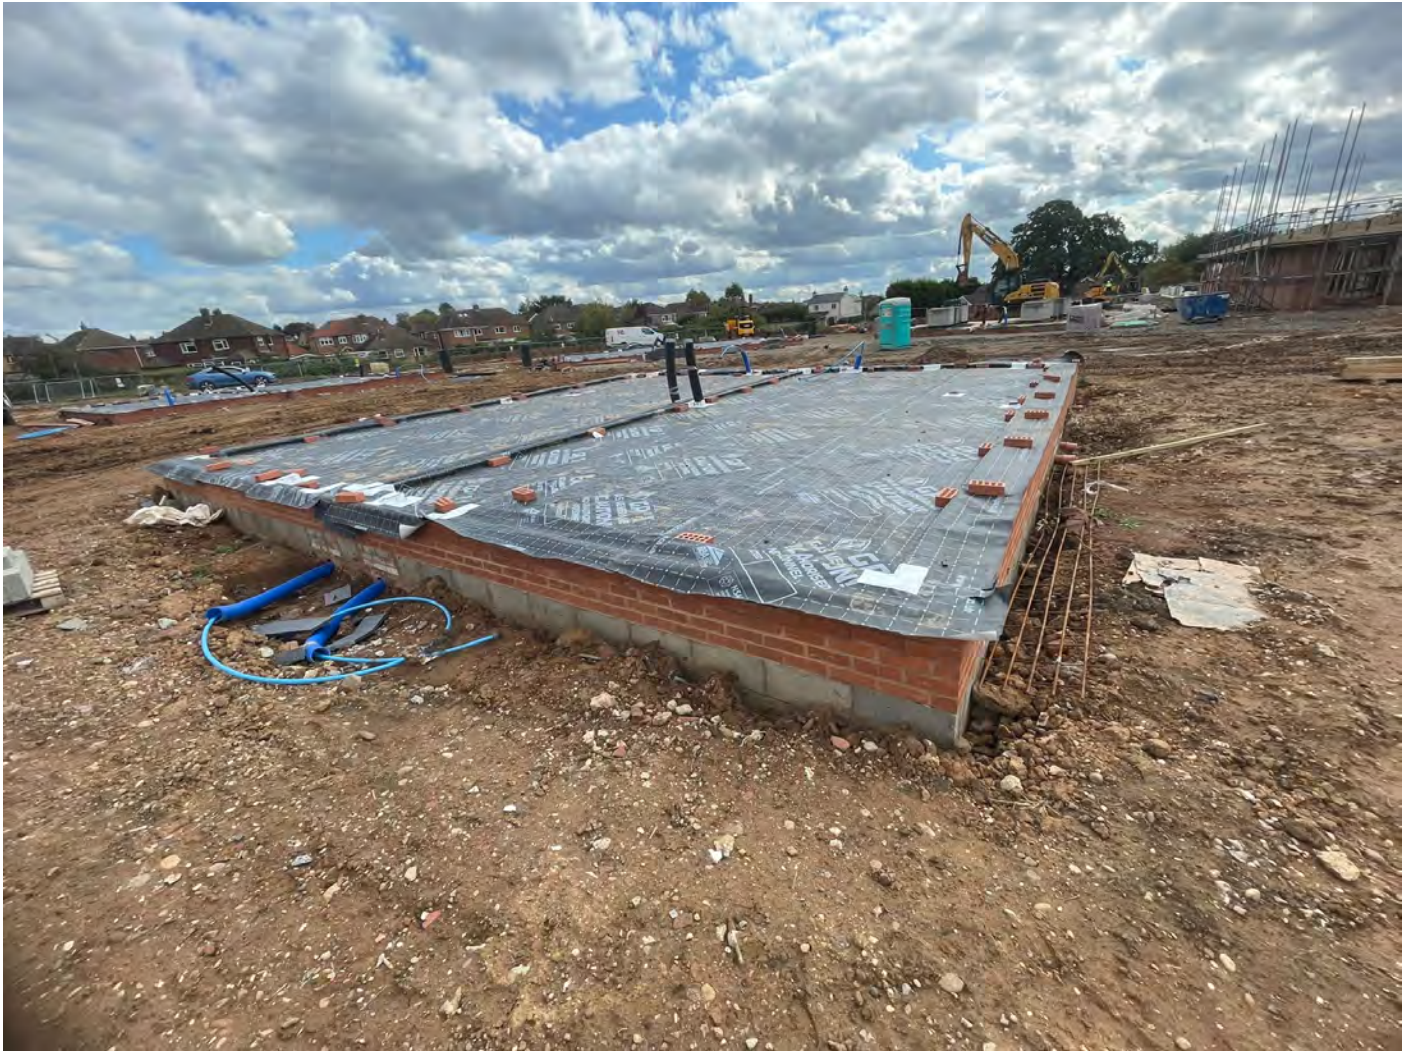
## OVERVIEW

The photograph above displays an overview of the area where today's verification inspection took place on site.

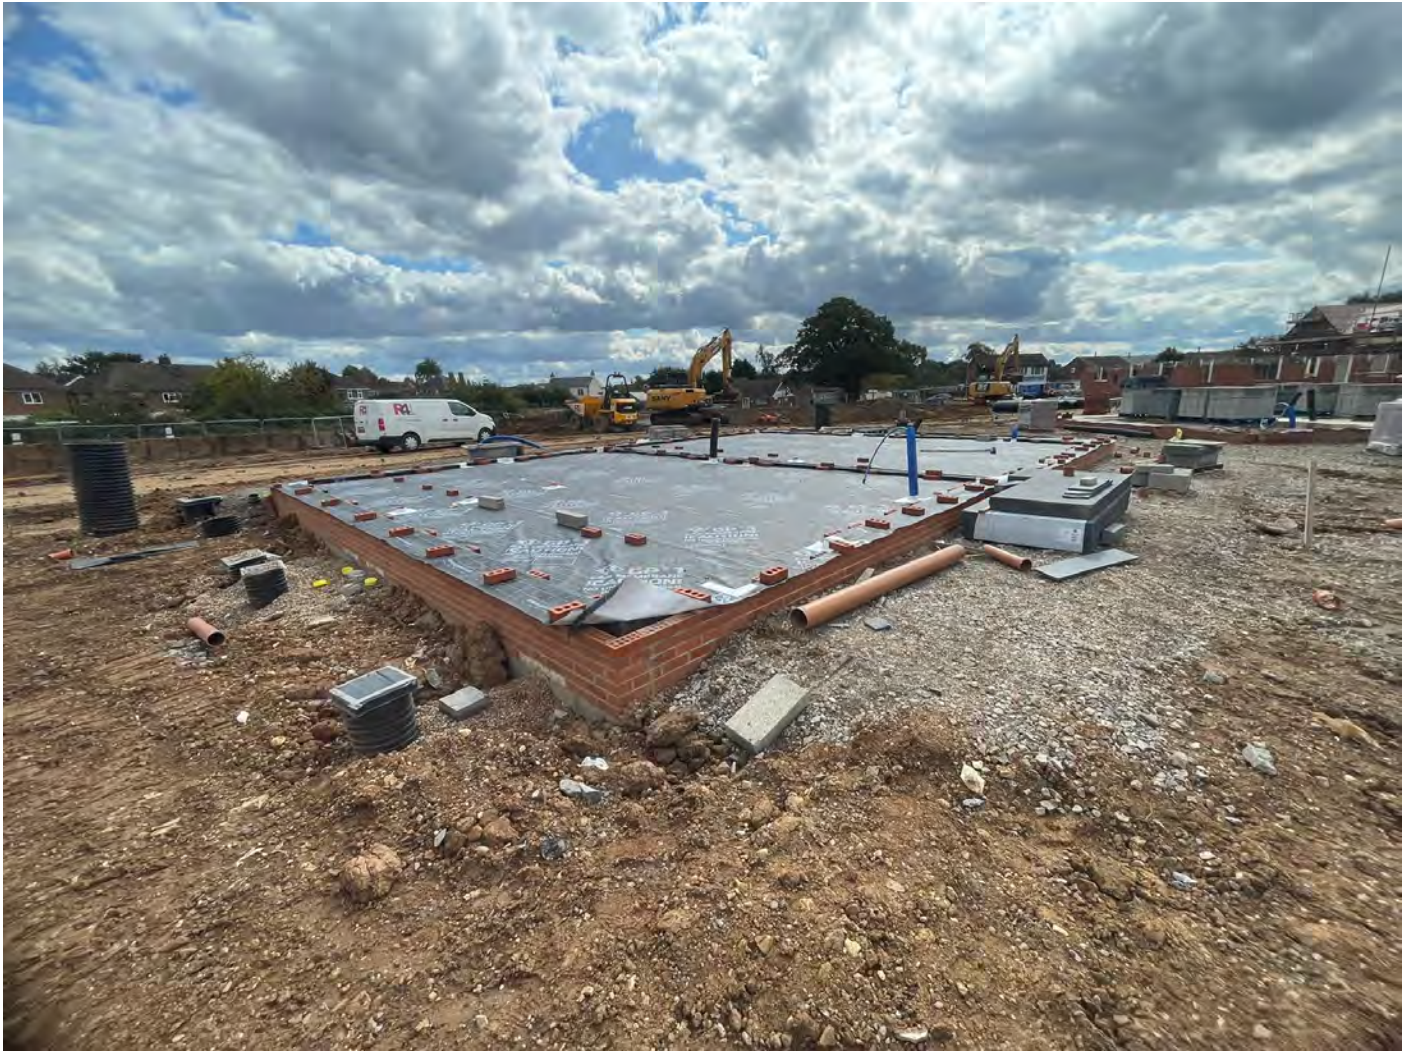
## OVERVIEW

The photograph above displays an overview of the area where today's verification inspection took place on site.

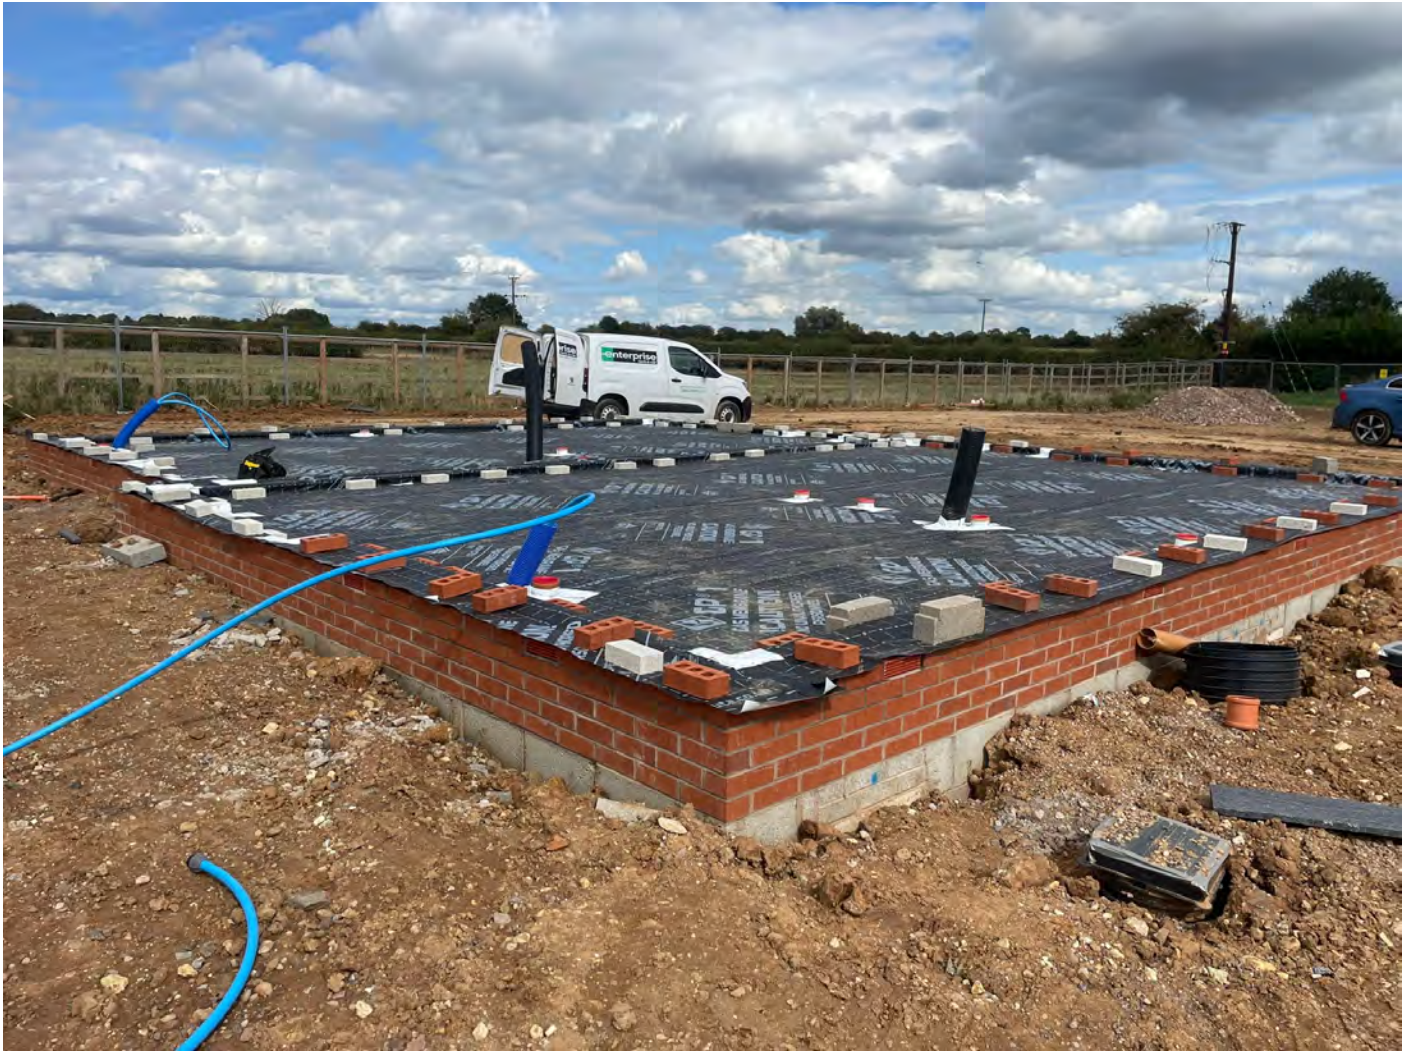
## OVERVIEW

The photograph above displays an overview of the area where today's verification inspection took place on site.

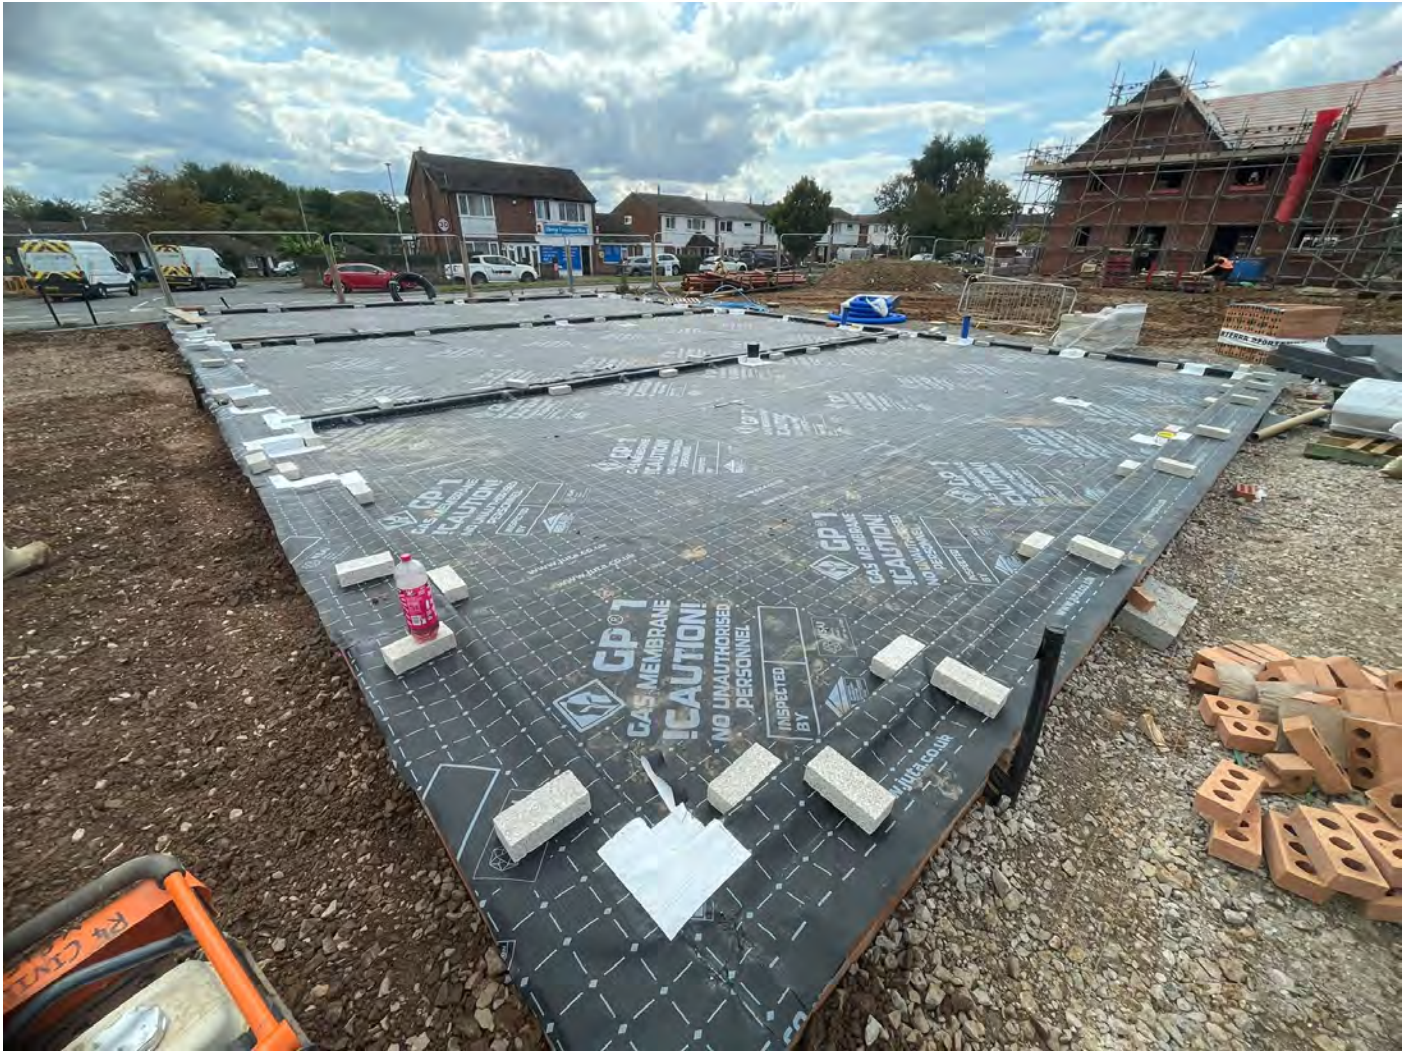
## OVERVIEW

The photograph above displays an overview of the area where today's verification inspection took place on site.
