# GeoShield Verification Report 6

GEO105396

R4 Civils,  
Barlestone,  
Barton Road,  
Osbaston  
Nuneaton,  
CV13 0EU

Plots 8, 9, 10, 11, 50, 51, 52, 53, 54 & 55 - Full Line Out

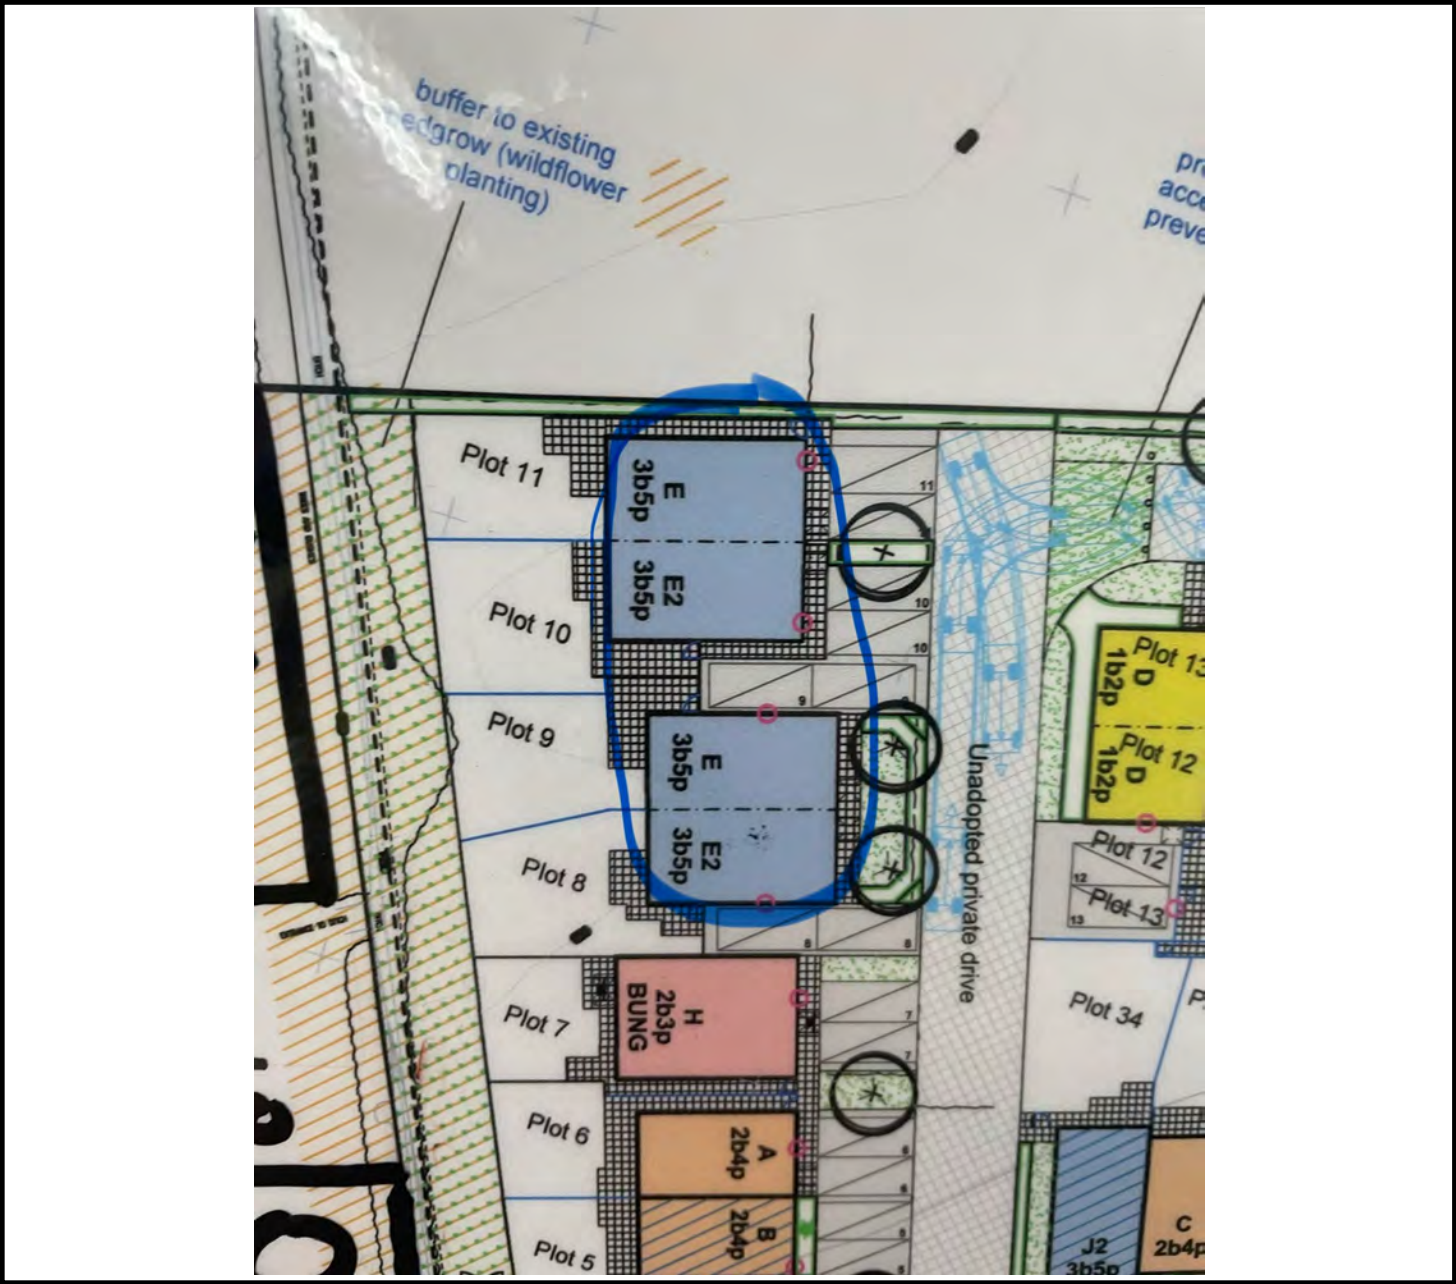
The photograph above shows a plan layout of the site. The areas highlighted in blue show Plots 8, 9, 10 & 11 where the verification inspection took place on site today.

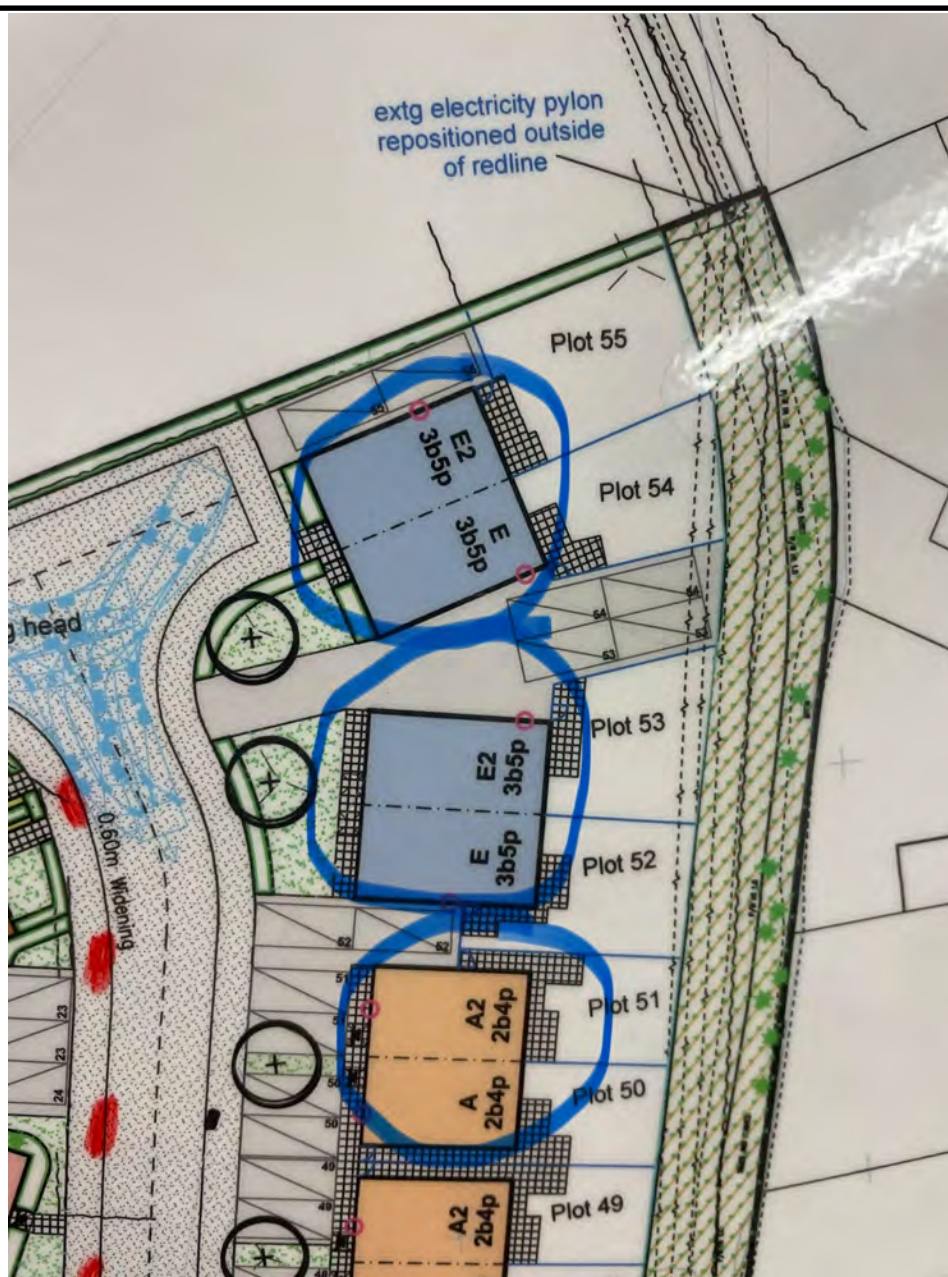
The photograph above shows a plan layout of the site. The areas highlighted in blue show Plots 50, 51, 52, 53, 54 & 55 where the verification inspection took place on site today.
