## **Level 2 Historic Building Record**

**The Old Rectory, Rectory Lane, Market Bosworth, Leicestershire**

**January 2024**

| Report type | Level 2 Historic Building Record | |

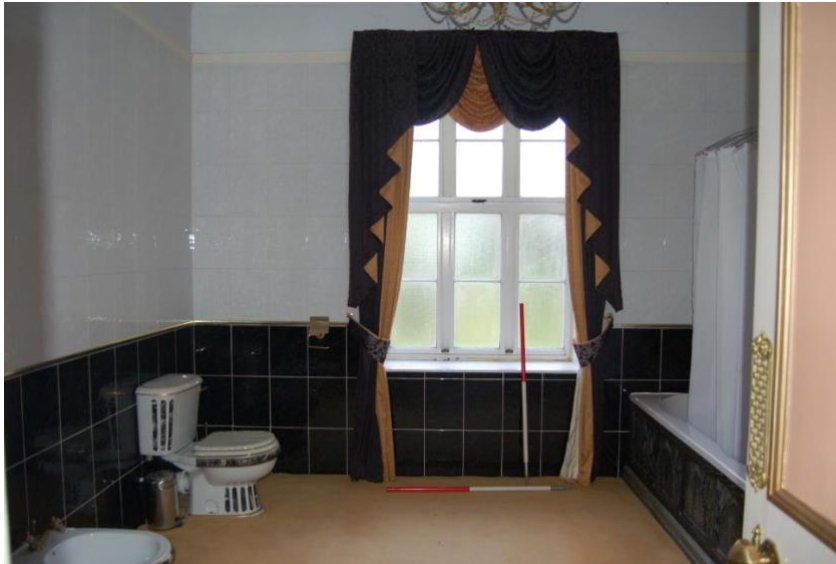
Figure 51: Ph (78). Room 14 facing north

4.20. Room 14 is situated to the north side of the landing to the east wing. It was most recently used as the main bathroom. This room would have originally formed part of the landing, or could have also been a further bedroom. Its conversion to a bathroom is likely to have taken place at some point after the 1860s, when such facilities started to be added to the first floors of houses such as this. The room is decorated with modern tiling and modern sanitary goods. The window to the north retains the original timber frame.

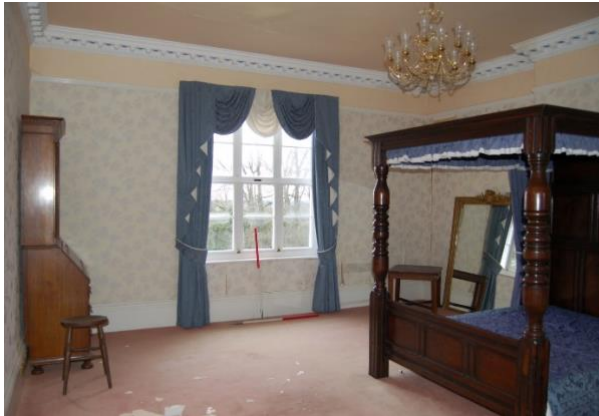
Figure 53: Ph (80). Room 15 facing south

4.21. Room 15 is situated to the southwest corner of the first floor of the east wing, accessed via a doorway in the east wall that leads to the first-floor landing. It was most recently used as a bedroom and would also have historically been used for this purpose. The bedroom is decorated with modern wallpaper and has decorative plasterwork, including a dentilated cornice and a ceiling rose. The plaster work is thought to be a later addition. The deep timber skirting board and panelled door in timber surround may be an original feature. The chimney breast to the west wall remains, but the fireplace is no longer in use. The floor is laid with modern carpet. The window to the south retains the original timber frame.

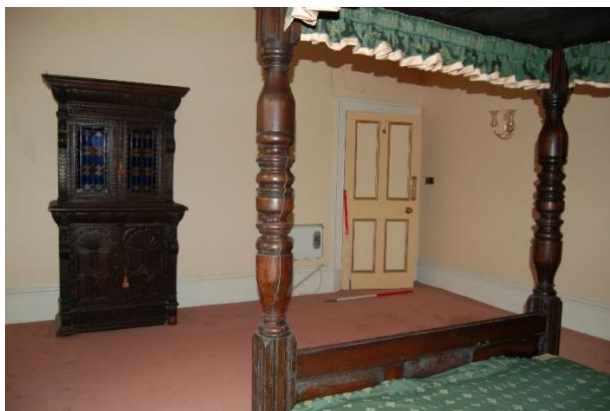
Figure 55: Ph (83). Room 16 facing southeast

- 4.22. Room 16 is situated to the northwest corner of the first floor of the east wing, accessed via a doorway in the east wall that leads to the first-floor landing. It was most recently used as a bedroom and would also have historically been used for this purpose. The bedroom is plastered and painted and has decorative plasterwork including a dentilated cornice and a ceiling rose. The plaster work is thought to be a later addition. The deep timber skirting board and panelled door in timber surround may be an original feature. The chimney breast has been removed. The window to the north retains the original timber frame. The floor is laid with modern carpet.

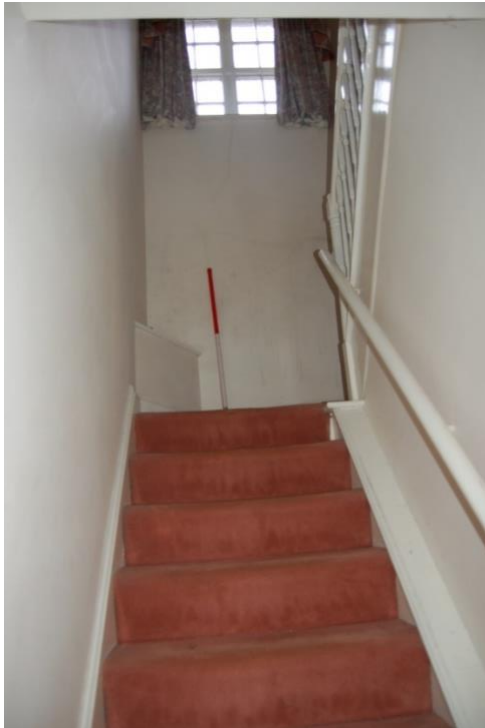
Figure 57: Ph (85). Room 17 facing north

- 4.23. Room 17 is the service stair to the north side of the west wing. It provides access to the first-floor rooms of the west wing, which now form a self-contained apartment/ annex. The room is plastered and painted and contains a simple staircase, the treads of which have been carpeted. The landing has a modern moulded plaster arch with glass panelled door set within. To the ceiling is a modern, moulded plaster cornice.

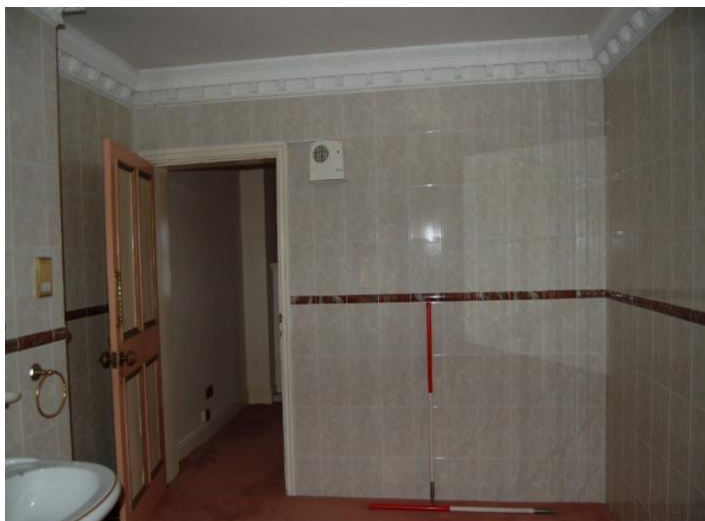
Figure 59: Ph (87). Room 18 facing south

- 4.24. Room 18 is situated to the northeast corner of the west wing, accessed via a doorway in the south wall that leads to lounge area. It was most recently used as the bathroom and would also have historically been used for sleeping accommodation for the house staff or sometimes for the children. The room is tiled with modern tiles and there is modern decorative plaster cornice to the ceiling. The room also contains modern sanitary ware including a corner bath to the northwest corner of the room. The floor is laid with modern carpet. The window to the north retains the original timber frame.

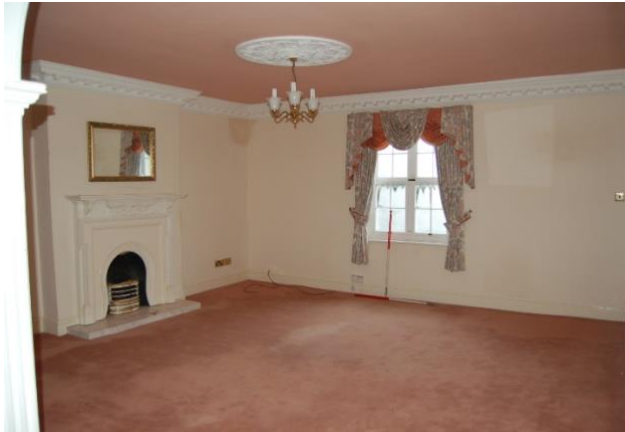
Figure 61: Ph (90). Room 19 facing southeast

- 4.25. Room 19 is situated to the southeast corner of the first floor of the west wing, accessed via an arched opening to the north wall that leads to the first-floor landing. It was most recently used as lounge for the self-contained annex, and would also have historically been used for sleeping accommodation for the house staff or perhaps as a nursery for the children of the house. The room is plastered and painted and has decorative plasterwork including a dentilated cornice and a ceiling rose. The plaster work is later addition. The floor is laid with modern carpet. The window to the north retains the original timber frame.

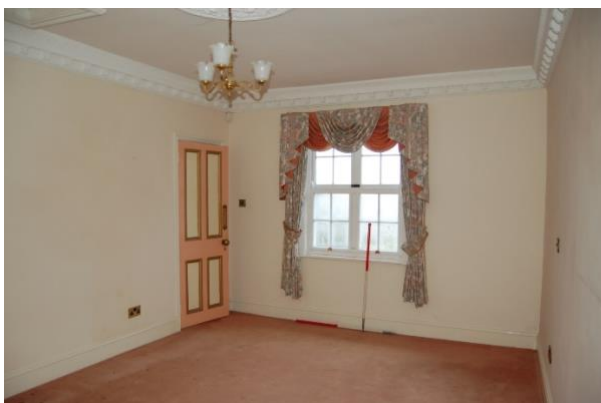
Figure 63: Ph (91).Room 20 facing south

- 4.26. Room 20 is situated to the southwest corner of the first floor of the of the west wing, accessed via a doorway to the east wall that leads to the lounge area. It was most recently used as a bedroom for the self-contained annex, and would also have historically been used for sleeping accommodation for the house staff. The room is plastered and painted and has decorative plasterwork including a dentilated cornice and a ceiling rose. The plaster work is later addition. The floor is laid with modern carpet. The window to the north retains the original timber frame.

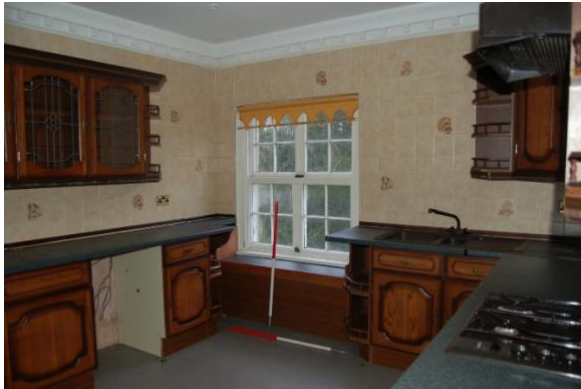
Figure 65: Ph (93). Room 21 facing north

4.27. Room 21 is situated in the northwest corner of the west wing, accessed via a plaster arched opening in the east wall, which leads to the first-floor landing. It was most recently used as the kitchen for the self-contained annex and would have historically been used for sleeping accommodation for the house staff. The room is decorated with modern tiles and a decorative plaster cornice. The chimney breast has been removed. The floor is laid with modern vinyl flooring.
