## **Arboricultural Impact Assessment & Draft Arboricultural Method Statement**

**Client:** Invicta Universal

**Site:** Little Lane, Desford, Leicestershire.

**Ref:** AIA-25-01-001

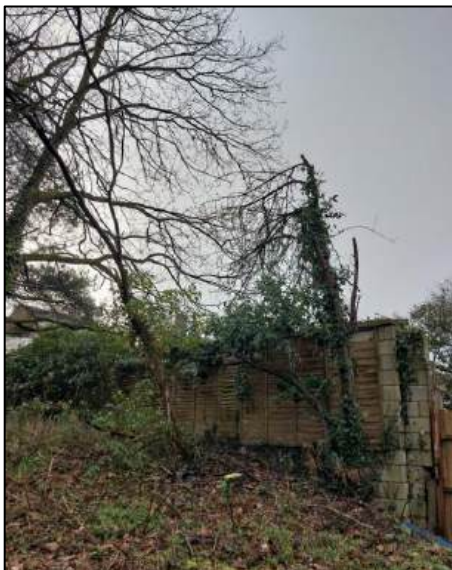
3.5.

- 3.3. The proposal will require the removal of four trees, one group and two part groups to facilitate the proposal.
- 3.4. One tree T003 Birch and Group G003 Apple (below) are recommended for removal regardless of the development.

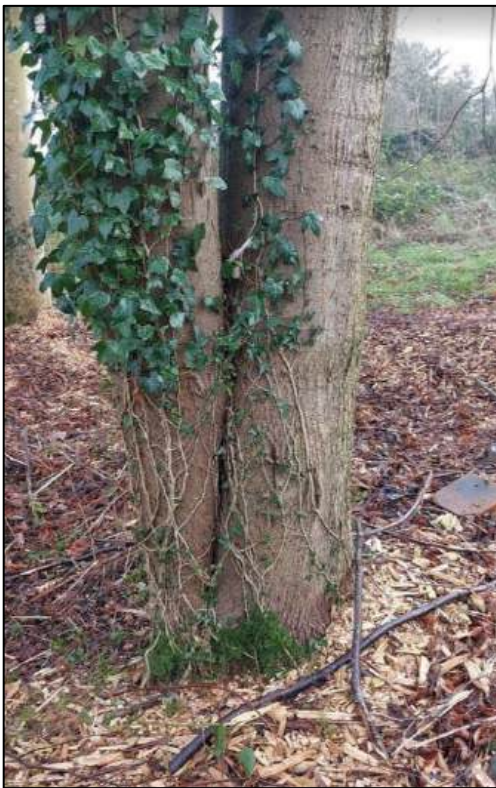
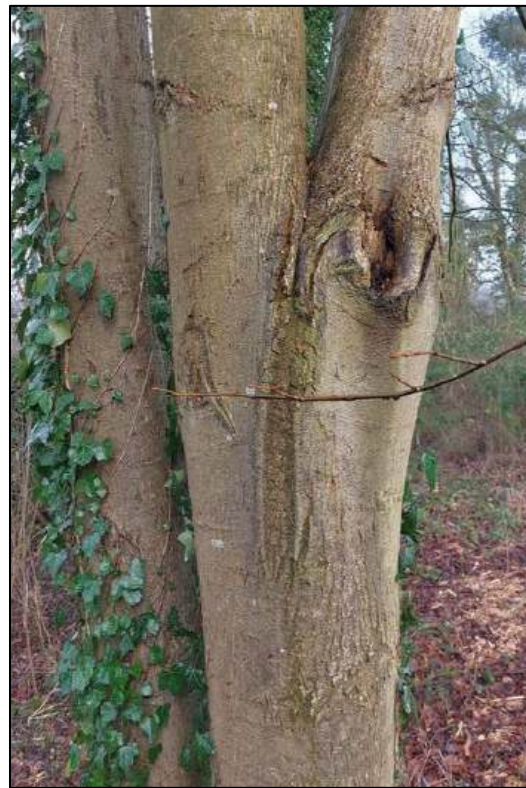
3.10.

- 3.9. The other tree T004 Lime (Below) is of low quality due to poor unions and is recommended due to the proximity to the proposed dwelling, and to allow creation of open garden space.
