# Arboricultural Appraisal Report

## Subsidence Damage Investigation at:

9 The Laurels  
Markfield Court Retirement Village  
Markfield  
Leicestershire  
LE67 9HA

| REPORT DATE: | 30-04-2018 |

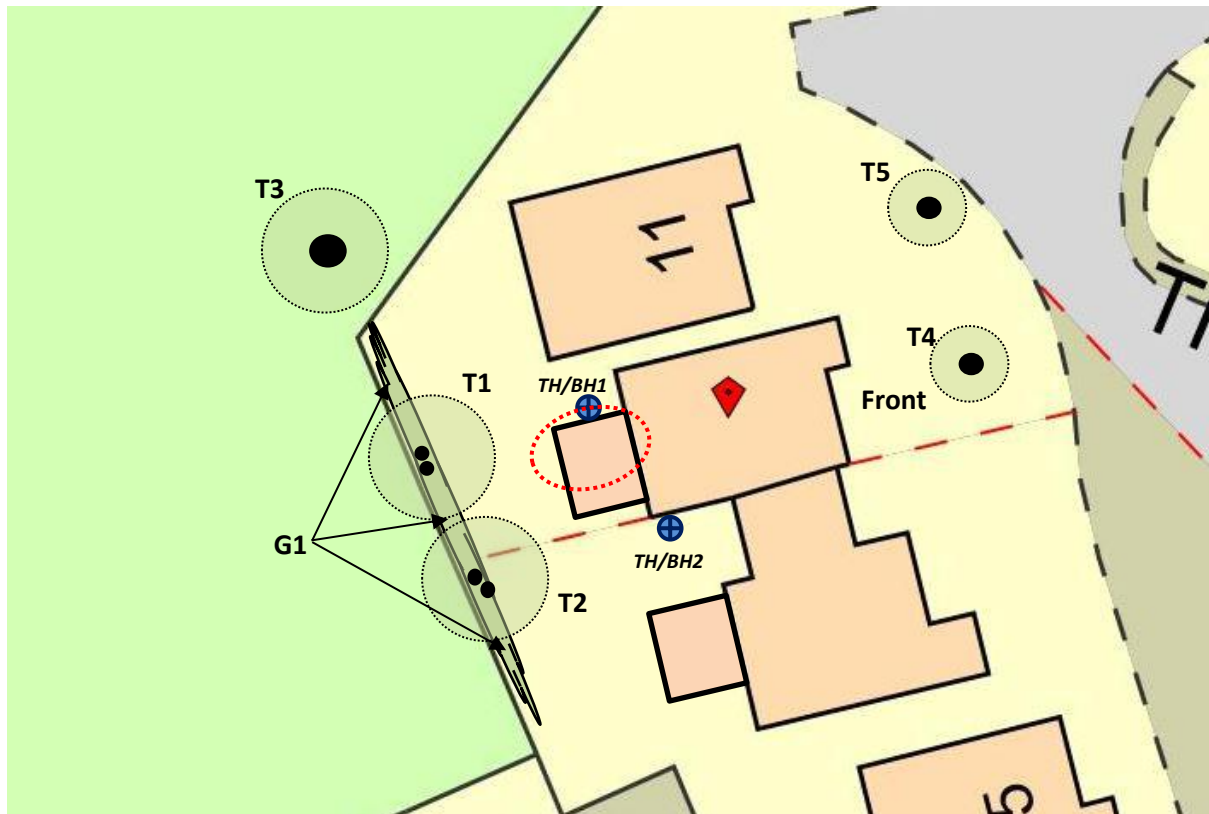
## SITE PLAN

Roots were observed to a depth of 2.2m and 2.3m and recovered samples from both boreholes have been positively identified (using anatomical analysis) as oak, the origin of which will be T1 and T2 confirming their influence on the soils below the foundations.

| Tree No. | Species | Ht (m) | Dia (mm) | Crown Spread (m) | Dist. to building (m) | Age Classification | Ownership |
|---|---|---|---|---|---|---|---|
| Recommendation | | Remove (fell) to near ground level and treat stump to inhibit regrowth | | | | | |
