**SOAKAWAY INVESTIGATION REPORT**  
**AT**  
**LAND OFF WATLING STREET,**  
**HINCKLEY**  
**FOR**  
**BEK LTD**

Report Reference: 3162-23 SA

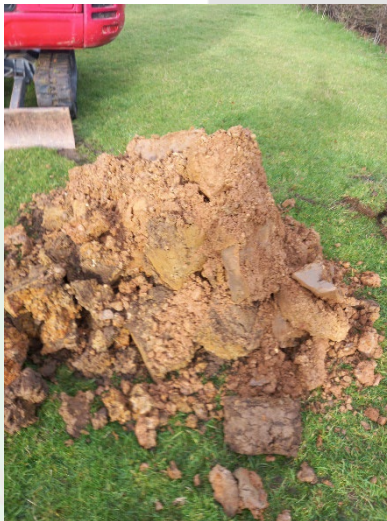
- I. Photograph of TP02 side wall
- J. Photograph of TP02 infiltration test.
- K. Photograph of TP02 airings
- L. Photograph of TP02 reinstatement.
