BS5837:2012 Tree Survey  
Land at 60 Main Street  
Carlton  
Leicestershire  
NGR SK40003 05120

| | Report ref:<br><b>P2801 /0823 /02</b> | C B E Consulting<br>Highbank, 5 Grantham Road, Navenby<br>Lincoln. LN5 0JJ.<br>Telephone (01522) 810086.<br><a href="http://www.cbeconsulting.co.uk">www.cbeconsulting.co.uk</a> |

# **BS5837 Tree Survey, Land at 60 Main Street, Carlton**

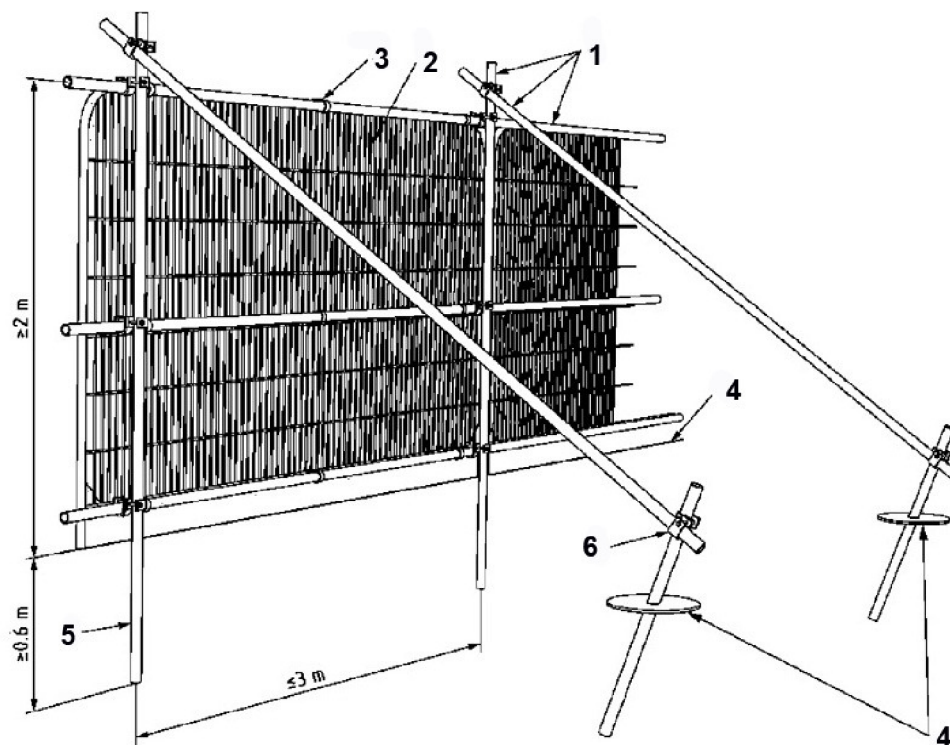
1. Standard scaffold poles
2. Heavy Gauge 2m tall galvanised tube and weld mesh infill panels
3. Panels secured to uprights and cross members with wire ties
4. Ground Level
5. Uprights driven into ground until secure (up to 0.6m)
6. Standard scaffold clamps

- Fencing must be clearly visible and suitable for the location, type and proximity of construction activity.

- It may be appropriate on some sites to use temporary site offices as components of the protection barriers.
